## Verification Report

009

GCL - Clarendon Road PHASE 3

DATE: 29/01/2021

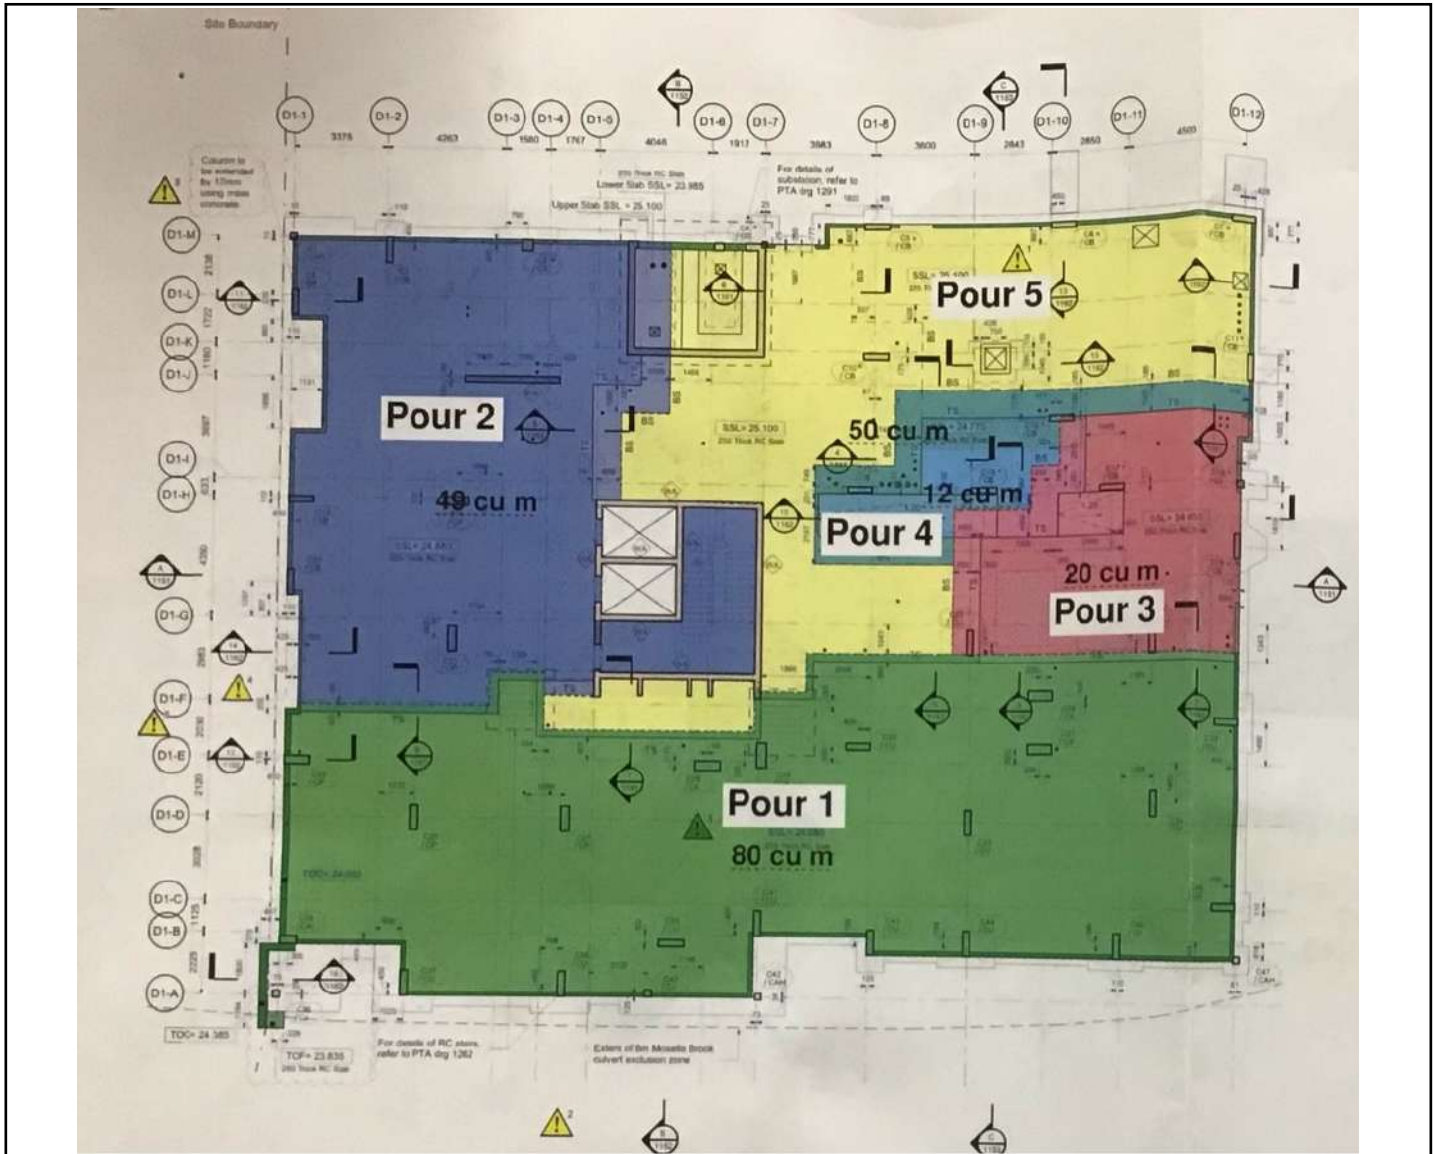
Verification of Block D1 Pour 3, 4, and 5 took place during this visit. Pour 3 and 4

have now been verified and signed off. Pour 5 will need another visit before the

area can be signed off.

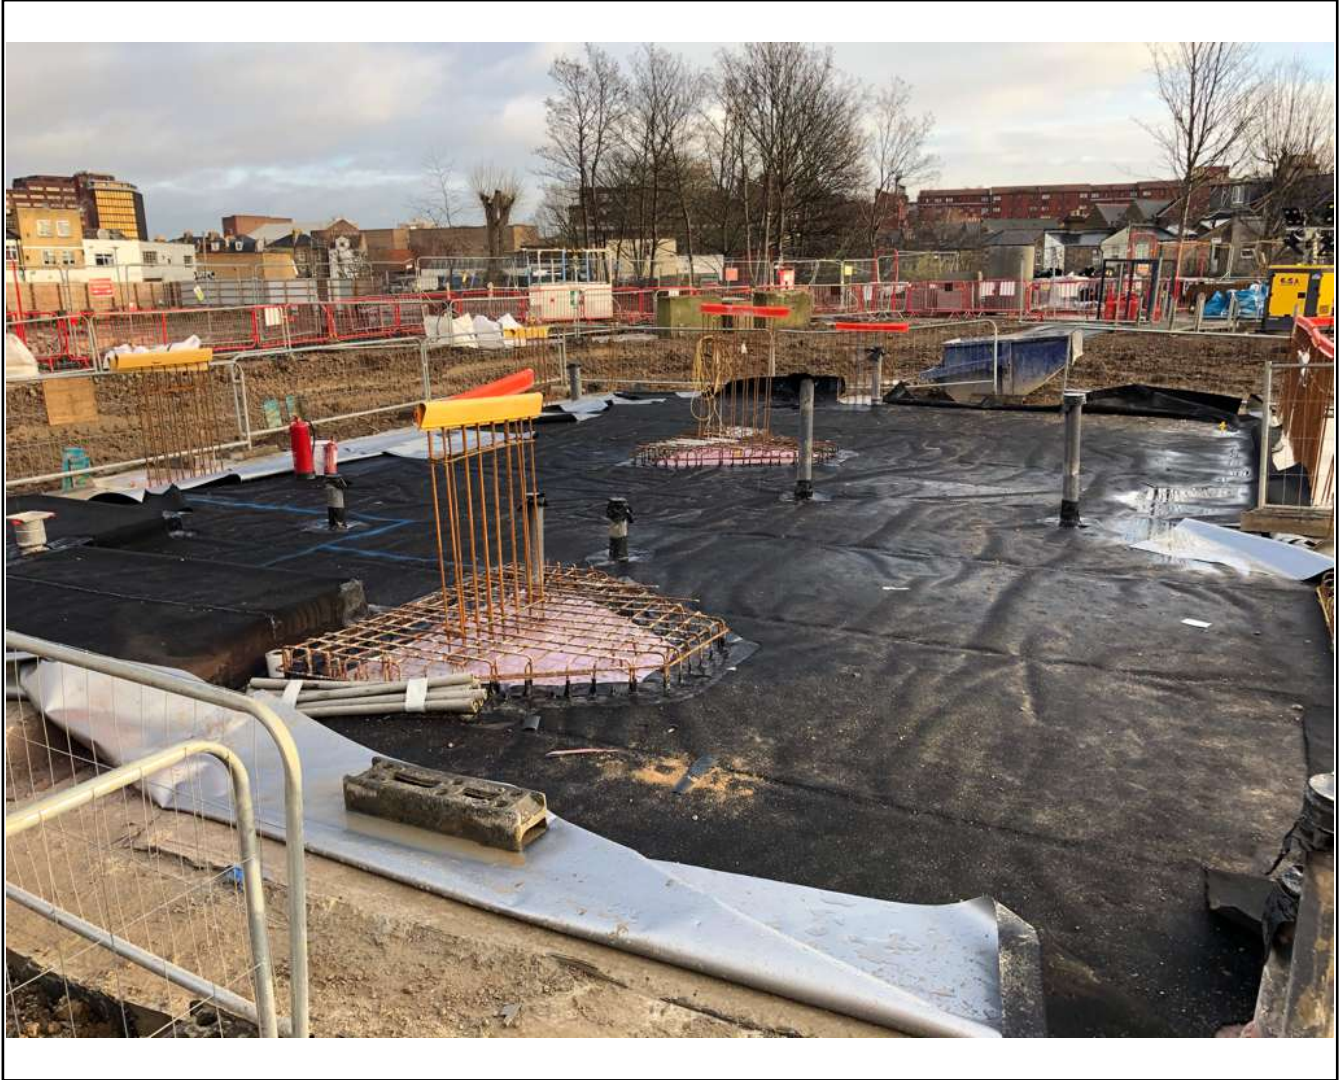
The photograph above shows the area of Block D2 which was verified during this visit. The installers have installed the Pudlo GP Ultra+ Gas Barrier to the area but not all details have been completed.

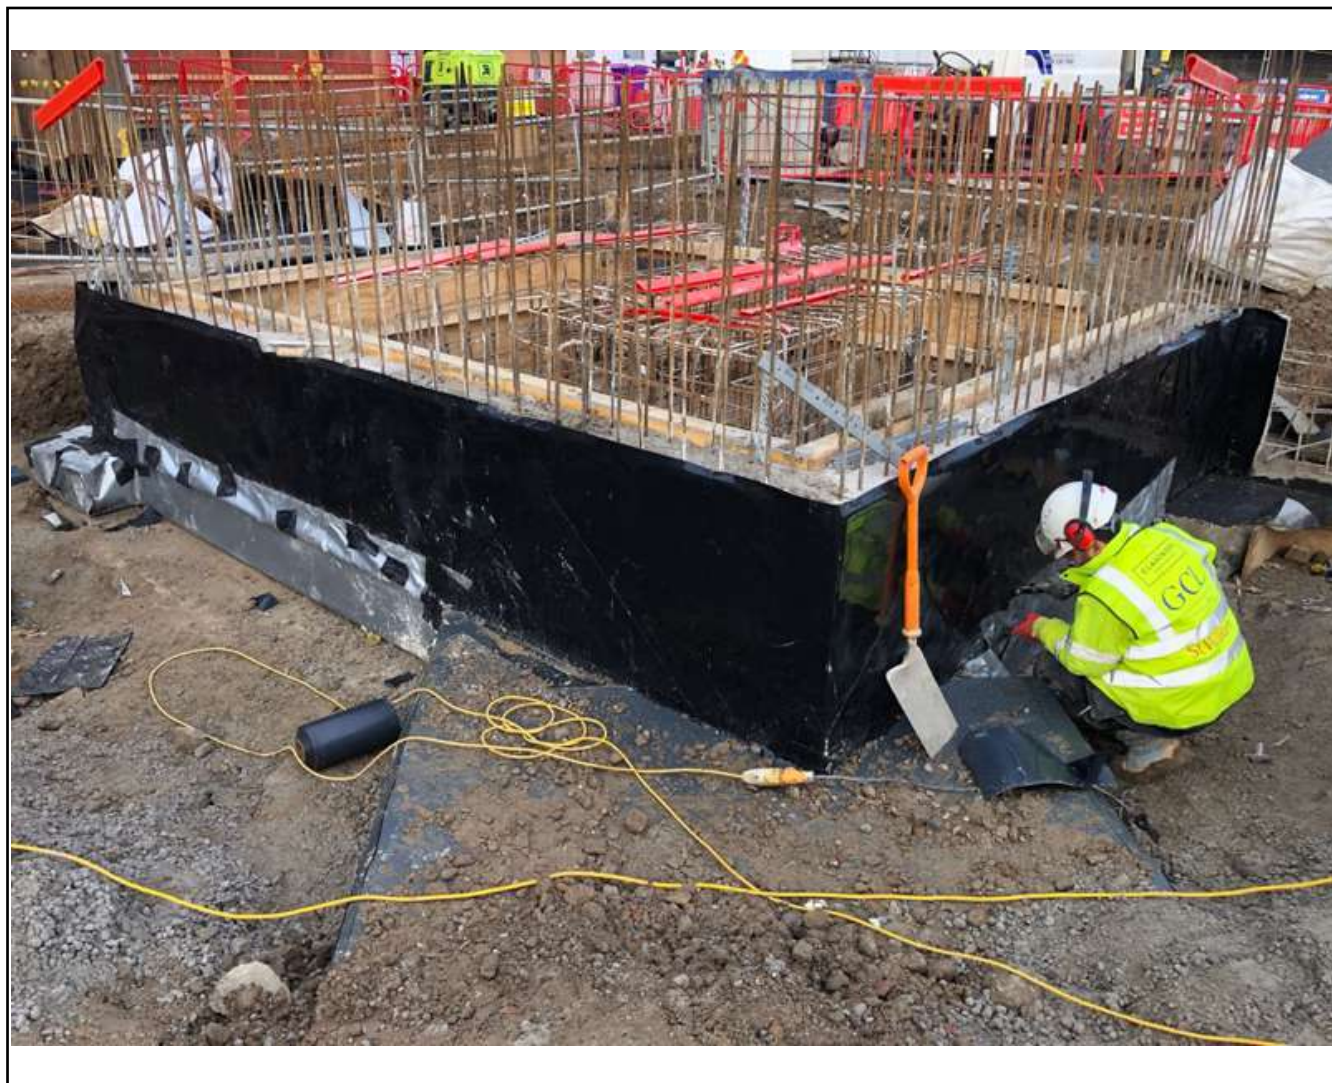
The photograph above shows Block D1 substation which has been wrapped and verified during this visit.

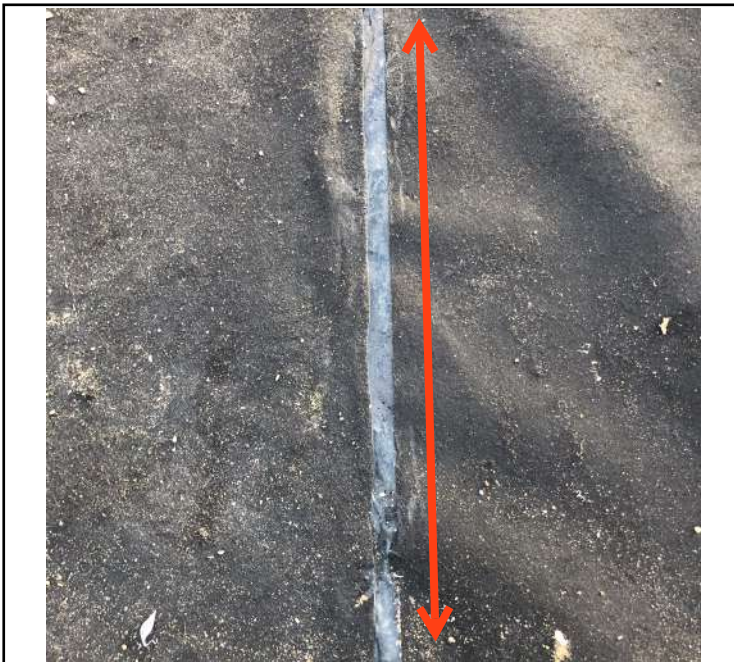
The first photograph below shows an overview of a welded lap of the Pudlo GP Ultra + Gas Barrier. The installers have used a hot air leister and roller to achieve a consistent 40mm weld.

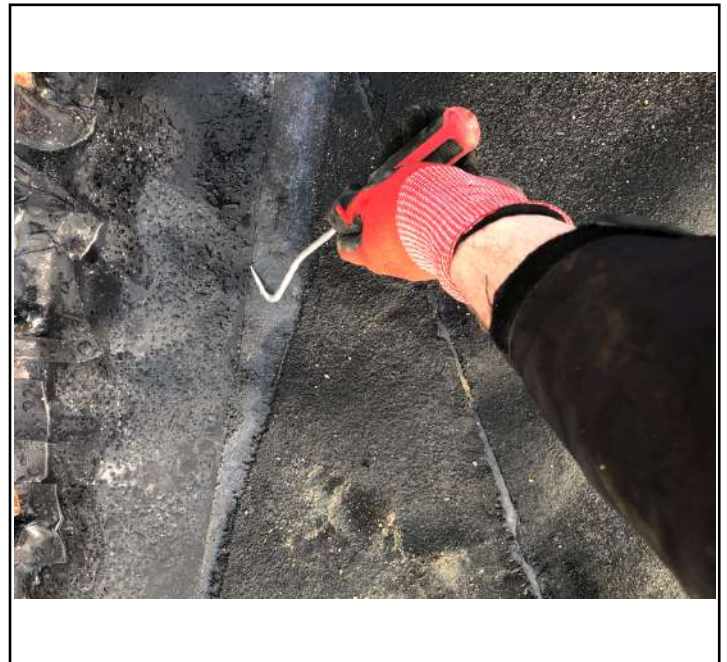
The second photo above shows a pick and probe test carried out to a welded lap.

No faults or defects identified. Verified in accordance with CIRIA 735.

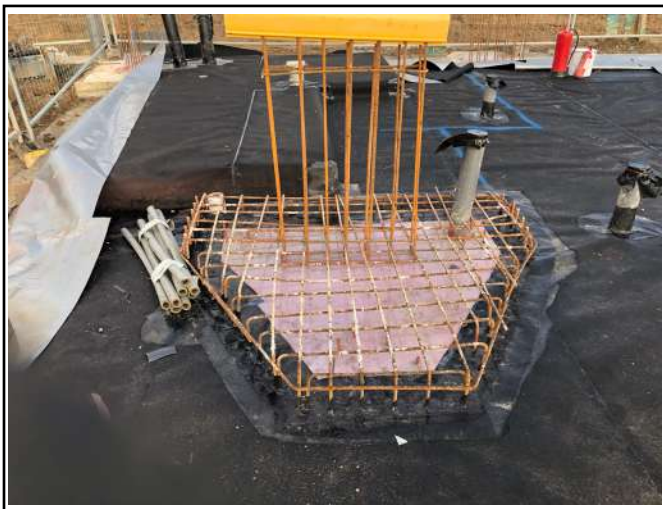
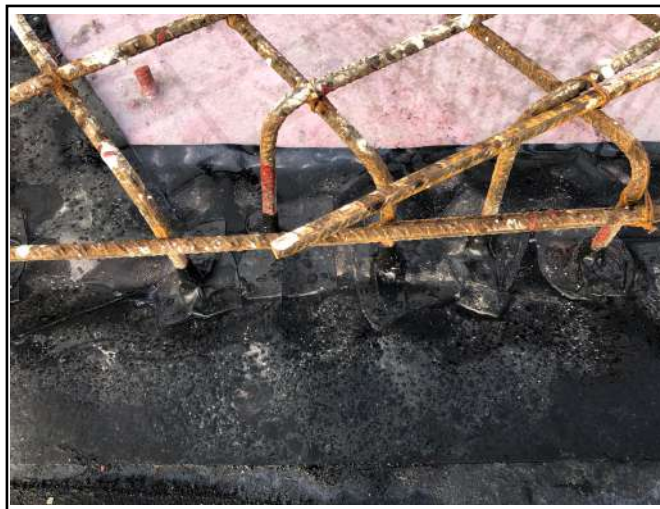
The two photographs below show examples of sealed piles. The installers have first applied a coat of Pudlo liquid membrane to all pile heads. Once dry the installers have the used a hot air leister and roller to adhere the EXT tape to the membrane and ...

.... the painted pile head. The installers have also used the EXT tape to seal each steel bar. The Dina tellers have achieved a strong seal.

No faults or defects identified.

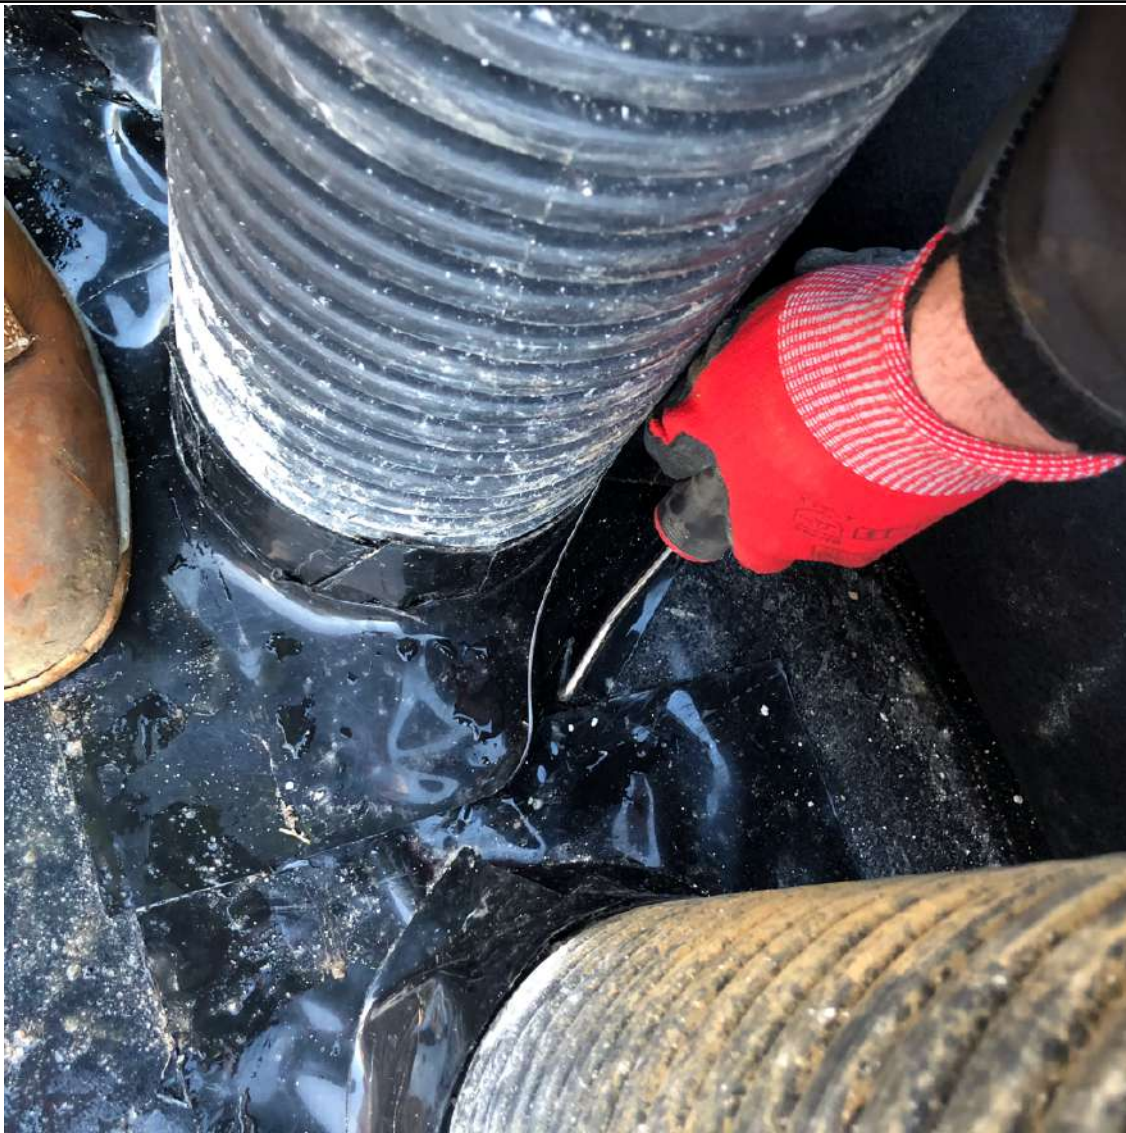
The photograph above shows a pick and probe test carried out to a sealed pipe

penetration. The installer have used a hot air leister and roller to achieve a good

seal. No faults or defects identified.

Verified in accordance with CIRIA 735.

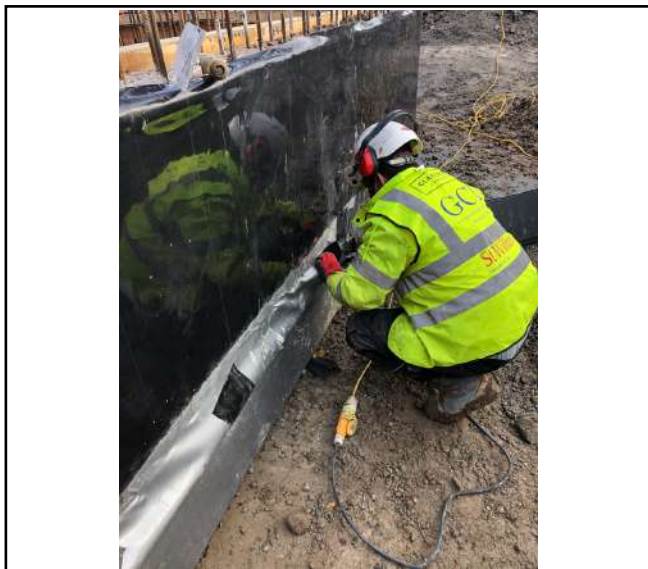
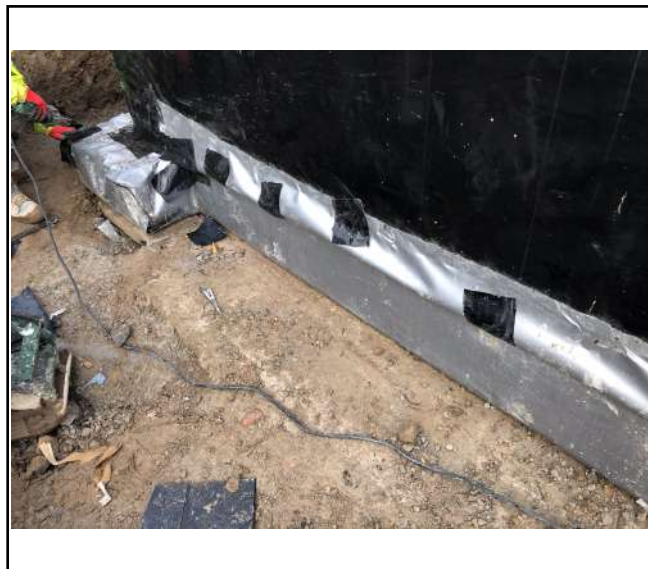
The first photograph below shows the installers have wrapped the substation. They first applied a coat of primer to all areas of concrete where the tanking had been adhered to. The installers have then welded the previously installed membrane....

... to the newly installed tanking. A large number of holes were identified in the Pudlo GP Ultra+ Gas Barrier installed to the base of the substation. As shown in both photos above the installers have patched all the holes using EXT tape and a hot air leister and roller to aid in the adherence of the patches.

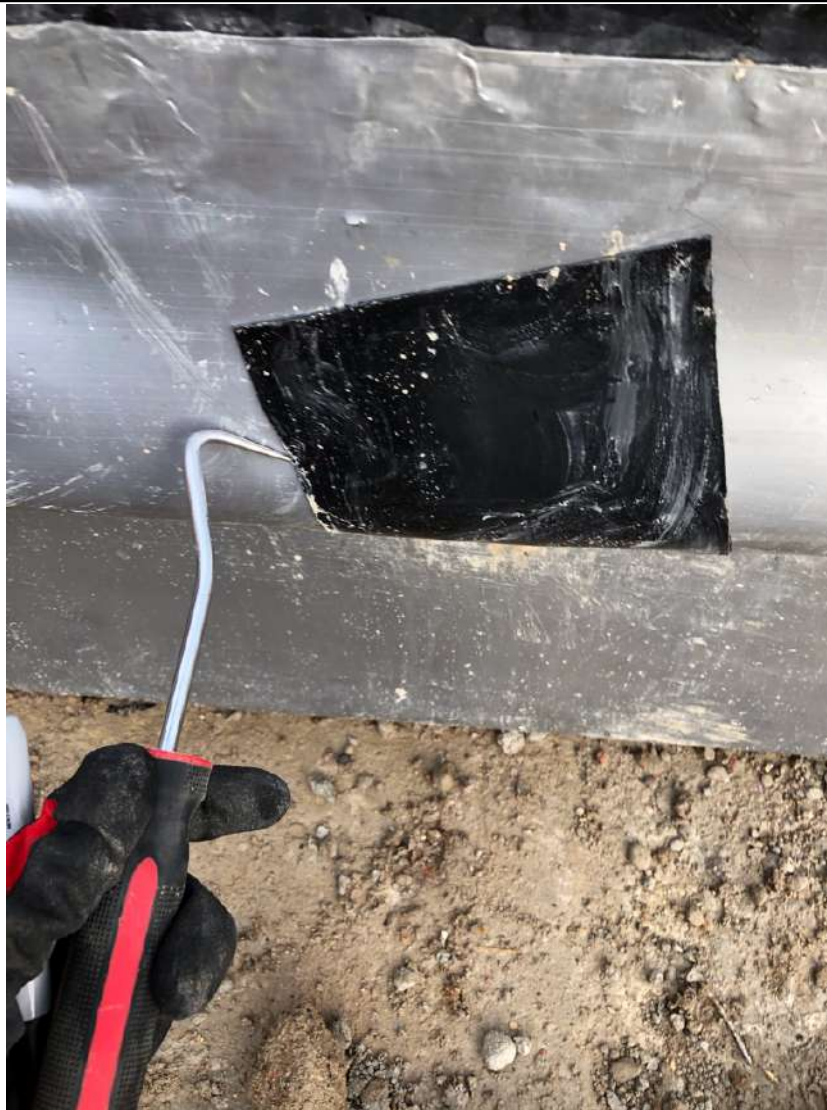
The photograph above shows a pick and probe test carried out to a patched hole which was identified when inspecting the Substation. A strong seal has been achieved by the installers. No faults or defects identified.

Verified in accordance with CIRIA 735.

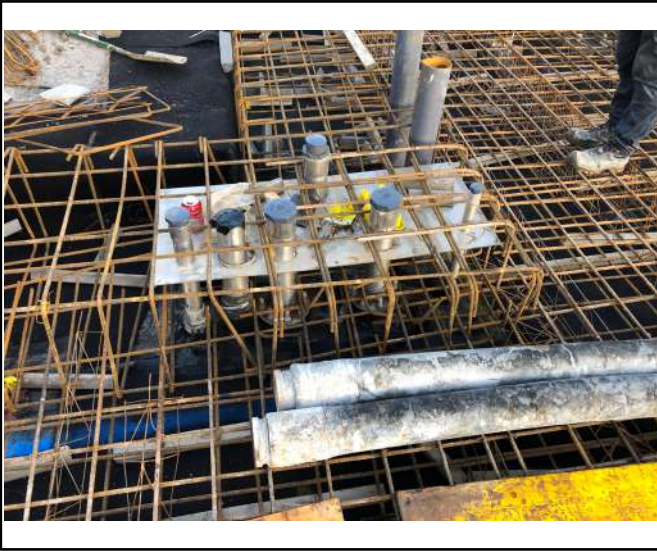
Penetrations from last visit have now  
been sealed.

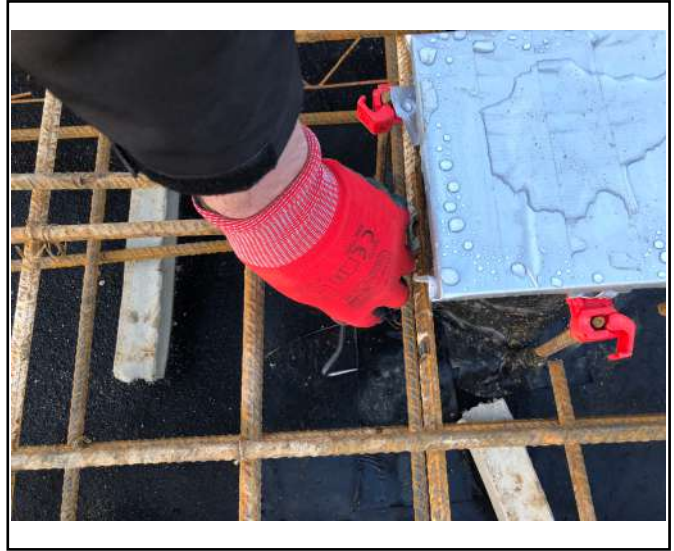
Pick and probe test to penetrations  
through steel.

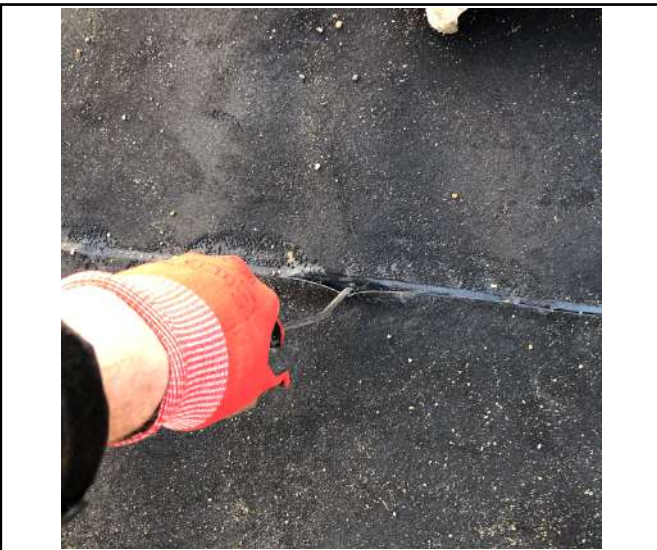
Fault identified in welded lap.
