## Verification Report

GEO101436

010

GCL - Clarendon Road PHASE 3

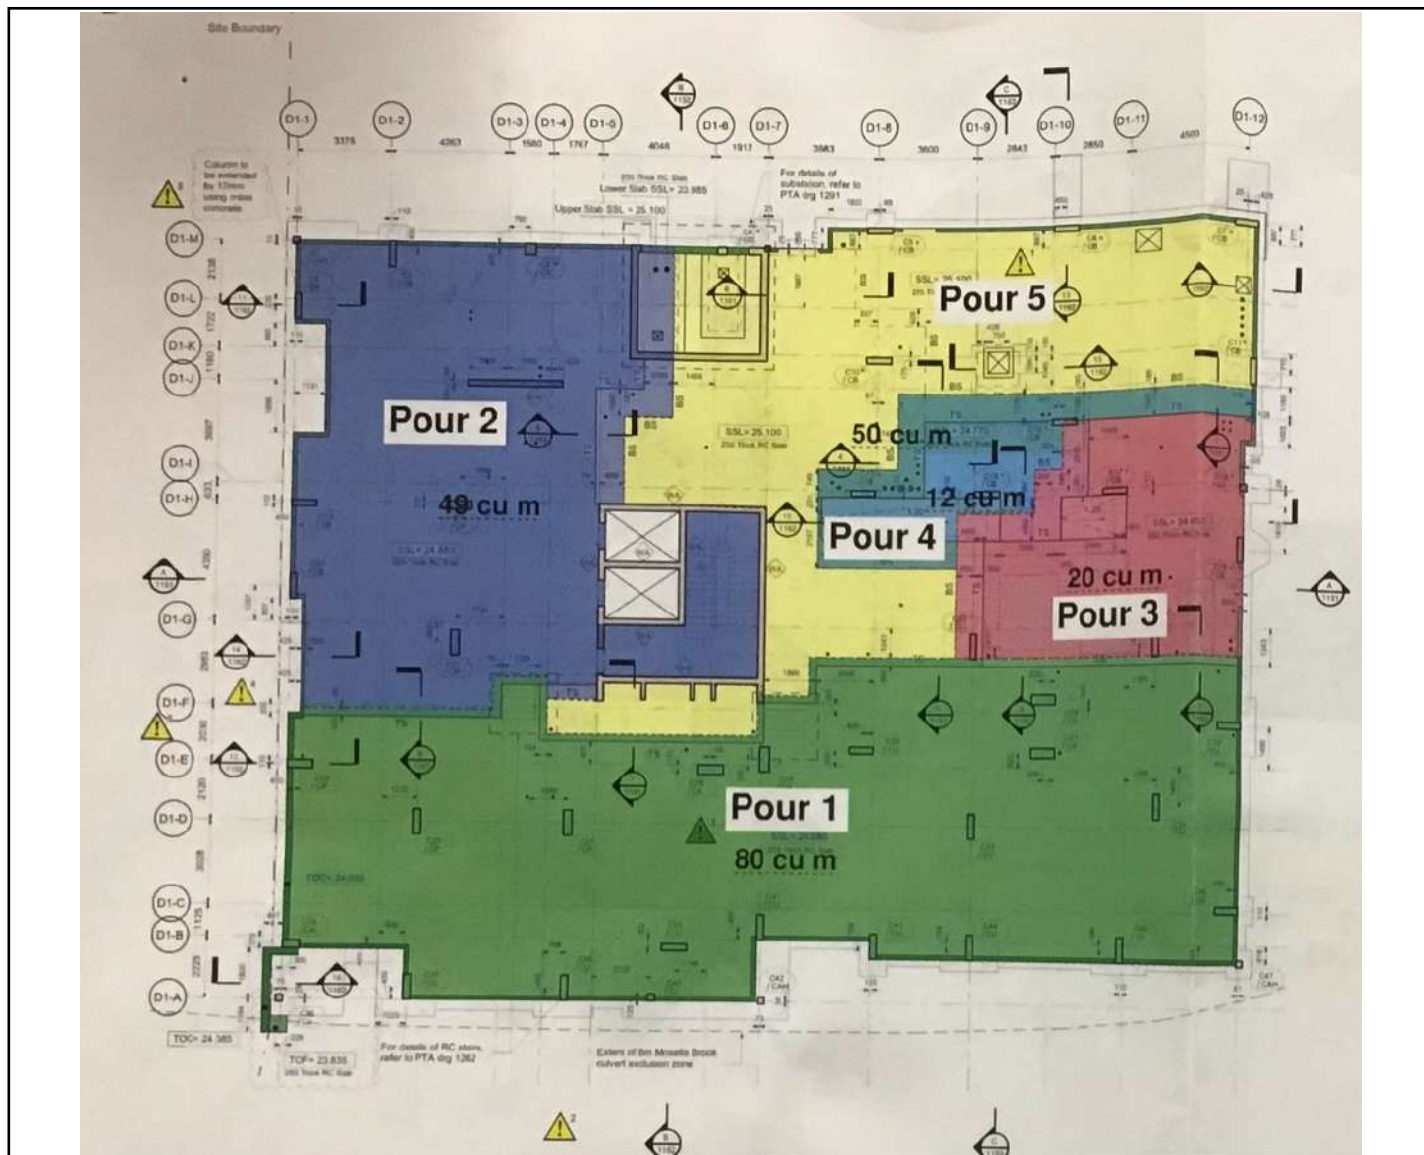
The pour sequence above shows where the areas have been inspected for block D1.

Pour 2 + 5 have been inspected and signed off during this visit.

Block D1 slab installation is now complete - termination detail remains to be verified.

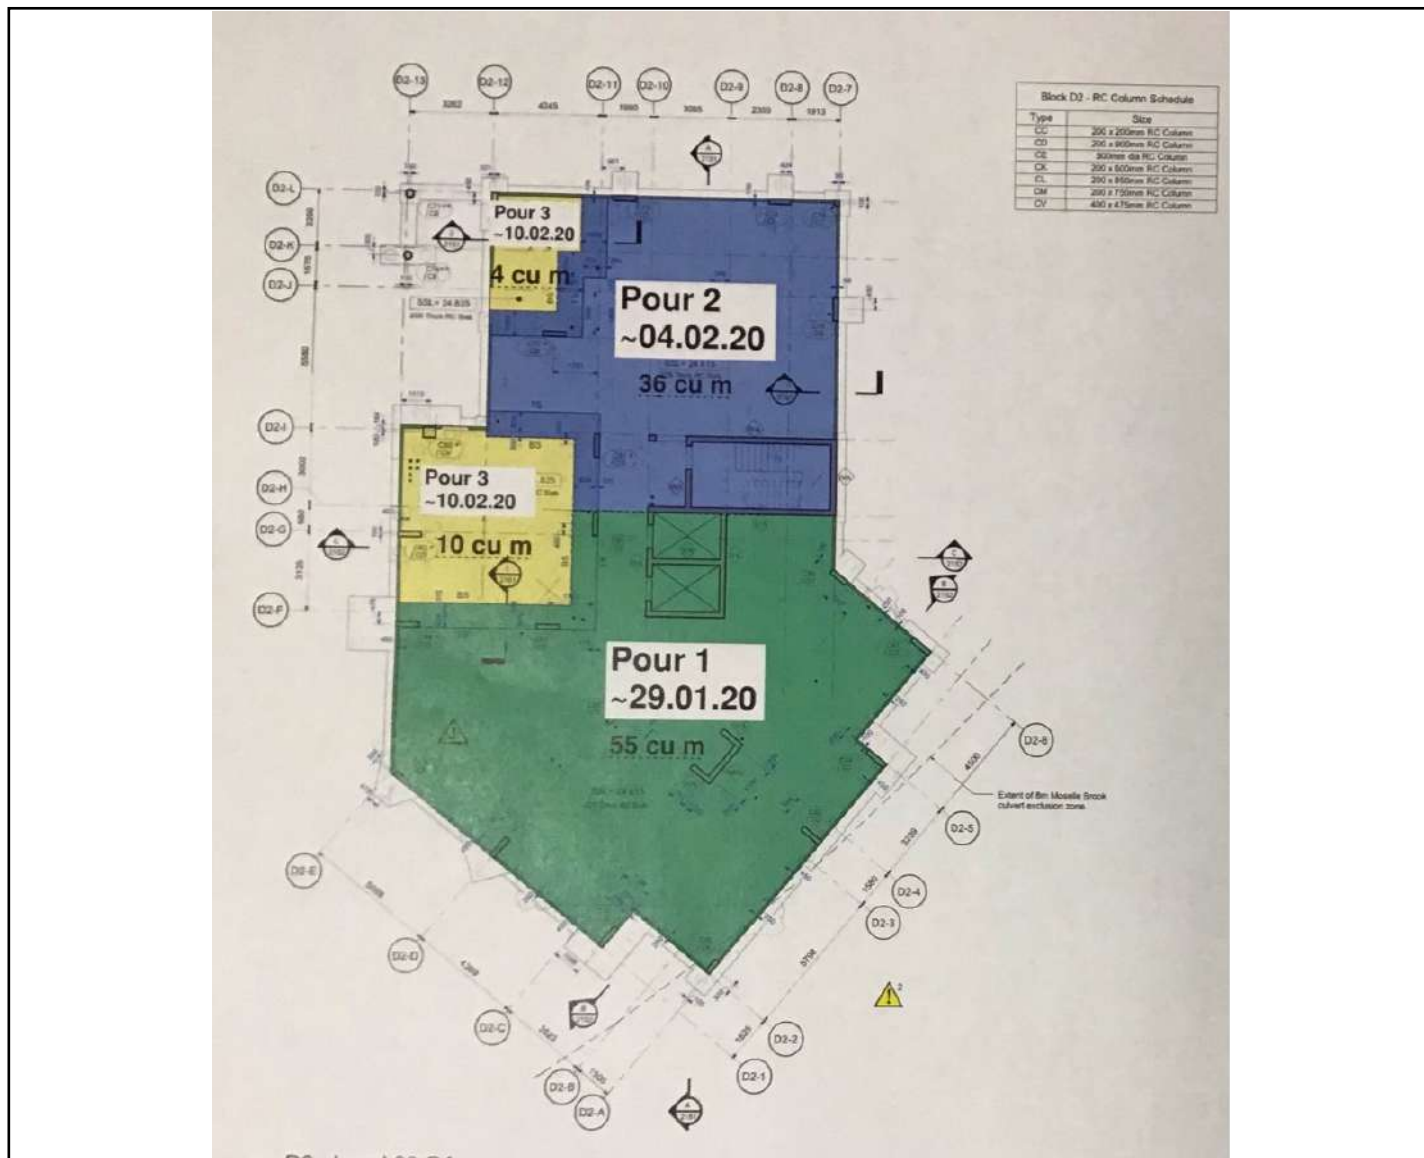
The pour sequence above shows where the areas have been inspected for block D2.

All pours shown have been inspected and signed off during this visit.

Block D2 slab installation is now complete - termination detail remains to be verified.

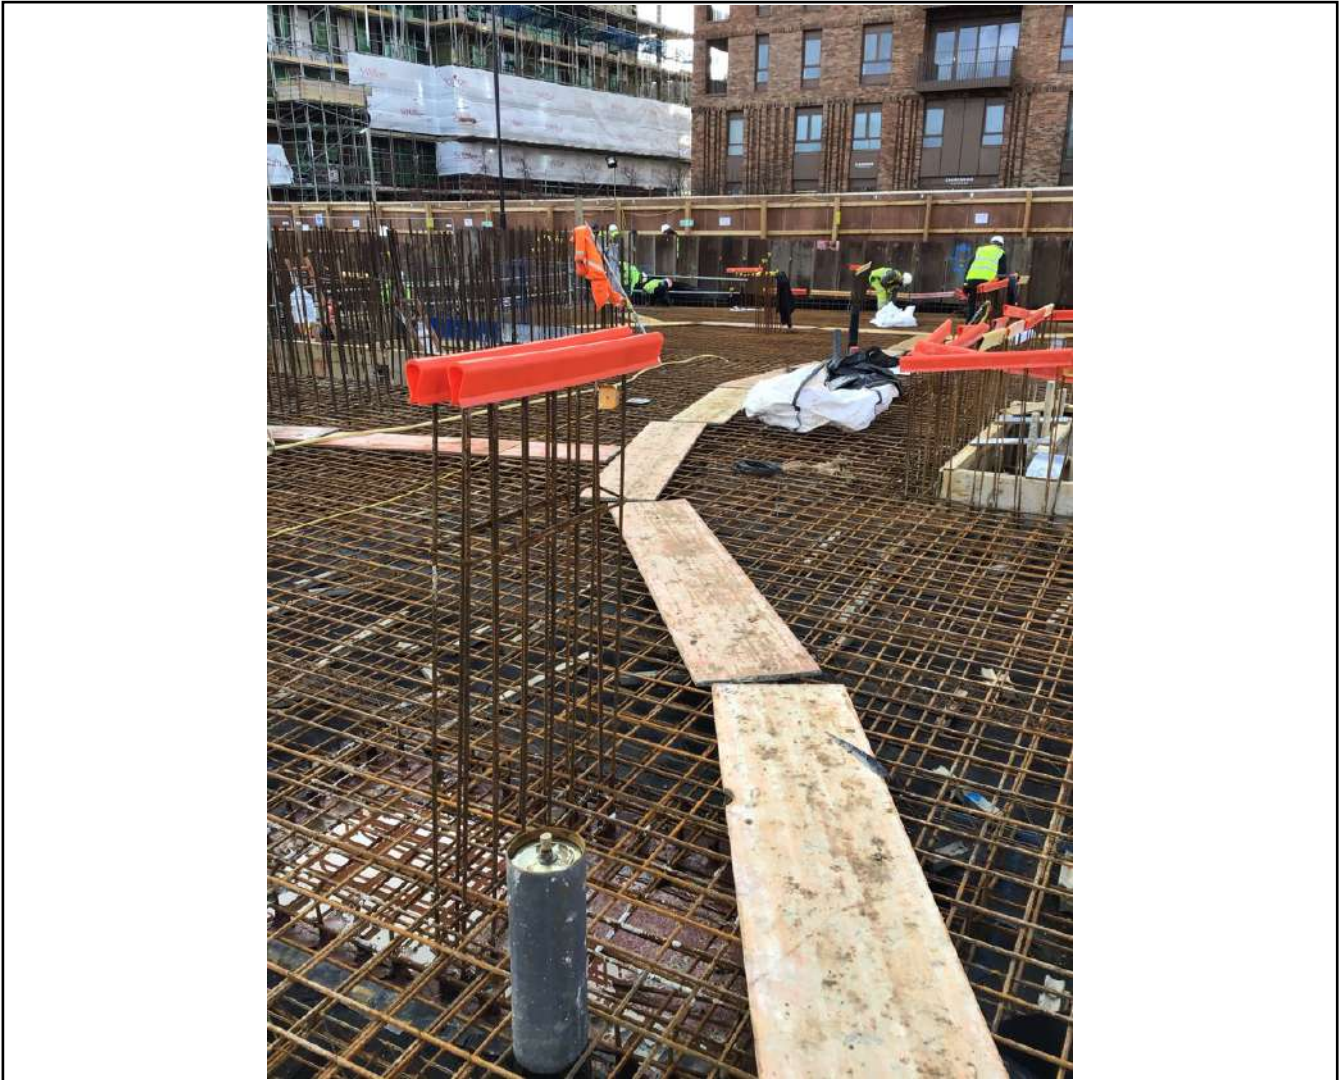
The photograph above shows the area of Pour 2+5 Block D1 was verified during this visit. The installers have installed the Pudlo GP Ultra+ Gas Barrier and sealed all details as per manufacturers specification.

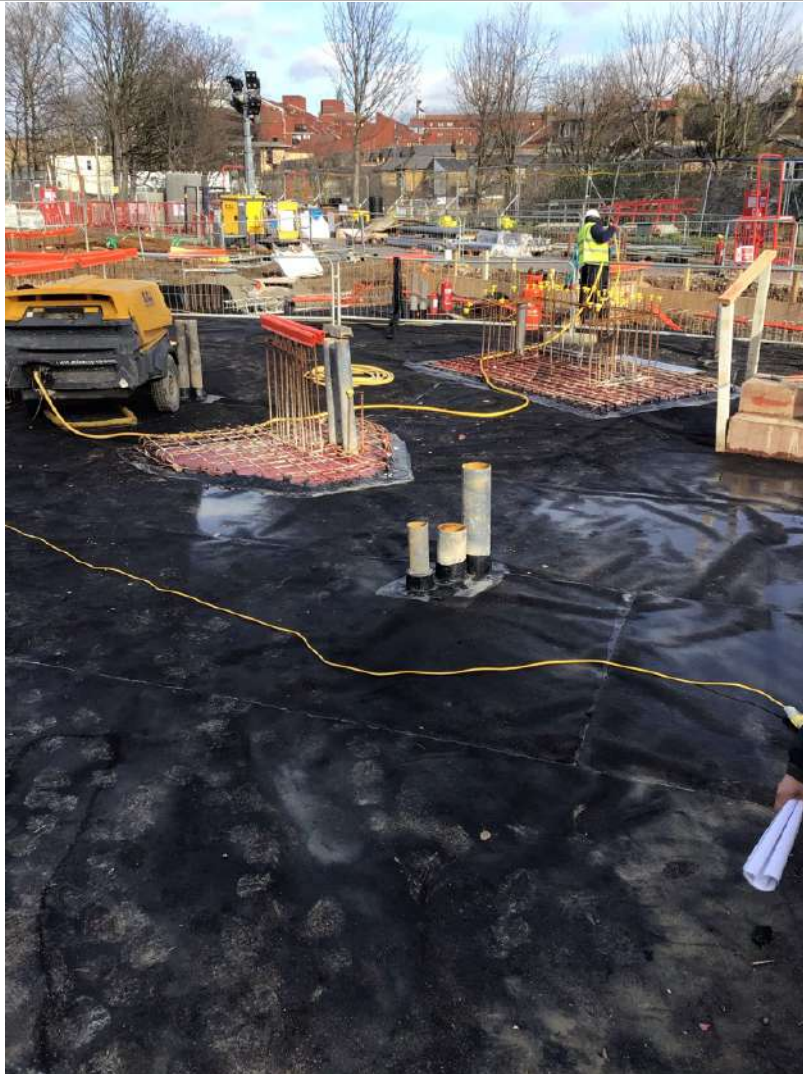
The photograph above shows Block D2 slab area which has been completed and verified during this visit.

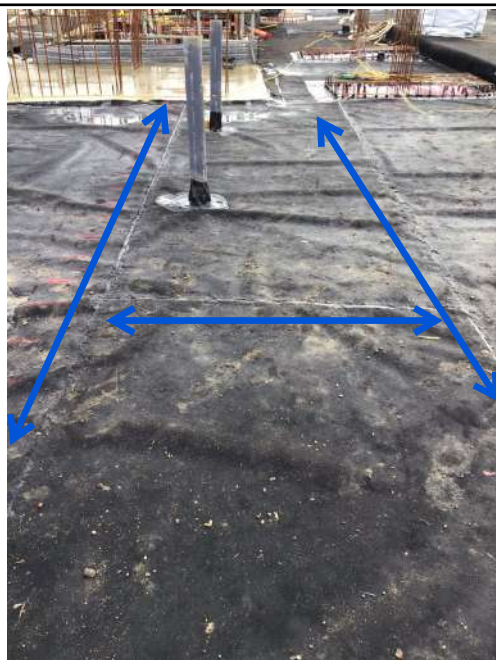
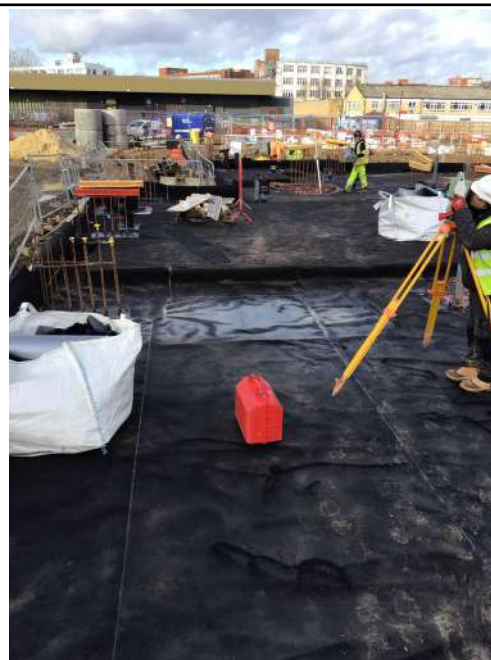
The two photographs below show overviews of the welded laps of the Pudlo GP Ultra + Gas Barrier. The installers have used a hot air leister and roller to achieve a consistent 40mm weld.

The installers have used the 100mm lap present in the membrane, where the fleece is removed, to allow the weld to take place.

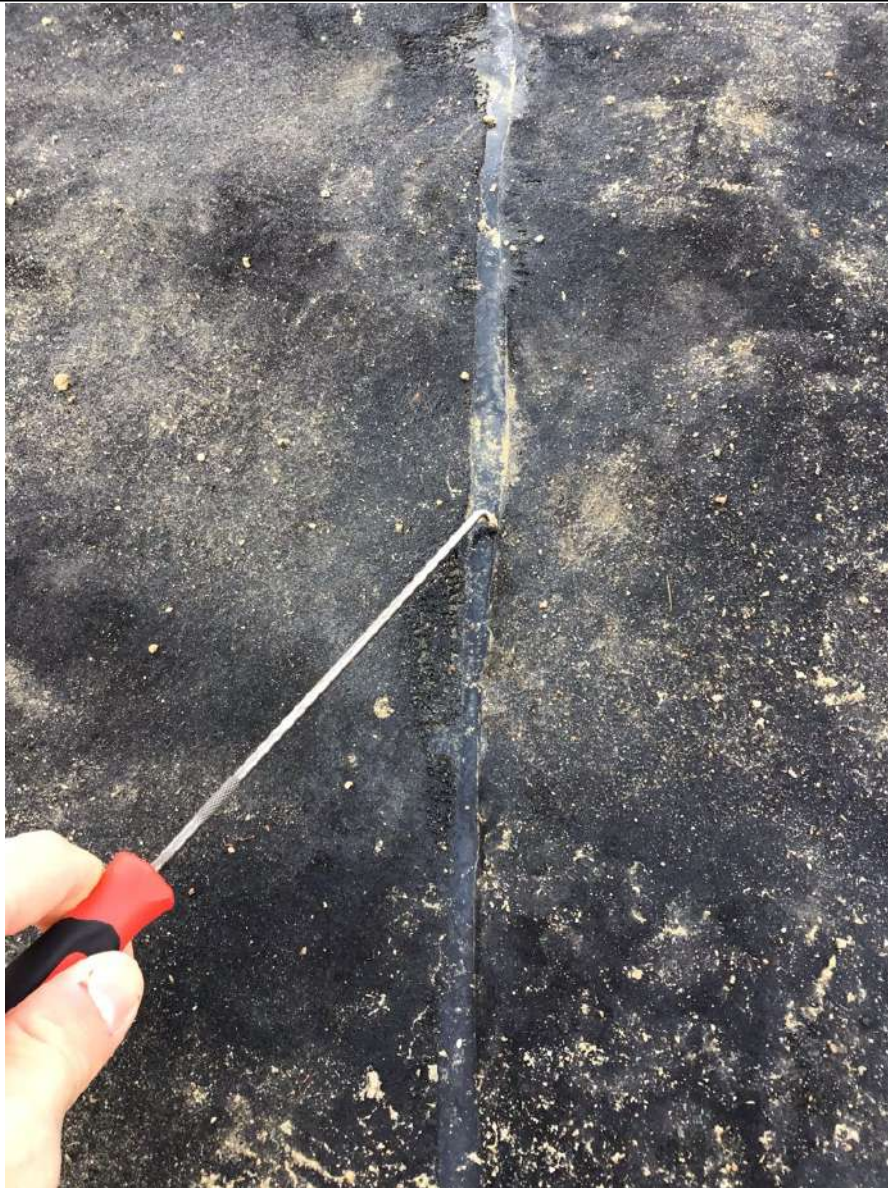
The photograph above demonstrates a pick and probe test being carried out to a welded lap joint, within the verified on Block D2. All joints and laps have been verified using a constant visual, pick and probe method, as well as an air lance integrity test.

3 x mis-welds identified during this visit, all of which have been remediated during visit.

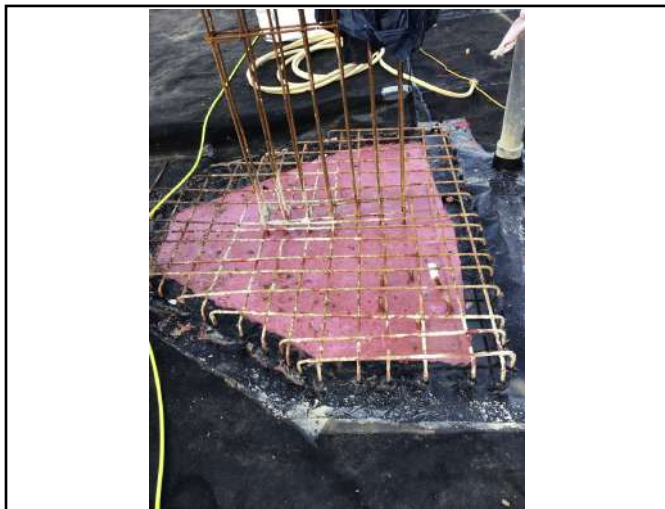
The first photograph below shows an overview of a sealed pile head detail, within Block D2. The installers have sealed all pile head details within block D2, as per the design detail, using pudlo liquid gas barrier and pudlo ext tape.

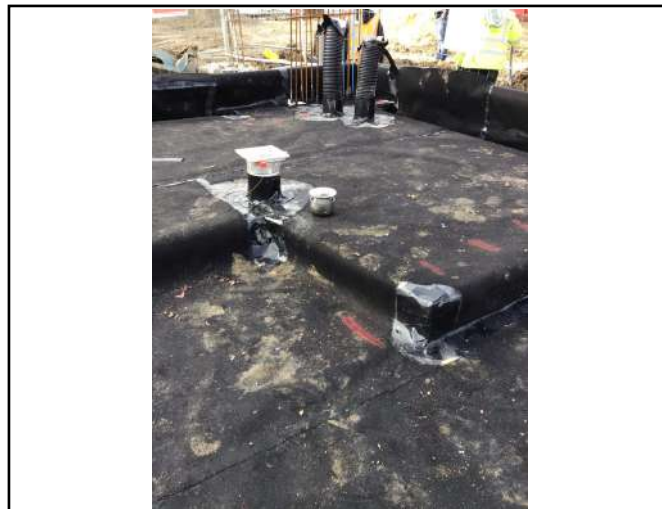
The second photograph above shows examples of corner details and pipe penetration details, also sealed within the slab area of block D2. The installers have removed the fleece facing from the pudlo GP+ Ultra gas barrier, before applying any pudlo Ext tape.

The pipe penetrations and corner details have been sealed to manufacturers specification, with no holes or gaps being identified during the inspection visit.

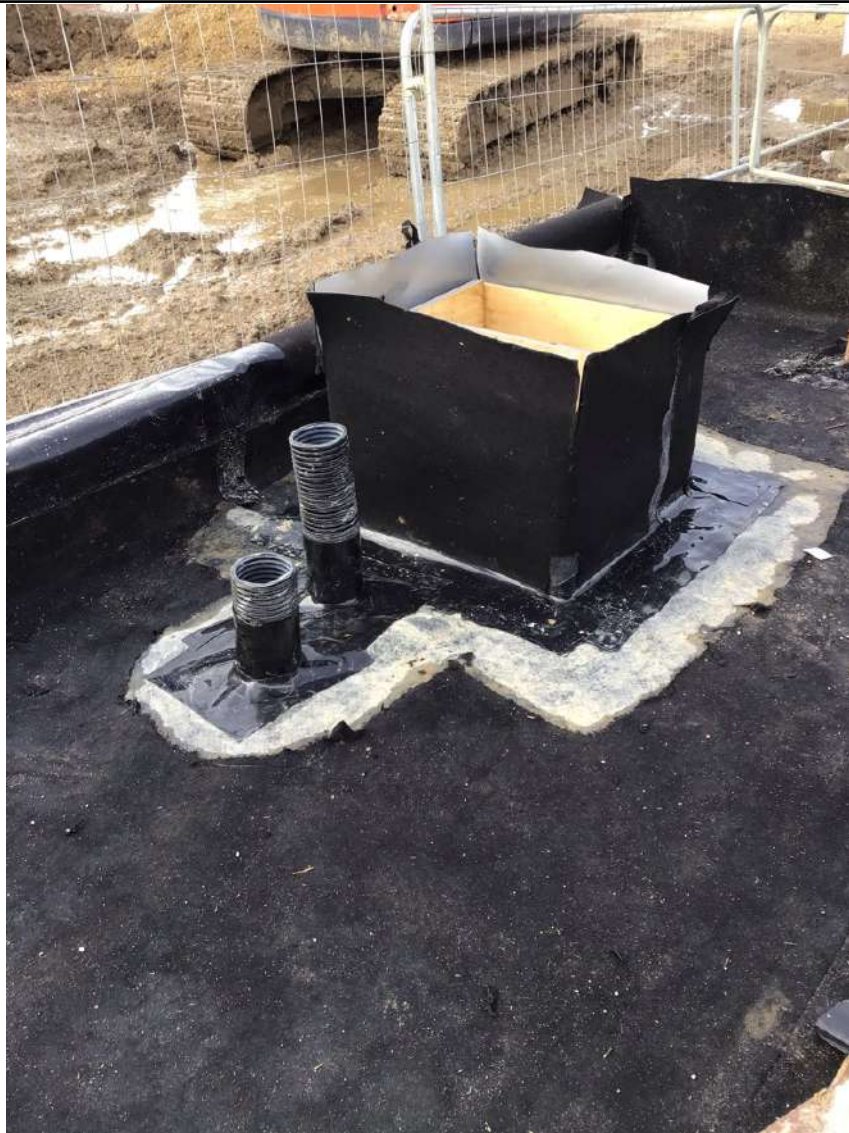
The photograph above again portrays examples of sealed details within the slab verified on Block D2. The installers have again sealed the pipe penetration details as per manufacturers specification. They have also taken the membrane around the temporary shutter, where pipe penetrations may be inserted at a later date.

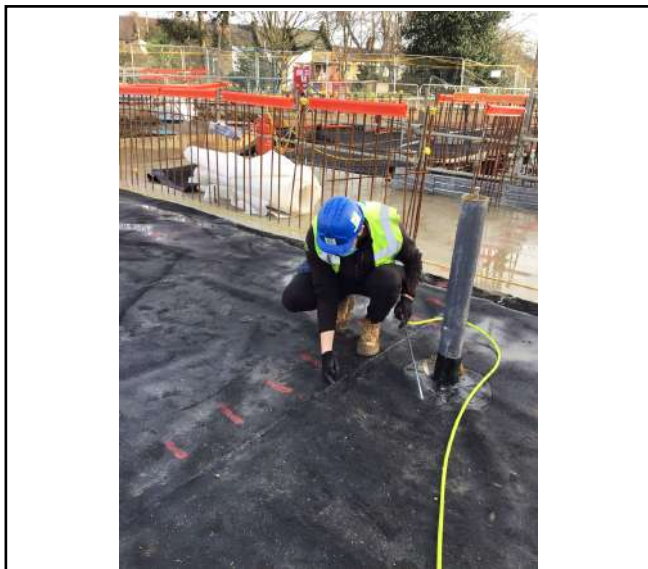
The first photograph below shows a demonstration of where a fault was found in the welding of lap joints, during the air lance integrity testing. The fault is identified to the installation team, who rectified the error, during the site inspection visit.

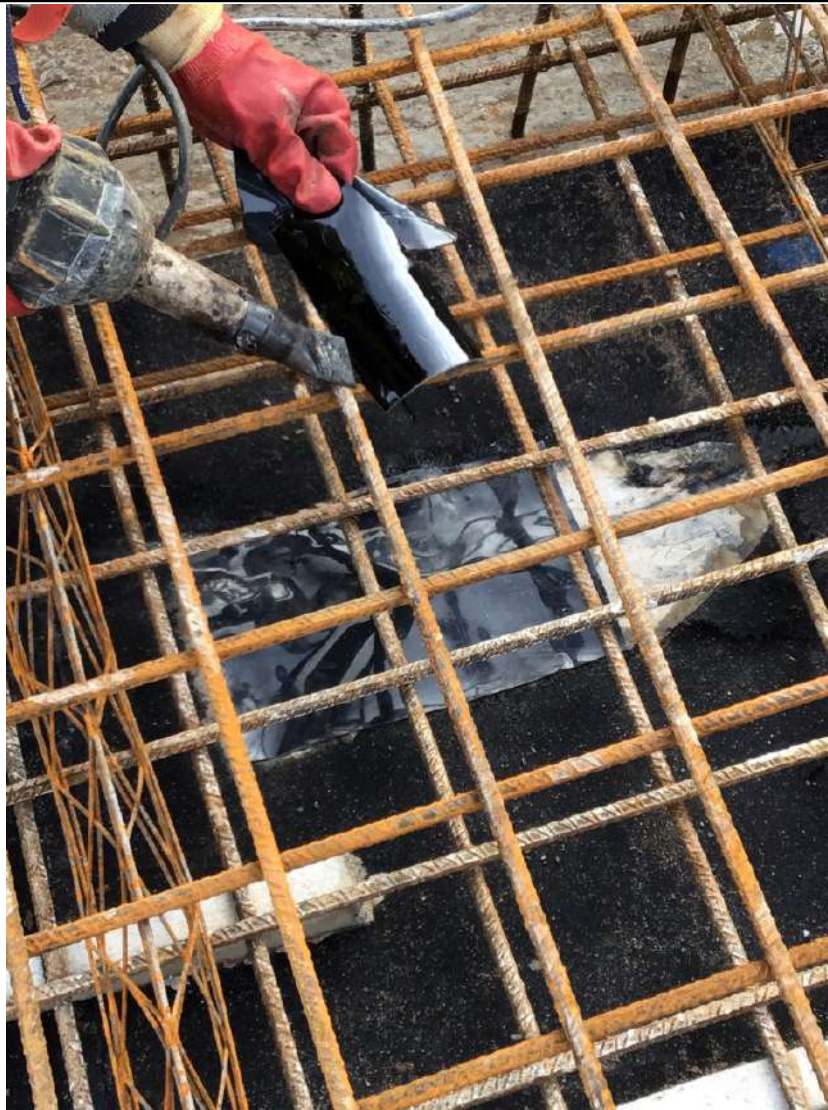
The photograph above demonstrates the installer from GCL repairing a hole found in the GP+ ultra gas barrier, on pour 5 of Block D1. Although the steel reinforcement bars had already been installed, the membrane could still be visually inspected, and the installers also had enough room to repair the hole found, as shown above.

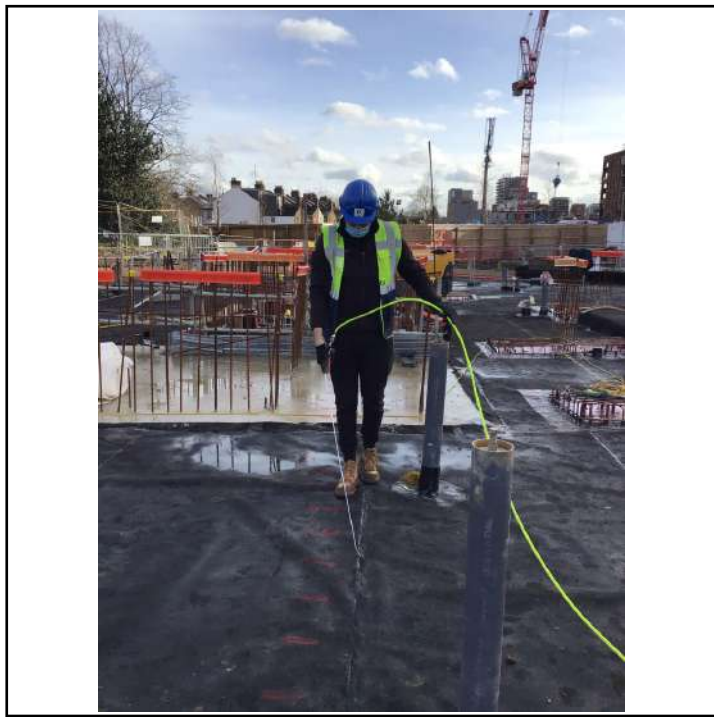
Air lance integrity test being carried out to welds.

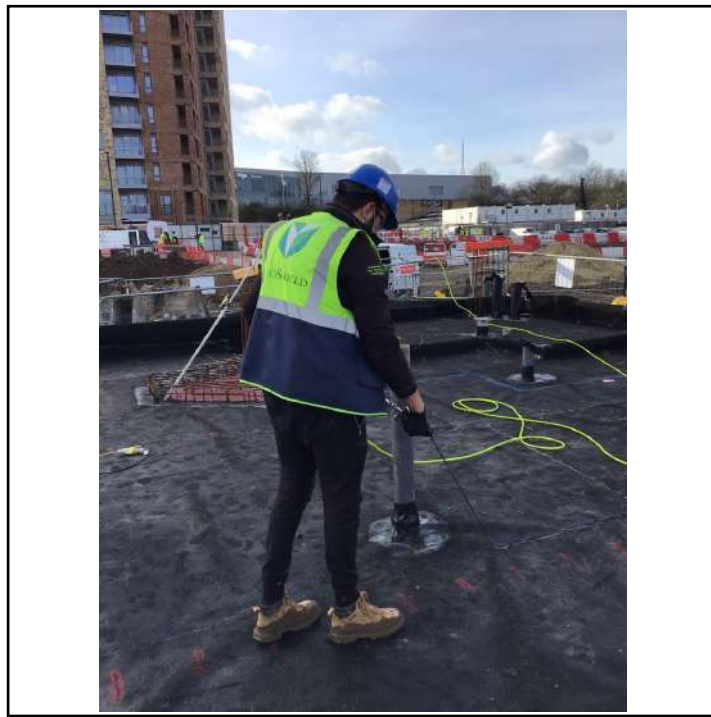
Air lance test again being carried out.

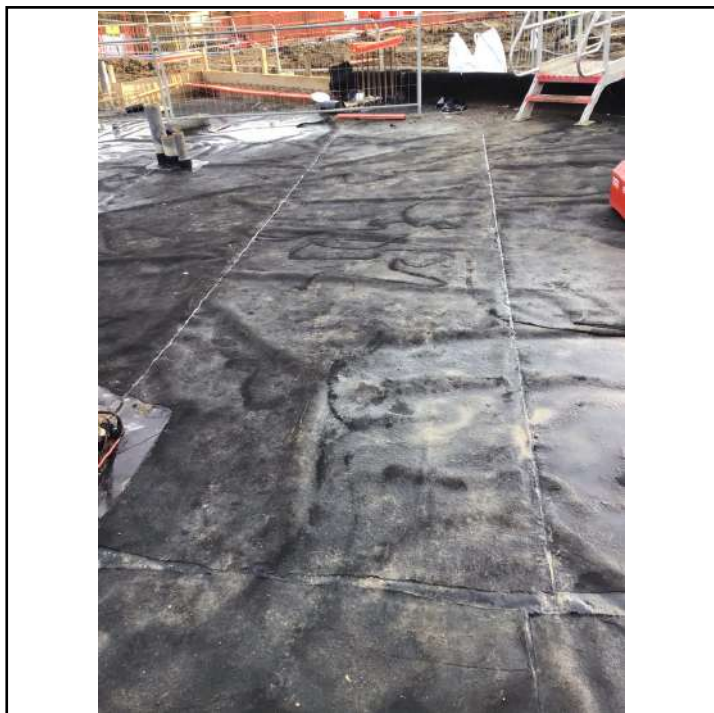
Example of two welded joints air lance tested.

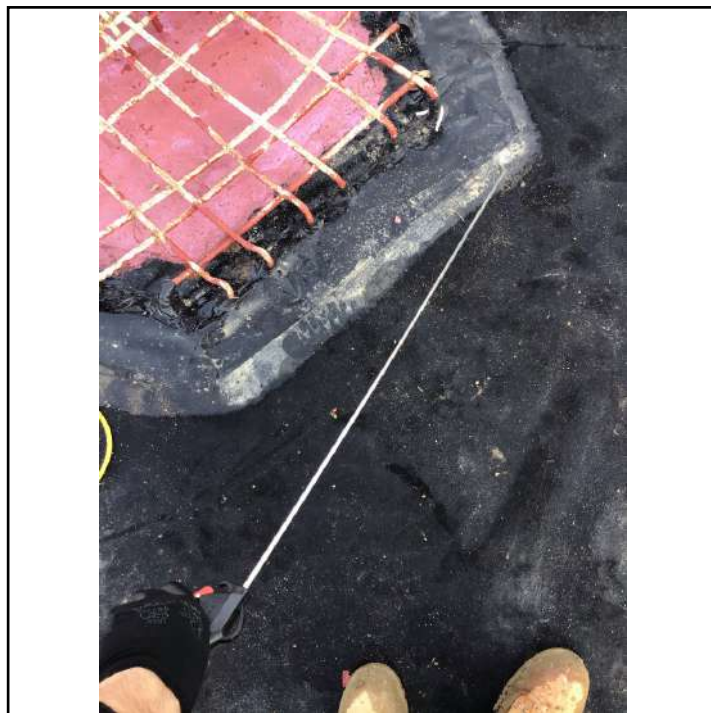
Air lance integrity test carried out to detail.
