# Drainage Report

**Clarendon Road**  
**Mary Neuer Road**

**Wood Green**  
**London**  
**N8 0NW**

## Clarendon Road Block D - CCTV Survey Report : 21/05/21

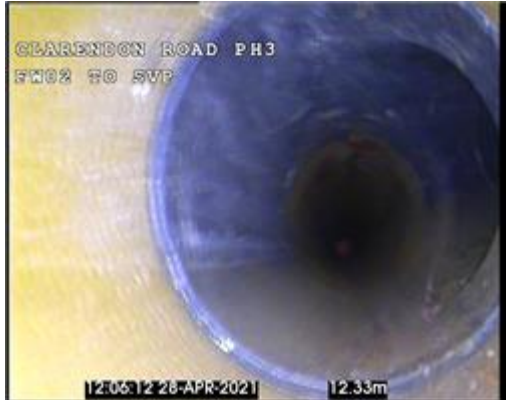
| Pos | Video Ref | Code | Description | Image |
|---|---|---|---|---|
| 12.50m | 0:01:15 | JN | Junction at 03 o'clock: 100mm Diameter | Image Provided - Ref: 1_2<br> |

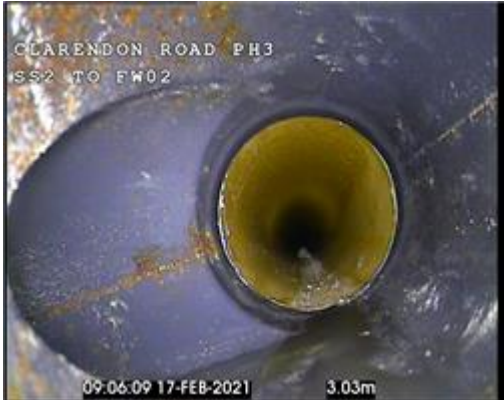
| Pos | Video Ref | Code | Description | Image |
|---|---|---|---|---|
| 03.00m | 0:00:11 | JN | Junction at 09 o'clock: 100mm Diameter | Image Provided - Ref: 11_2<br> |

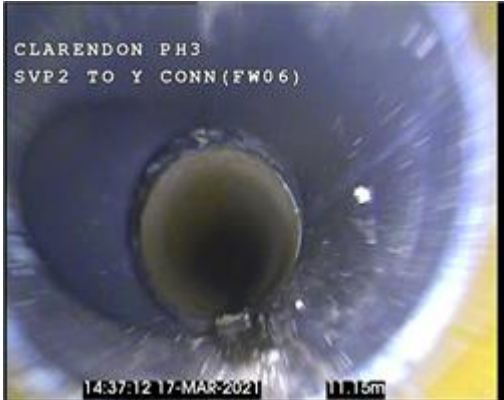
| Pos | Video Ref | Code | Description | Image |
|---|---|---|---|---|
| 11.30m | 0:00:27 | JN | Junction at 09 o'clock: 150mm Diameter | Image Provided - Ref: 19_2<br> |

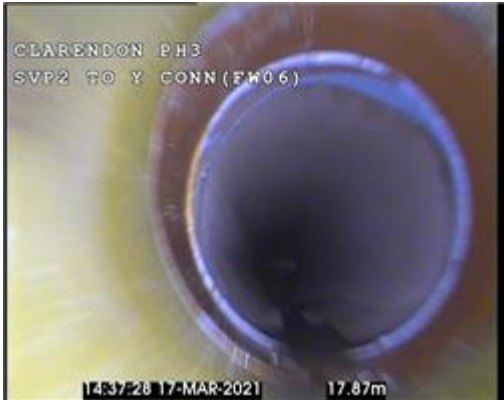
| Pos | Video Ref | Code | Description | Image |
|---|---|---|---|---|
| 17.90m | 0:00:43 | MCVC | Material of pipe changes to Vitrified Clay (i.e. all clayware) | Image Provided - Ref: 19_3<br> |

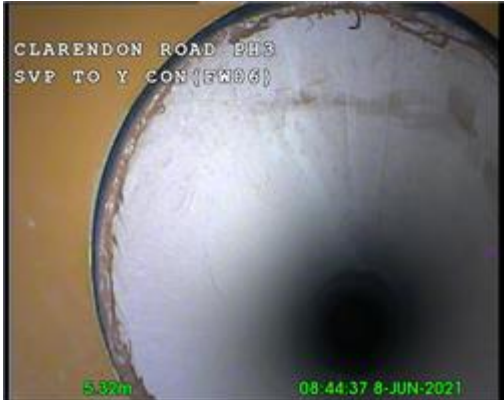
| Pos | Video Ref | Code | Description | Image |
|---|---|---|---|---|
| 05.30m | 0:00:54 | MCVC | Material of pipe changes to Vitrified Clay (i.e. all clayware) | Image Provided - Ref: 92_2<br> |

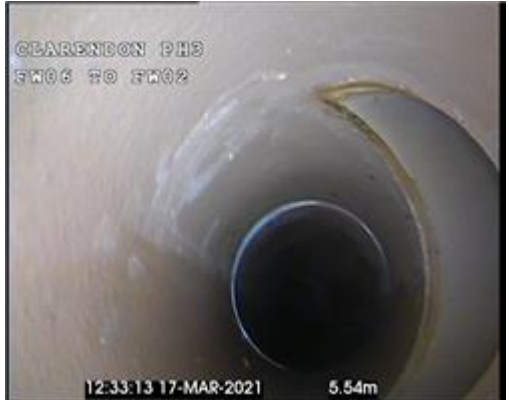
| Pos | Video Ref | Code | Description | Image |
|---|---|---|---|---|
| 05.60m | 0:00:21 | JN | Junction at 03 o'clock: 150mm Diameter | Image Provided - Ref: 15_2<br> |

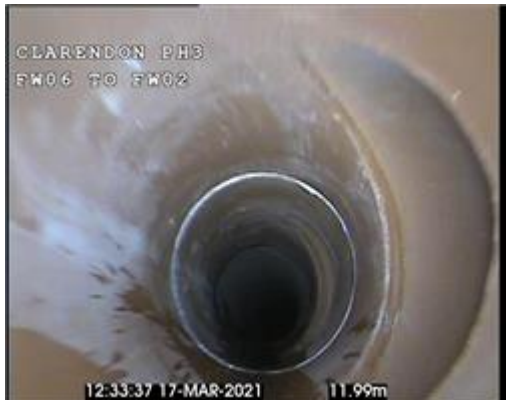
| Pos | Video Ref | Code | Description | Image |
|---|---|---|---|---|
| 12.00m | 0:00:46 | JN | Junction at 03 o'clock: 150mm Diameter | Image Provided - Ref: 15_3<br> |

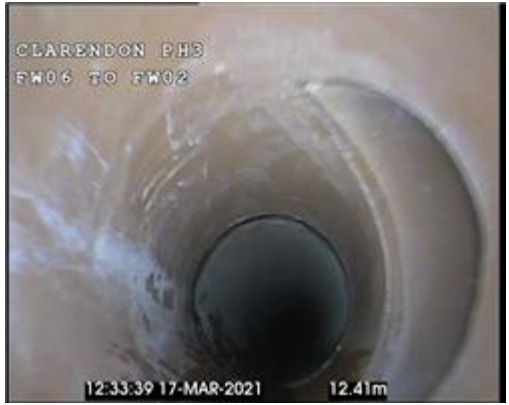
| Pos | Video Ref | Code | Description | Image |
|---|---|---|---|---|
| 12.50m | 0:00:48 | JN | Junction at 03 o'clock: 150mm Diameter | <p>Image Provided - Ref: 15_4</p> |

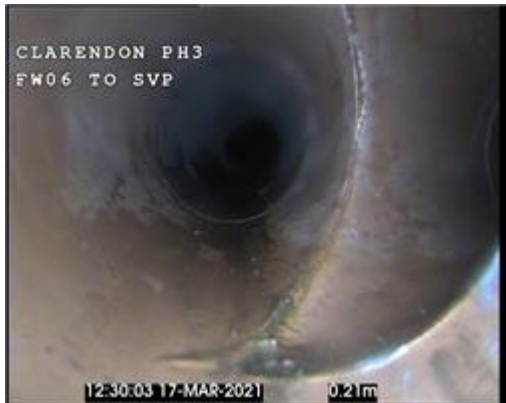
| Pos | Video Ref | Code | Description | Image |
|---|---|---|---|---|
| 00.20m | 0:00:02 | JN | Junction at 03 o'clock: 100mm Diameter | Image Provided - Ref: 16_2<br> |

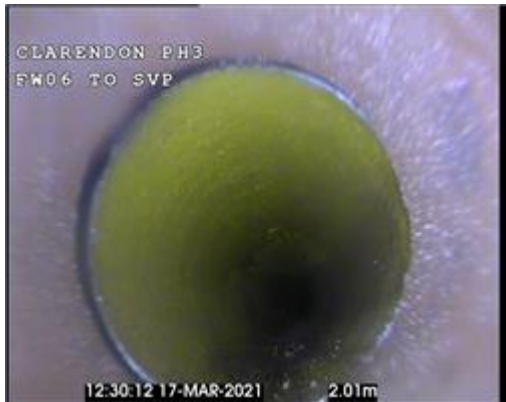
| Pos | Video Ref | Code | Description | Image |
|---|---|---|---|---|
| 02.10m | 0:00:12 | MCCI | Material of pipe changes to Cast Iron | Image Provided - Ref: 16_3<br> |

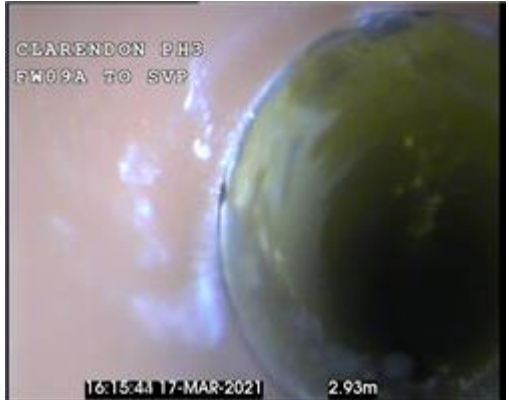
| Pos | Video Ref | Code | Description | Image |
|---|---|---|---|---|
| 03.00m | 0:00:15 | MCCI | Material of pipe changes to Cast Iron | <p>Image Provided - Ref: 17_2</p> |

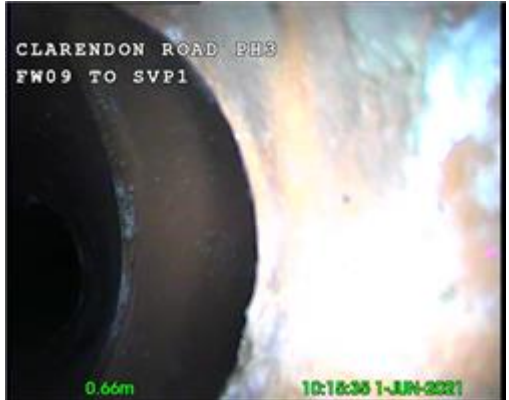
| Pos | Video Ref | Code | Description | Image |
|---|---|---|---|---|
| 00.70m | 0:00:07 | JN | Junction at 03 o'clock: 100mm Diameter | Image Provided - Ref: 20_2<br> |

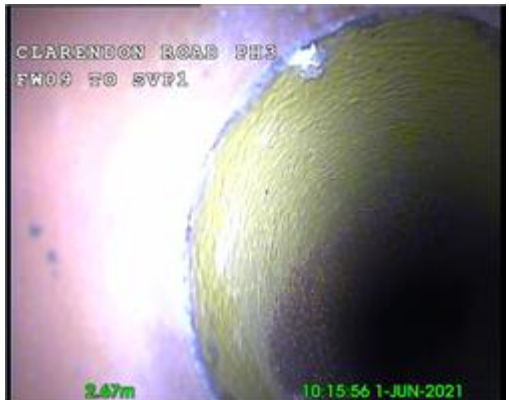
| Pos | Video Ref | Code | Description | Image |
|---|---|---|---|---|
| 02.60m | 0:00:17 | MCCI | Material of pipe changes to Cast Iron | Image Provided - Ref: 20_3<br> |

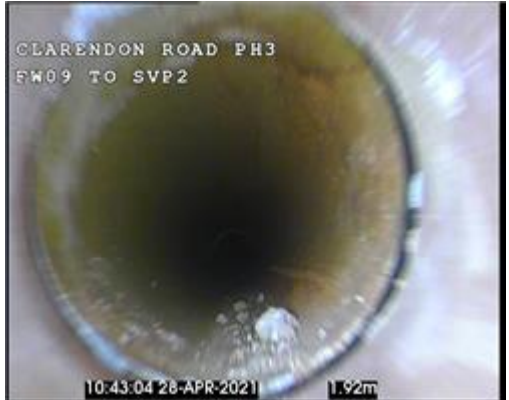
| Pos | Video Ref | Code | Description | Image |
|---|---|---|---|---|
| 02.00m | 0:00:12 | MCCI | Material of pipe changes to Cast Iron | Image Provided - Ref: 21_2<br> |

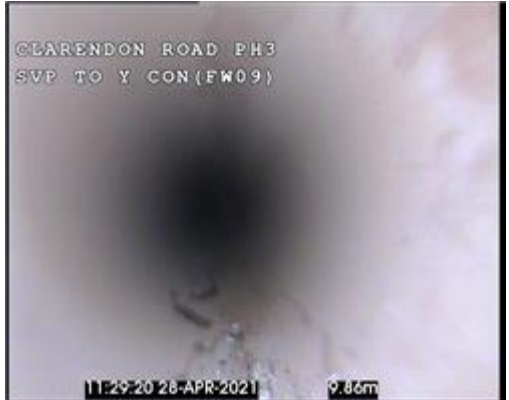
| Pos | Video Ref | Code | Description | Image |
|---|---|---|---|---|
| 09.80m | 0:00:43 | MCVC | Material of pipe changes to Vitrified Clay (i.e. all clayware) | Image Provided - Ref: 22_2<br> |

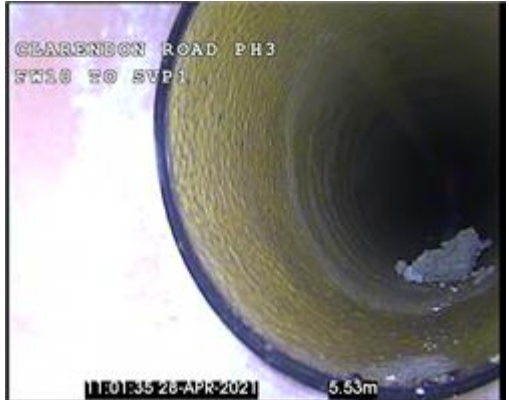
| Pos | Video Ref | Code | Description | Image |
|---|---|---|---|---|
| 05.60m | 0:00:41 | MCCI | Material of pipe changes to Cast Iron | Image Provided - Ref: 23_2<br> |

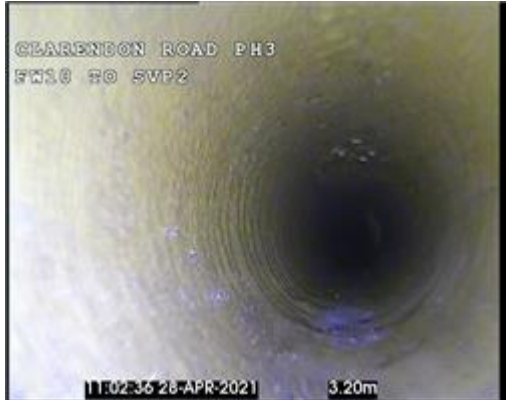
| Pos | Video Ref | Code | Description | Image |
|---|---|---|---|---|
| 03.20m | 0:00:14 | MCCI | Material of pipe changes to Cast Iron | Image Provided - Ref: 24_2<br> |

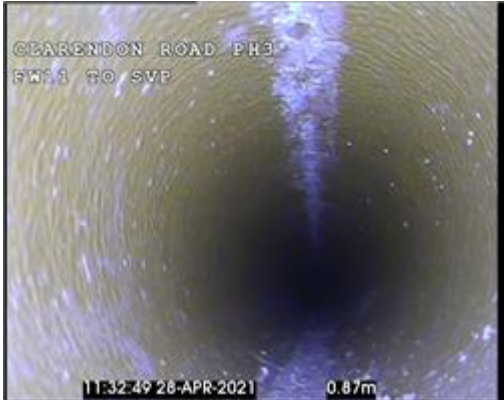
| Pos | Video Ref | Code | Description | Image |
|---|---|---|---|---|
| 00.80m | 0:00:05 | MCCI | Material of pipe changes to Cast Iron | Image Provided - Ref: 27_2<br> |

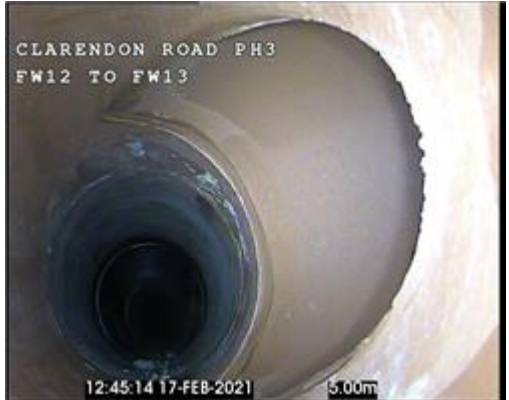
| Pos | Video Ref | Code | Description | Image |
|---|---|---|---|---|
| 05.10m | 0:00:27 | JN | Junction at 03 o'clock: 150mm Diameter | <p>Image Provided - Ref: 29_2</p> |

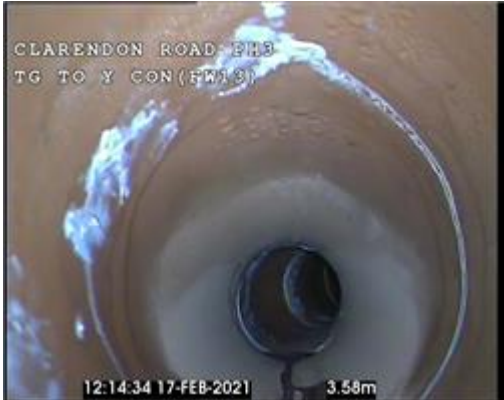
| Pos | Video Ref | Code | Description | Image |
|---|---|---|---|---|
| 03.50m | 0:00:17 | MCVC | Material of pipe changes to Vitrified Clay (i.e. all clayware) | Image Provided - Ref: 30_2<br> |

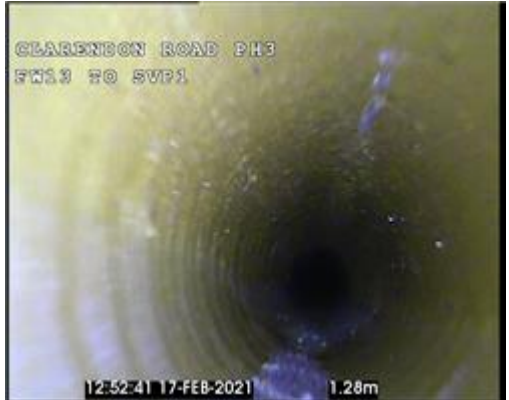
| Pos | Video Ref | Code | Description | Image |
|---|---|---|---|---|
| 01.20m | 0:00:05 | MCCI | Material of pipe changes to Cast Iron | Image Provided - Ref: 31_2<br> |

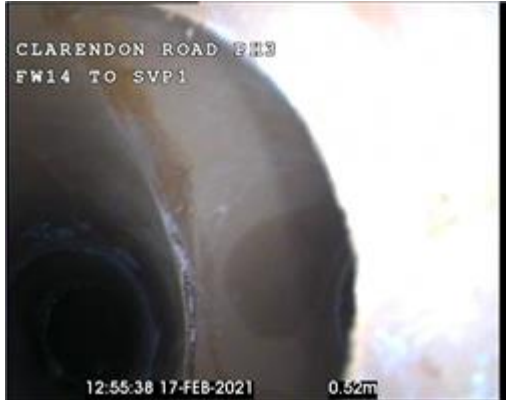
| Pos | Video Ref | Code | Description | Image |
|---|---|---|---|---|
| 00.50m | 0:00:07 | JN | Junction at 03 o'clock: 100mm Diameter | Image Provided - Ref: 34_2<br> |

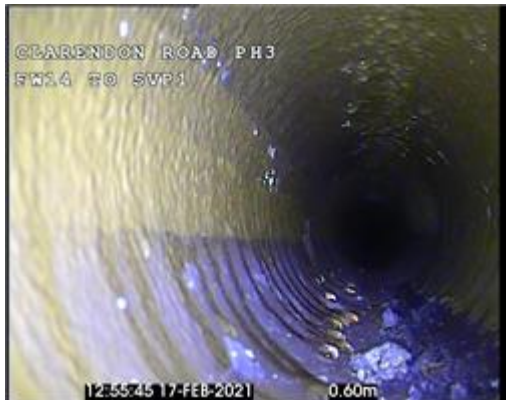
| Pos | Video Ref | Code | Description | Image |
|---|---|---|---|---|
| 00.60m | 0:00:14 | MCCI | Material of pipe changes to Cast Iron | Image Provided - Ref: 34_3<br> |

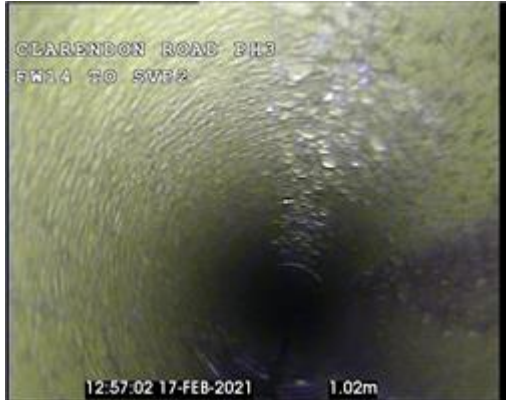
| Pos | Video Ref | Code | Description | Image |
|---|---|---|---|---|
| 00.80m | 0:00:05 | MCCI | Material of pipe changes to Cast Iron | Image Provided - Ref: 35_2<br> |

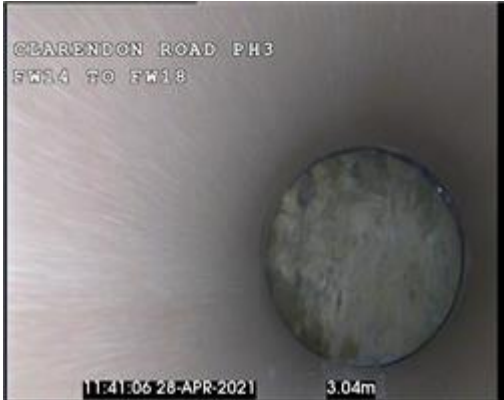
| Pos | Video Ref | Code | Description | Image |
|---|---|---|---|---|
| 03.30m | | SA | Survey abandoned Pipe not completed yet. | <p>Image Provided - Ref: 37_9999</p> |

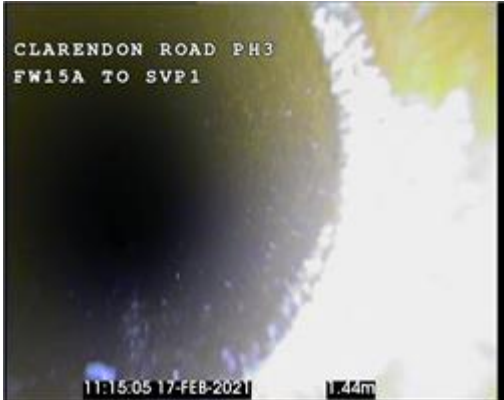
| Pos | Video Ref | Code | Description | Image |
|---|---|---|---|---|
| 01.40m | 0:00:09 | MCCI | Material of pipe changes to Cast Iron | Image Provided - Ref: 38_2<br> |

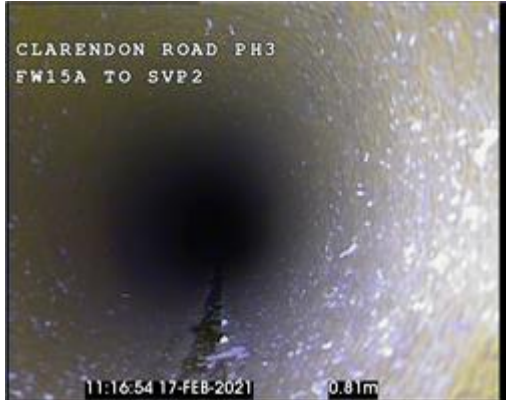
| Pos | Video Ref | Code | Description | Image |
|---|---|---|---|---|
| 00.80m | 0:00:06 | MCCI | Material of pipe changes to Cast Iron | Image Provided - Ref: 39_2<br> |

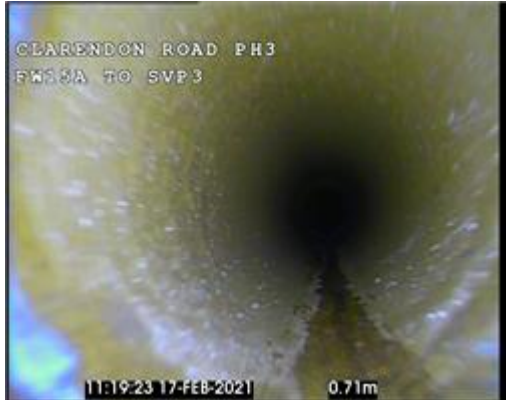
| Pos | Video Ref | Code | Description | Image |
|---|---|---|---|---|
| 00.80m | 0:00:04 | MCCI | Material of pipe changes to Cast Iron | Image Provided - Ref: 40_2<br> |
