# GEOSHIELD Verification Report

## VERIFICATION ITEM TWO

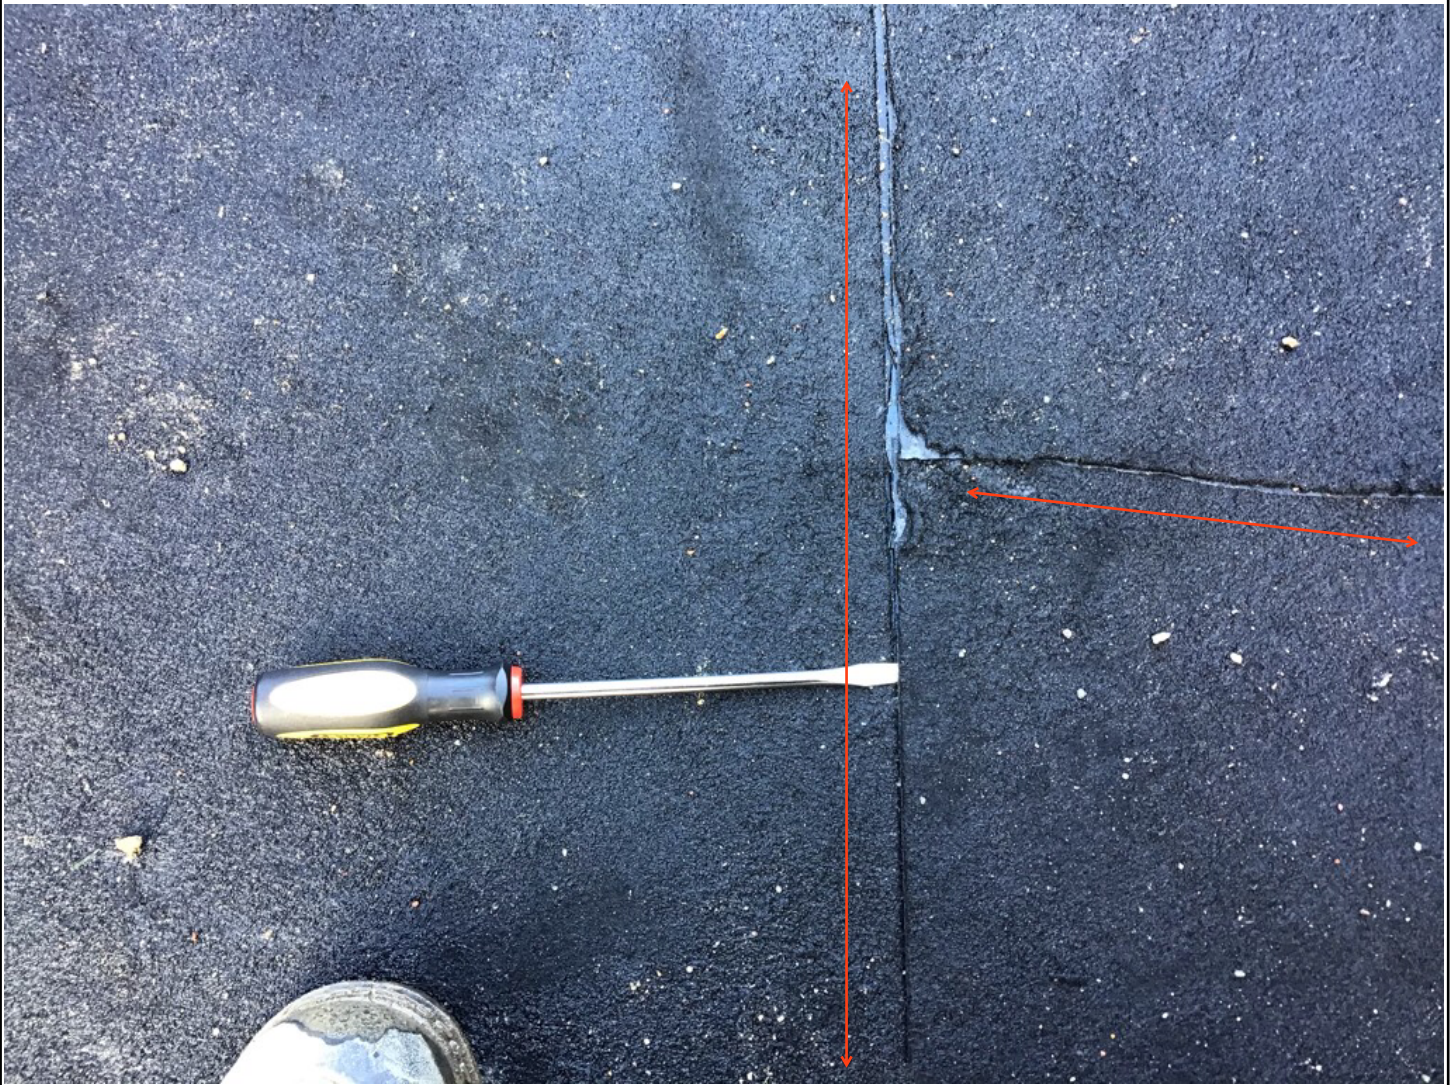
Above photo) all welded lap joints were verified using a pick and probe method.

Above shows the verification being carried out and the red arrows show the welded

lap joints. Passed and verified.

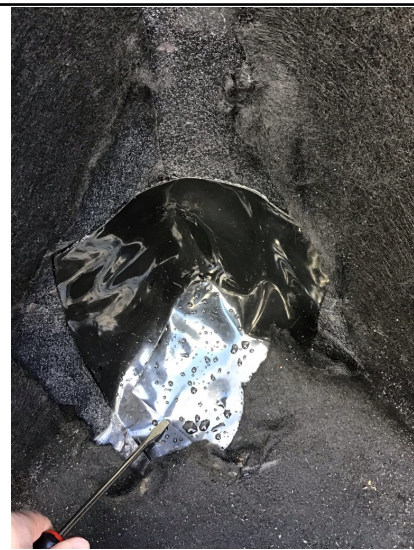
Reinforced corner detail
