# GEOSHIELD Verification Report

## VERIFICATION ITEM THREE

LOCATION/GRID LINE: Block D1 - Core - Middle and Upper

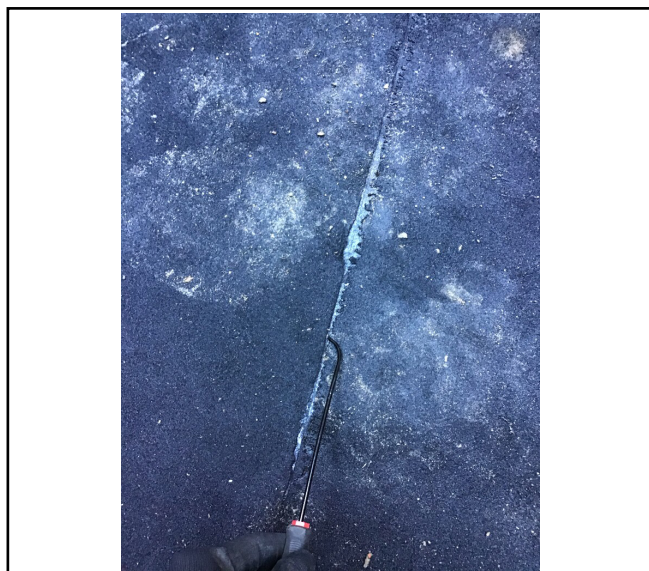
1. Pick and probe test carried out

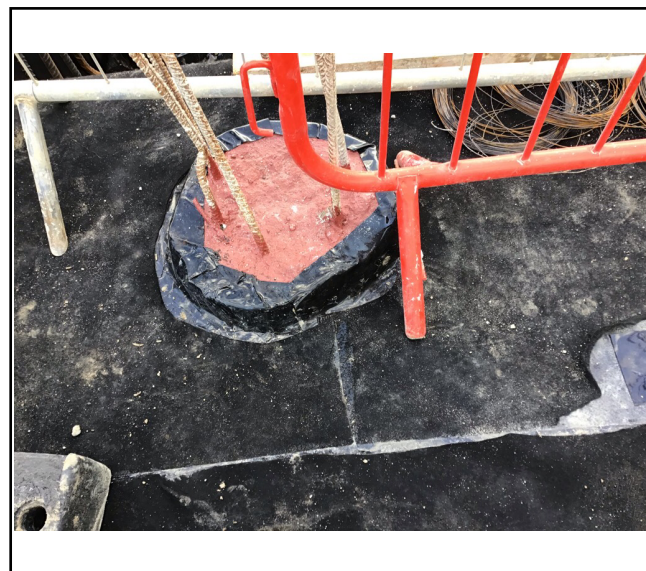
2. Overview of joints and T Junctions all fully sealed

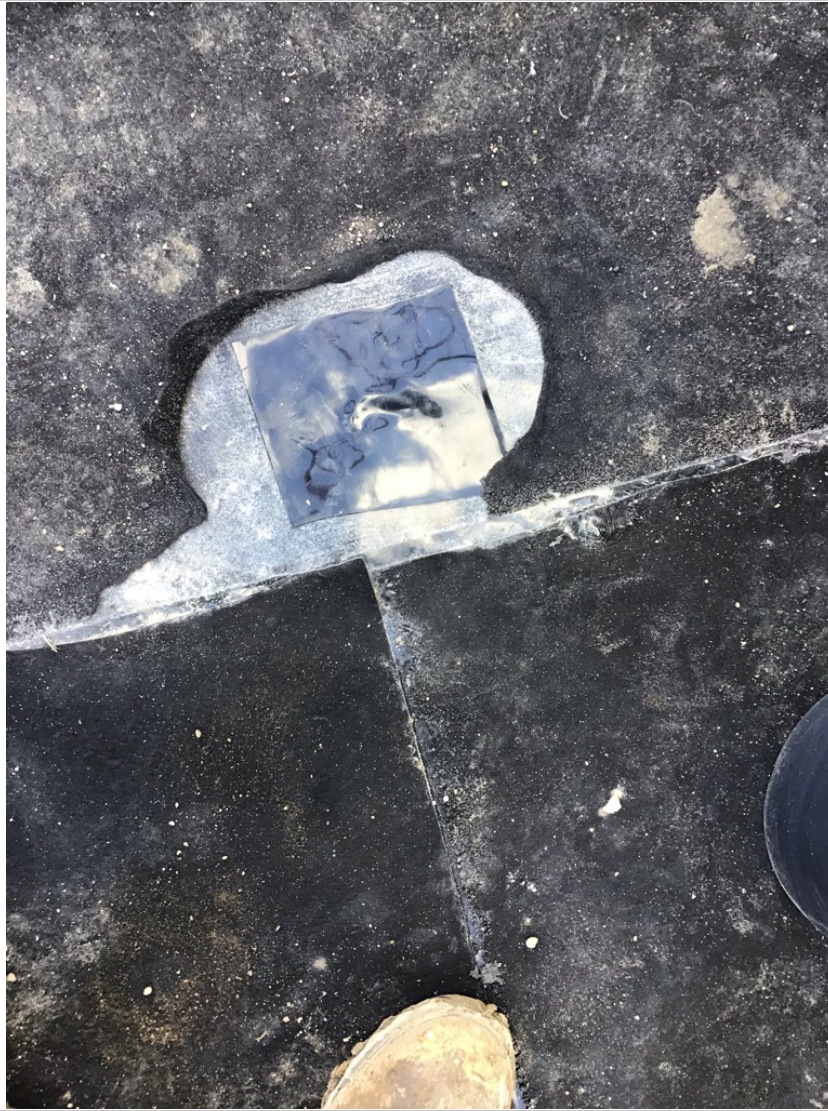
3. Patch repair had been made prior to inspection as installers have taken

great care to ensure membrane fully sealed.

Excellent installation throughout.
