# GEOSHIELD Verification Report

## VERIFICATION ITEM ONE

## VERIFICATION ITEM TWO

LOCATION/GRID LINE: Block D1 - Core - Middle and Upper

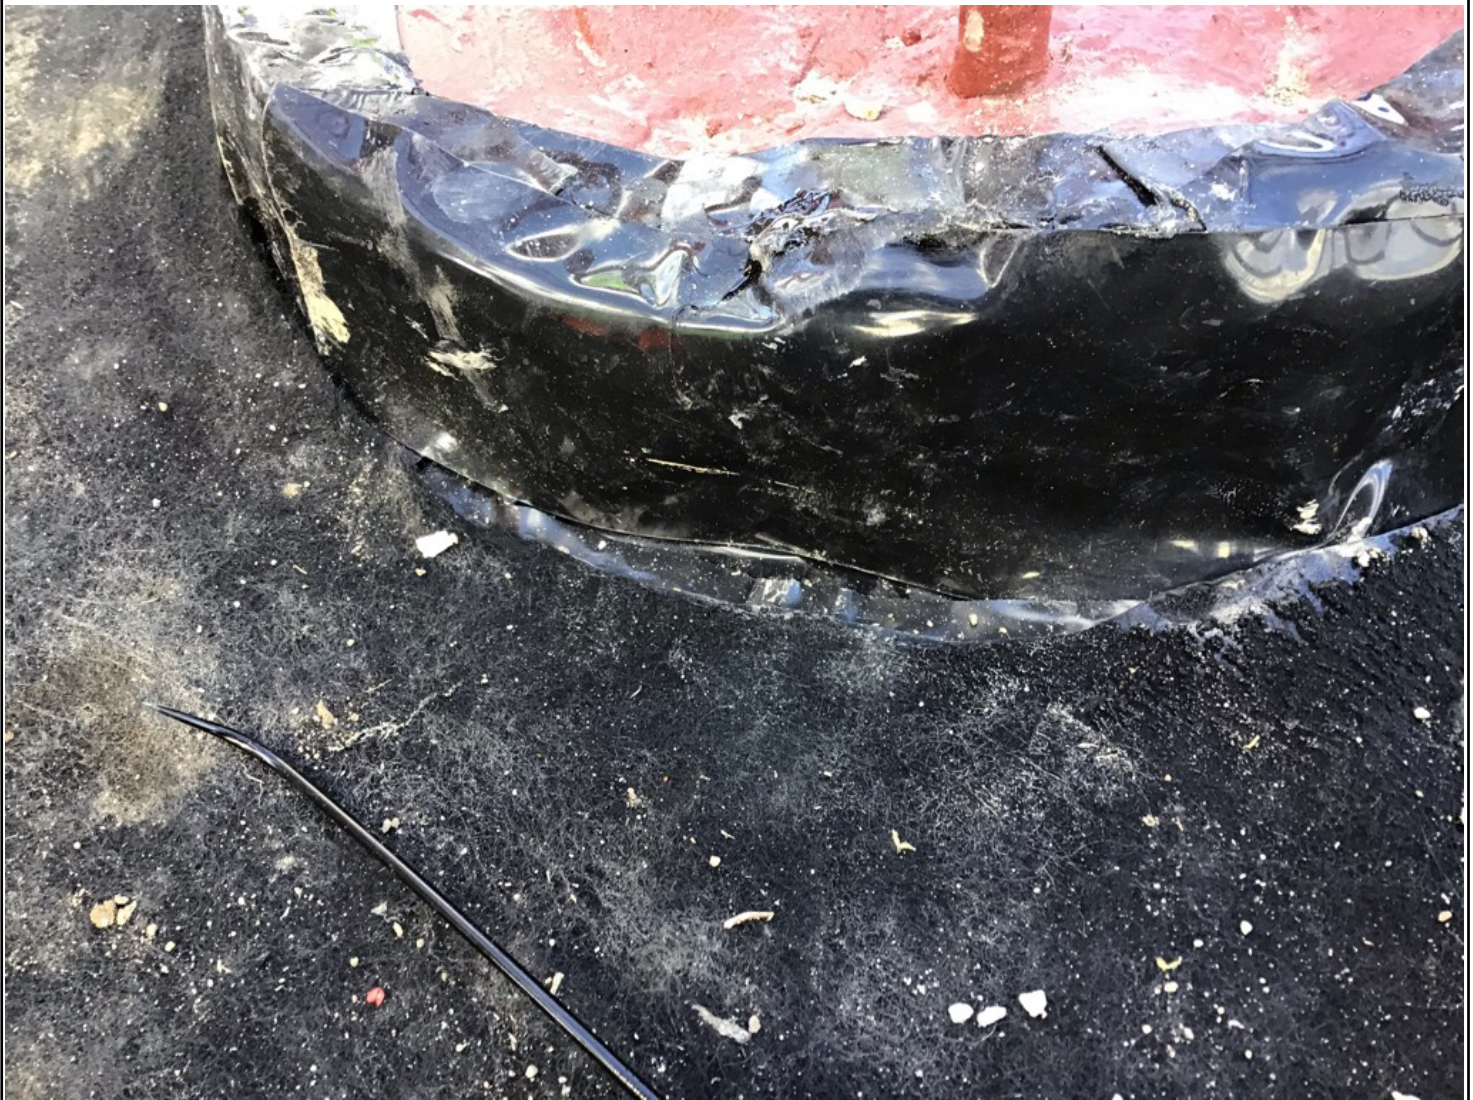
3. Photo evidence. Double sided tape visible. Pick and probe to ensure all the way around pile head and good consistent seal achieved.

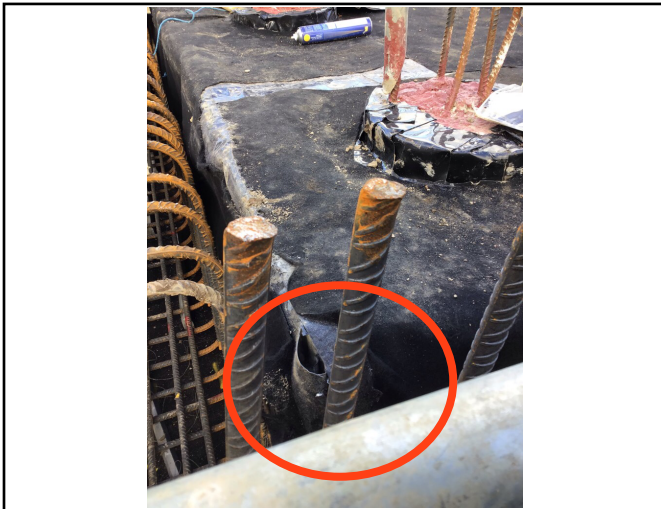
NOTES: All works visually inspected and only one area of damage

detected. Corner damaged during install of rebar. This was patch repaired and sealed

1. Corner of Pudlo GP Ultra+ damaged

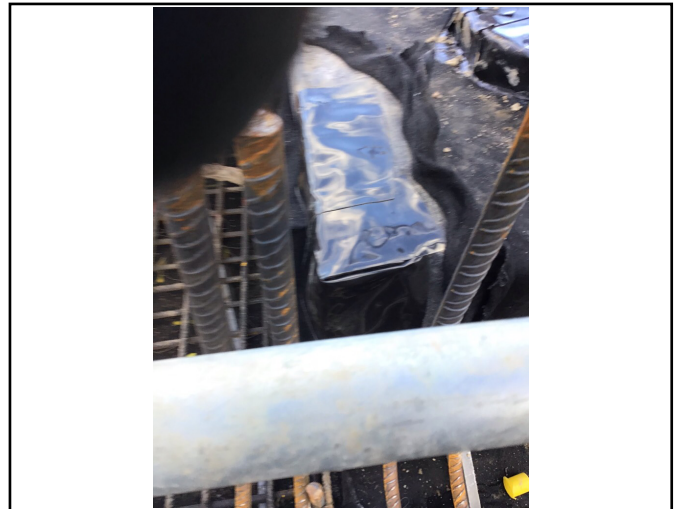
2. Patch repaired during inspection

during inspection. Passed and verified.

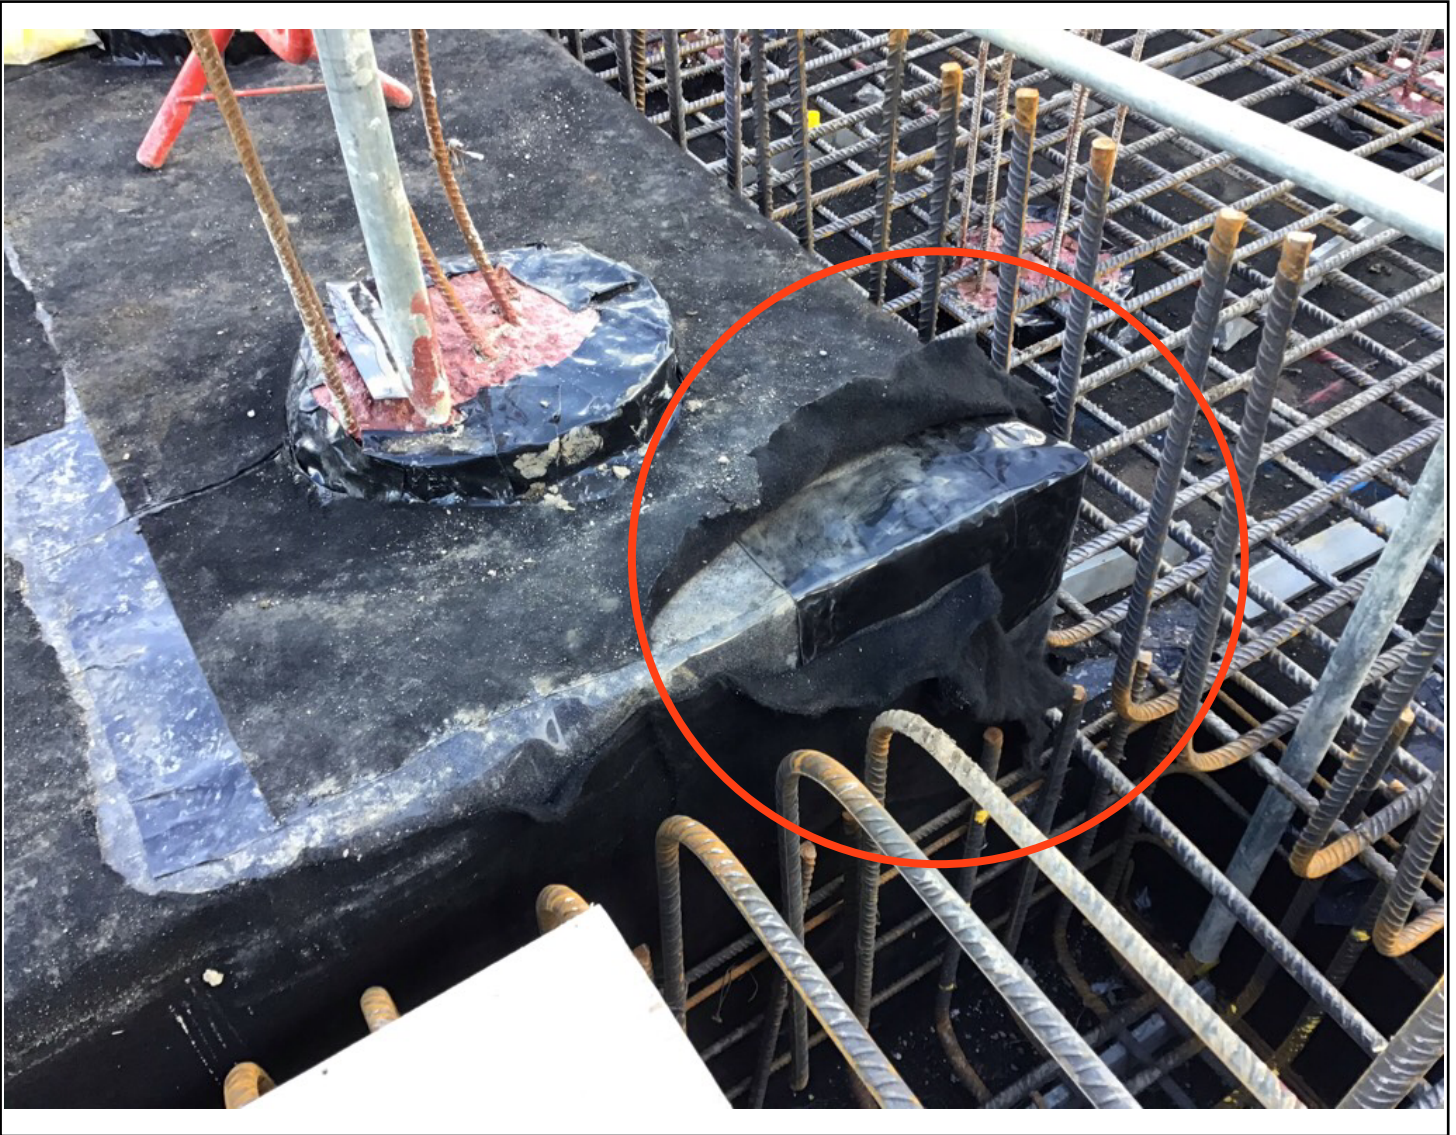
3. Patch repair made during inspection.

Excellent standard of installation and patch repair.

Passed and verified.
