# GEOSHIELD Verification Report

007

GCL - Clarendon Road PHASE 3

AREA SURVEYED: Block D1 Slab - Pour 1 (third visit for this area)

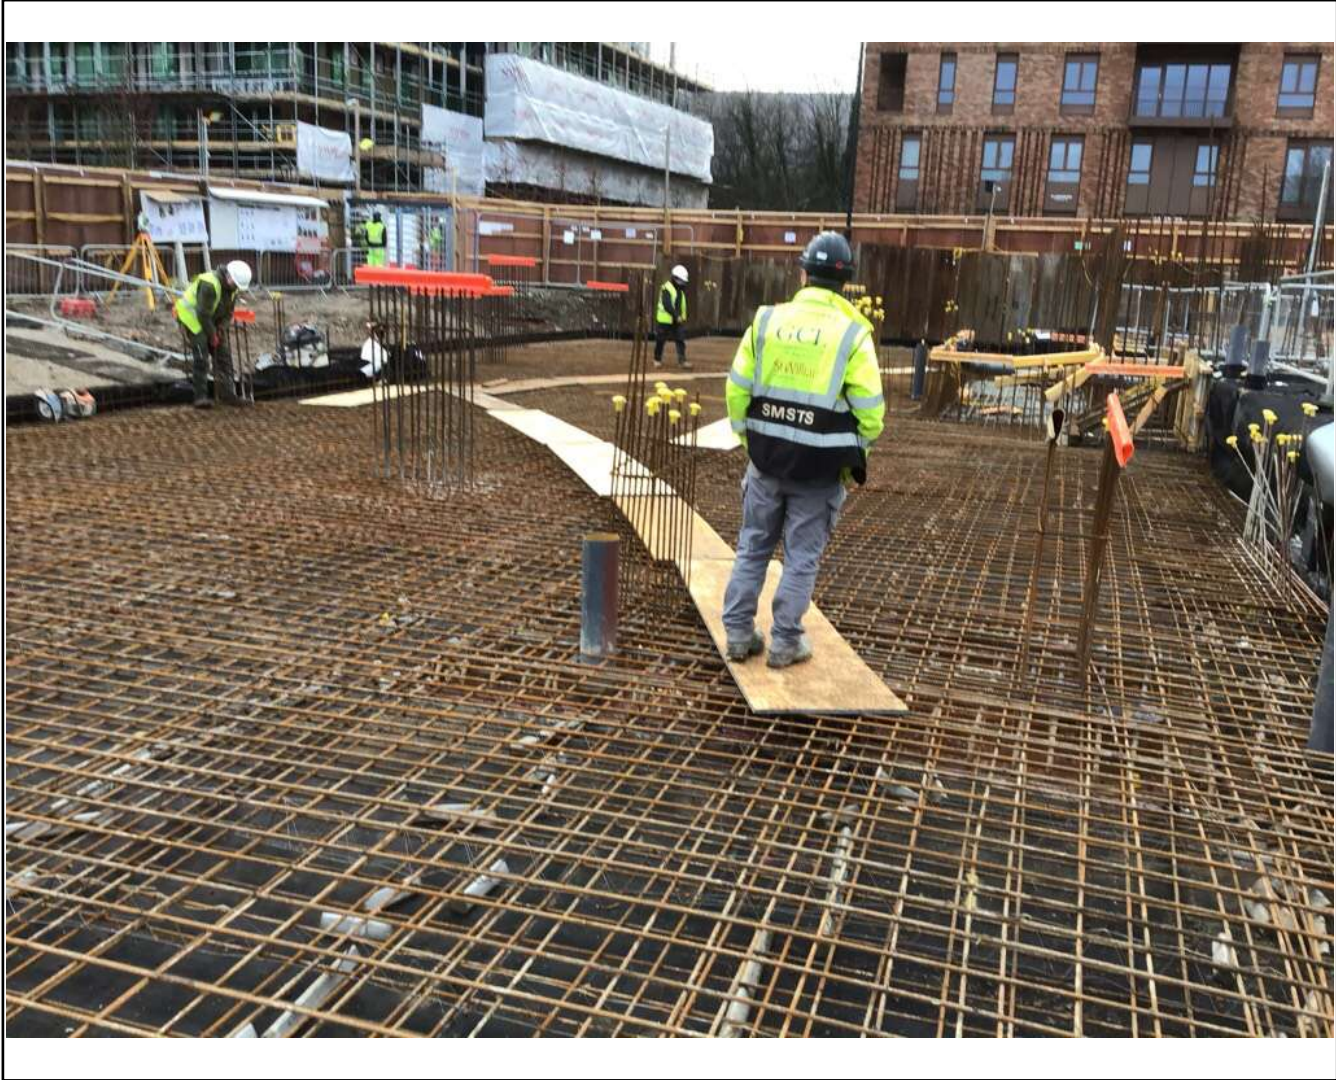
The photograph above shows an overview of D1 slab where verification of the remaining works identified in the last report was carried out.

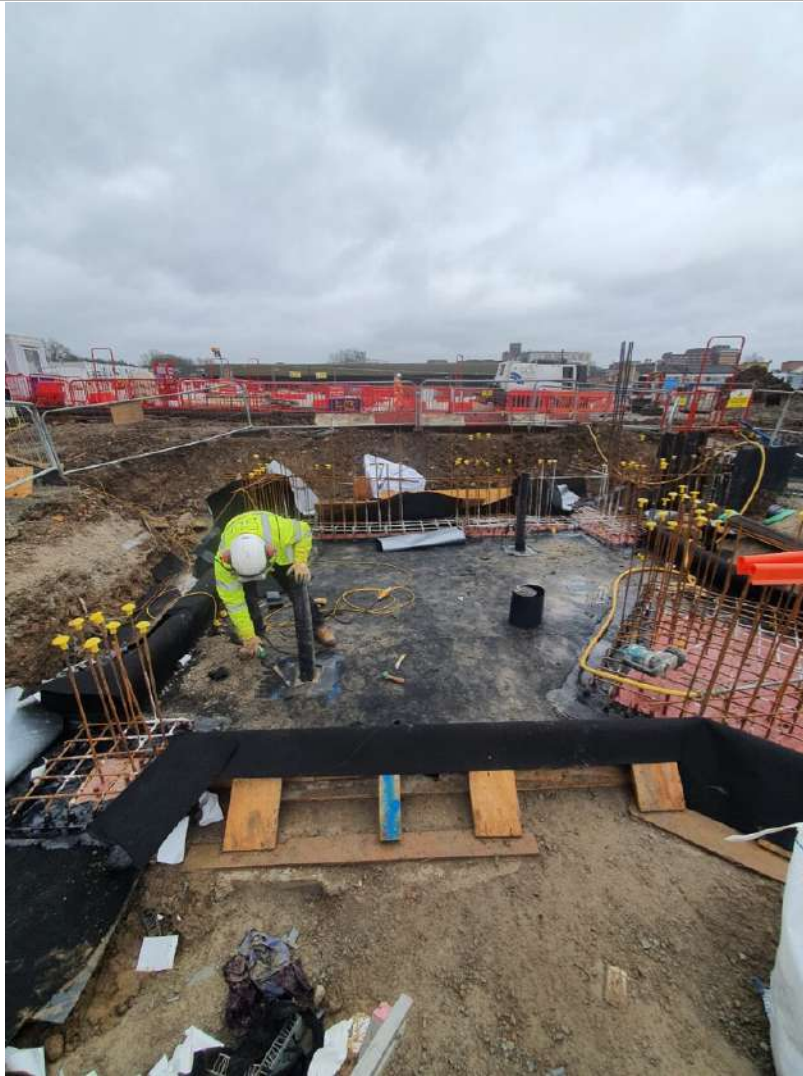
The photograph above shows an overview of D1 substation which was also  
verified during this visit.

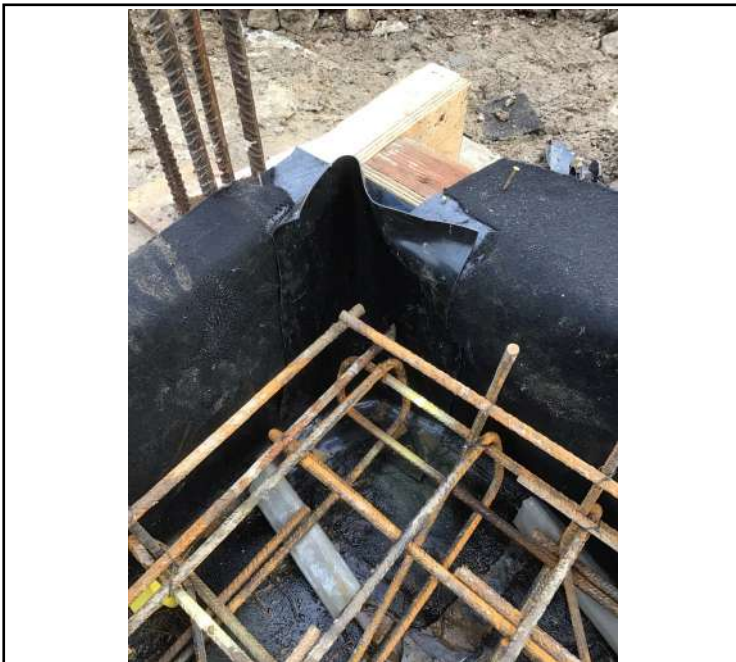
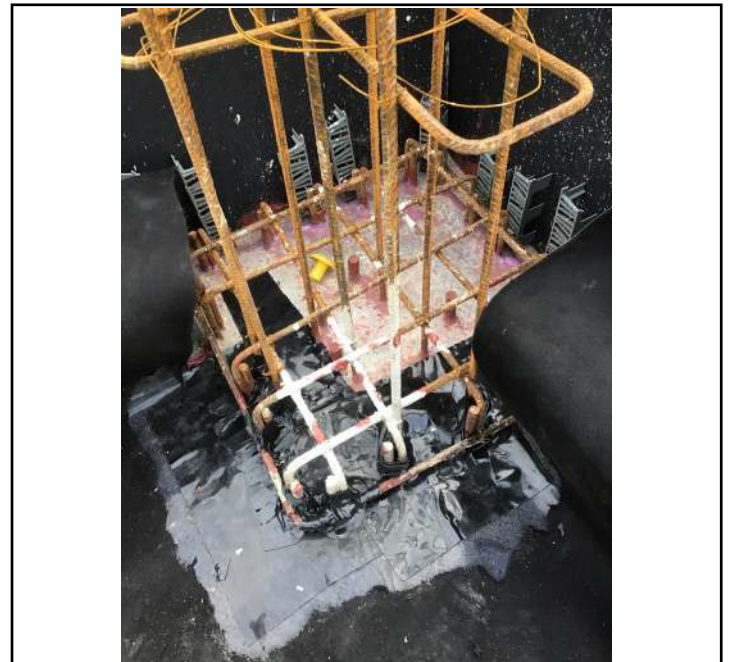
LOCATION/GRID LINE: Block D1 Slab.

The first photo below shows the installers have sealed the corner details using Pudlo

EXT tape. The installers have used a hot air leister and roller to ensure a good seal has

been achieved. The second photo below shows the installers have first applied a coat...

... of Pudlo liquid membrane before sealing around the pile using the Pudlo EXT tape.

Installed in accordance with BS 8485:2019.

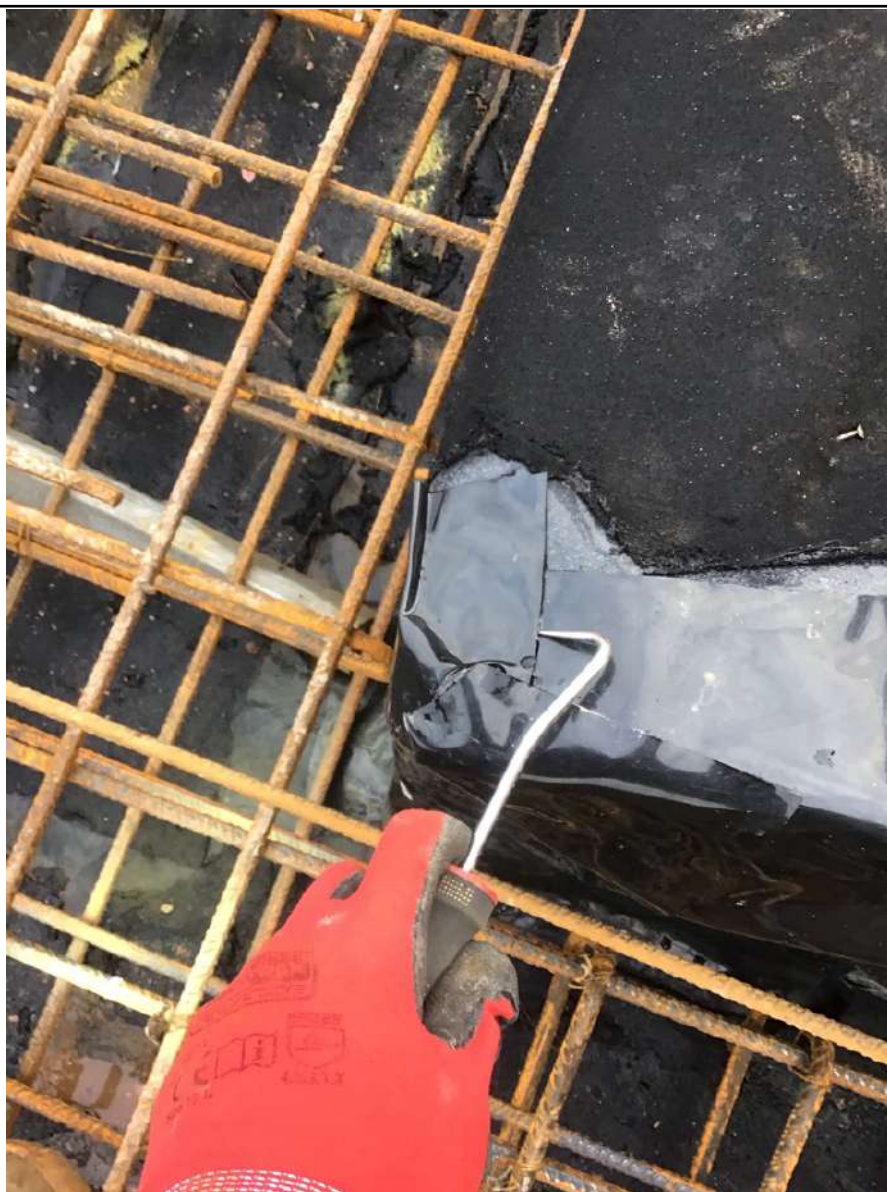
The photograph above shows a pick and probe test was carried out to a sealed corner which has been sealed using Pudlo EXT tape and a hot air leister to achieve a good seal. No faults or defects identified.

Verified in accordance with CIRIA 735.

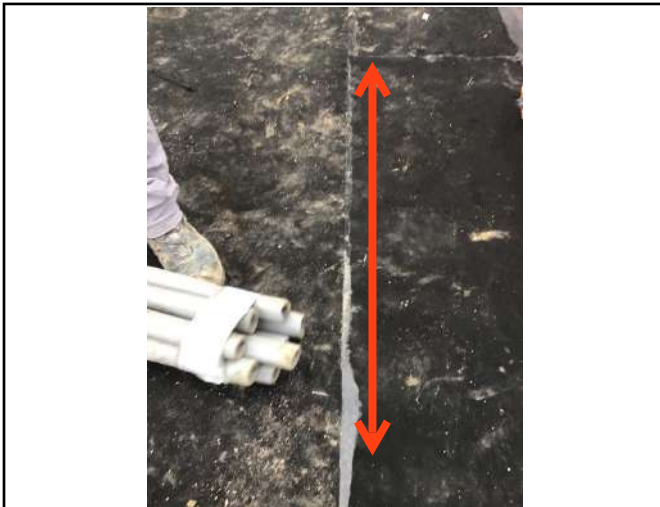
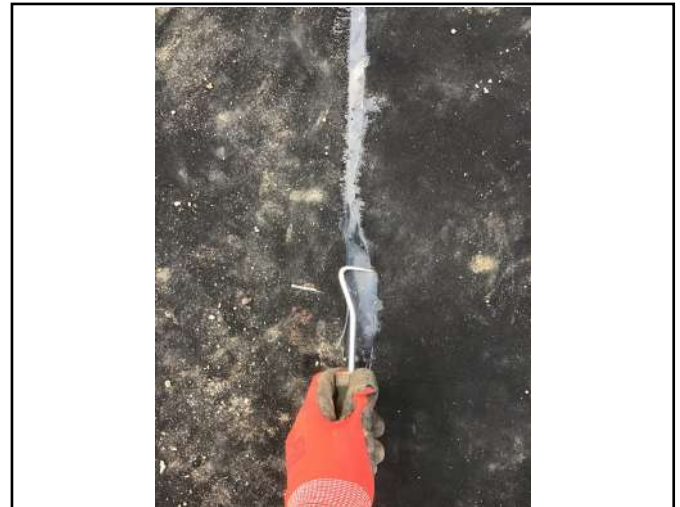
LOCATION/GRID LINE: D1 Substation.

The first photo below shows an overview of a welded lap of the Pudlo GP Ultra+

Gas Barrier. The installers have first ensure the gas barrier is clean and dry before

using the hot air leister and roller to achieve a consistent 40mm weld.

The second photo above shows a pick and probe test carried out to a welded

lap of the Pudlo GP Ultra+ Gas Barrier. A strong weld has been achieved.

No faults or defects identified.

Verified in accordance with CIRIA 735.

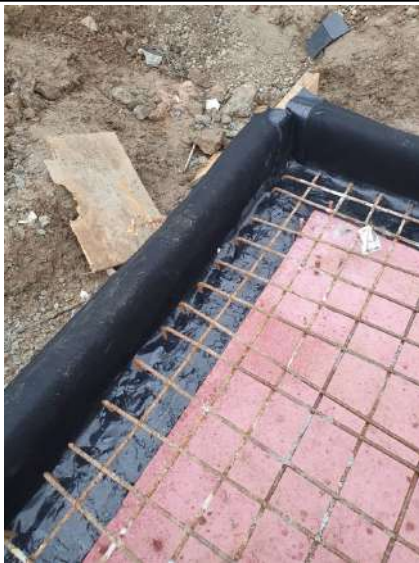
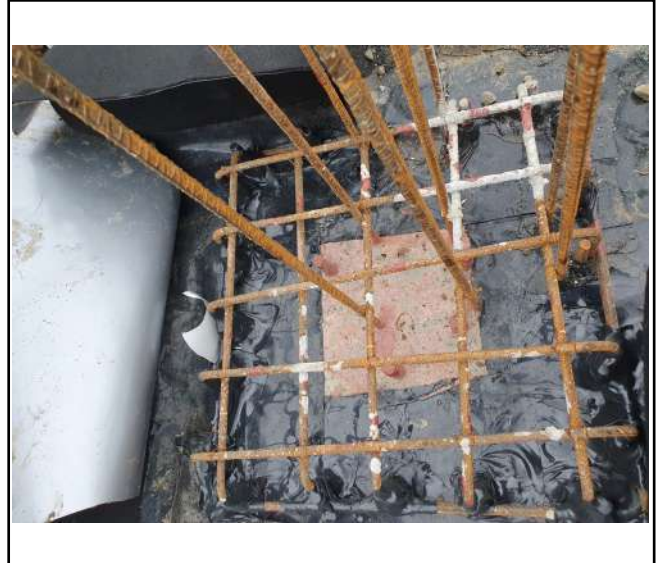
LOCATION/GRID LINE: D1 Substation

The two photographs below show examples sealed pile heads. The installers have first applied a coat of the Pudlo liquid membrane to each pile head. Once dry the installers have then used the Pudlo EXT tape to seal the pile heads to the....

... Pudlo GP Ultra+ Gas Barrier. The EXT tape has been cut around each steel bar before using a hot air leister to seal the EXT tape to the pile head. Next the installers have then used additional EXT tape to seal each steel bar individually.

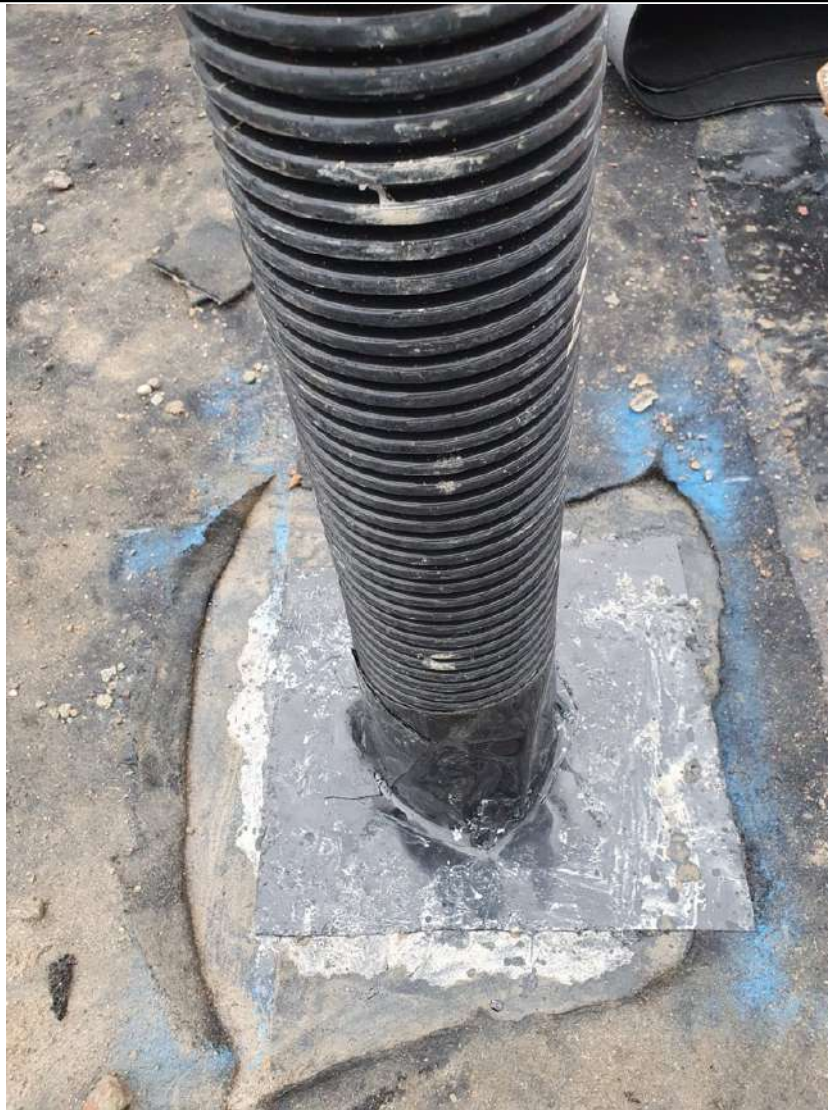
The photograph above shows a pipe penetration which has been sealed. The

installers have first cut a hole tightly around the pipe to minimise gaps. Next the

fleece of the membrane has been removed in order to seal the pipe using Pudlo

EXT Tape.

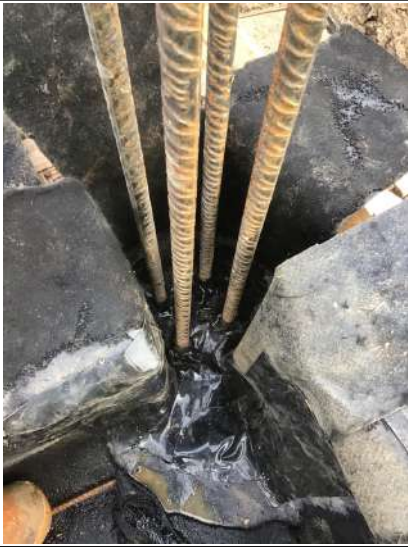
Sealed corner detail.

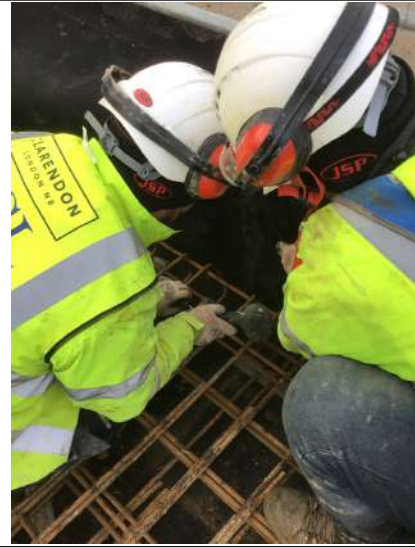
Installers welding a lap which had

not been sealed correctly.

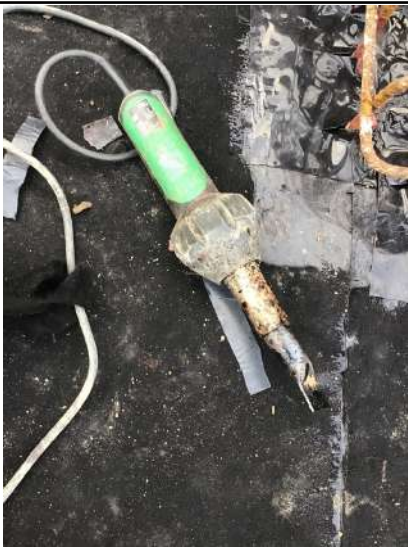
Hot air leister used to weld laps of the

Pudlo GP Ultra+ Gas Barrier.

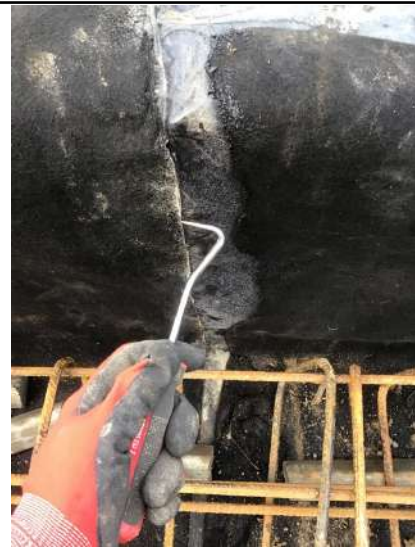
Additional pick and probe test carried

out to welded joint.
