## Verification Report

GEO101436

008

GCL - Clarendon Road PHASE 3

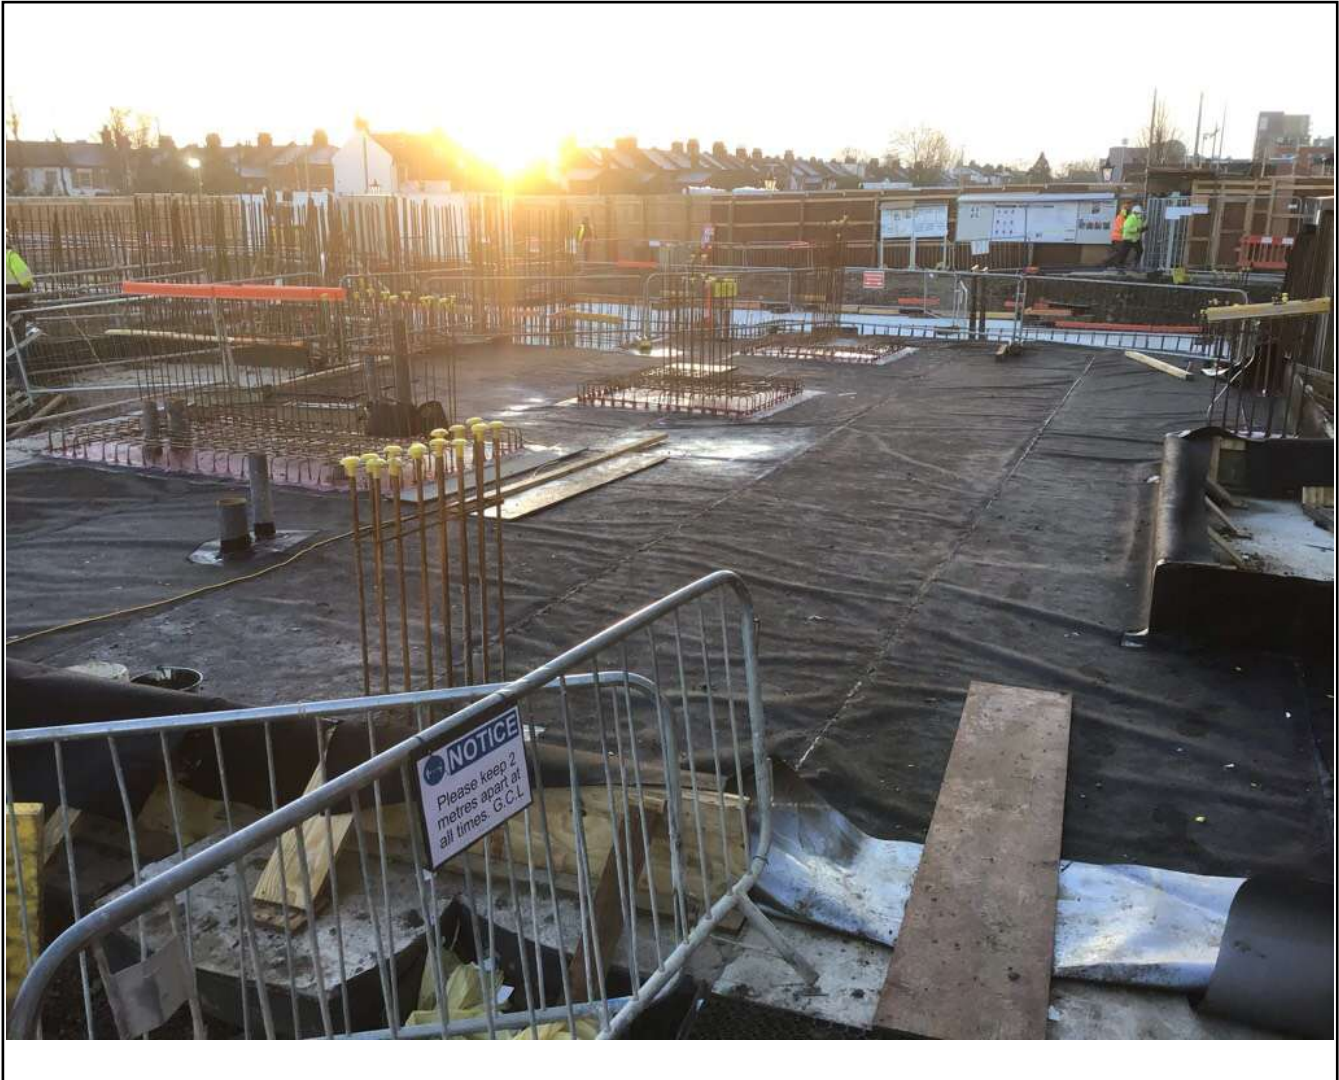
The photograph above shows an overview of pour 2. Pour 2 is not yet complete

due to ongoing works to D1 substation which is preventing all the blinding

being poured.

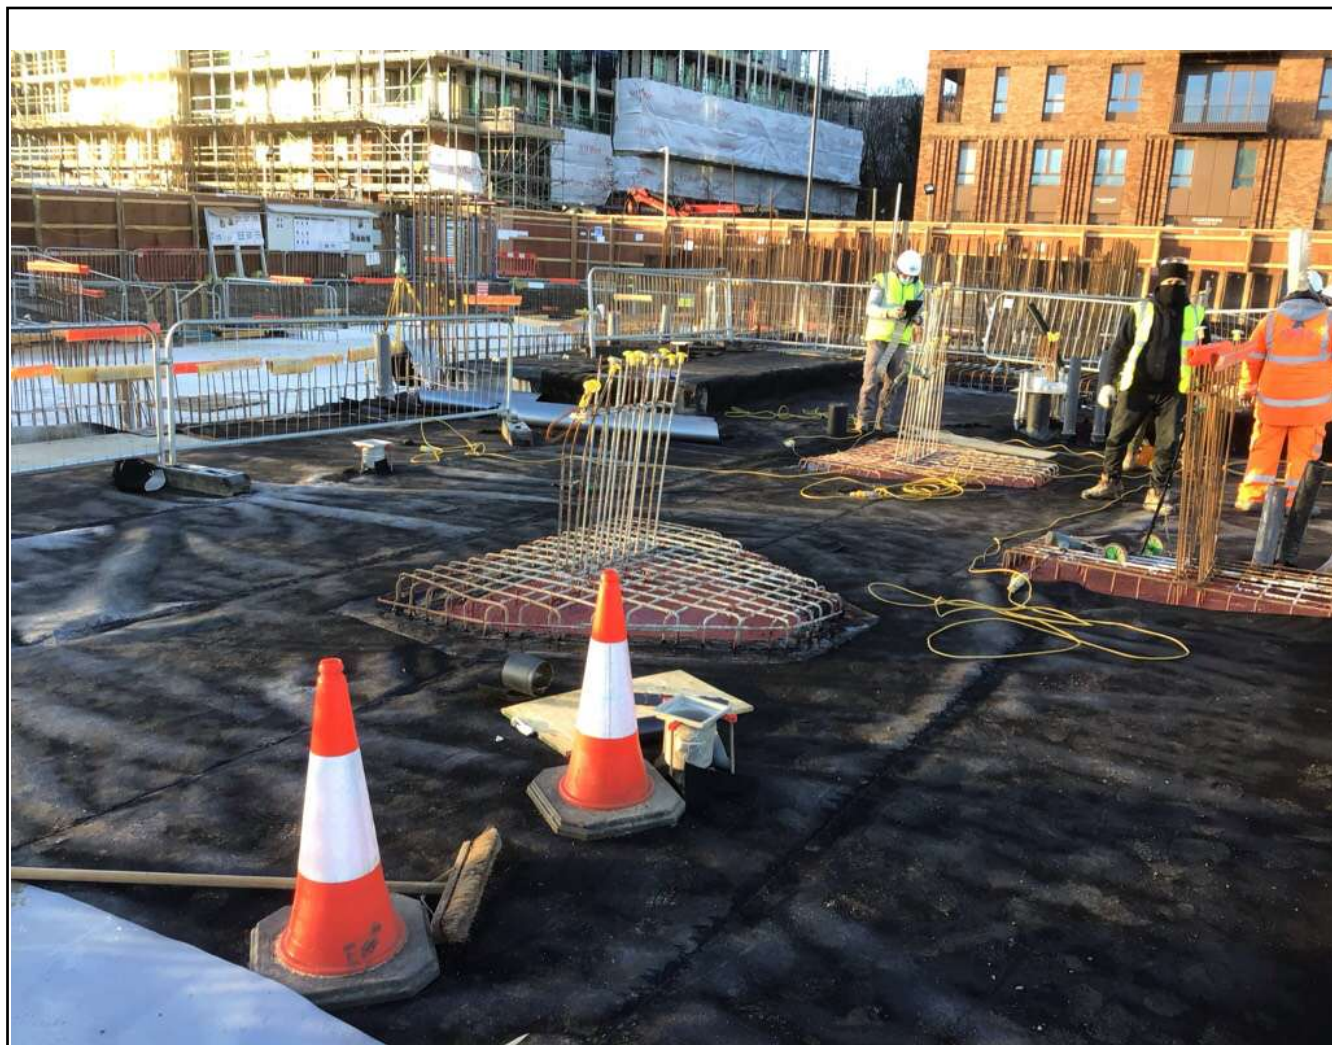
The photograph above shows pour 3 of Block D1 where verification also took place during this visit. Area is not yet complete due to outstanding penetrations to the membrane which haven't been sealed.

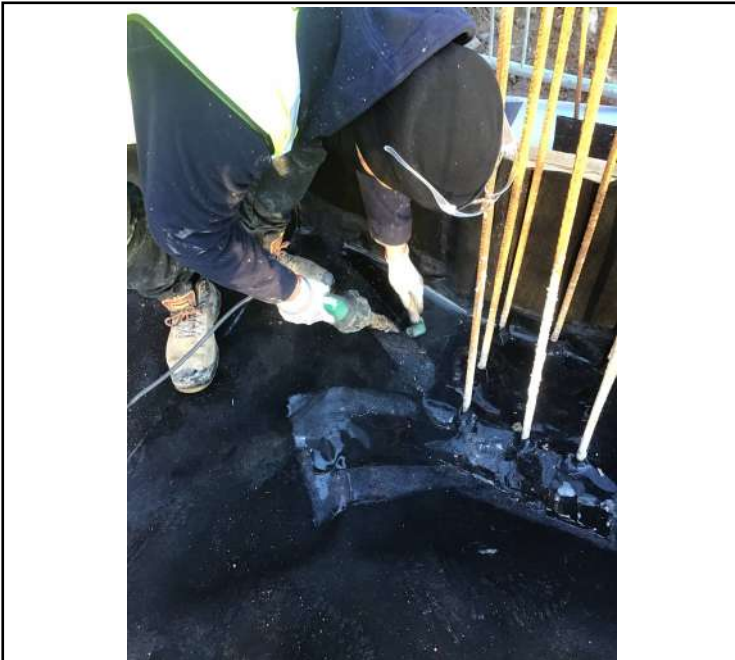
The first photograph below shows the installers using a hot air leister and roller to weld the laps of the Pudlo GP Ultra+ Gas Barrier. The installers have achieved a 40mm weld on all laps of the membrane.

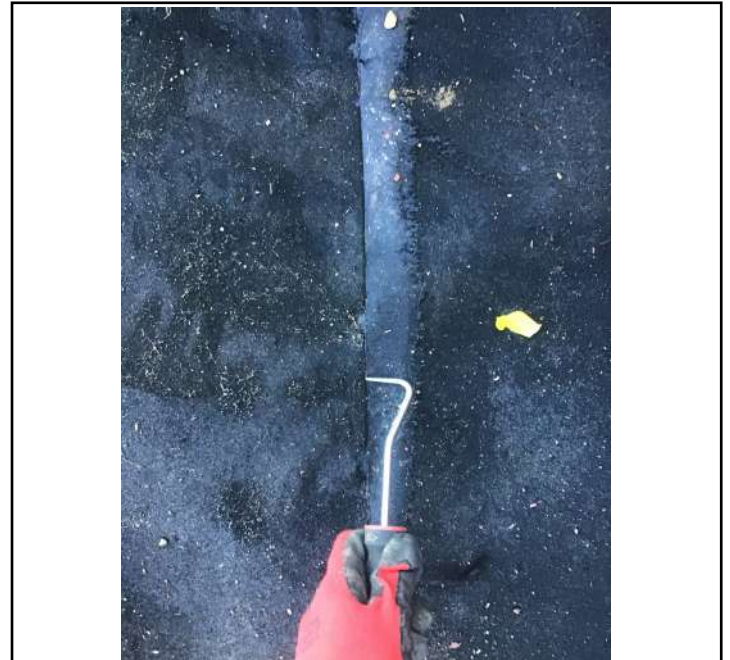
The second photo above shows a pick and probe test carried out to a welded lap.

No faults or defects identified. Verified in accordance with CIRIA 735.

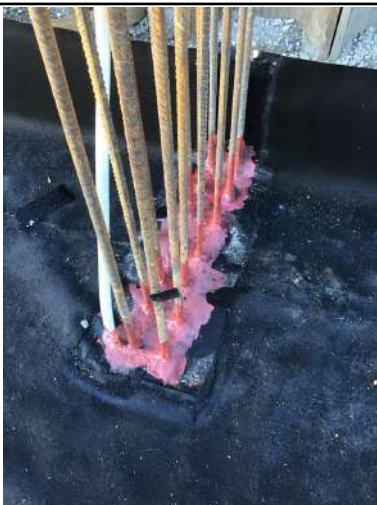
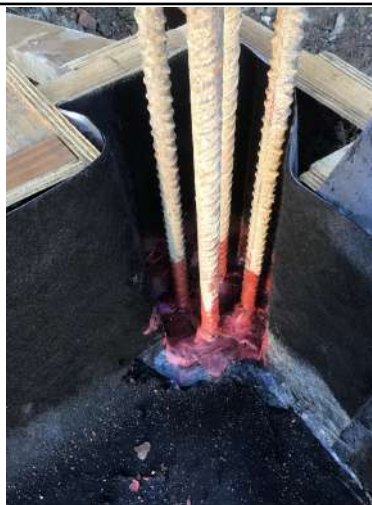
The two pictures below show examples of sealed piles. The installers have first applied a coat of Pudlo liquid membrane to the pile heads. Once dry the installers have used EXT tape to seal the Pudlo GP Ultra+ Gas Barrier to the pile heads and also...

.... to seal the steel bars. Once completed the installers have then applied additional Pudlo liquid membrane to ensure no concrete is showing through the paint.

No faults or defects identified.

Installed in accordance with BS 8485:2019.

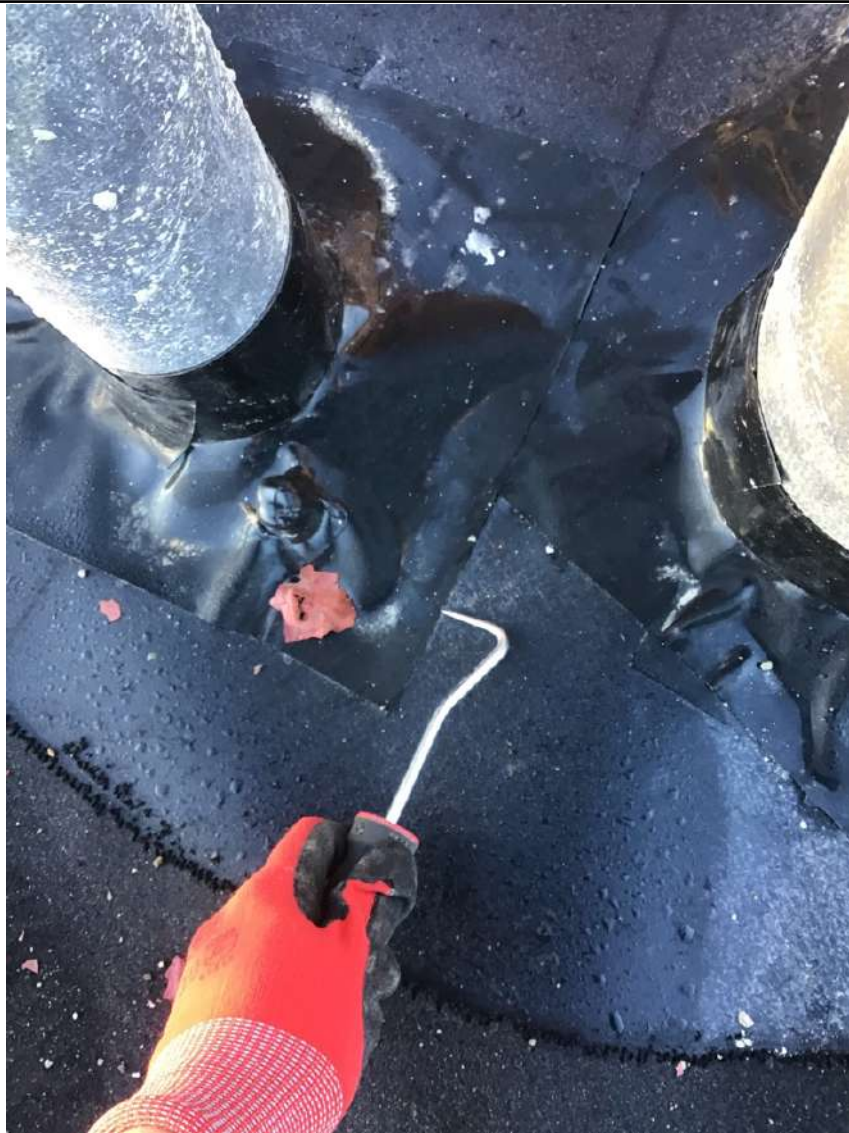
The photograph above shows a pick and probe test carried out to a sealed pipe

penetration verified during this visit.

No faults or defects identified.

Verified in accordance with CIRIA 735.

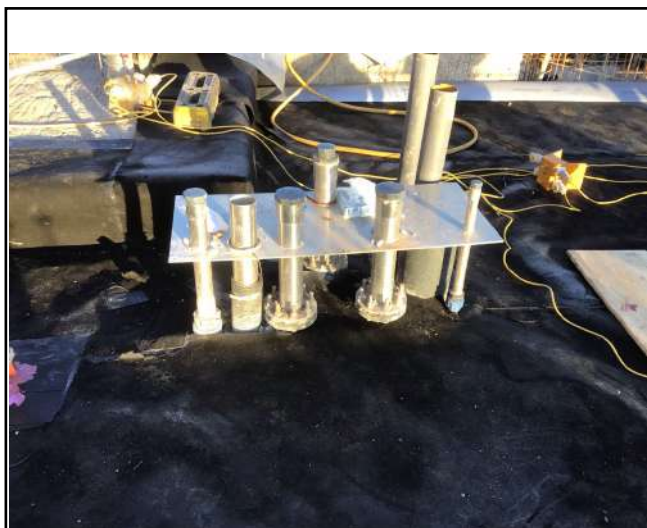
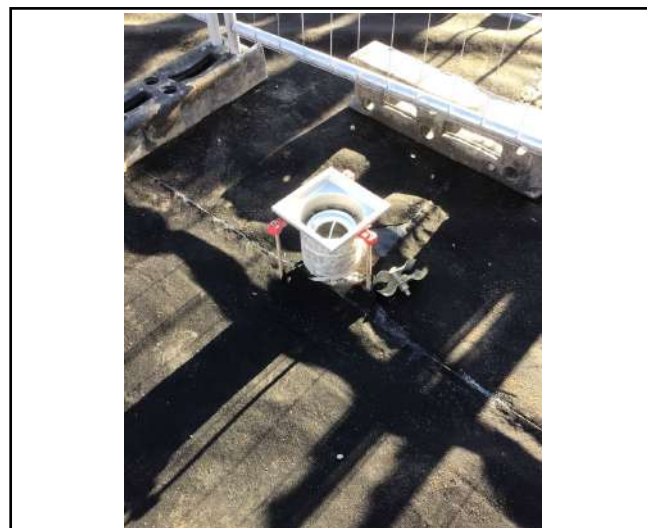
The two photographs below show outstanding penetrations of the Pudlo GP Ultra + Gas Barrier located in Block D1 pour 3. These penetrations will have to be sealed and verified during the next visit.

| Date | Nr | Remediation Description | Y/N |
|---|---|---|---|
| | | 3. Some penetrations of the membrane have not been sealed | |

| Date | Nr | Remediation Description | Y/N |
|---|---|---|---|
| | | these will have to be sealed and verified during the next visit | |

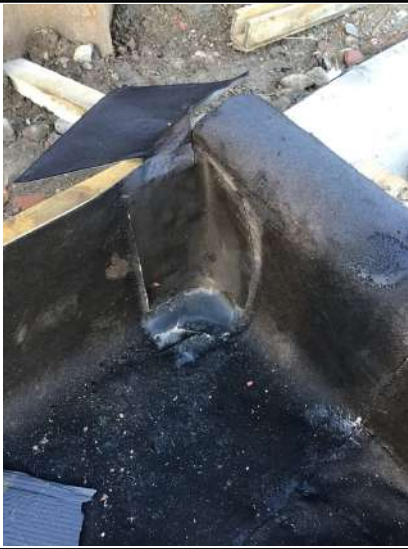
Sealed corner detail using EXT tape.

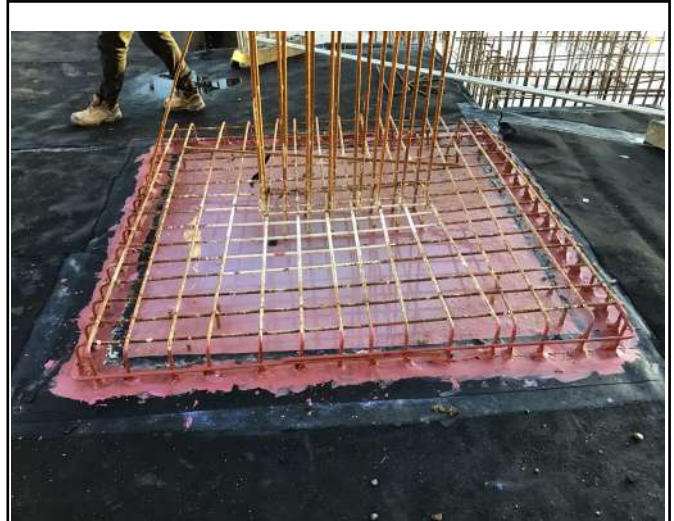
Sealed pile using Pudlo liquid

membrane and EXT tape.

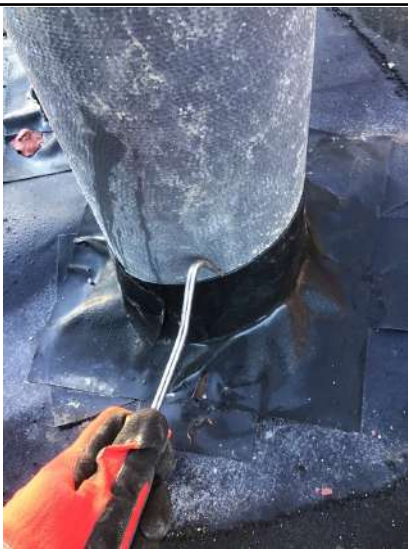
Additional pick and probe test carried

out to pipe penetration.

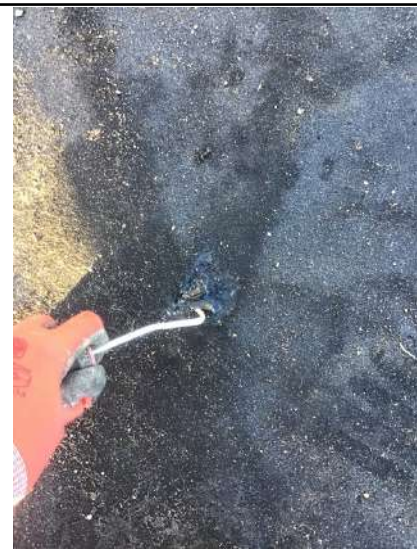
Hole identified in the membrane.

| Date | Nr | Remediation Description | Y/N |
|---|---|---|---|
| 22/01/2021 | 008 | 1. One hole in the membrane identified. The installers have | ✓ |

This was patched during this visit.

| Date | Nr | Remediation Description | Y/N |
|---|---|---|---|
| | | patched the hole by removing the fleece around the hole and then | ✓ |
| | | a hot air leister has been used to adhere EXT tape ove the hole. | ✓ |
