Site Photographs

St William

Clarendon Road Gasworks, Phase 3

6075

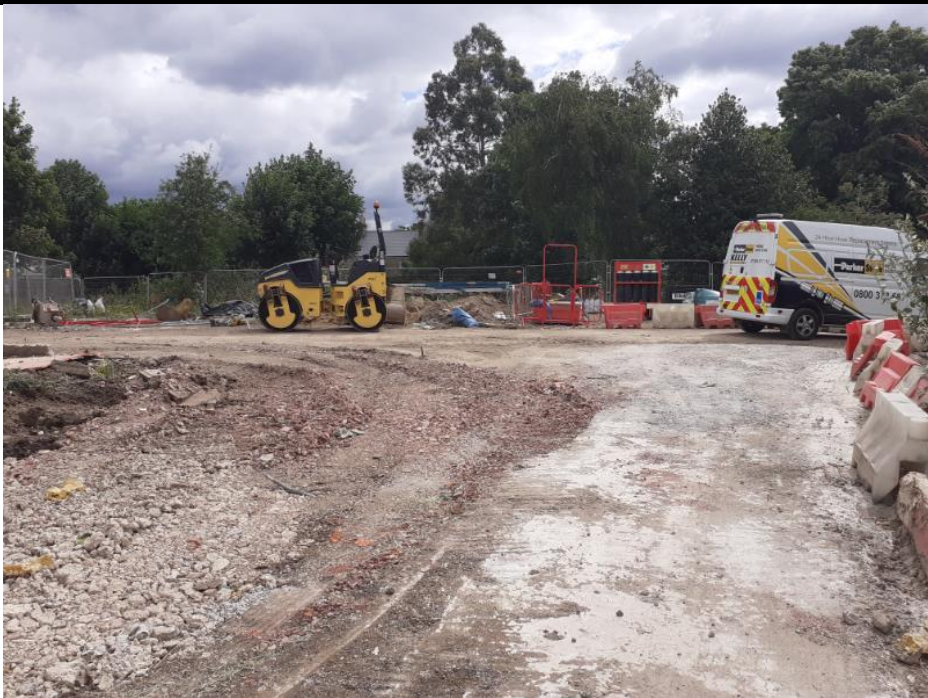
Photo: 1

Description: Crushed brickwork laid down and compacted to form ramp in the level change. Later scraped and formed into SP-0

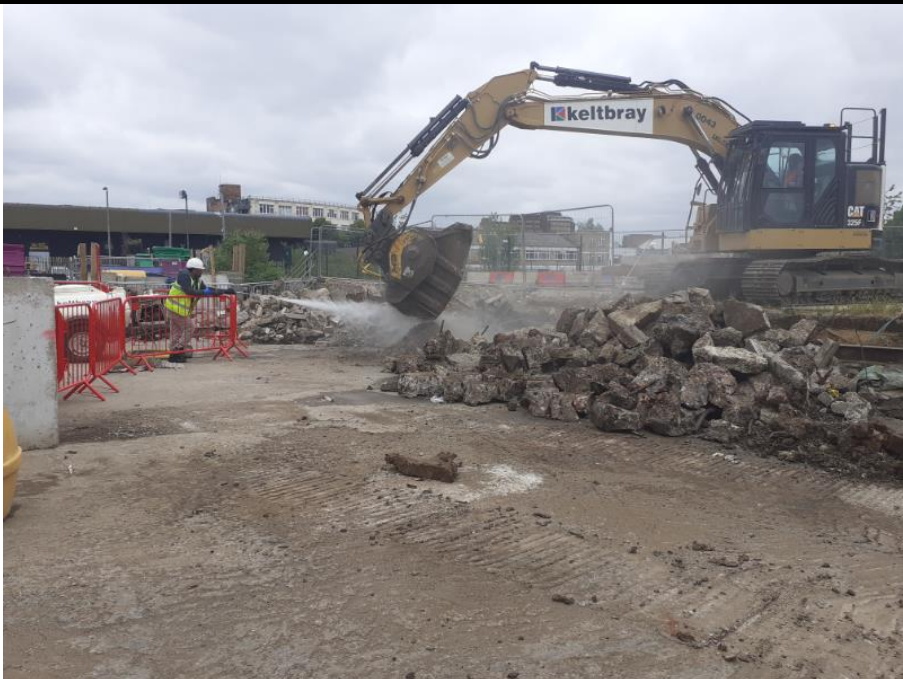
Photo: 2

Description: Stockpiling of concrete during breakout in Car Park, with jet wash for dust suppression.

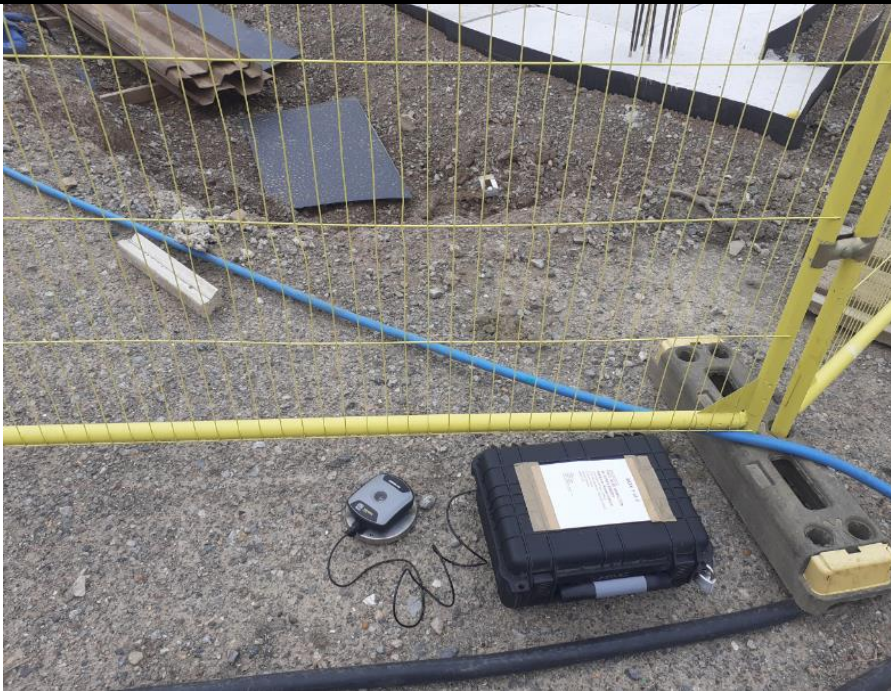
Photo: 3

Description: Set-up of vibration monitor 'Cadent Easement'.

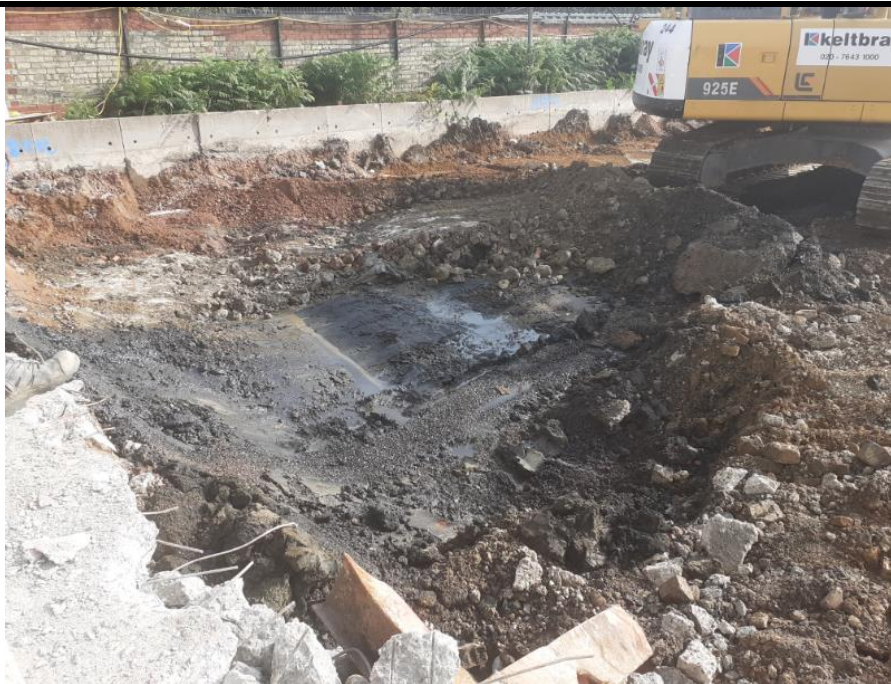
Photo: 4

Description: Breaking out of concrete and type 1 Made Ground in car park.

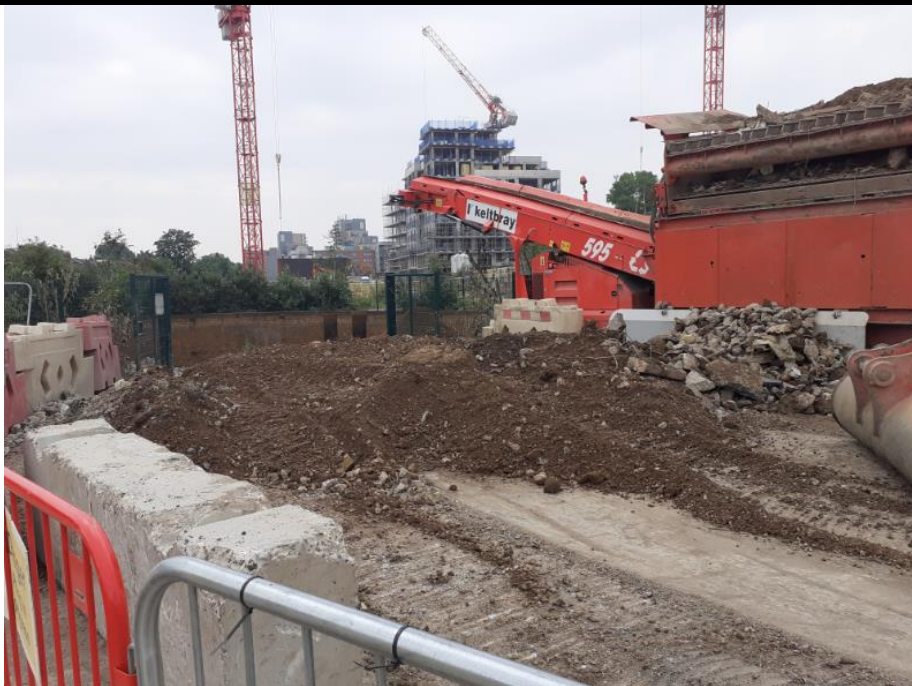
Photo: 5

Description: Material excavated from car park processed through screener. And stockpiled in GH1.

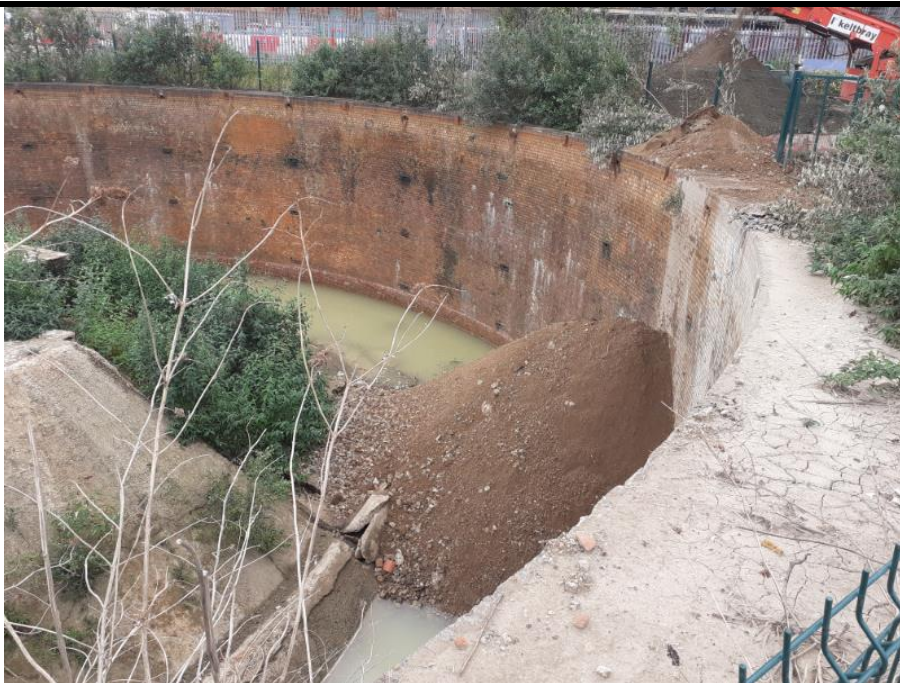
Photo: 6

Description: Formation of ramp using screened material from excavation in car park.

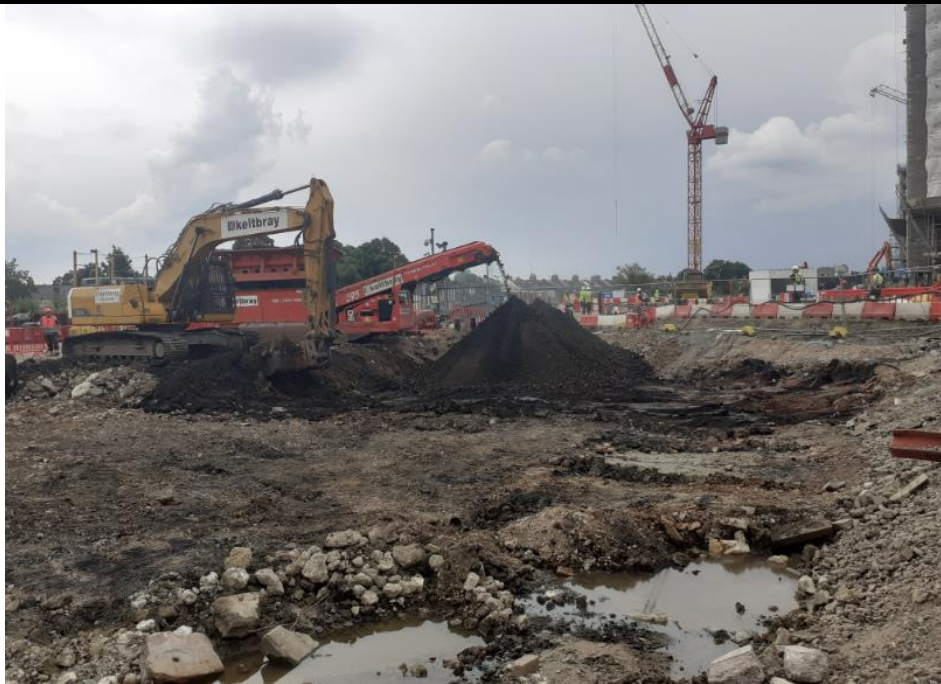
Photo: 7

Description: Screener active processing stockpile.

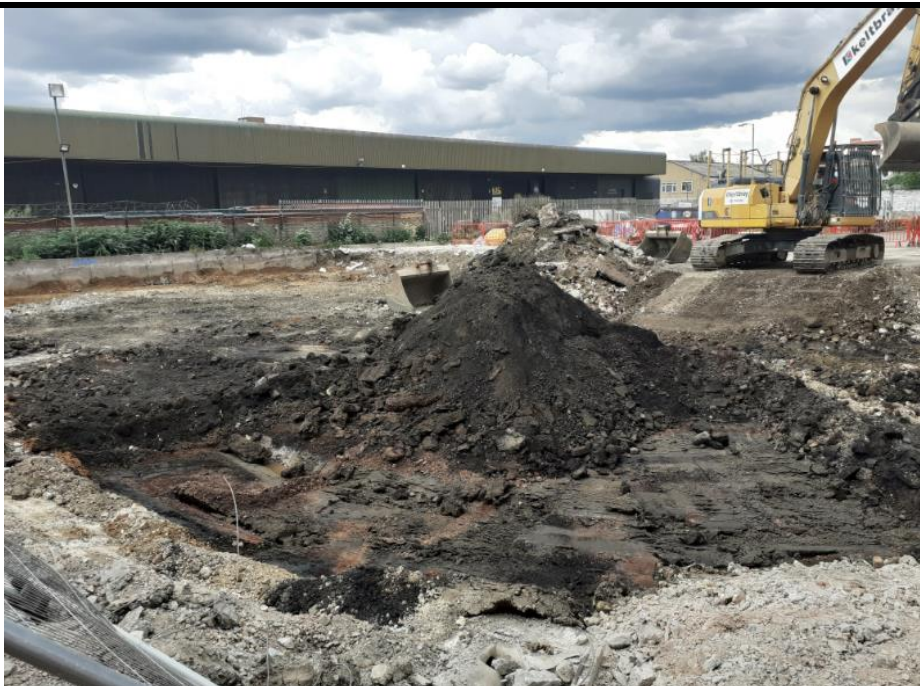
Photo: 8

Description: Break out and excavation of the car park.

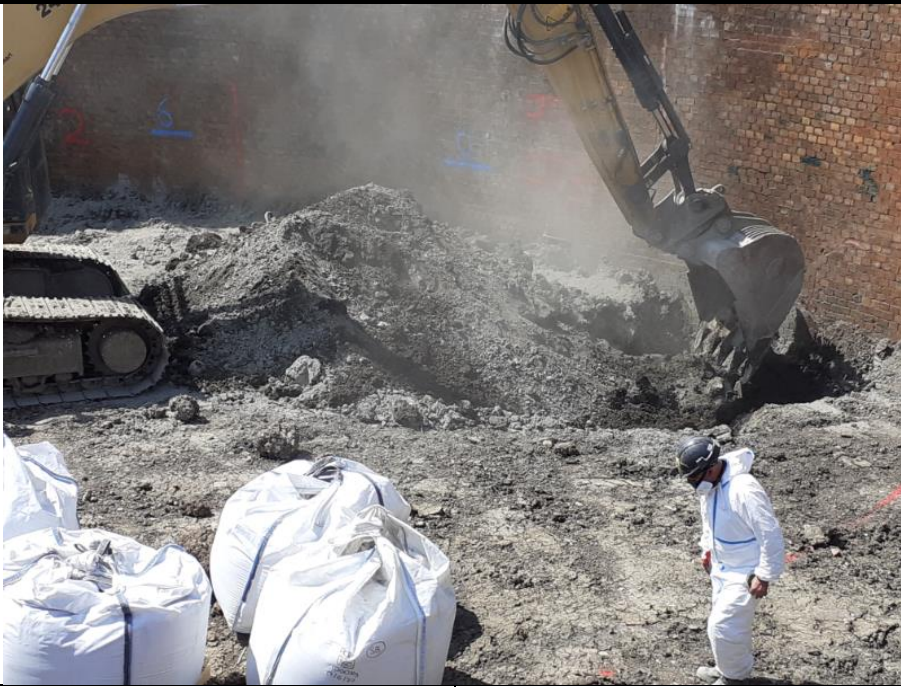
Photo: 9

Description: 5% wt CEM1 stabilisation in progress.

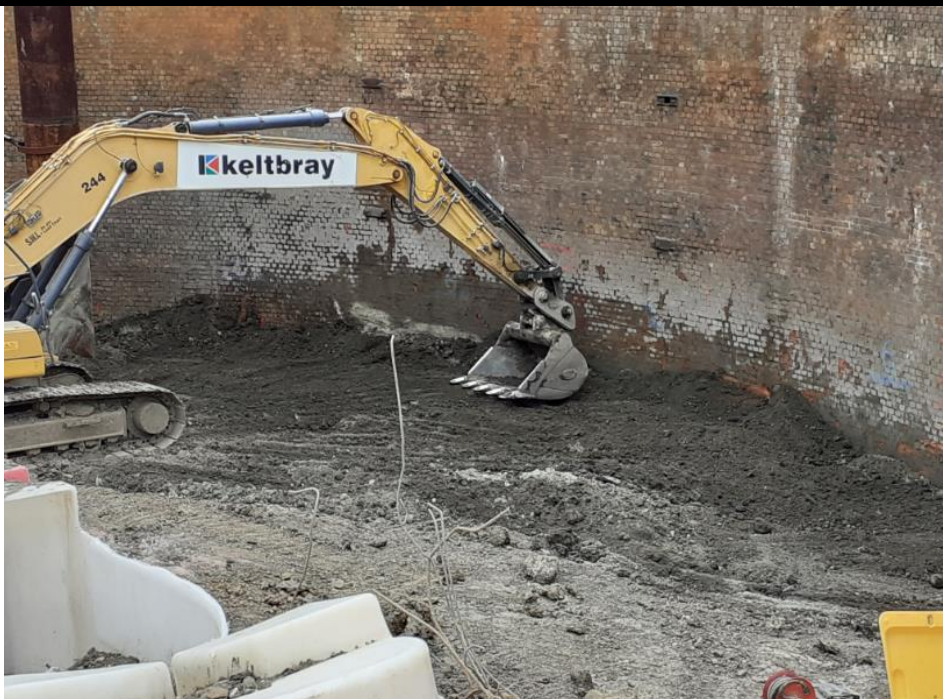
Photo: 10

Description: Placement of stockpiled material during backfill of GH1 prior to rolling.

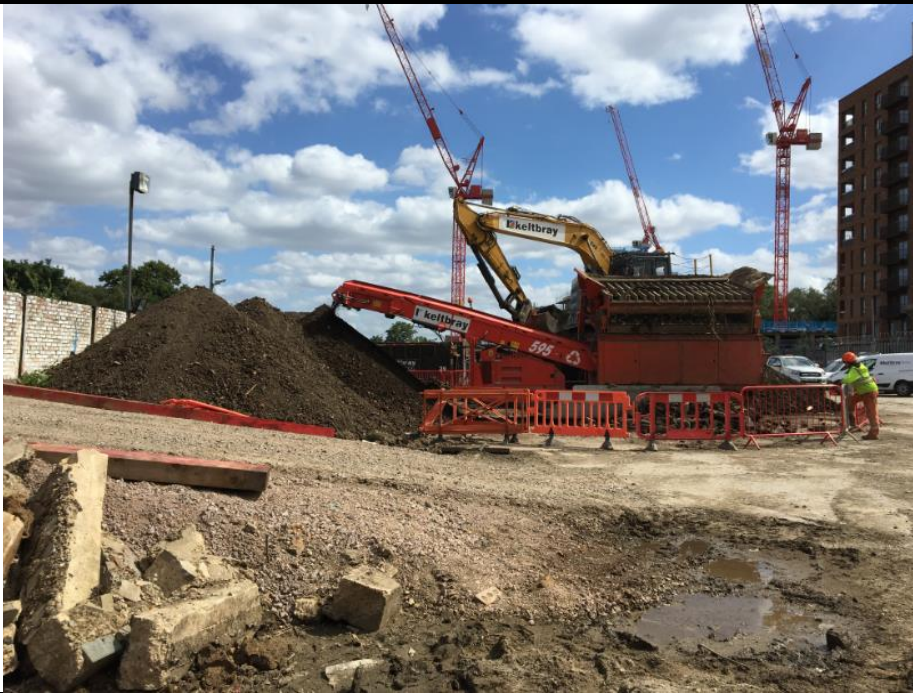
Photo: 12

Description: All material being excavated from car park screened and stockpiled on-site prior to reuse.

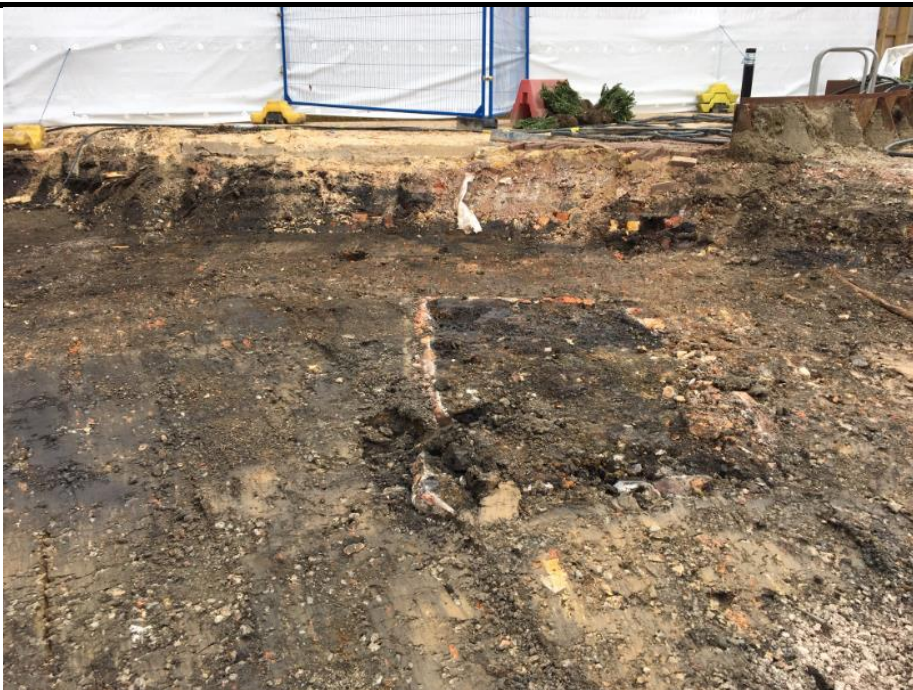
Photo: 13

Description: Tank hotspot located in Q2.

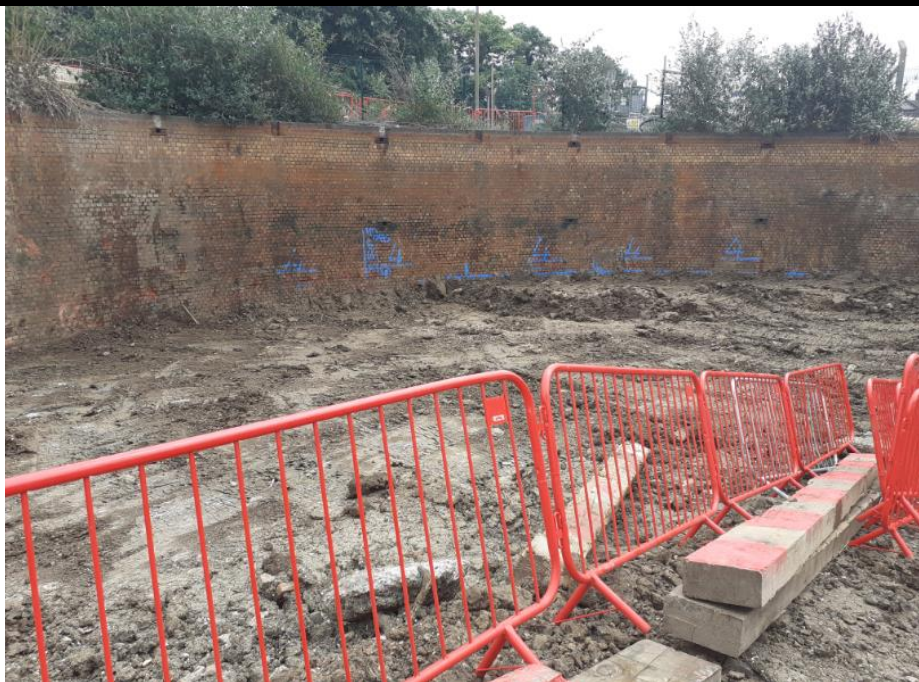
Photo: 14

Description: Continued process of backfilling in GH1. Depth levels marked on brick wall for reference.

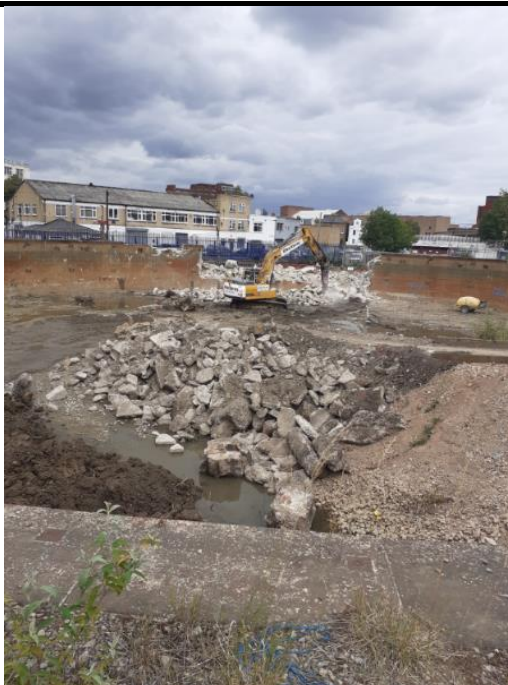
Photo: 15

Description: Concrete in GH3 being broken out and stockpiled prior to crushing in Gasholder 3.

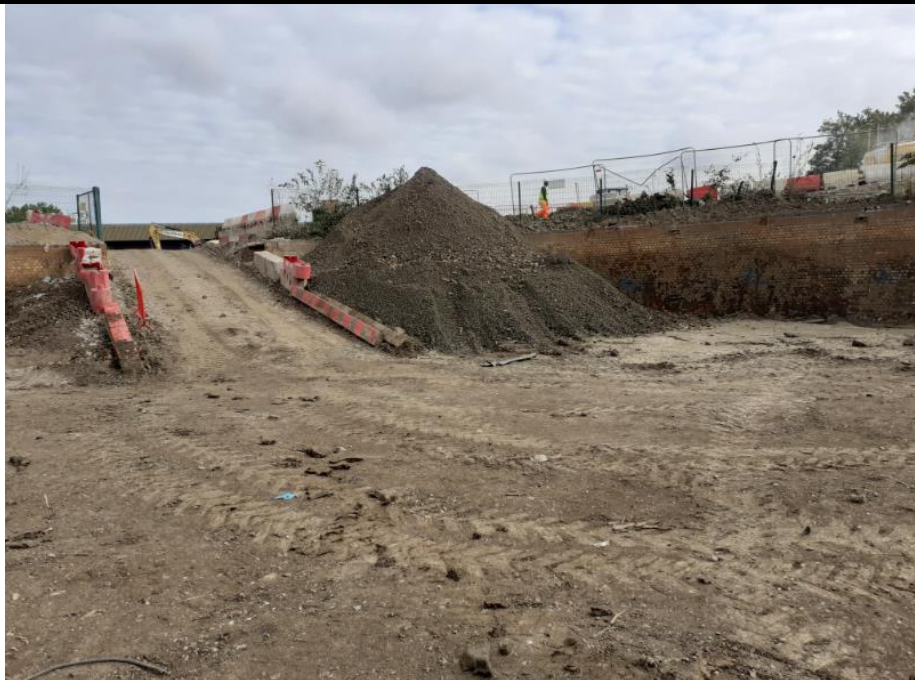
Photo: 16

Description: Processed material stockpiled in Gasholder 1 with 3m remaining until backfill complete.

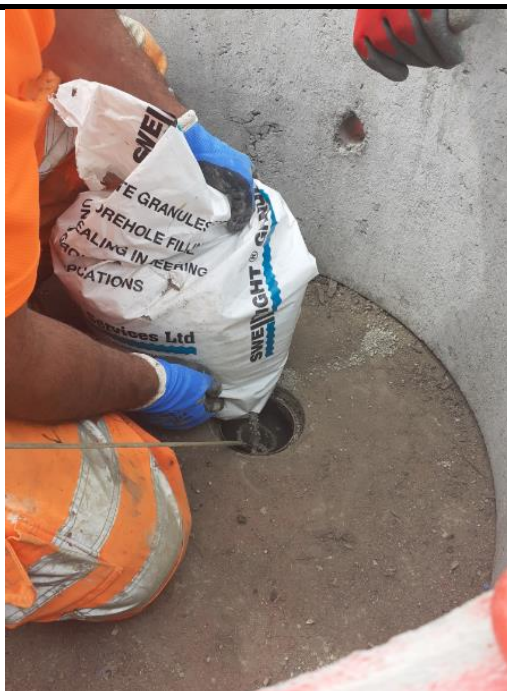
Photo: 17

Description: Decommissioning of borehole.

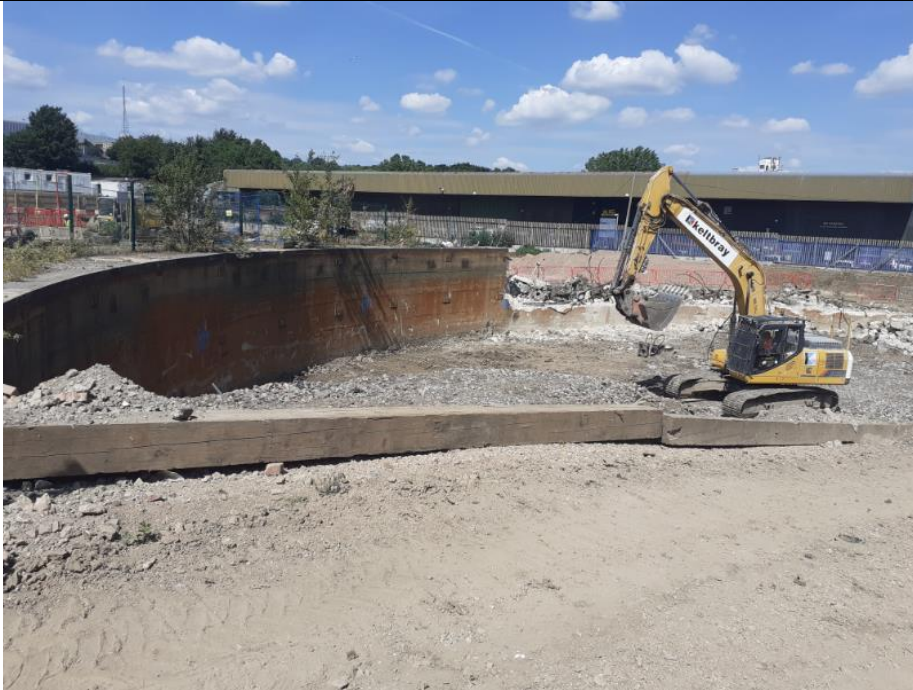
Photo: 18

Description: Breaking out wall in Gasholder 3 down to formation level.

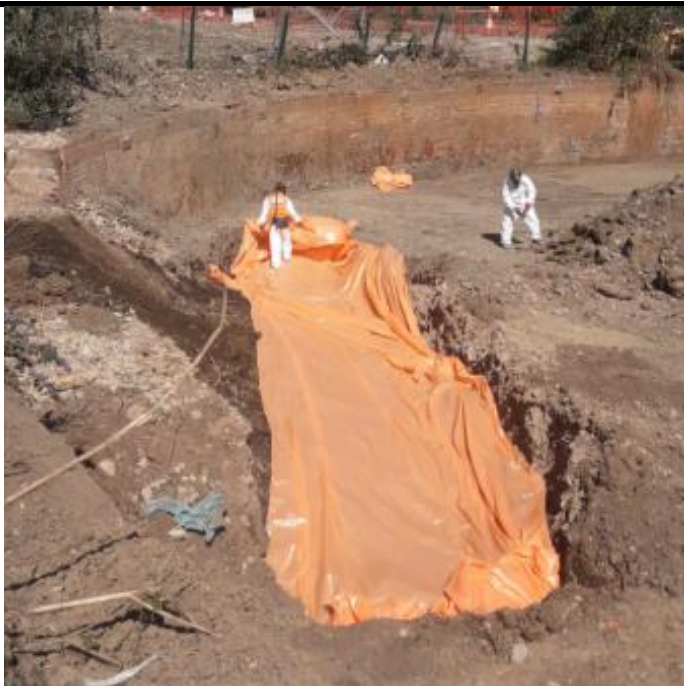
Photo: 19

Description: Asbestos hotspot during backfill. NNLW works.

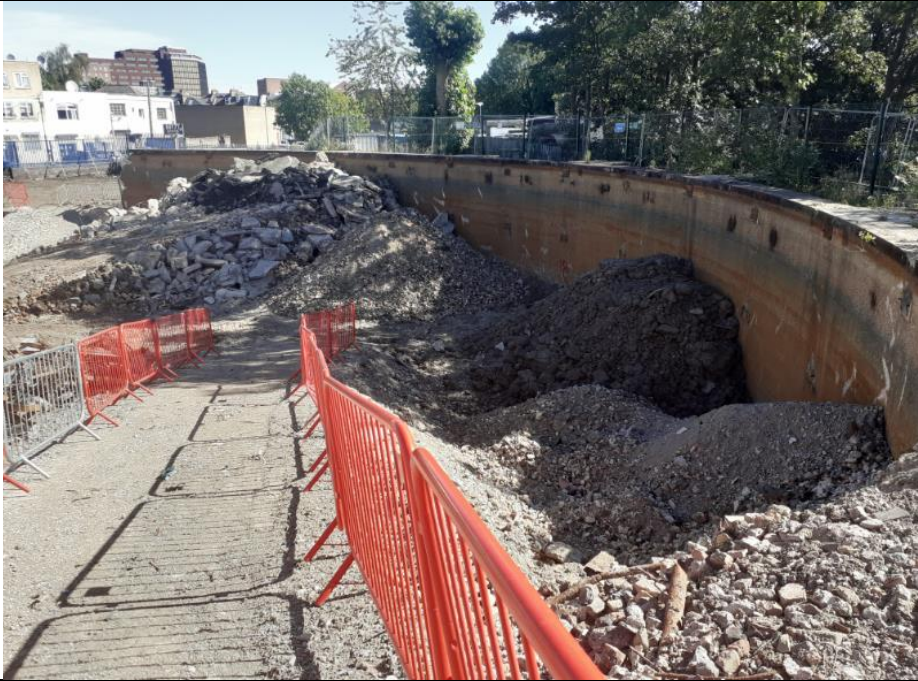
Photo: 20

Description: Initial stockpiling in GH3.  
Stockpiles awaiting screening, sampling and rolling.

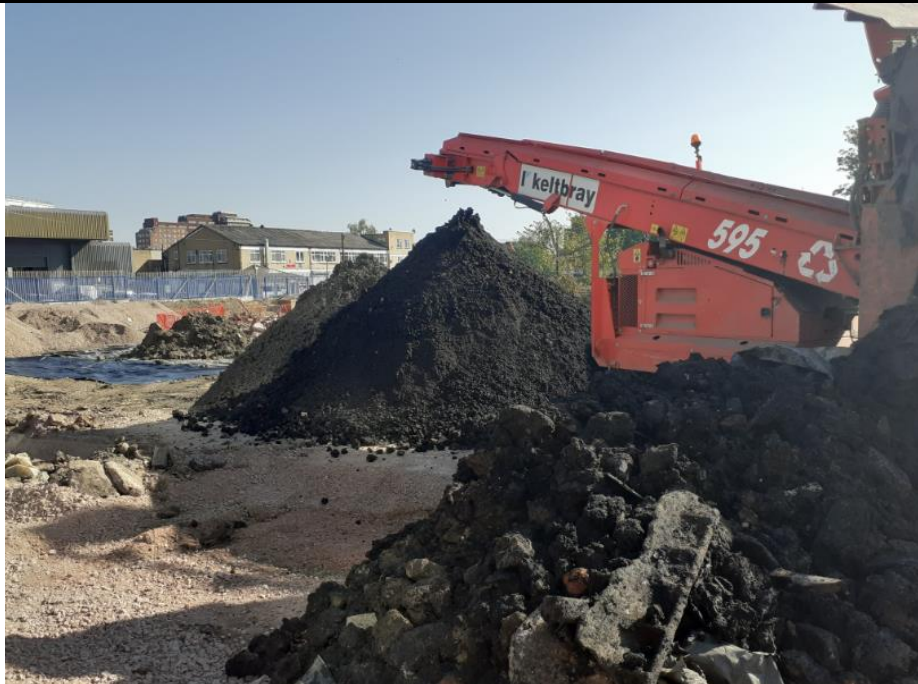
Photo: 21

Description: Material continued to be processed and being stockpiled in Gasholder 1.

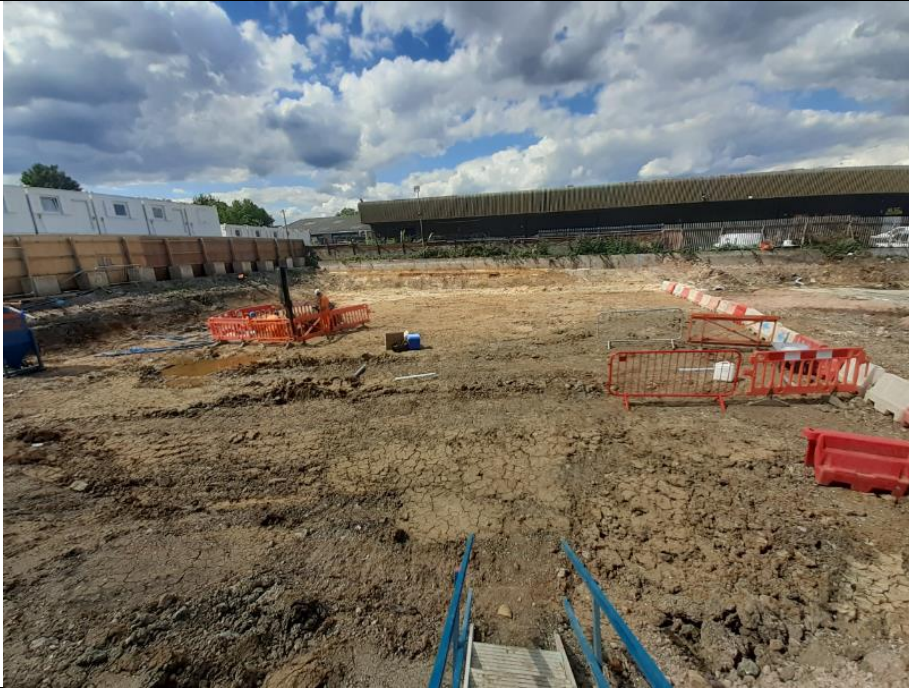
Photo: 22

Description: Further excavation of the car park and window sampling.

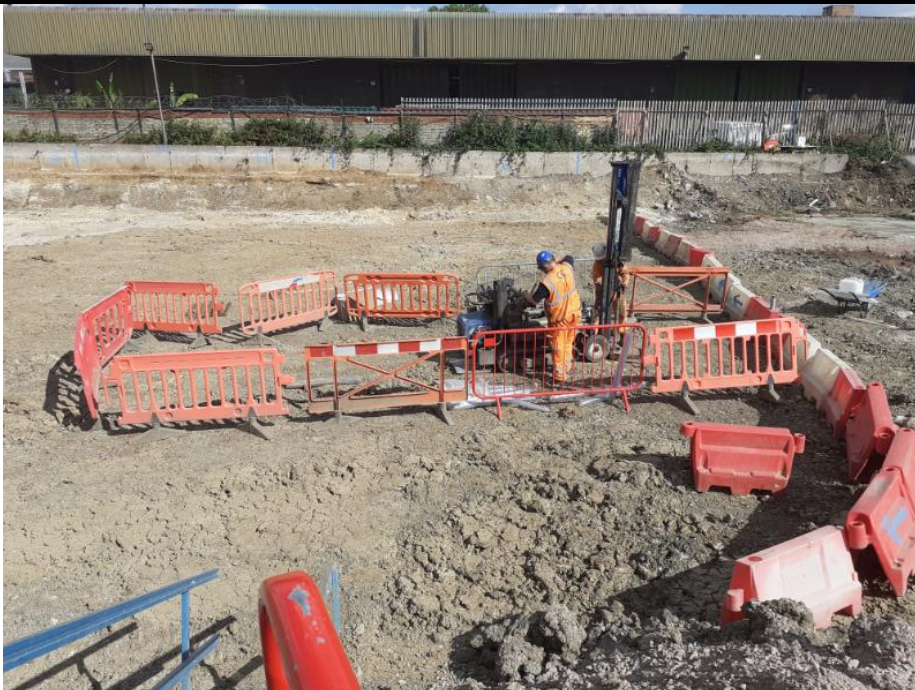
Photo: 23

Description: Window sampling in car park area.

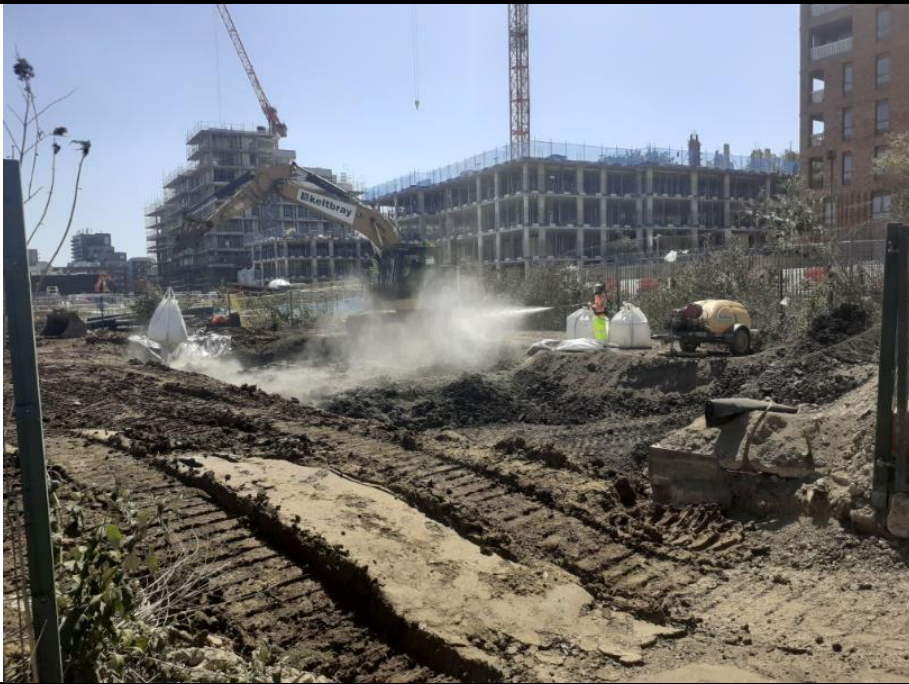
Photo: 24

Description: Continued backfill of Gasholder 1 with 5% wt CEM1 stabilisation and jet wash dust suppressant.

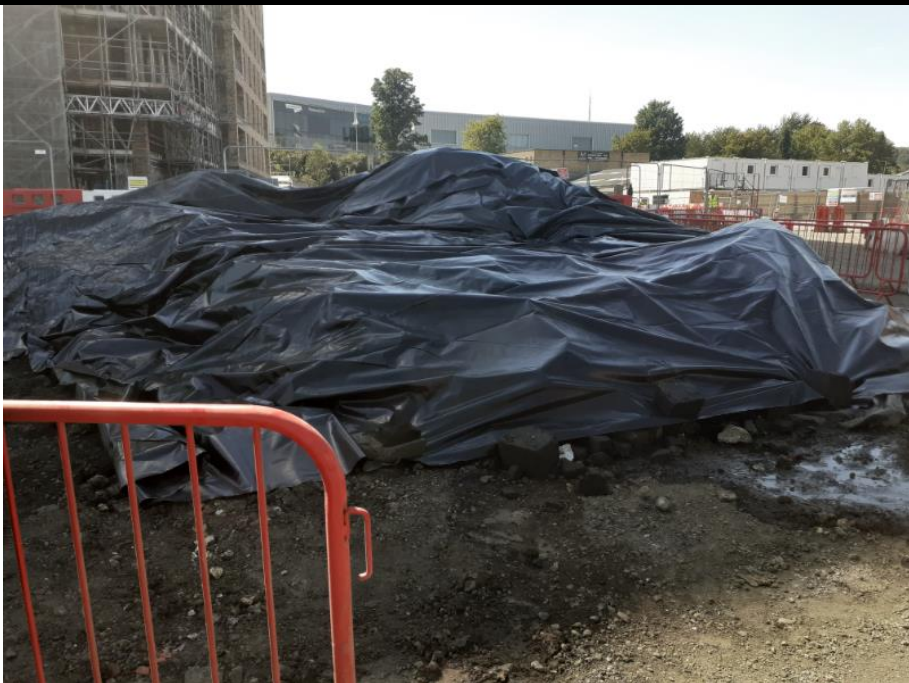
Photo: 25

Description: Stockpile covering to reduce odour.

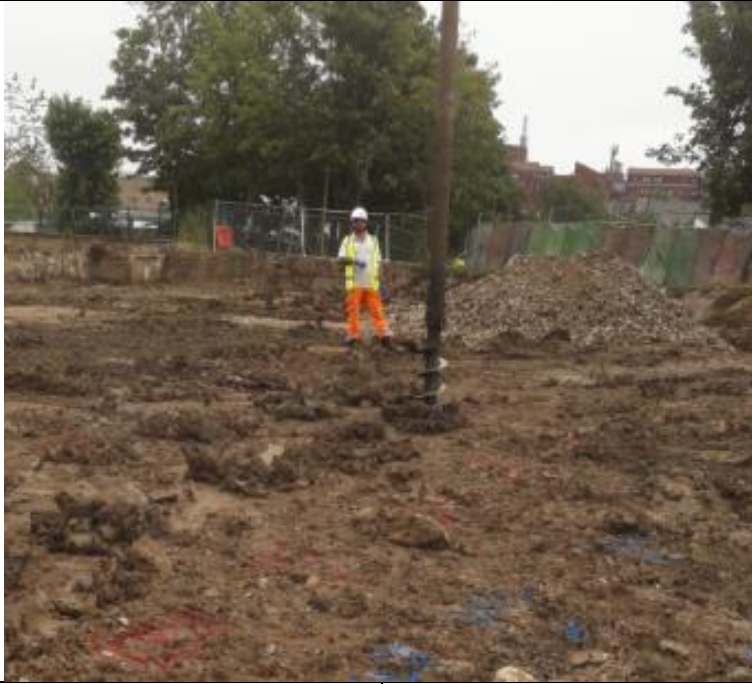
Photo: 26

Description: Pile probing activity.

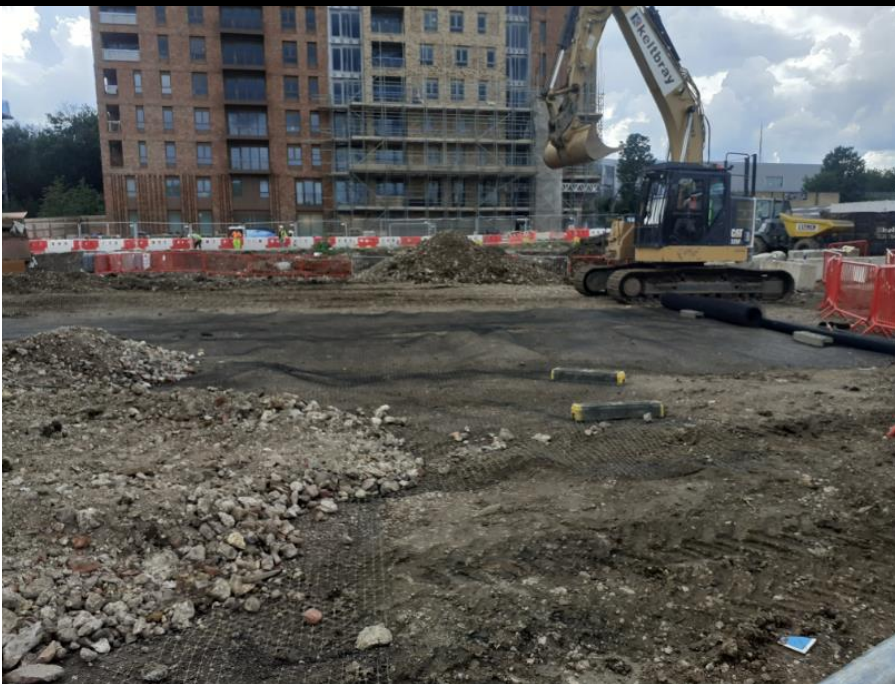
Photo: 27

Description: Installation of pile mat using site-won crushed material placed over 1 layer of geogrid.

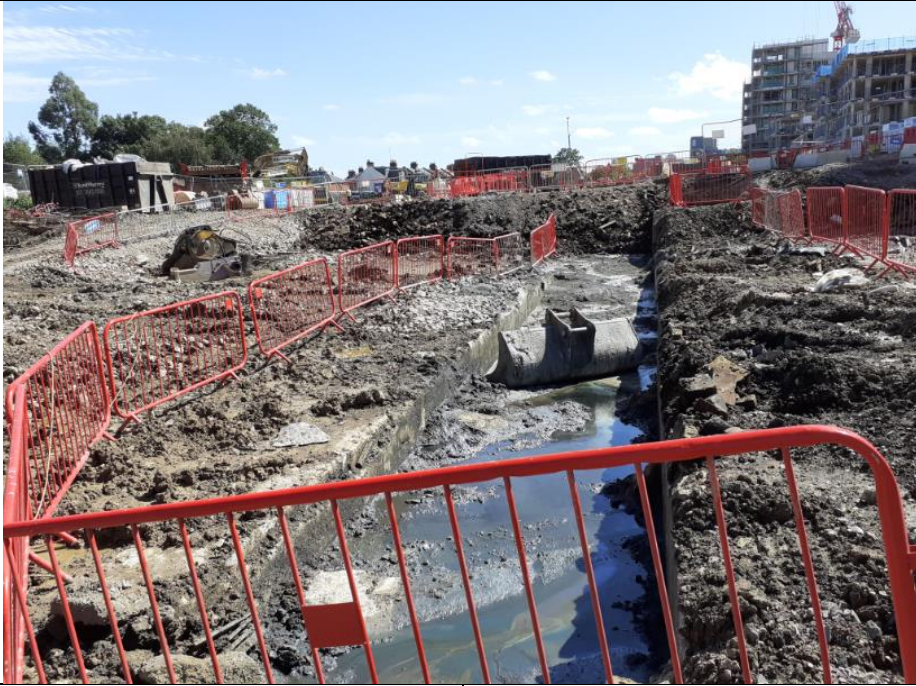
Photo: 28

Description: Excavation of hotspot in J9 North of Gasholder 1.

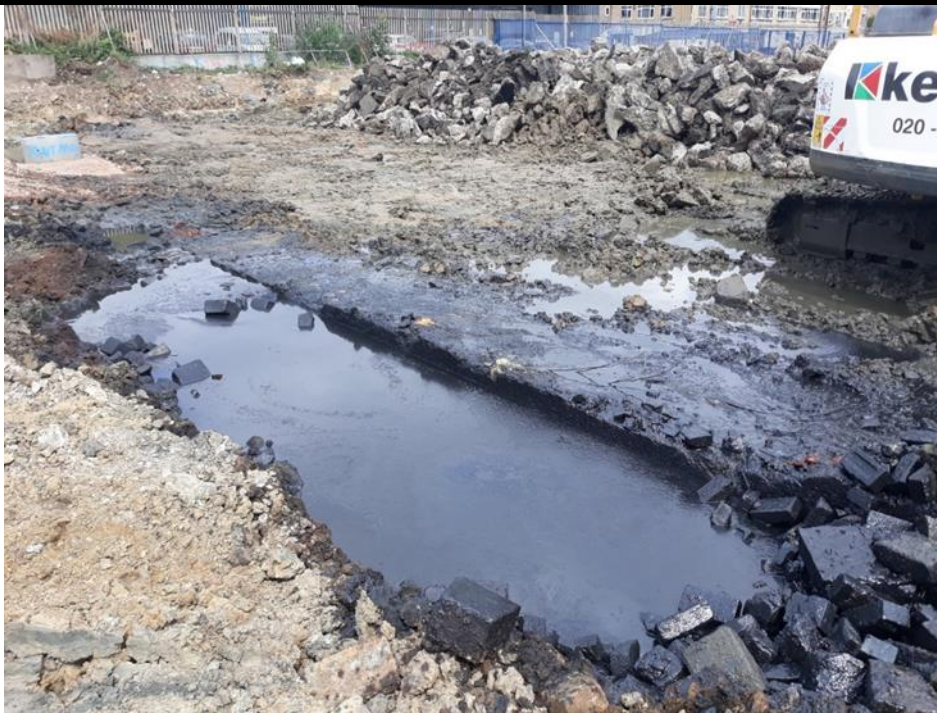
Photo: 29

Description: Initial uncovering of the contaminated trench.

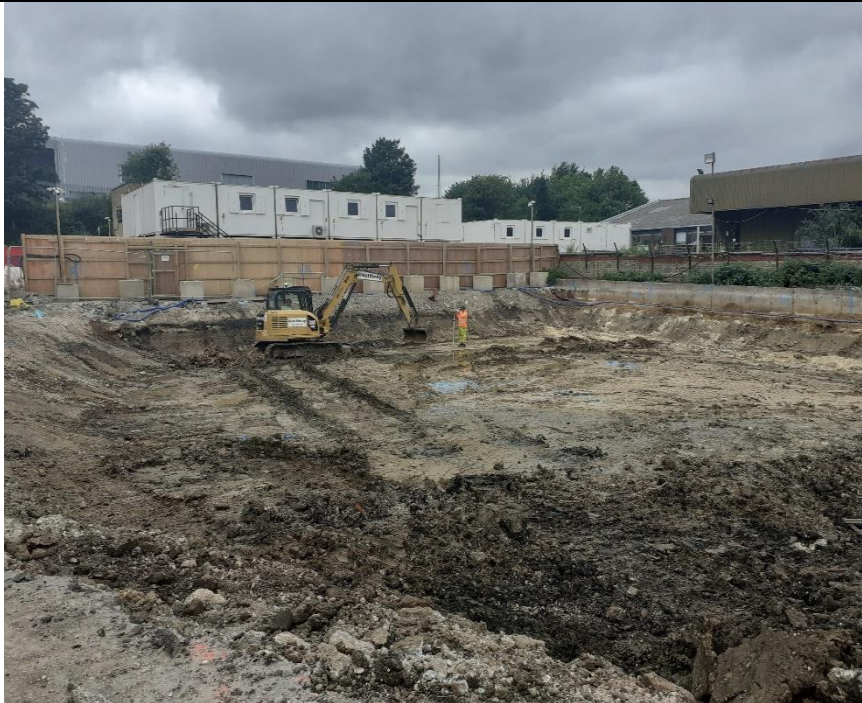
Photo: 31

Exposed Clay in I11 / H11, samples from this area exceeded the ammonium criteria

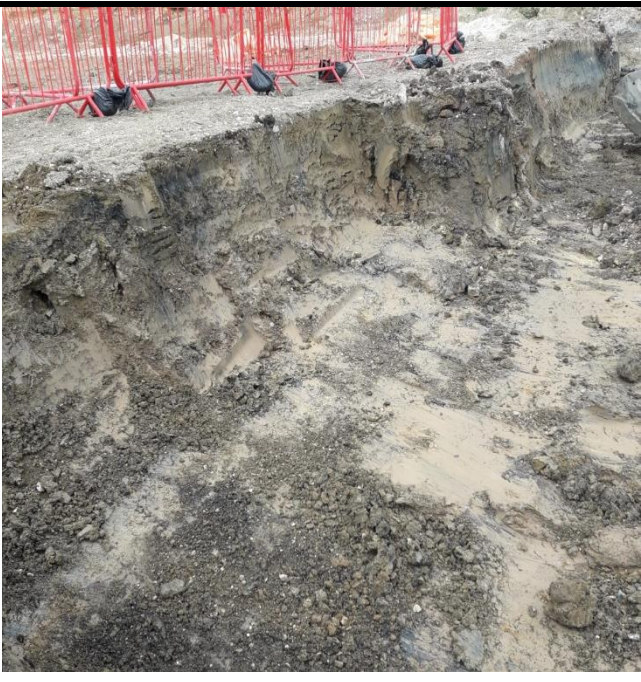
| Client:<br>St William | Site Location:<br>Clarendon Road Gasworks, Phase 3 | Project Number:<br>6075 |
|---|---|---|
| Photo: 32 | Description: Trench following excavation. | |

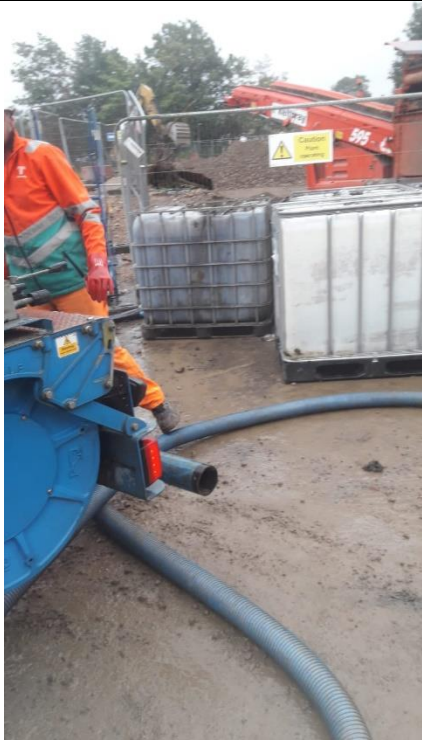
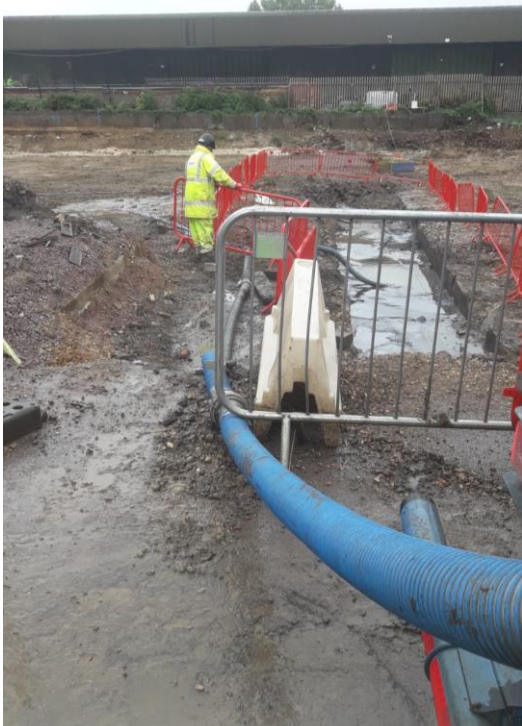
| Photo: 33 | Description: Vacuum extraction of contaminated water from the trench hotspot. |

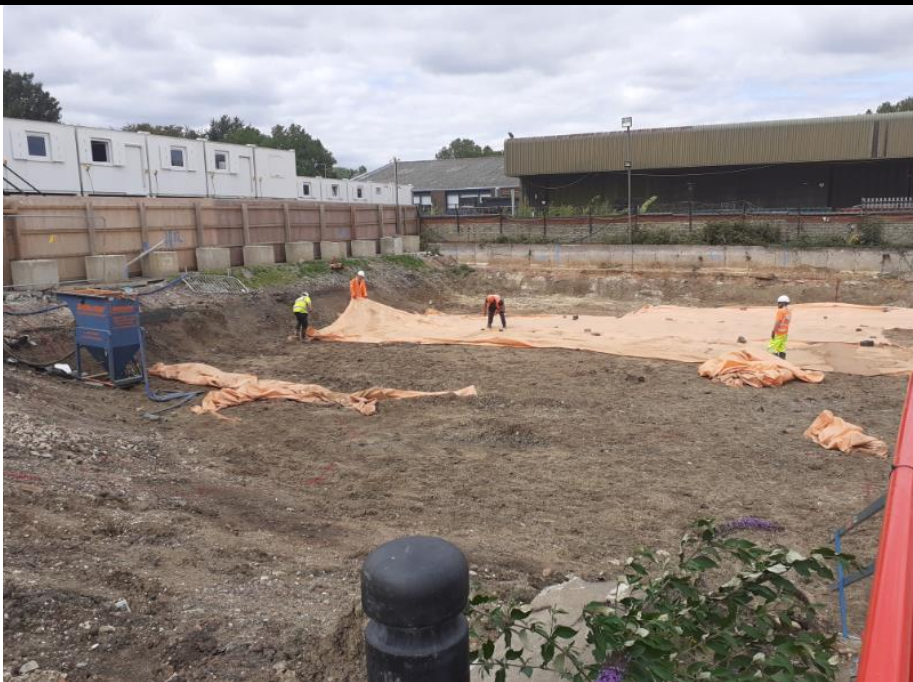
Photo: 34

Description: Placement of orange marker layer in Car Park.

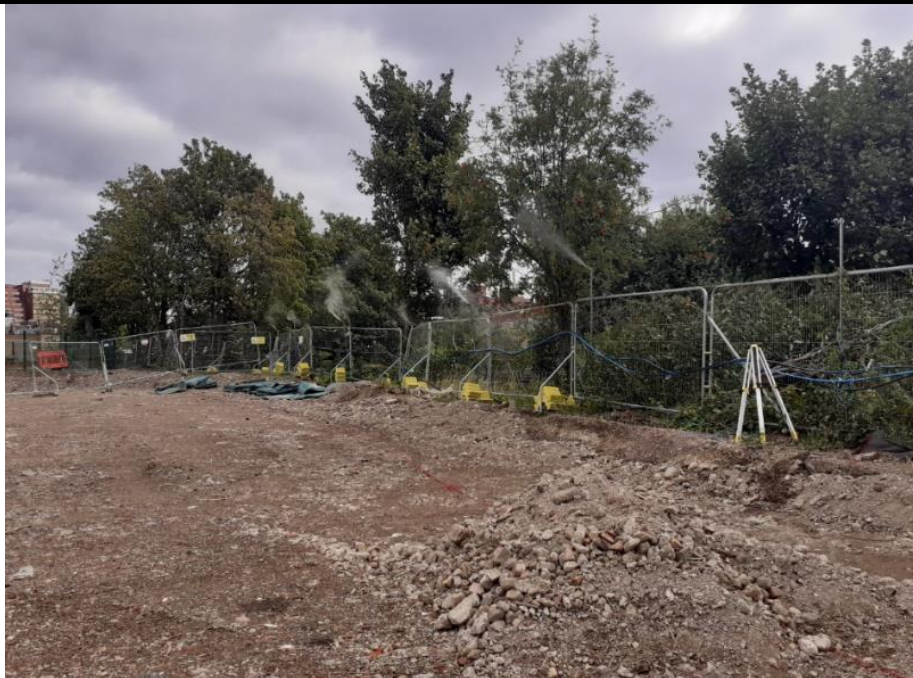
Photo: 35

Description: Dust suppression water jets on perimeter of site.

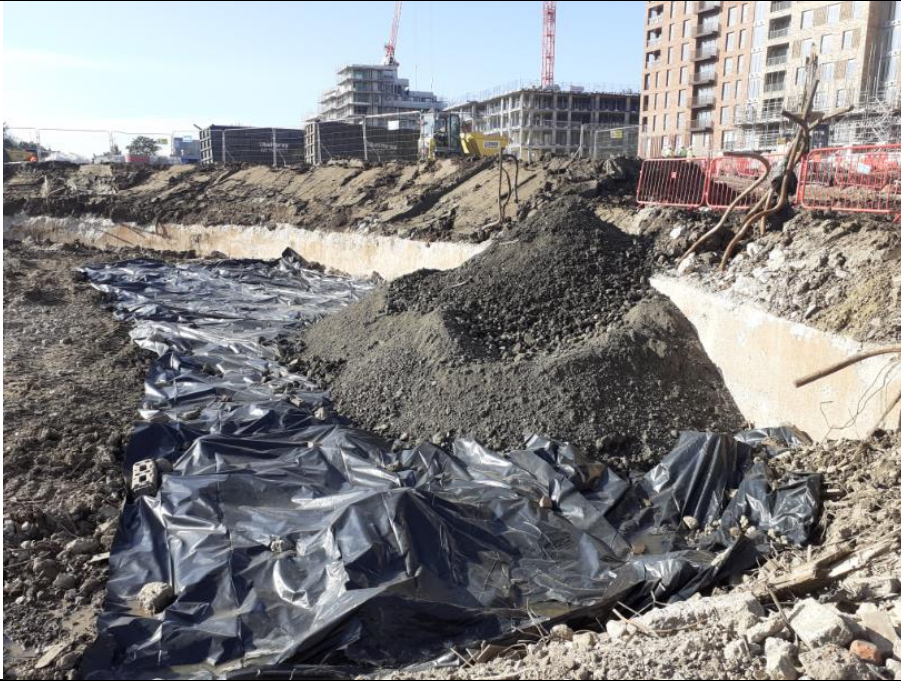
Photo: 36

Description: Placement of material onto black terram layer in Gasholder 3 prior to stabilisation.

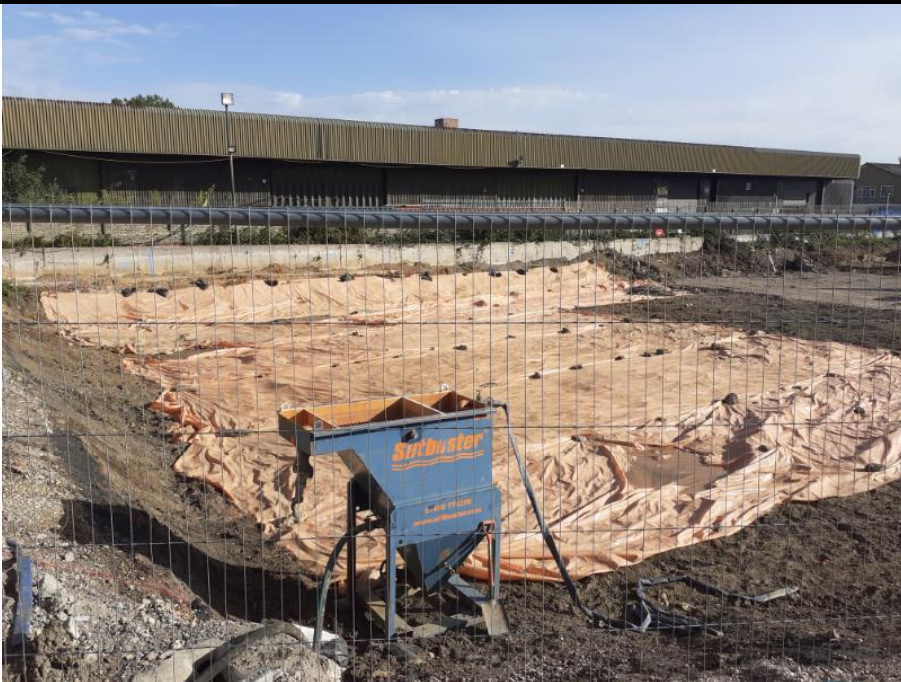
Photo: 37

Description: Placement of orange marker layer in car park. Siltbuster active and being used to treat water.

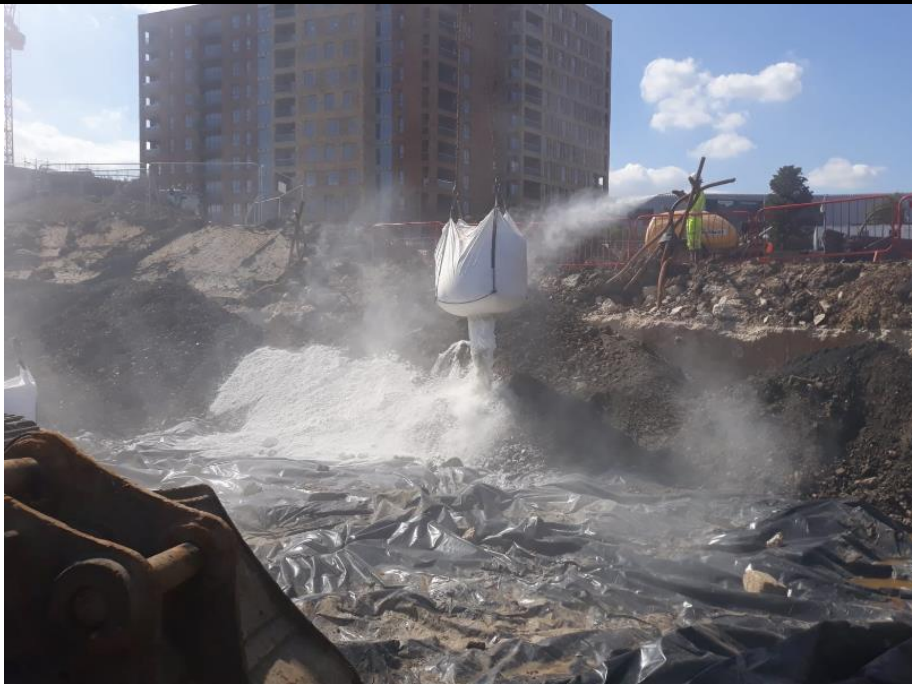
Photo: 38

Description: GGBS stabilisation with jet wash for dust suppression in Gasholder 3.

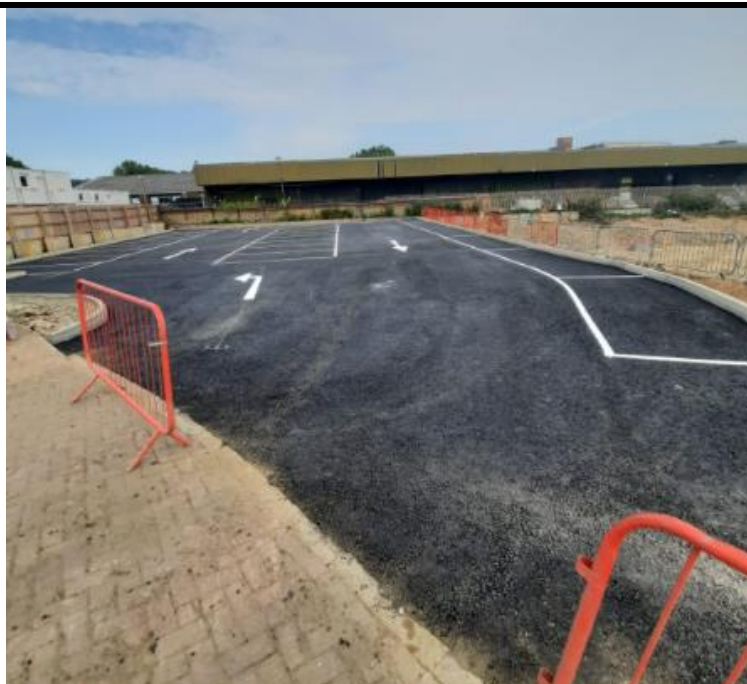
Photo: 39

Description: Installation of Car Park complete.
