Site Photographs

St William

Clarendon Road Gasworks, Phase 3

6075

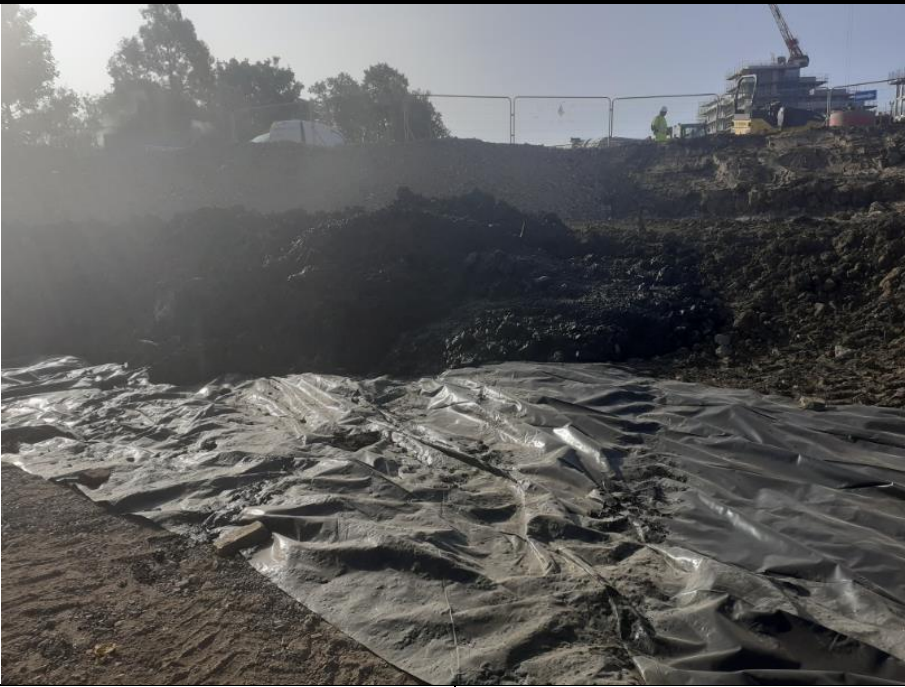
Photo: 40

Description: Stockpiling in Gasholder 3 to formation level using excavated material and site-won crushed concrete with stabilisation using cement and GGBS.

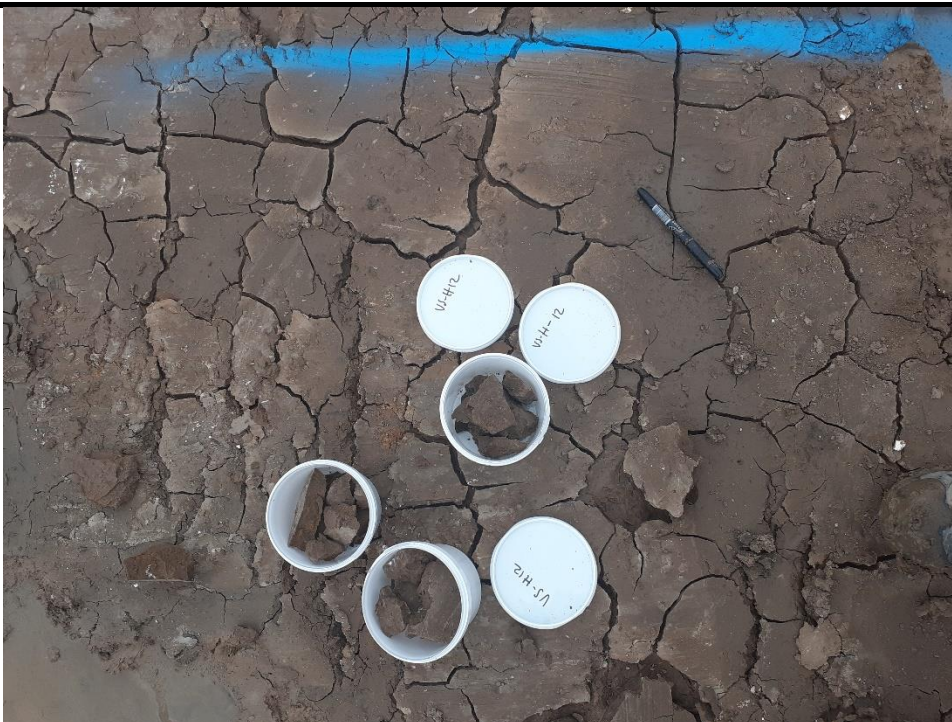
Photo: 41

Description: Validation sampling at formation level (H12).

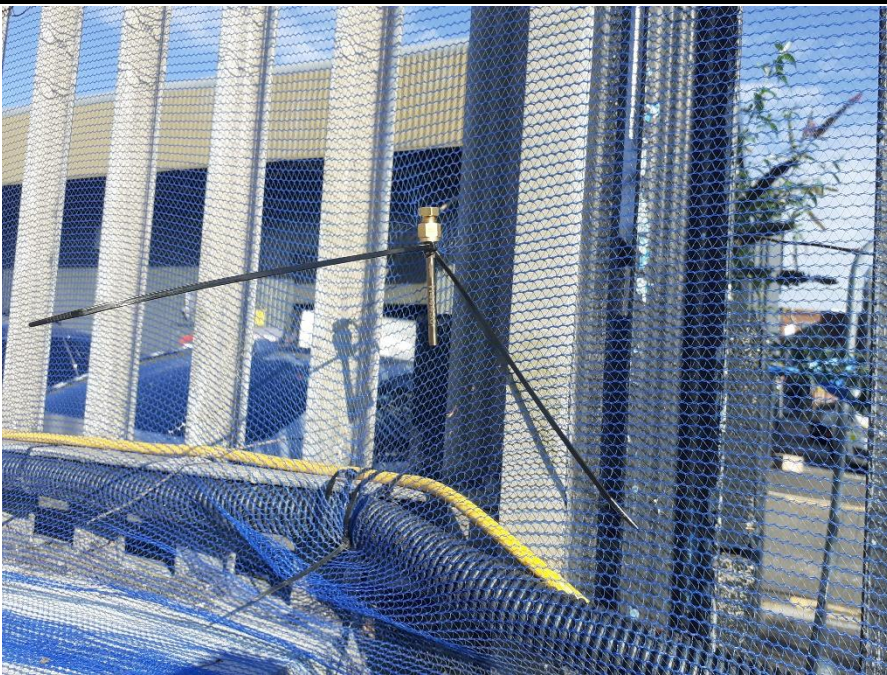
Photo: 42

Description: Tenax tube secured on boundary fencing at EMS 1.

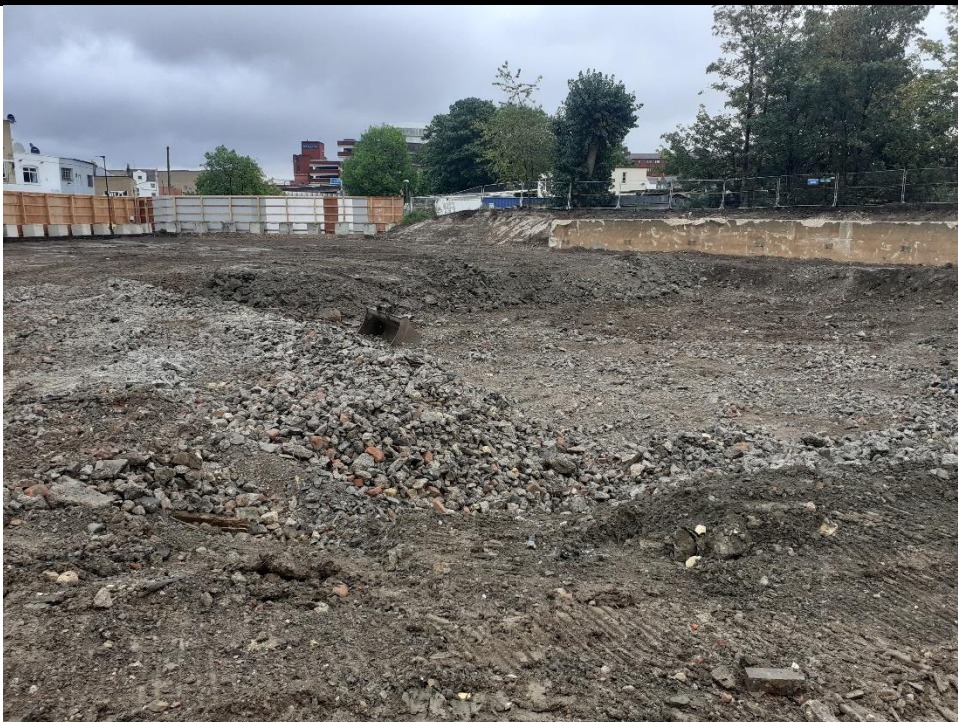
Photo: 43

Description: Final level backfill in GH3SP-40 and SP-38

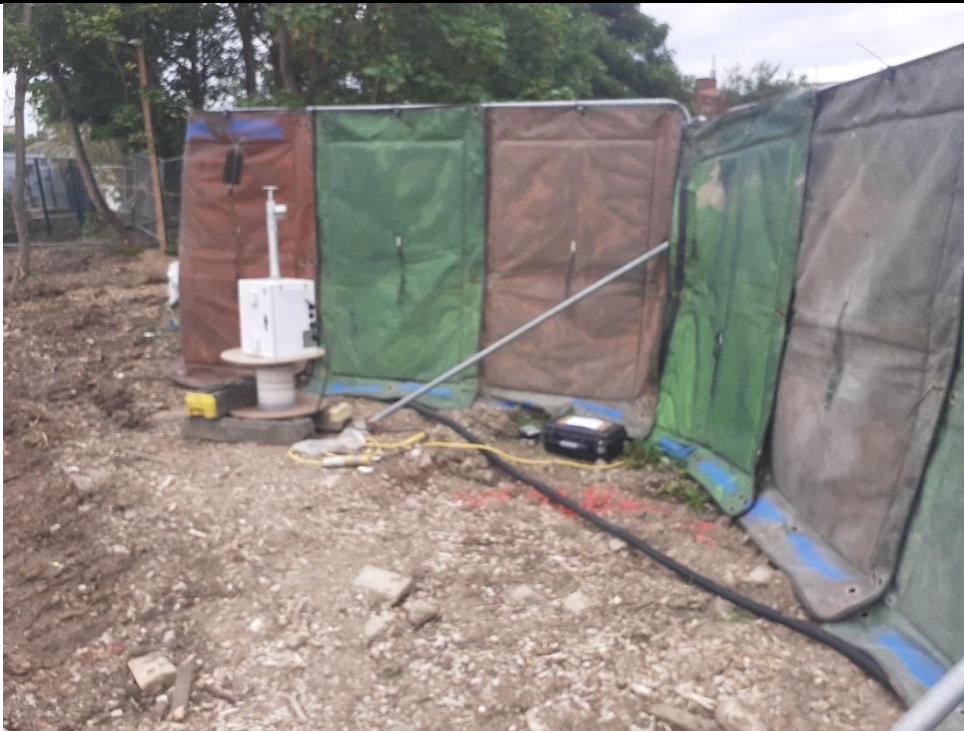
Photo: 44

Description: EMS2 monitoring point next to 'houses' sensitive receptor.

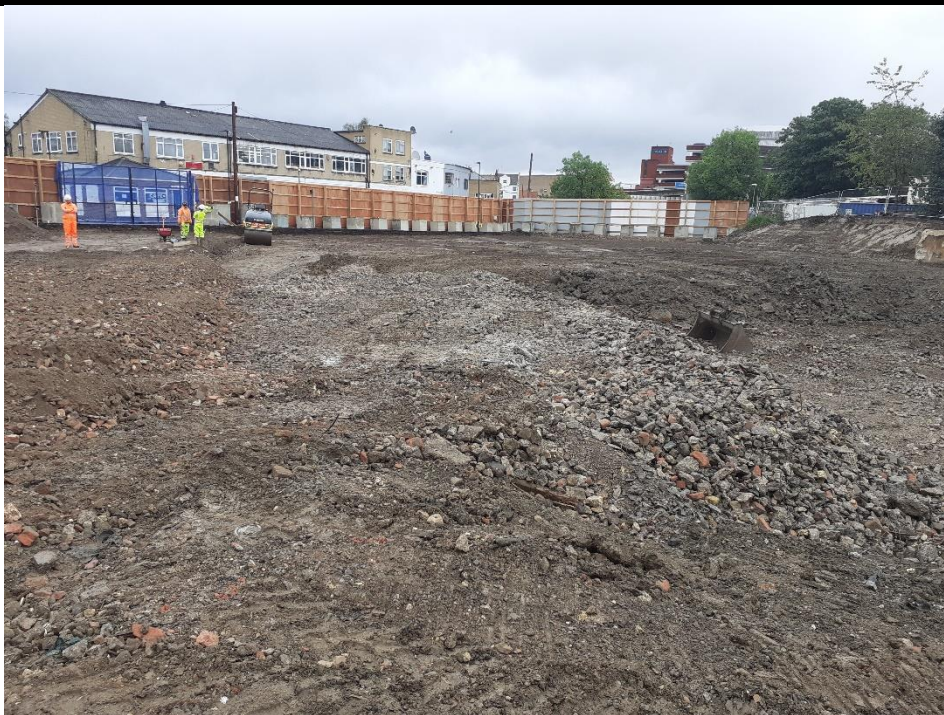
Photo: 45

Description: Haul road installation leading to Brook Road

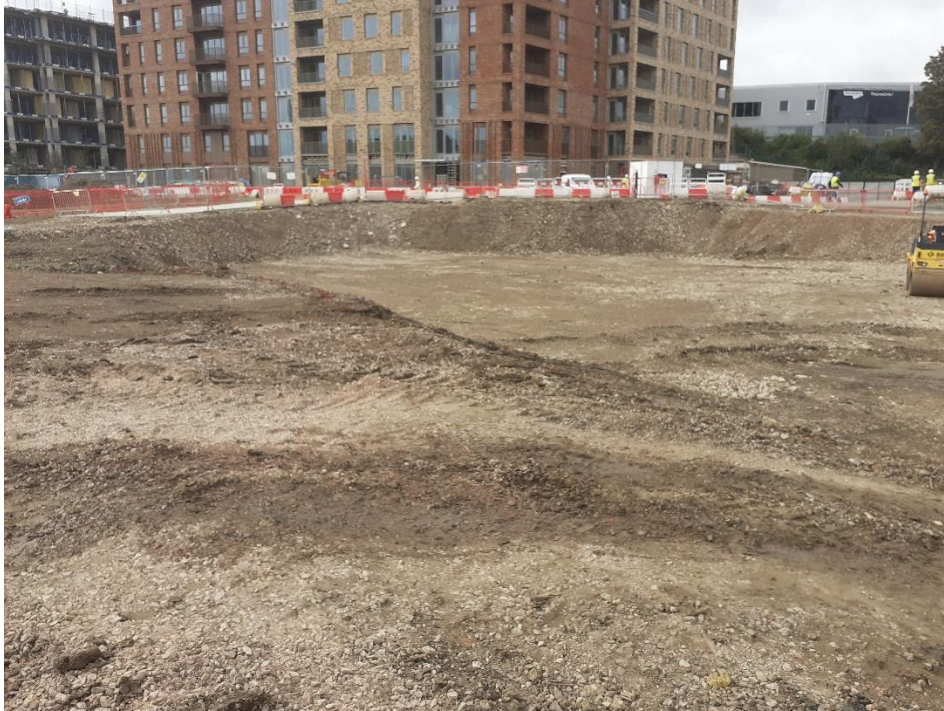
Photo: 46

Description: Haul road installation leading to Brook Road

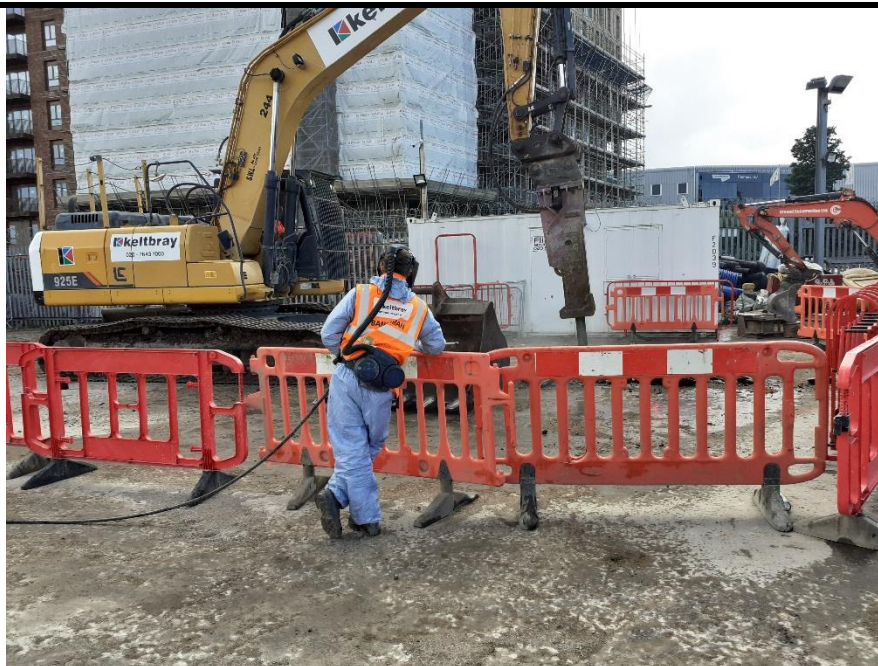
Photo: 47

Description: Excavation of TP424

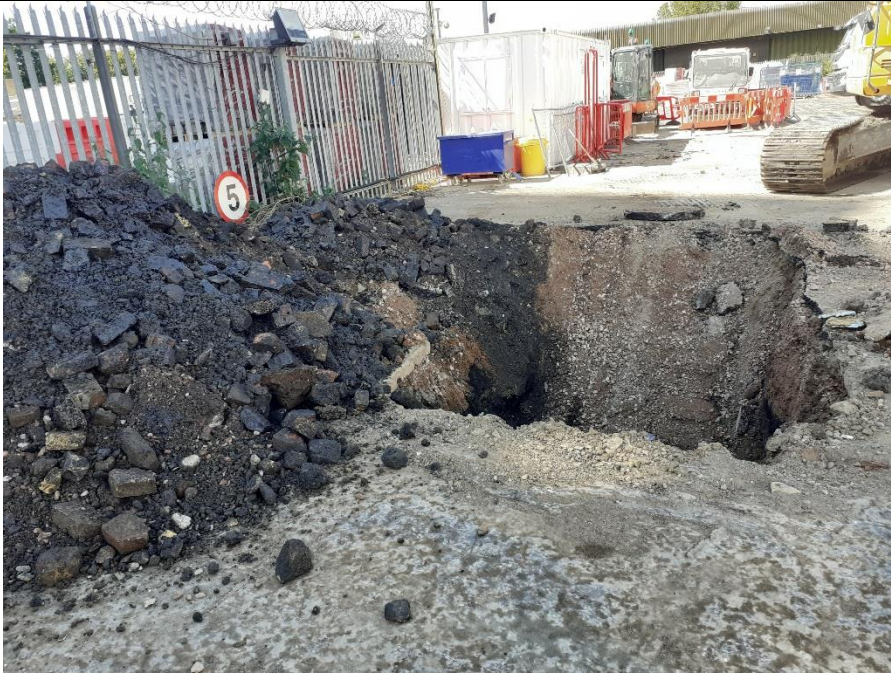
Photo: 48

Description: Excavation of TP419
