# Arboricultural Report

Tree Condition Survey

639 Tottenham High Road  
London  
N17 8AA

20<sup>th</sup> March 2023

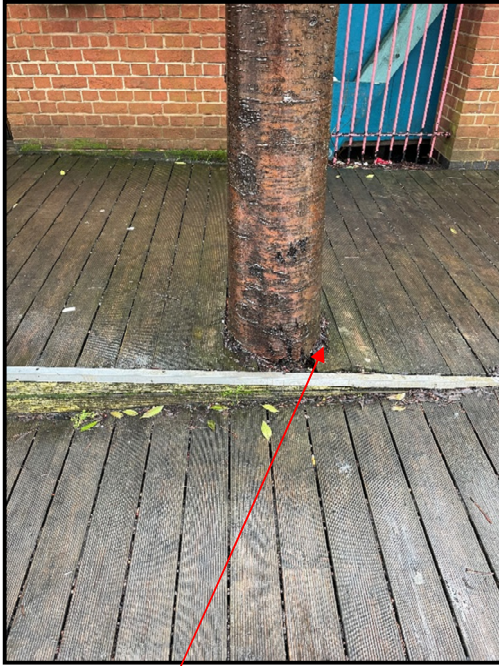
- Unable to inspect rooting area as entire tree has been overlaid with decking.

- Trunk is growing into decking causing trunk wounds, tree is pushing on decking causing an uneven surface. Trunk sounding brought no abnormalities.

- Co-dominant stems. Well balanced crown

**Conclusions:** The base of the tree appears sound, however as the base of the trunk and root flare were not visible at the time of inspection it was not possible to undertake a full tree condition assessment.

Photo 1: T1 with distorted decking at base

**Recommendations:** To canopy raise to 3m and thin by 20%. Decking at base will need to be lifted and replaced where it meets the trunk of the tree. A gap of 5-10cm is to be left around the trunk to allow for secondary thickening. I would recommend the tree be inspected when the decking has been lifted.

**Timescale:** Medium priority – within 6 months.

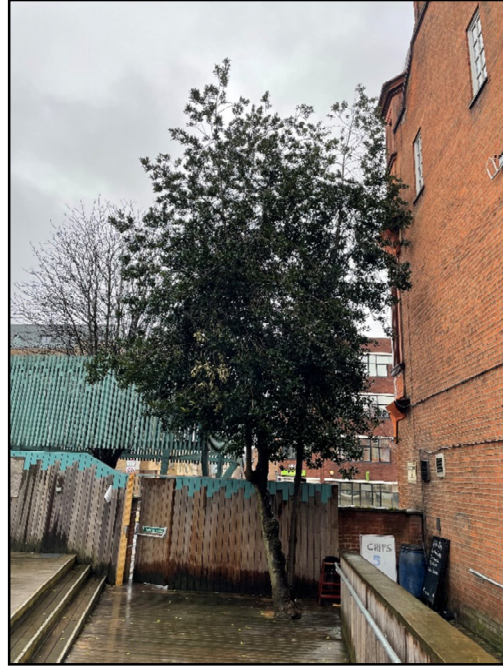
- Unable to inspect rooting area as entire trees has been overlaid with decking.

- Trunk is growing into decking causing trunk wounds, tree is pushing on decking causing an uneven surface. Trunk sounding brought no abnormalities.

- Co-dominant stems. Previously canopy raised. Branches encroaching onto property to South.

**Conclusions:** The base of the tree appears sound, however as the base of the trunk and root flare were not visible at the time of inspection it was not possible to undertake a full tree condition assessment.

Photo 2: T2 growing against building

**Recommendations:** To reduce in height by 2m and trim sides to leave a compact shape. Decking at base will need to be lifted and replaced where it meets the trunk of the tree. A gap of 5-10cm is to be left around the trunk to allow for secondary thickening. I would recommend the tree be inspected when the decking has been lifted.

**Timescale:** Medium priority – within 6 months.
