# Hutton + Rostron Environmental Investigations Limited

## Hornsey Town Hall, Broadway Annex: Parapet Condition Investigation

Site note 12 for November 2022, job no. 405-73

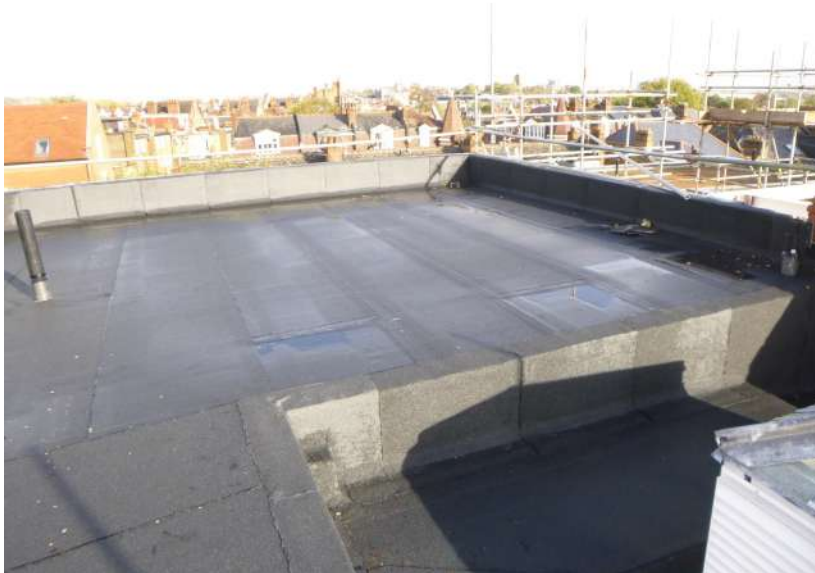
**Fig 1:**

Rear roof; showing area of roof finish lapped up and over wallhead

Laying of new concrete copings was underway

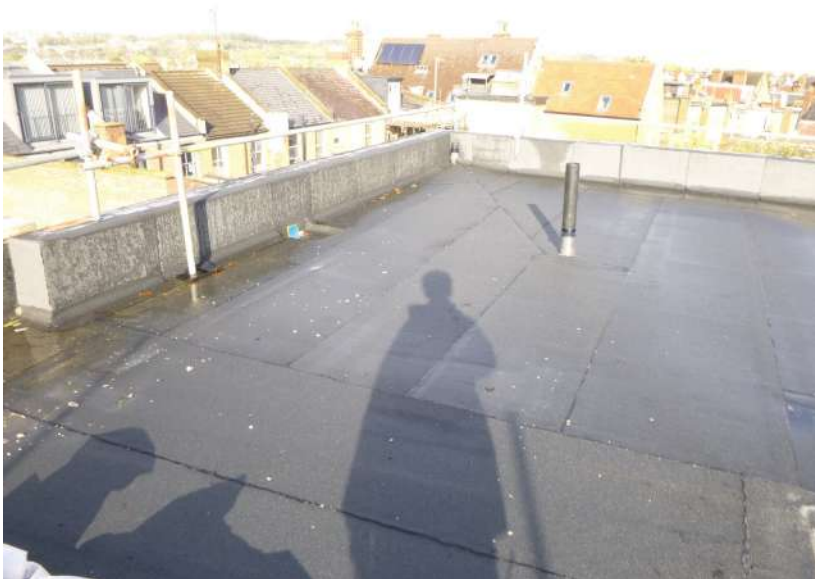
**Fig 2:**

Rear roof; showing area of roof finish lapped up and over wallhead

Laying of new concrete copings was underway

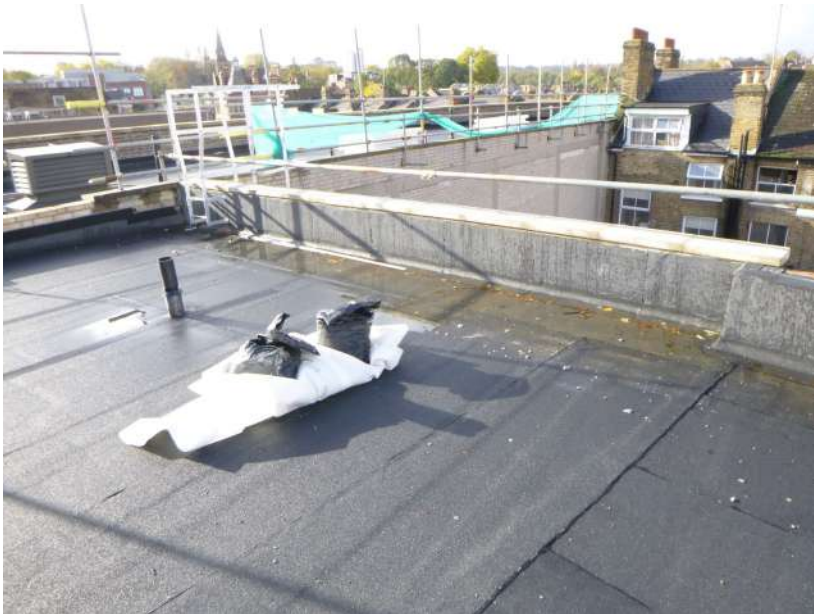
**Fig 3:**

Rear roof; showing area of roof finish lapped up and over wallhead

Laying of new concrete copings was underway

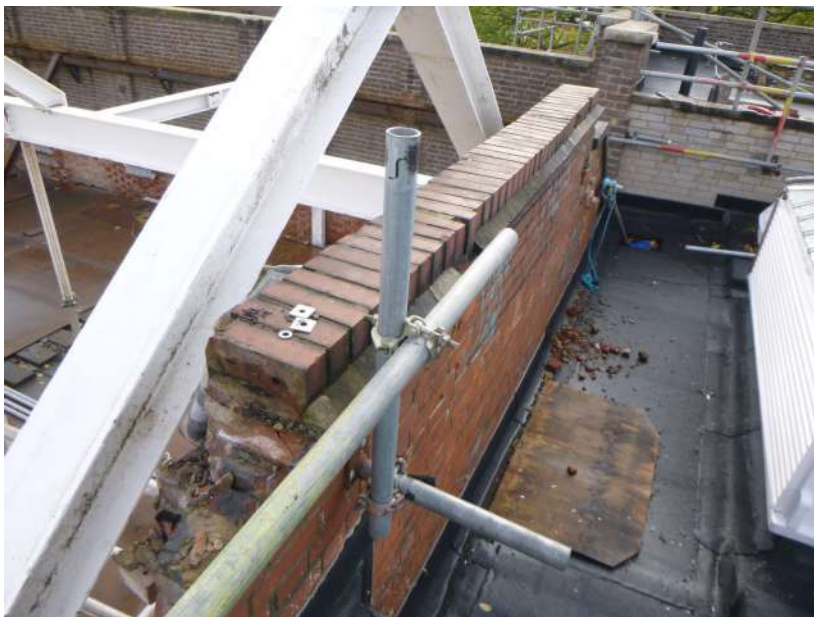
**Fig 4:**

Central roof area; showing demolition-scarred wallhead

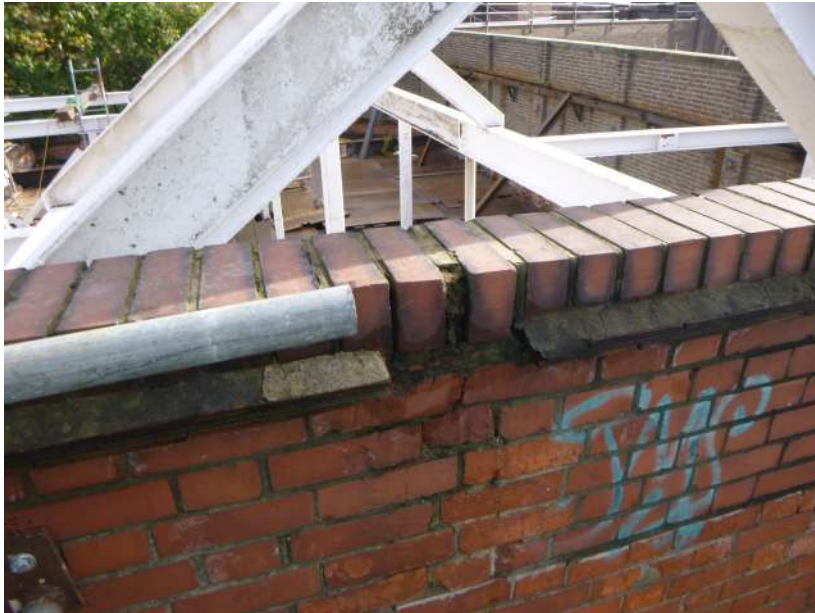
**Fig 5:**

Central roof area; showing demolition-scarred wallhead

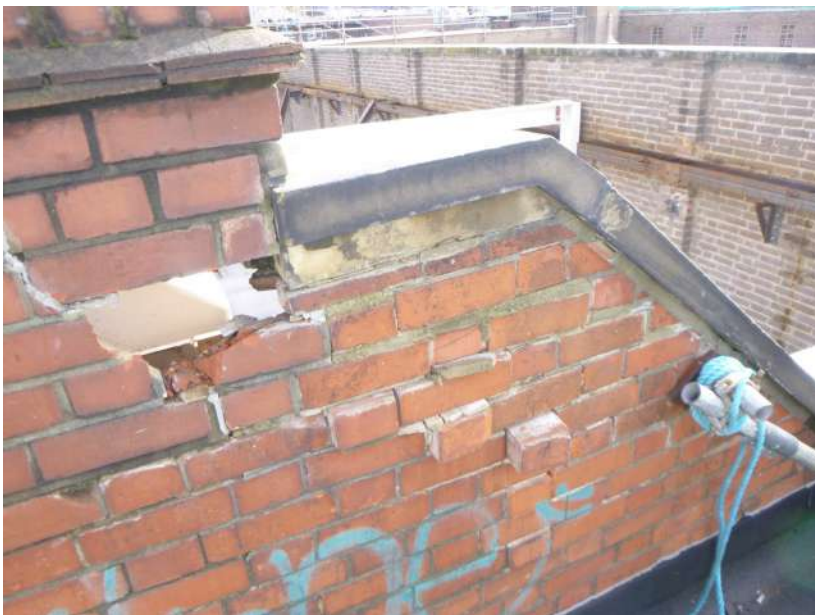
**Fig 6:**

| REFERENCE | ITEM | OBSERVATIONS | RECOMMENDATIONS | CLIENT COMMENTS |
|---|---|---|---|---|
| SN12.2.5 | Other (localised use of sandstone copings) | <p>A small area (in a run no longer than 5 metres) of the 'Broadway Lofts' was capped in sandstone copings. This was used for pitched/gabled wallheads (alongside the brick-on-tile detail at level wallheads)</p> <p>The stones were in a poor state; sandstones used in this manner can often suffer delamination. Demolition scarring has also been sustained (including cutting new pockets into wallheads for casting steel frame bearings)</p> | <p><i>Given the condition and limited run of this coping arrangement, H+R would suggest replacement in new materials</i></p> | |

Central roof area; showing demolition-scarred wallhead

Note localised use of sandstone coping

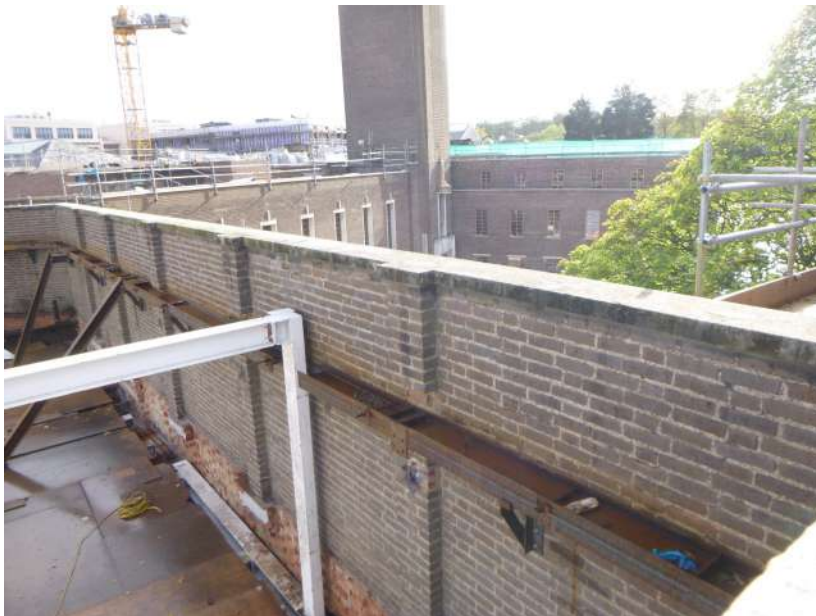
**Fig 7:**

Frontage wallhead; showing façade retention scheme underway

Note large limestone copings

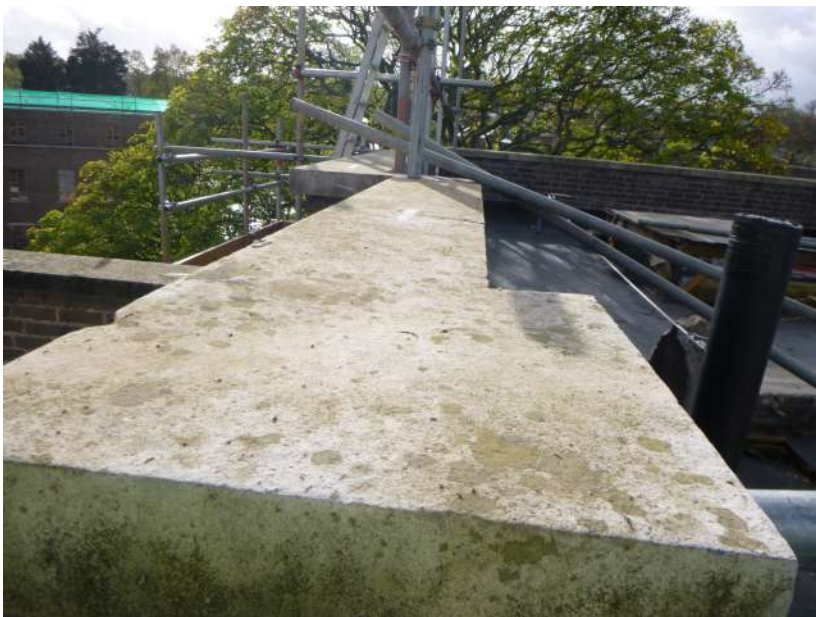
**Fig 8:**

Frontage wallhead; showing surface falls in topside of stone copings

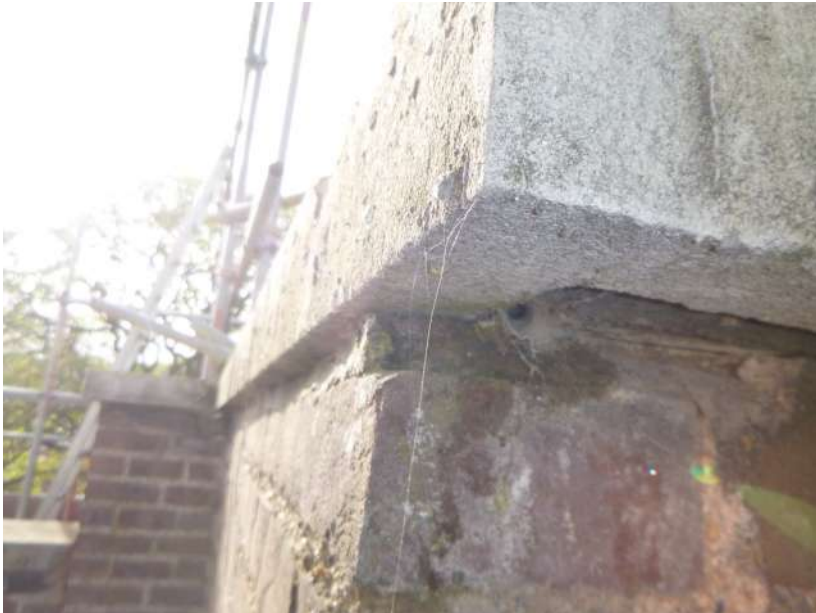
**Fig 9:**

Frontage wallhead; showing localised area of irregular wall thickness which did not allow an effective overhang/drip

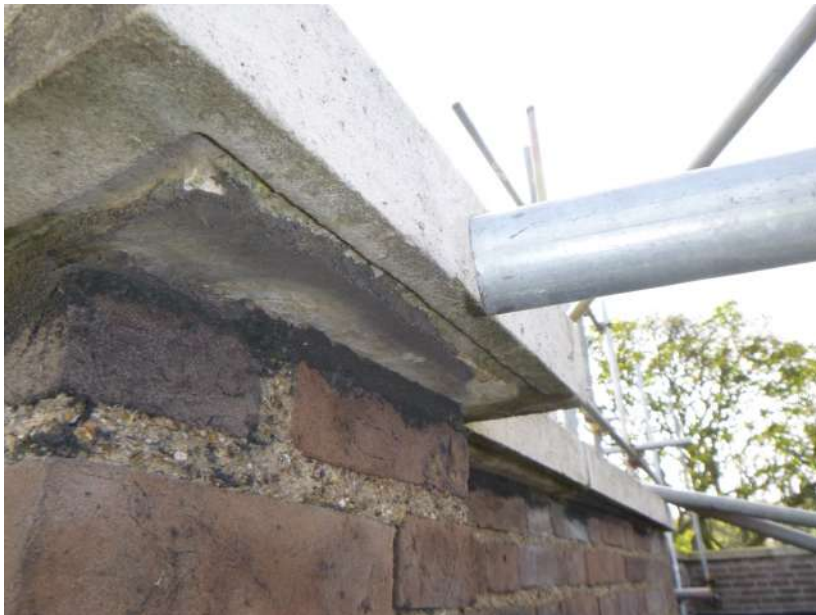
**Fig 10:**

Frontage wallhead; showing overhang and drip rebate

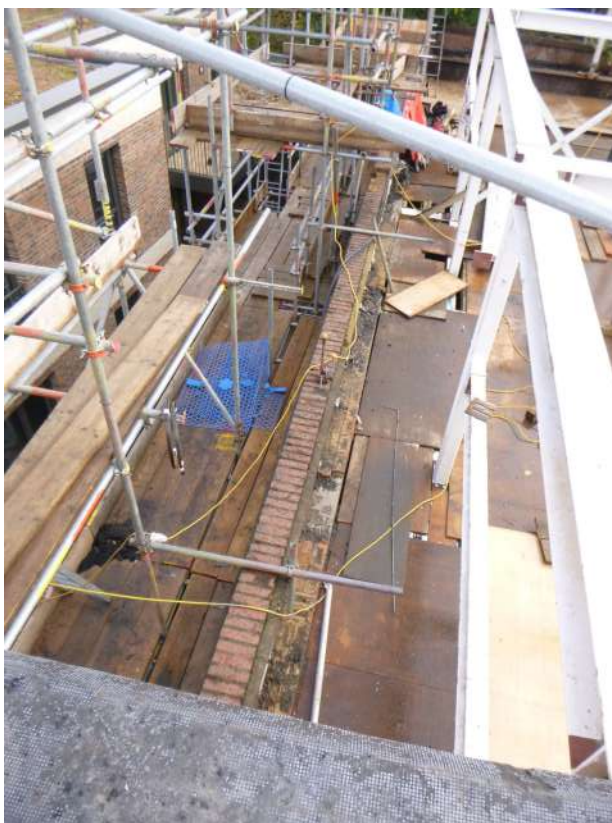
**Fig 11:**

| REFERENCE | ITEM | OBSERVATIONS | RECOMMENDATIONS | CLIENT COMMENTS |
|---|---|---|---|---|
| SN12.2.4 | Brick-on-tile coping to rear of 'Broadway Lofts' | <p>As shown in attachments, the rear of 'Broadway Lofts' was capped in a brick-on-tile detail. The wallhead being a single brick thick with tiles laid over and finished with a 'rowlock' brick course and mortar fillets</p> <p>This was a lesser-quality detail than the stone copings seen elsewhere. However, as a northerly aspect, this was less exposed to driving rain to some degree and as a solid wall, this form of coping was fairly typical for this type of construction and not necessarily subject to any inherent flaw</p> <p>Current demolition works had resulted in localised scarring to the coping detail. Water ingress from the topside of the wall would only tend to occur where total failure of mortar and disintegration of the wallhead might develop (which was not found to be the case)</p> | <p><i>Subject to repairs of scarred/damaged areas, the brick-on-tile coping could remain serviceable for future occupancy</i></p> <p><i>Mitigation for potential water ingress/weathering could be provided (as already seen in 'Broadway Apartments') by way of independent wall linings. Ensuring all plasterboard internal finishes (including board-edges) are kept clear of external brickwork would greatly reduce risk of dampness internally in relation to copings</i></p> <p><i>The designated 15-year service life could be achieved in this manner, subject to normal ongoing inspection and maintenance</i></p> | |

Rear elevation; showing brick-on-tile wallhead subject to localised damage

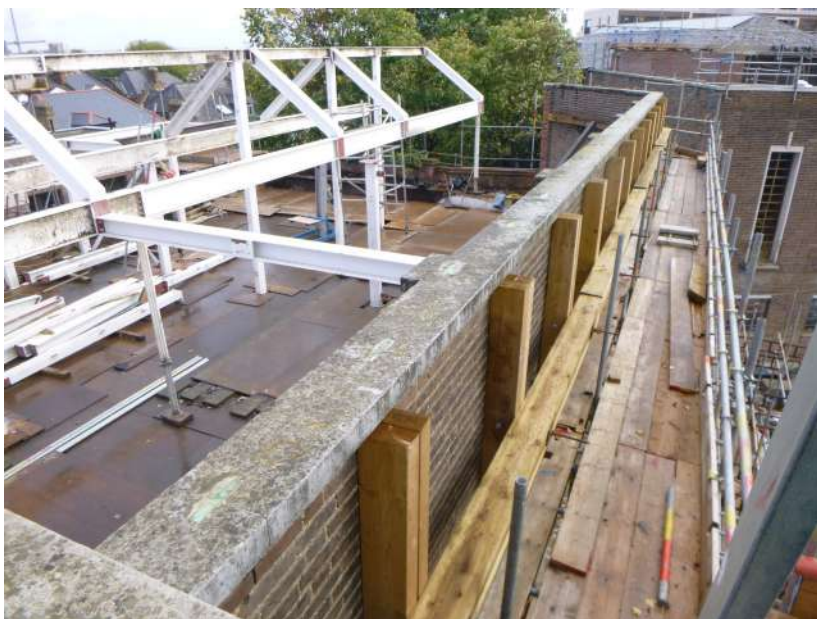
**Fig 12:**

Frontage wallhead; showing façade retention scheme underway

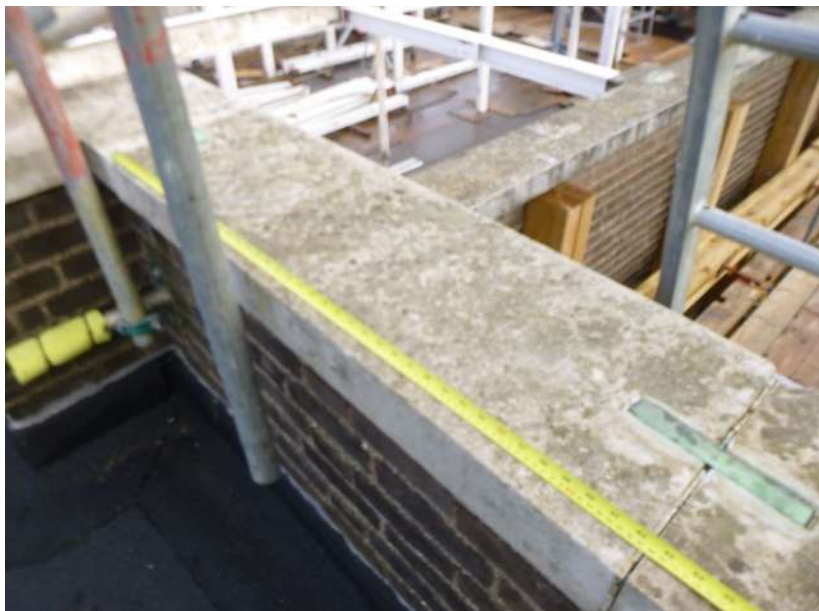
**Fig 13:**

Frontage wallhead; showing measurement of coping

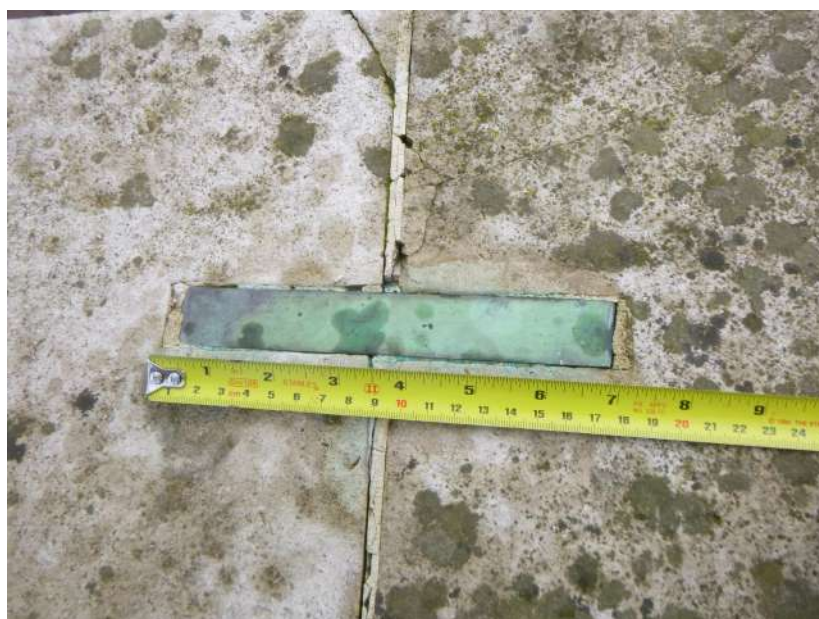
**Fig 14:**

Frontage wallhead; showing measurement of crack

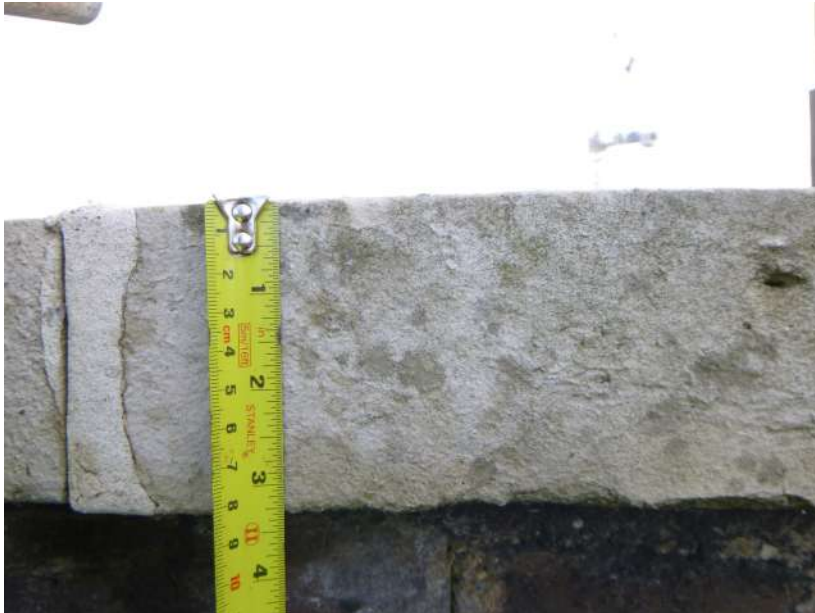
**Fig 15:**

Frontage wallhead; showing measurement of coping

Note previous mortar repairs to joint (lhs image)

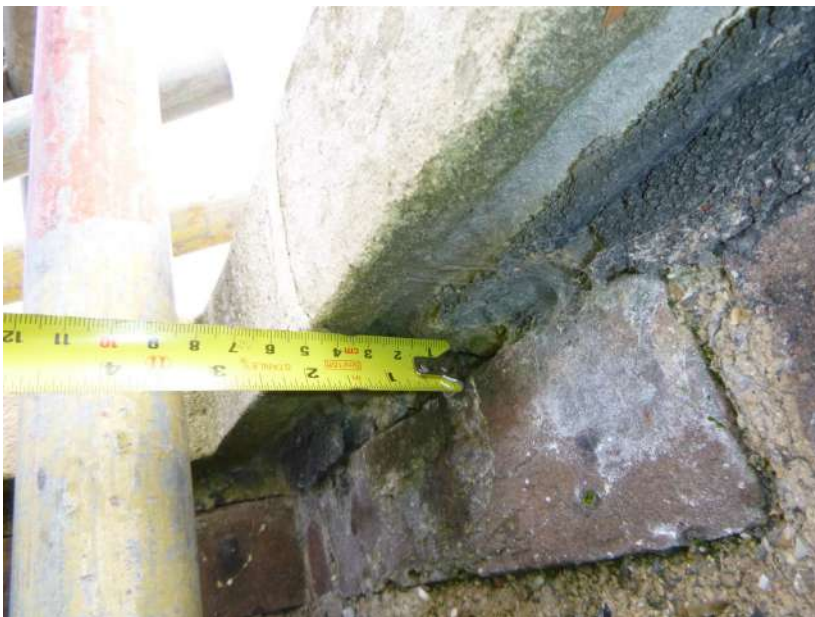
**Fig 16:**

Frontage wallhead; showing overhang and drip

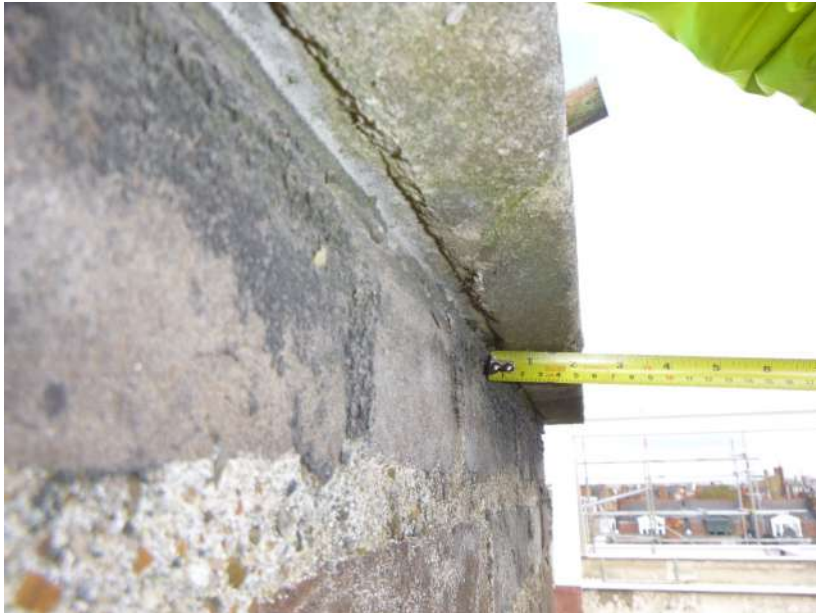
**Fig 17:**

Frontage wallhead; showing overhang and drip

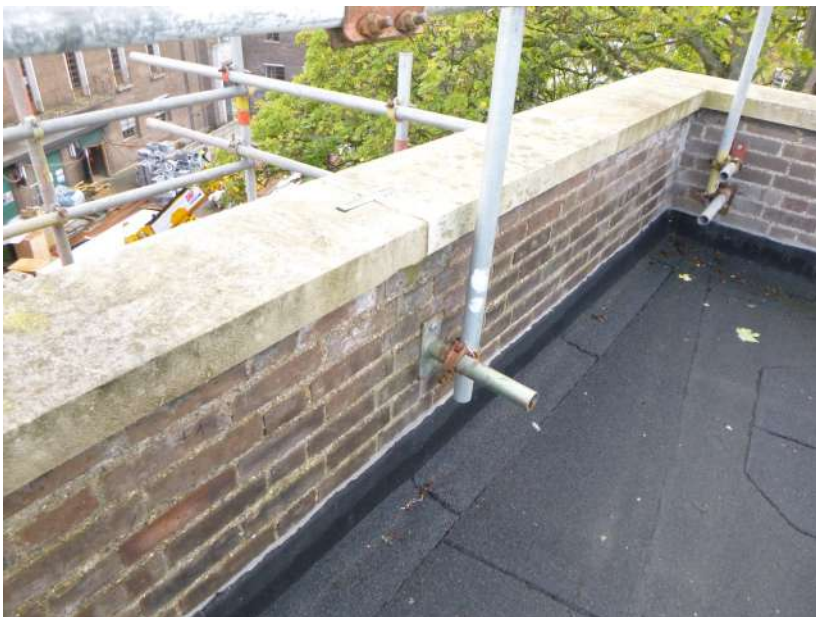
**Fig 18:**

Frontage wallhead; showing newly installed roof finish and upstand

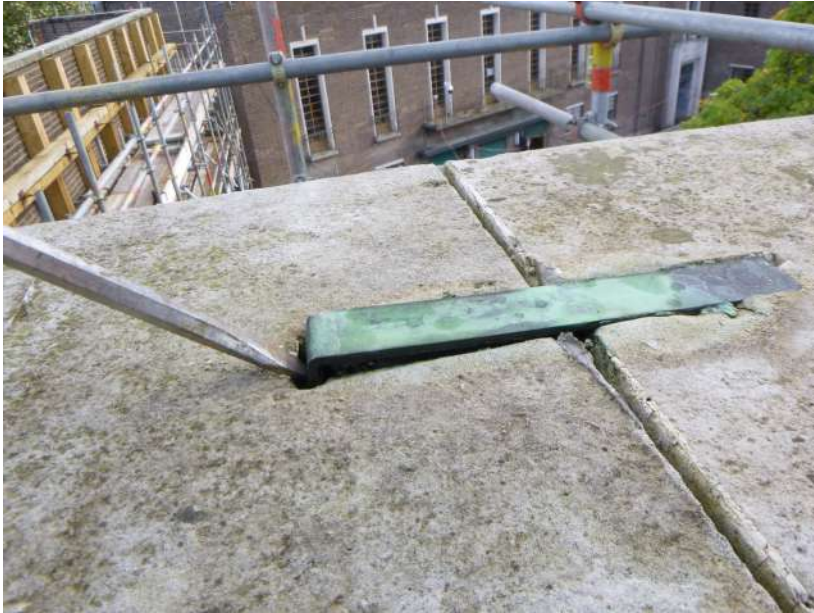
**Fig 19:**

| REFERENCE | ITEM | OBSERVATIONS | RECOMMENDATIONS | CLIENT COMMENTS |
|---|---|---|---|---|
| <b>SN12.1.2</b> | Condition | <p>Mortar joints have washed-out or cracked over time due to the effects of weathering and/or thermal movement. Joints to the west ('Broadway apartments') have been re-pointed. Joints to the east ('Broadway lofts') have yet to be refurbished and show pending defects in the mortar joints</p> <p>The stones themselves have proven to be high quality with no evidence of erosion/failure to suggest inherent weakness in the stone type</p> <p>The external face of the brick wallhead showed various mortar repairs where horizontal bed-joints have washed-out or cracked in the past. This may be suggestive of rust-jacking from embedded steel structures. The newly installed pointing mortar appeared successful although H+R have no knowledge of what underlying issues may have led to these defects</p> | <i>These parapet and copings arrangements are deemed suitable to satisfy the guarantor's 15-year longevity requirement. This will be subject to satisfactory completion of work to roof finishes, roof drainage, re-pointing of coping joints and subject to normal inspection and maintenance on future occupancy</i> | |

Frontage wallhead; showing measurement of cramp embedment

Note mortar joint and cramp bedding pending renewal

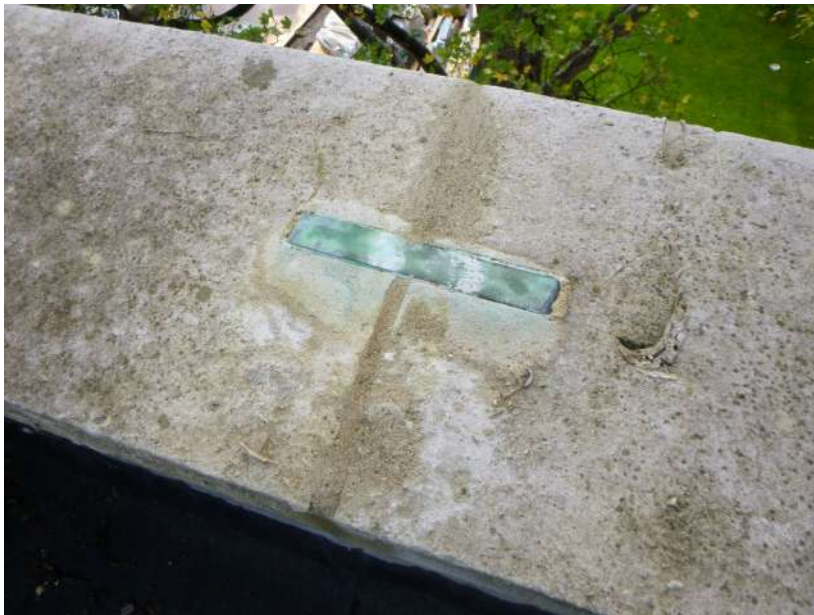
**Fig 20:**

Frontage wallhead; showing newly repaired coping mortar joint

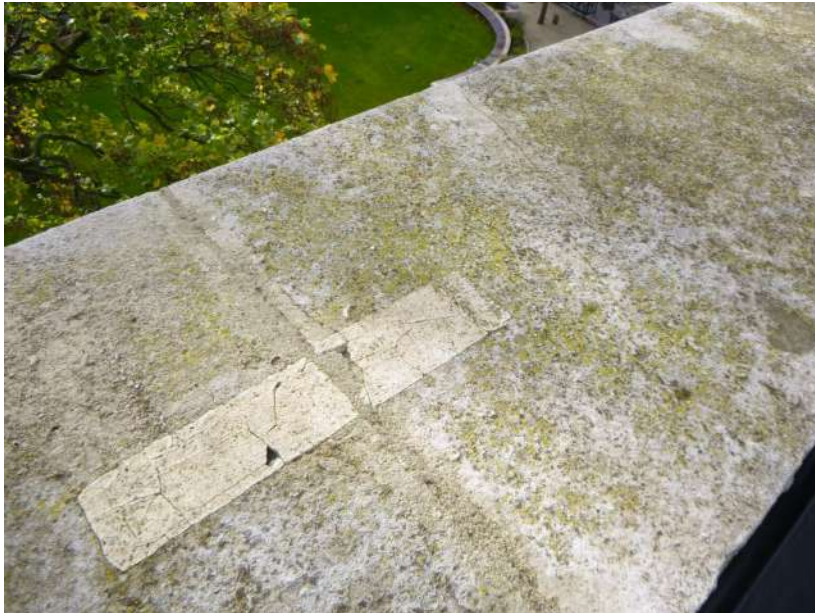
**Fig 21:**

Frontage wallhead; showing newly repaired coping mortar joint

There were various areas where copings had historically been rebated and mortared-over

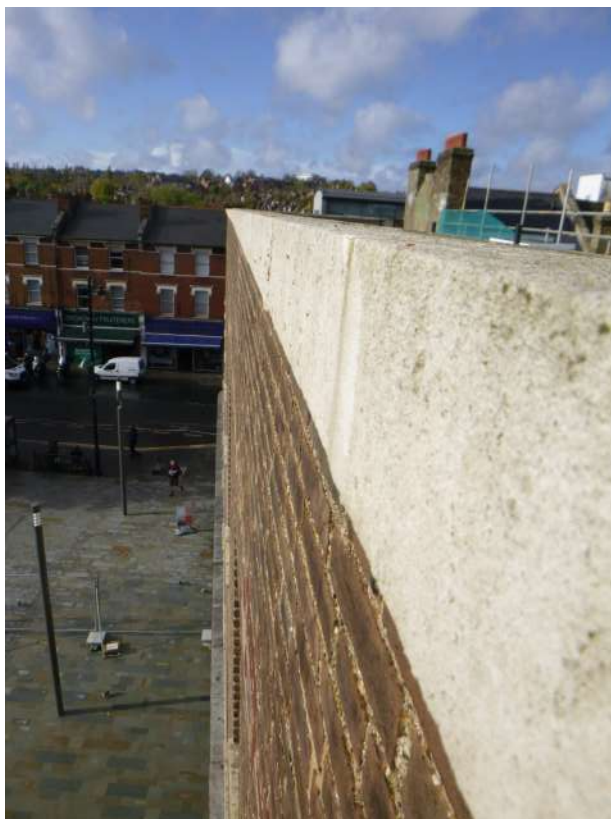
**Fig 22:**

Frontage wallhead; showing external face

Note wall line appears to have remained straight/true

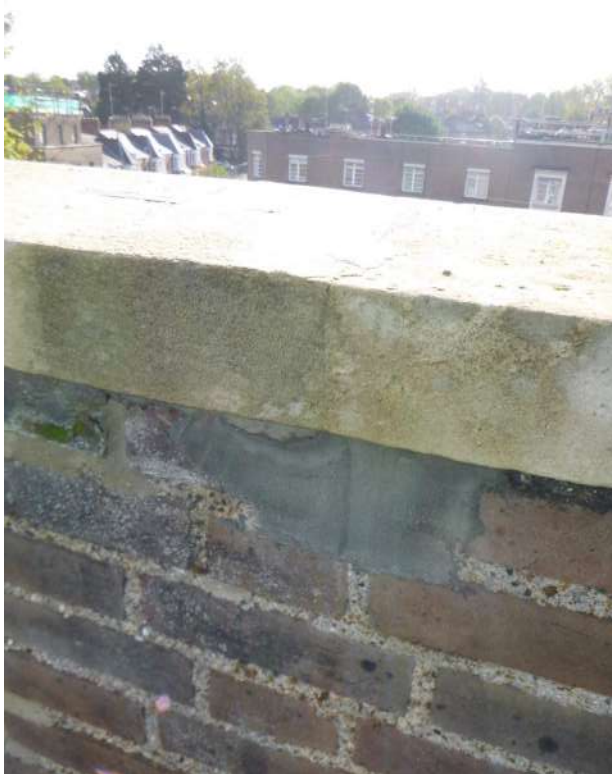
**Fig 23:**

Frontage wallhead; showing example of previous mortar repair to coping

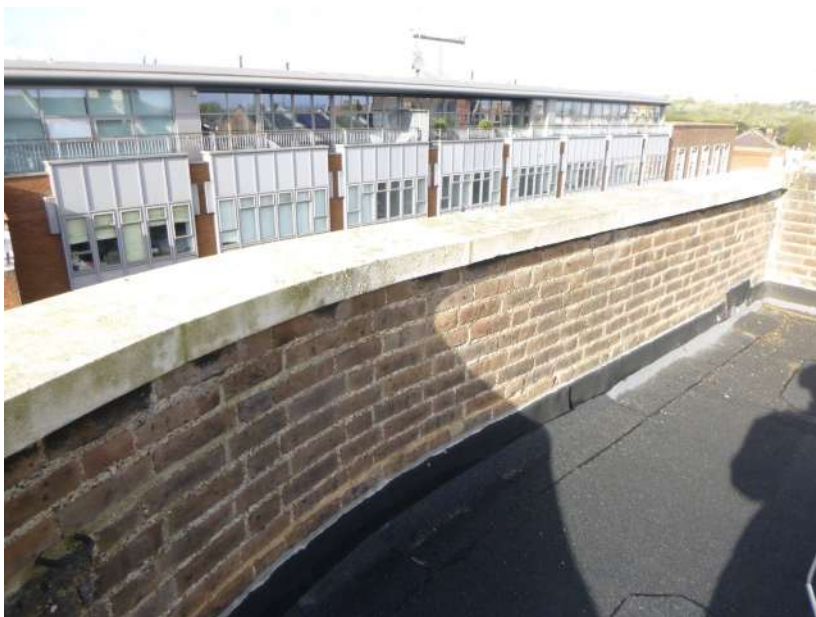
**Fig 24:**

Frontage wallhead; showing curved wall line towards south-west

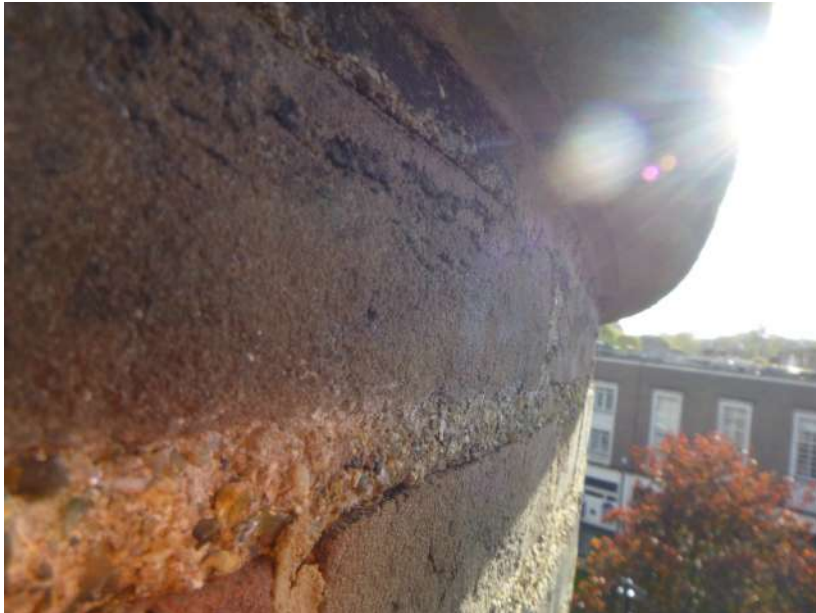
**Fig 25:**

Frontage wallhead; showing curved wall line towards south-west

Note overhang and drip

Note original course aggregate brick pointing generally free of weathering damage

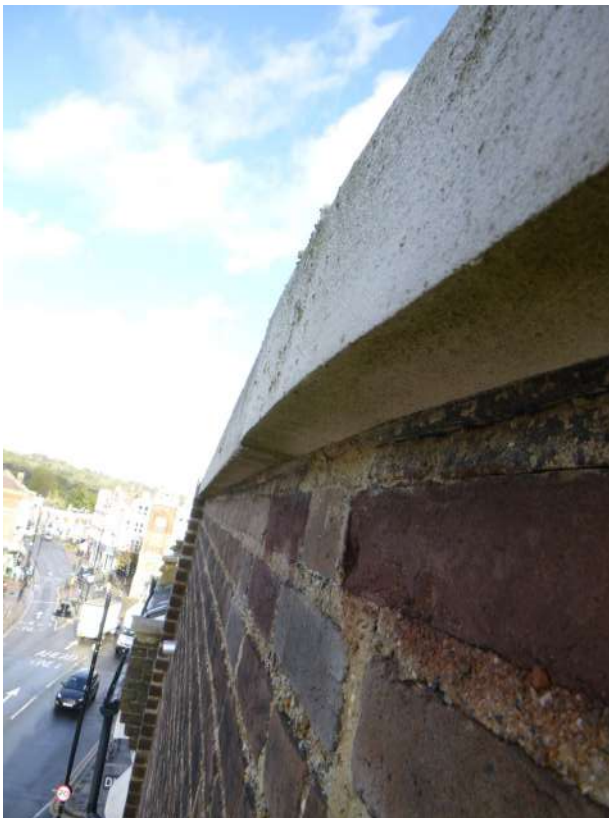
**Fig 26:**

Frontage wallhead; showing external face of west side

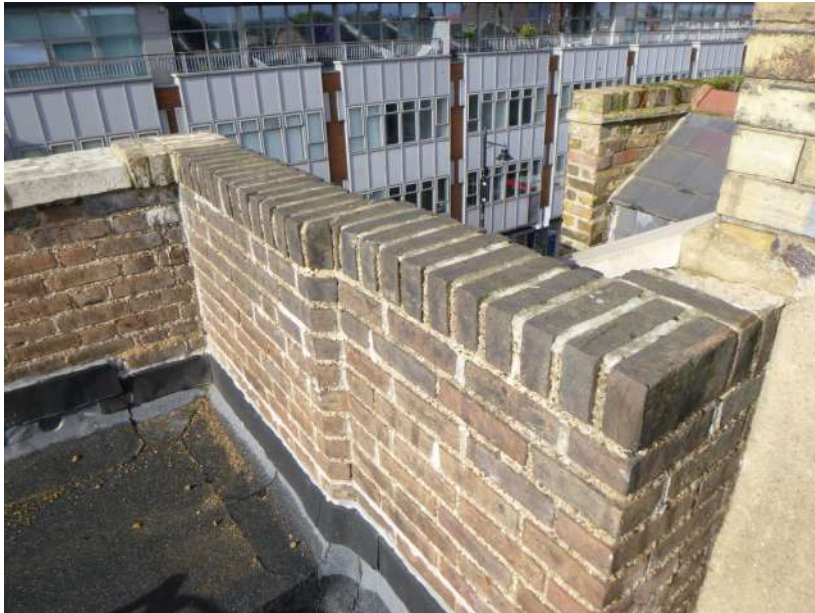
**Fig 27:**

Party wall junction towards north-west corner; showing brick wallhead without a coping detail

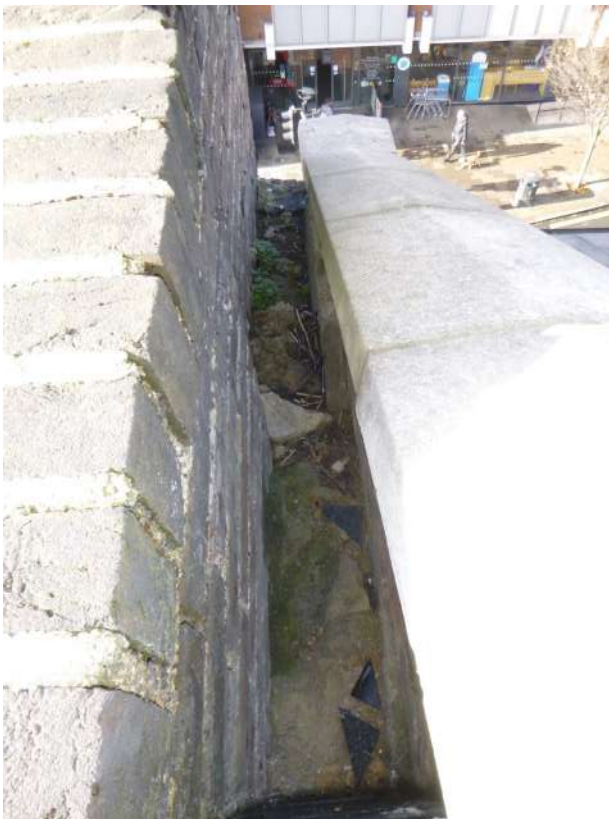
**Fig 28:**

| REFERENCE | ITEM | OBSERVATIONS | RECOMMENDATIONS | CLIENT COMMENTS |
|---|---|---|---|---|
| <b>SN12.2.1</b> | Junction with neighbouring property roof to north-west | <p>As raised by the Building Guarantee surveyor, there was an unsatisfactory water-trap formed by the interface of two walls in this location. The result was a masonry 'trough' which was liable to collect debris, roosting birds and allow water penetration. Internally, this risk was mitigated (as throughout) by independent plasterboard wall linings</p> <p>The remainder of the party wall junction in this area features a brick gable wall of the neighbouring structure which rises above the flat roof line of 'Broadway Apartments'</p> | <p><i>Party wall agreement may be required</i></p> <p><i>Consider infilling the 'trough' to provide a surface which can support a lead flashing or similar. The flashing should allow rainwater to run off onto a nearby roof surface which can be collected by the drainage system</i></p> | |

Party wall junction towards north-west corner; showing water-trap due to lack of weathering detail

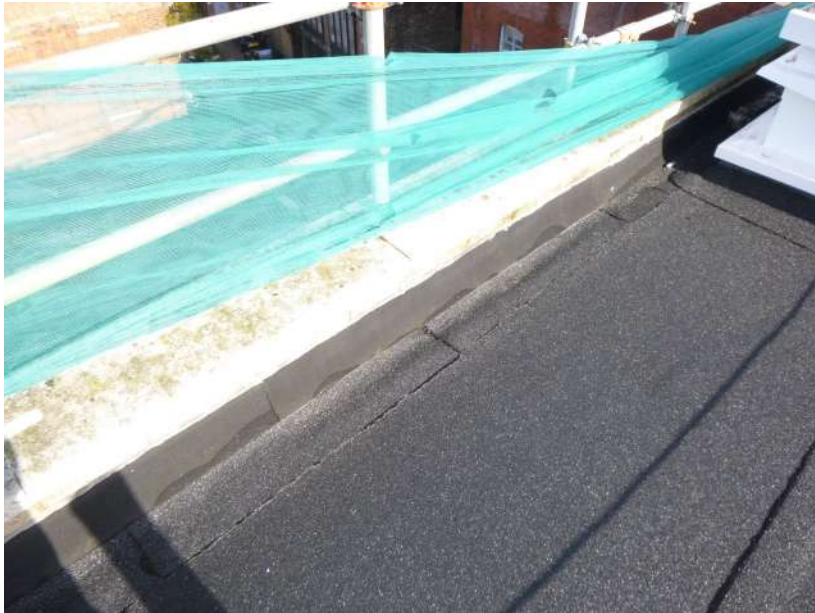
**Fig 29:**

Rear wallhead; showing smaller section stone copings and lower-rise wallhead (compared to frontage)

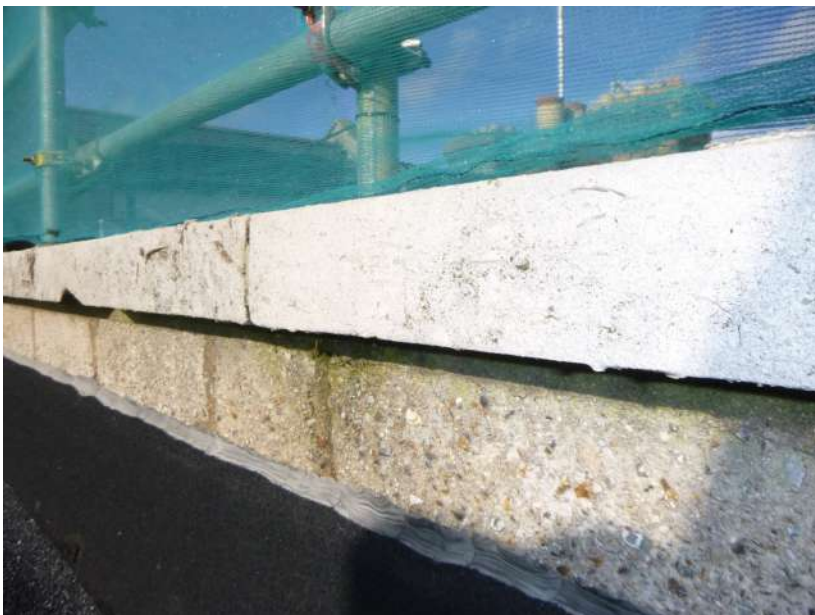
**Fig 30:**

Rear wallhead; showing smaller section stone copings and lower-rise wallhead

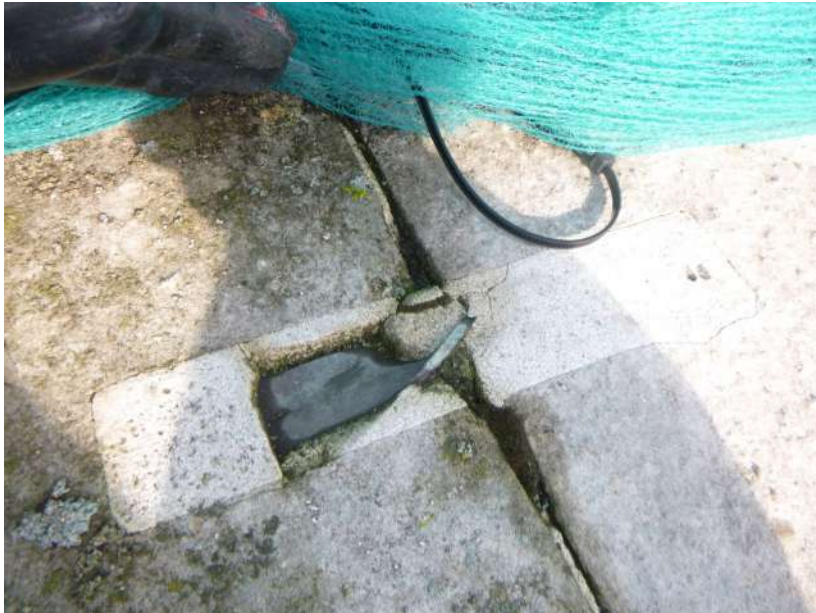
**Fig 31:**

Rear wallhead; showing twist-shank ties used as cramps (different to plain 'dog' profile at frontage)

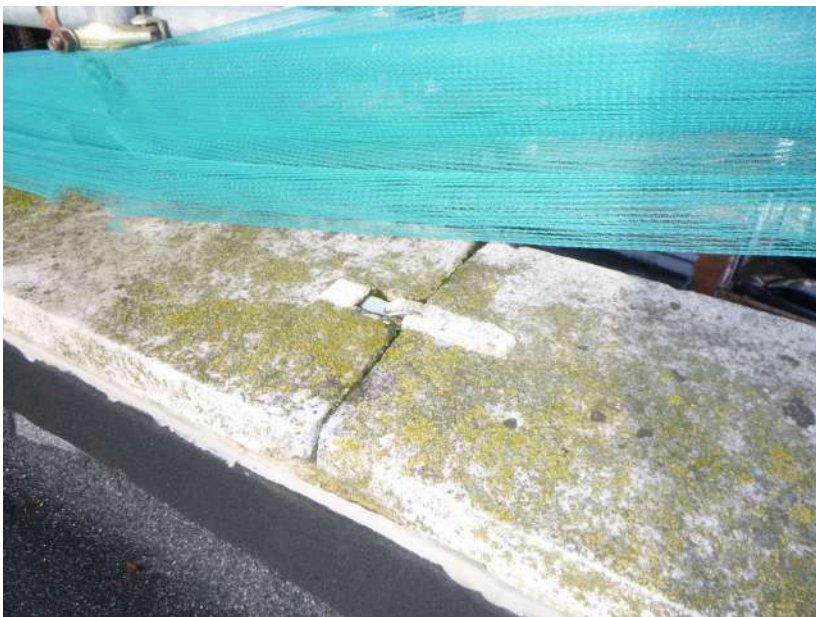
**Fig 32:**

Rear wallhead; showing typical loss of mortar joints

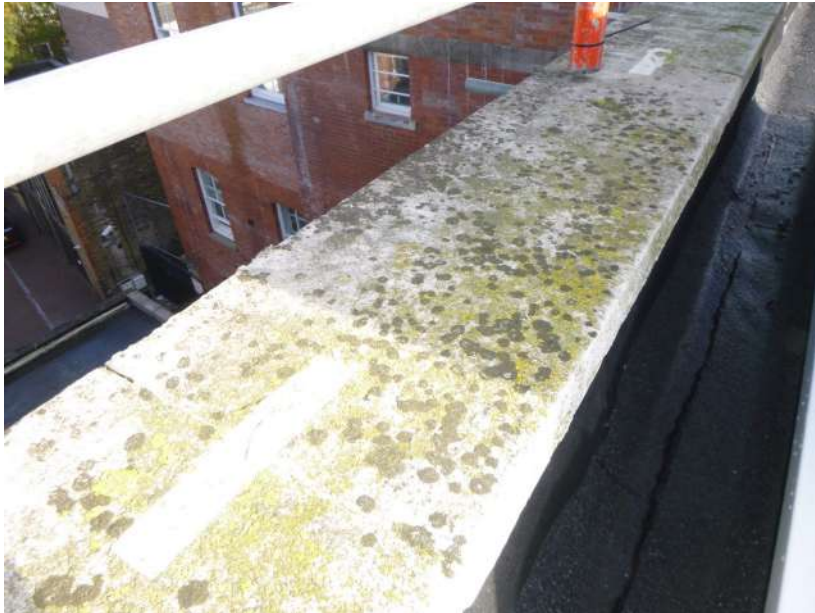
**Fig 33:**

Rear wallhead; showing typical protrusion of cramp through surface of bed mortar (due to unusual use of twist shank)

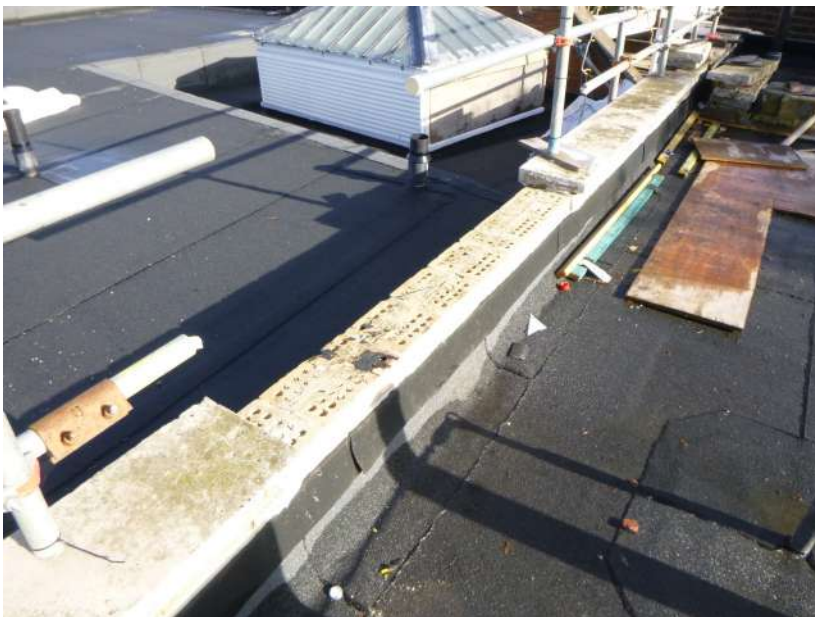
**Fig 34:**

Rear wallhead; showing area of recently removed copings

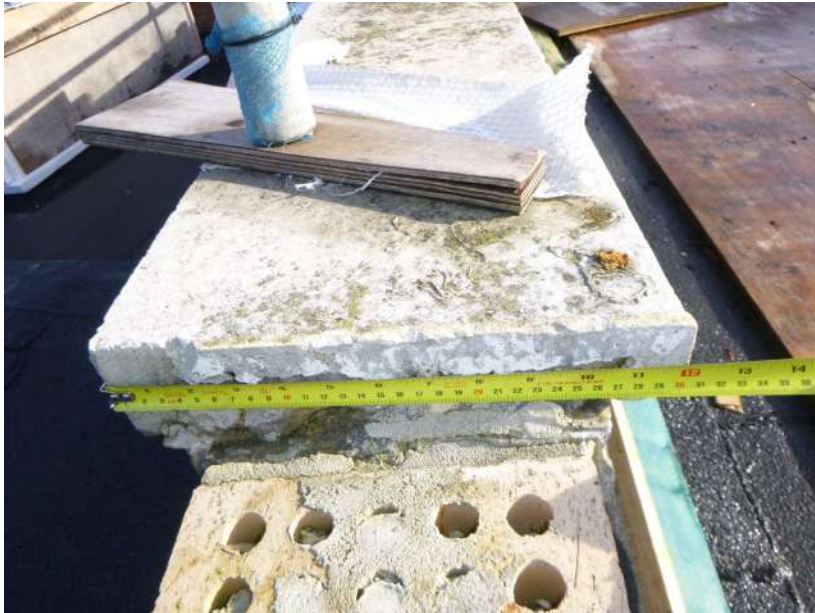
**Fig 35:**

Rear wallhead; showing area of recently removed copings

Dimensions recorded

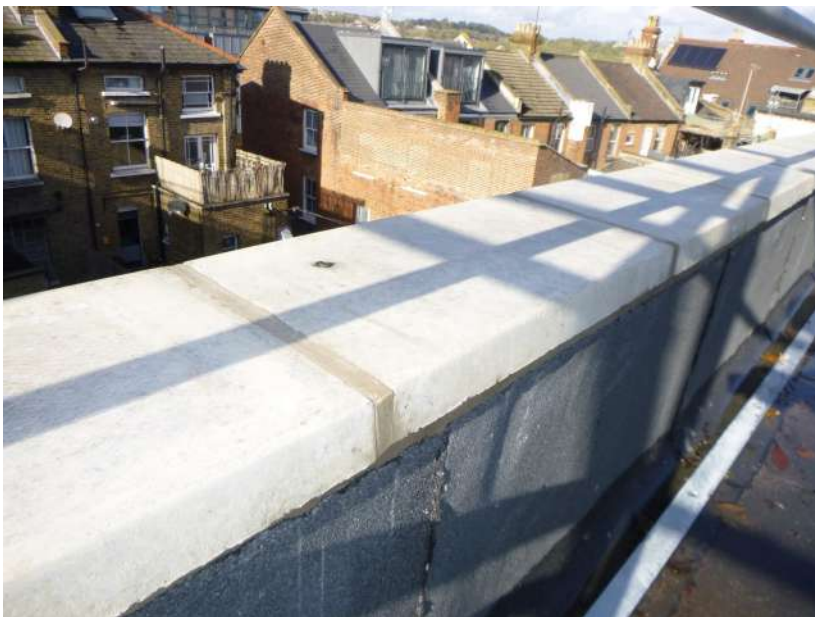
**Fig 36:**

Rear roof; showing newly installed concrete coping

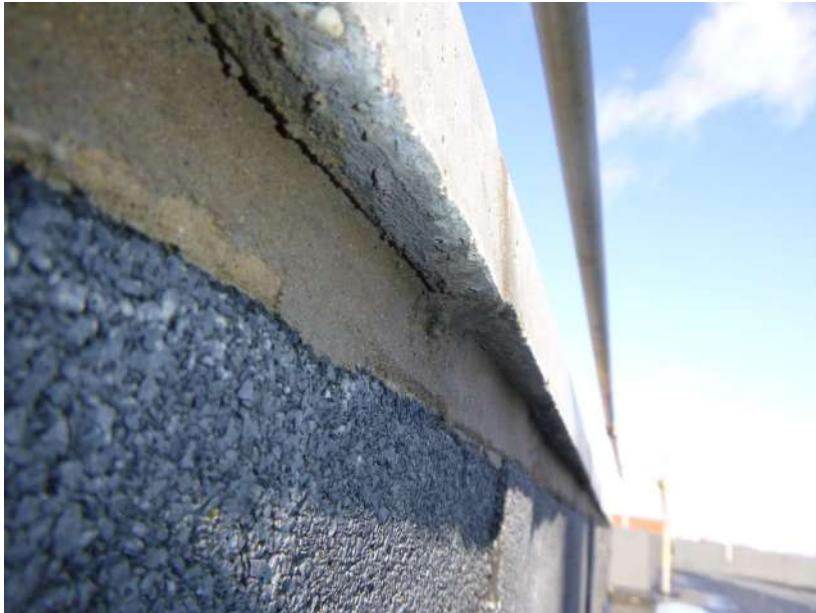
**Fig 37:**

Rear roof; showing newly installed concrete coping

Note relatively little overhang but viable drip rebate present

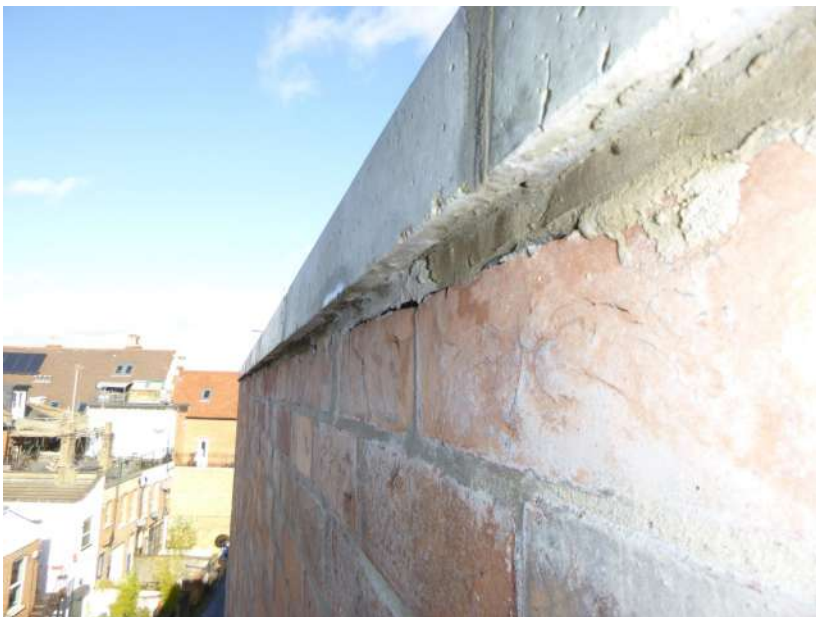
**Fig 38:**

Rear roof; showing newly installed concrete coping

Note relatively little overhang but viable drip rebate present

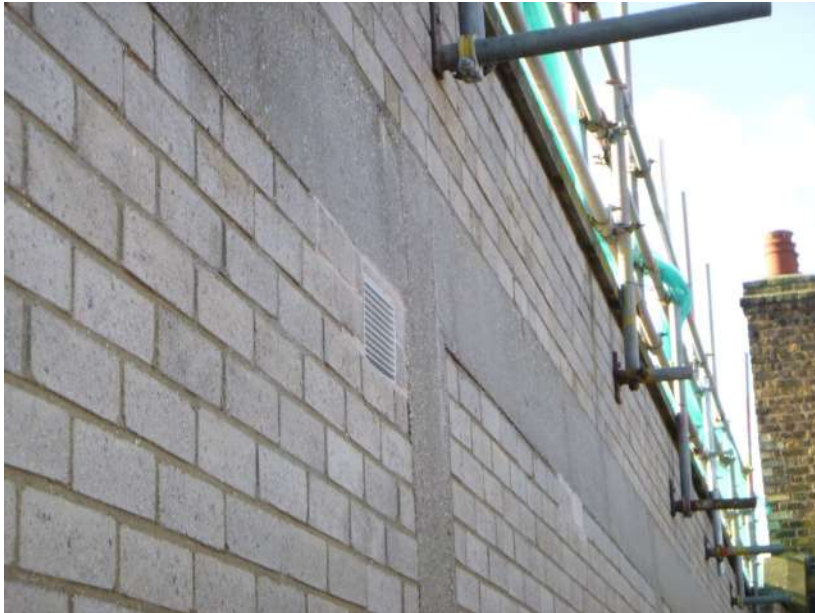
**Fig 39:**

Rear wallhead; showing exposed brickwork and RC framing at 'secondary status' rear façade

Note solid wall bond at parapet and cavity wall bond within frame infill panels

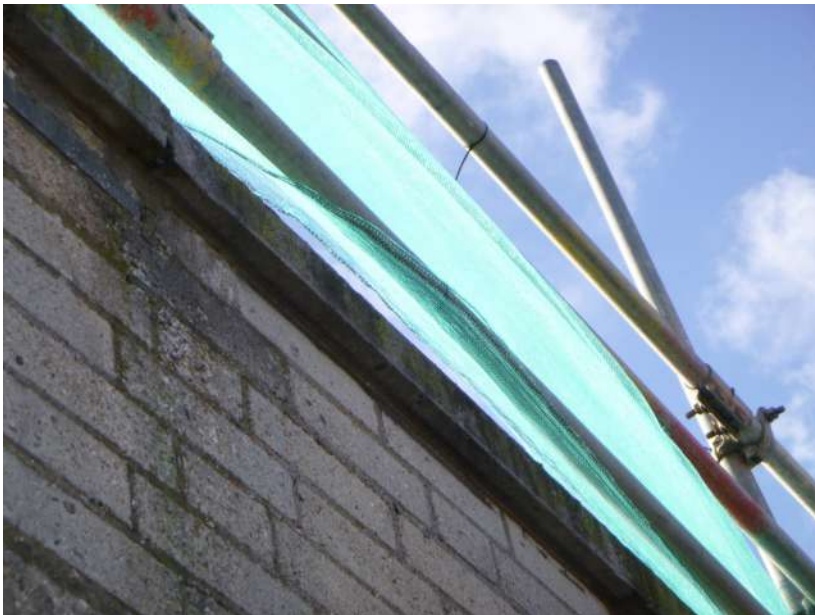
**Fig 40:**

Rear wallhead; showing coping overhang and drip

Note run-off staining below washed-out coping joint mortar

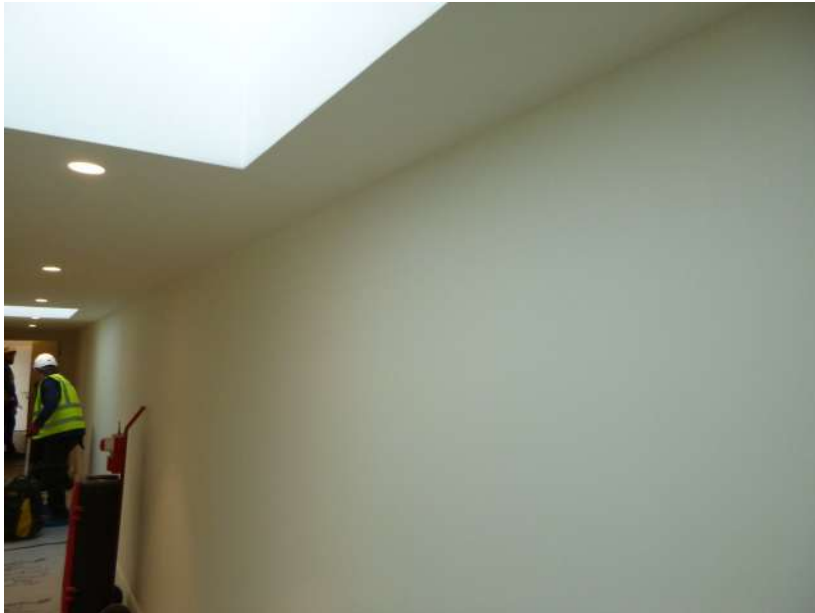
**Fig 41:**

Interior view of Fig.40; showing independent wall linings
