# Hutton + Rostron Environmental Investigations Limited

## Hornsey Town Hall, Broadway Annex: Parapet Condition Investigation

Site note 12 for November 2022, job no. 405-73

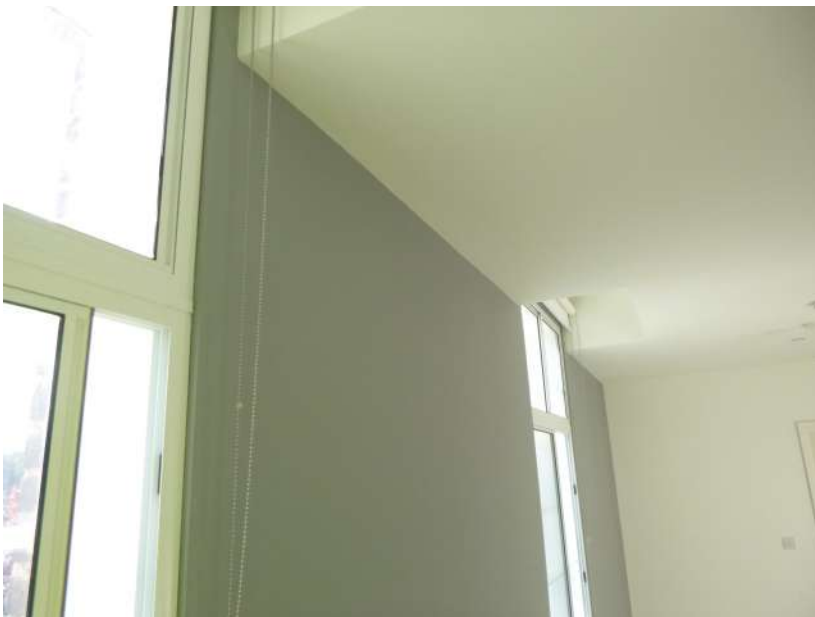
**Fig 42:**

Interior view of Fig.22; showing independent wall linings

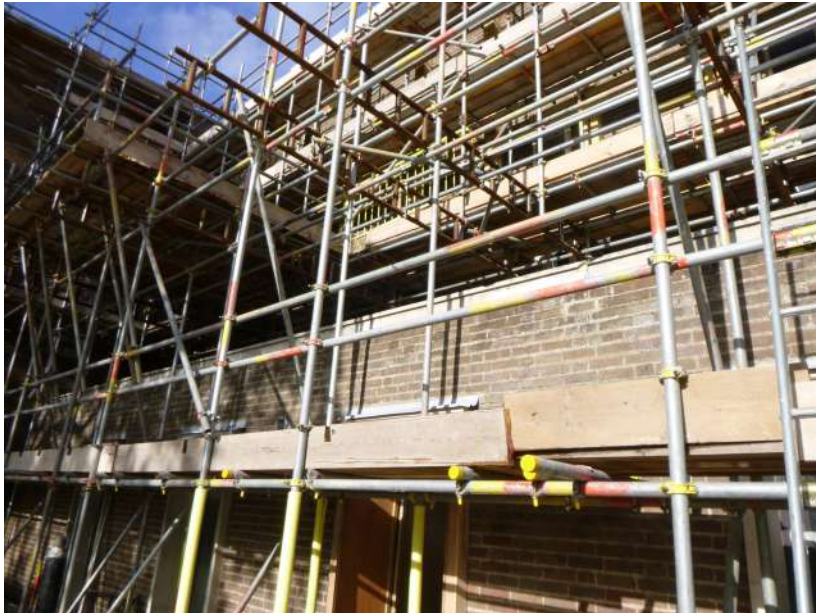
**Fig 43:**

Low level roof towards south-east

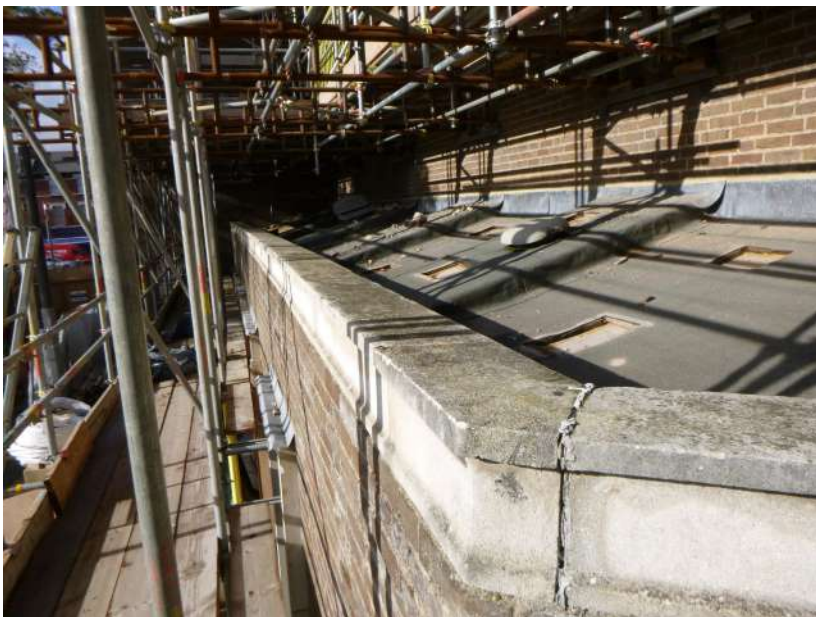
**Fig 44:**

Low level roof towards south-east;  
showing wallhead

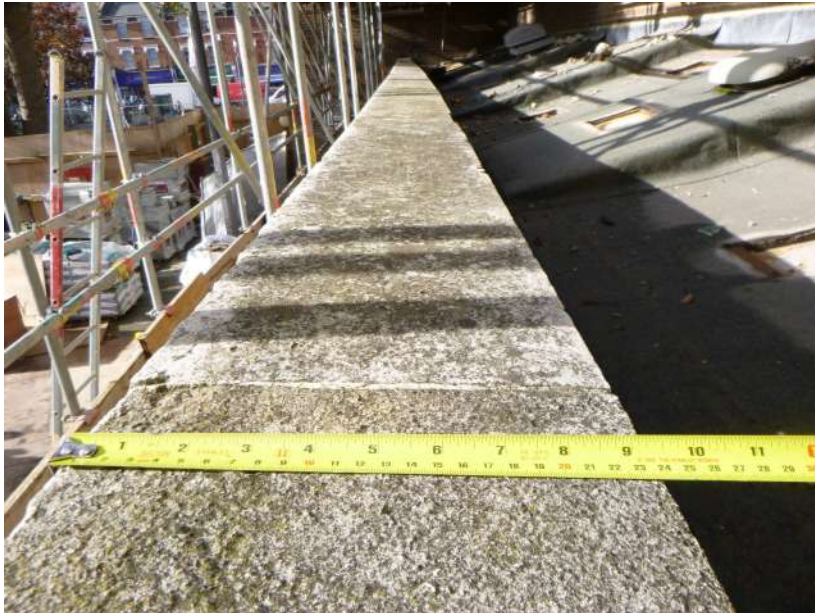
**Fig 45:**

Low level roof towards south-east;  
showing (scant) surface falls in topside

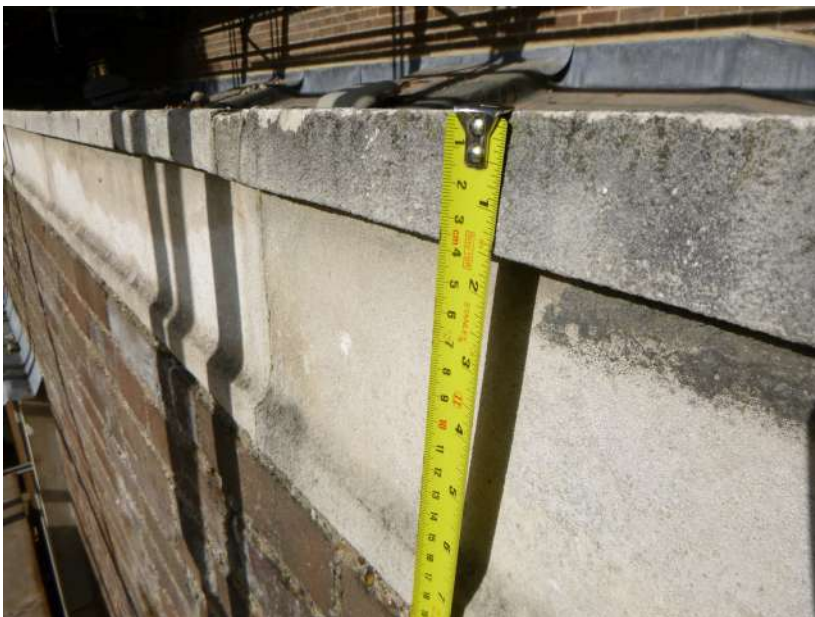
**Fig 46:**

Low level roof towards south-east;  
showing lack of overhang/drip at  
junction to brick wallhead below

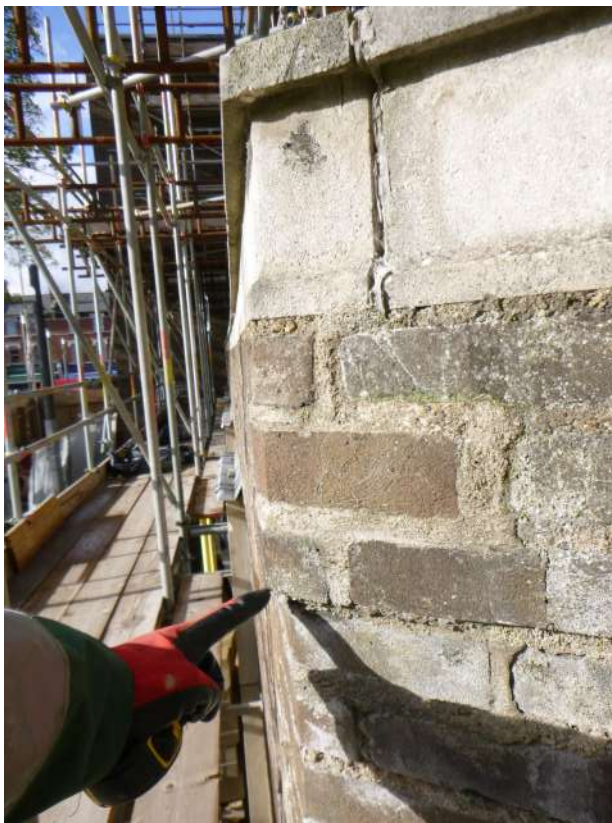
**Fig 47:**

| REFERENCE | ITEM | OBSERVATIONS | RECOMMENDATIONS | CLIENT COMMENTS |
|---|---|---|---|---|
| <b>SN12.3.2</b> | Condition | <p>Mortar joints generally remained intact. As mentioned above, surface run-off was a concern due to lack of overhangs</p> <p>Water ingress by blockage and overflow in the parapet gutter was also potential concern. There were various areas of cracking and displacement in the external face of brickwork wallheads, indicative of embedded steel corrosion (roof structure bearings/plates?). This may well have occurred due to dampness in the masonry where steel has been embedded</p> <p>The stones themselves have proven to be high quality with no evidence of erosion/failure to suggest inherent weakness in the stone type</p> | <p><i>H+R would suggest the architect revises the existing parapet wall/coping arrangement to provide an overhang drip detail</i></p> <p><i>This would probably entail carefully lifting and re-laying the existing stonework (at which point the Guarantor's preference for extending the roof finish membrane up and over the wallhead could be executed). Ideally the stones would be re-set to project beyond the face of the brick wall below by say 50mm</i></p> <p><i>The Structural Engineer should review cracking/displacement in the wallhead in relation to potential embedded steel corrosion defects. Correction of such defects could entail partial dismantlement of the wallhead to clean and protect affected steel elements</i></p> | |

Low level roof towards south-east;  
showing evidence of cracking and  
displacement affecting parapet  
brickwork

Embedded steel corrosion was  
suspected
