# Arboricultural Appraisal Report

## Subsidence Damage Investigation at:

27 Woodfield Way  
London  
N11 2NP

| MWA REF: | SUB210514-8959 |

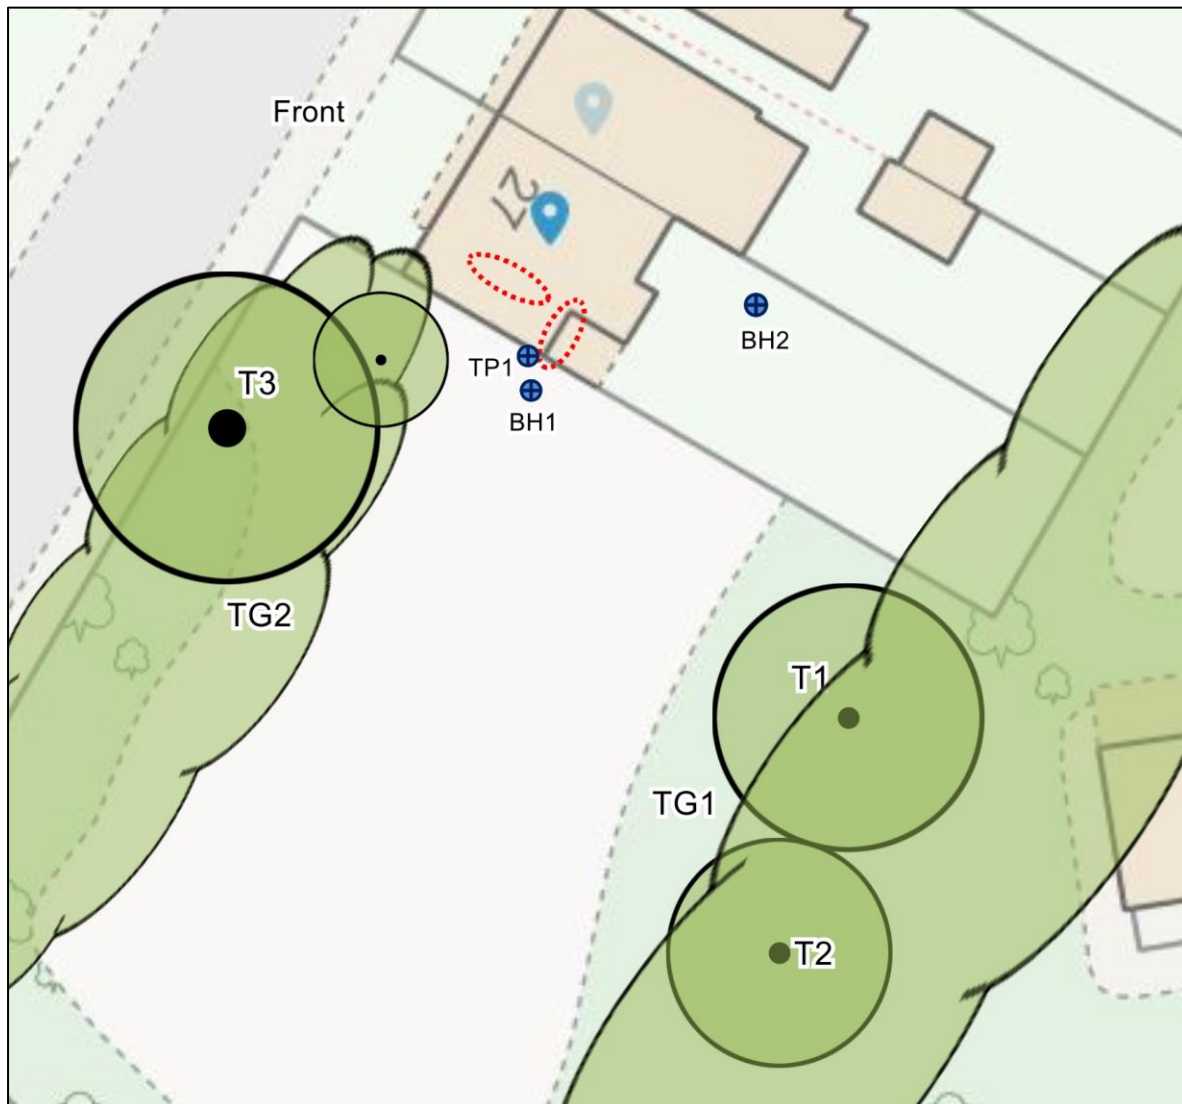
Approximate areas of damage

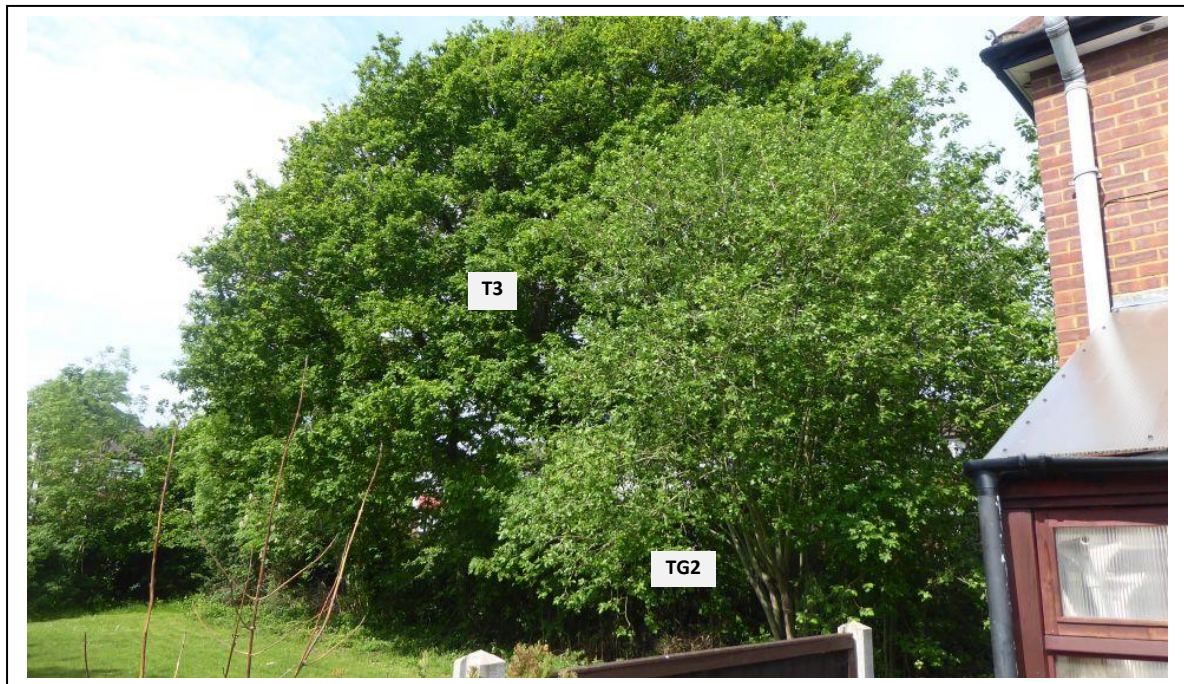
Having considered the information currently available, it is our opinion that ongoing presence of the T3 Oak, is the principal cause of the current subsidence damage. The tree will have exerted an ongoing drying influence on the soils below the property and the previous pruning of the tree also appears to have lapsed, which will have resulted in its moisture uptake increasing over recent years.

View from property rear of T3 Oak with TG2 group understorey

Given the history of damage and previous attempts to stabilise the property, if an arboricultural solution is to be implemented to mitigate the influence of the oak recommend its removal along with elements of TG2.

| Tree No. | Species | Ht (m) | Dia (mm) | Crown Spread (m) | Dist. to building (m) | Age Classification | Ownership |
|---|---|---|---|---|---|---|---|
| Recommendation | | Remove (fell) to near ground level and treat stump to inhibit regrowth. | | | | | |
| Recommendation | | Remove (fell) all within 8.0m of the building to near ground level and remove regrowth as it emerges [Herbicide translocation risk to remaining Sycamores and Ash]<br>Treat stump of Goat Willow to inhibit further regrowth. | | | | | |

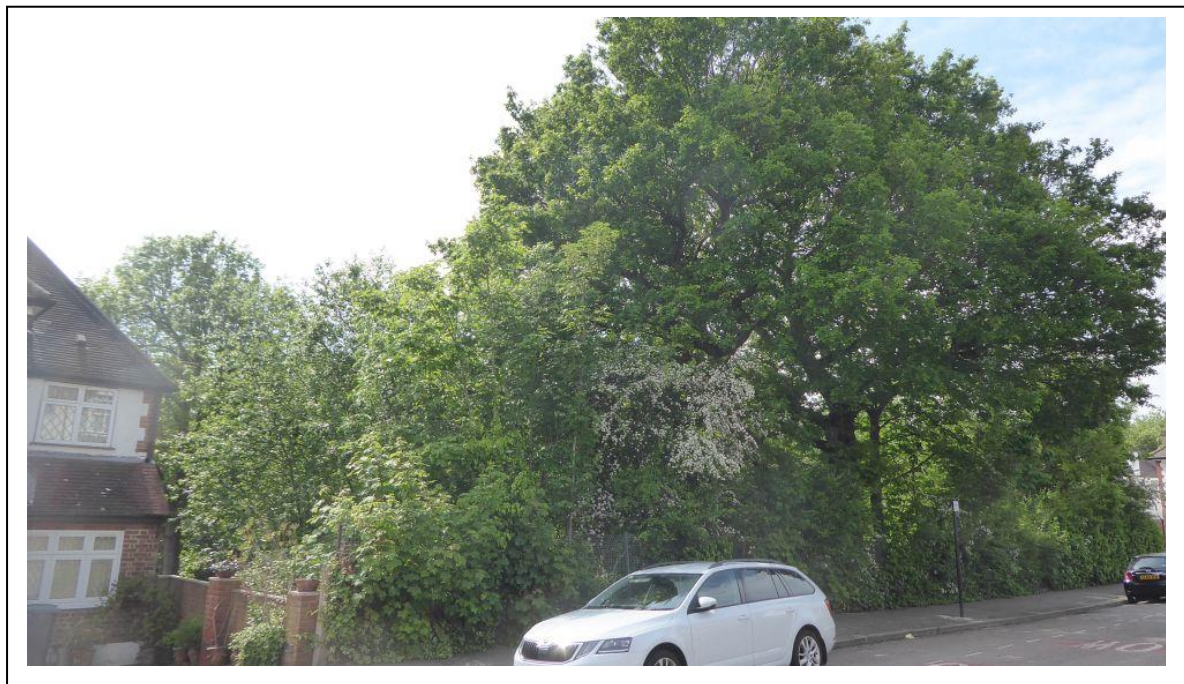
View from property frontage of T3 Oak with TG2 group understorey

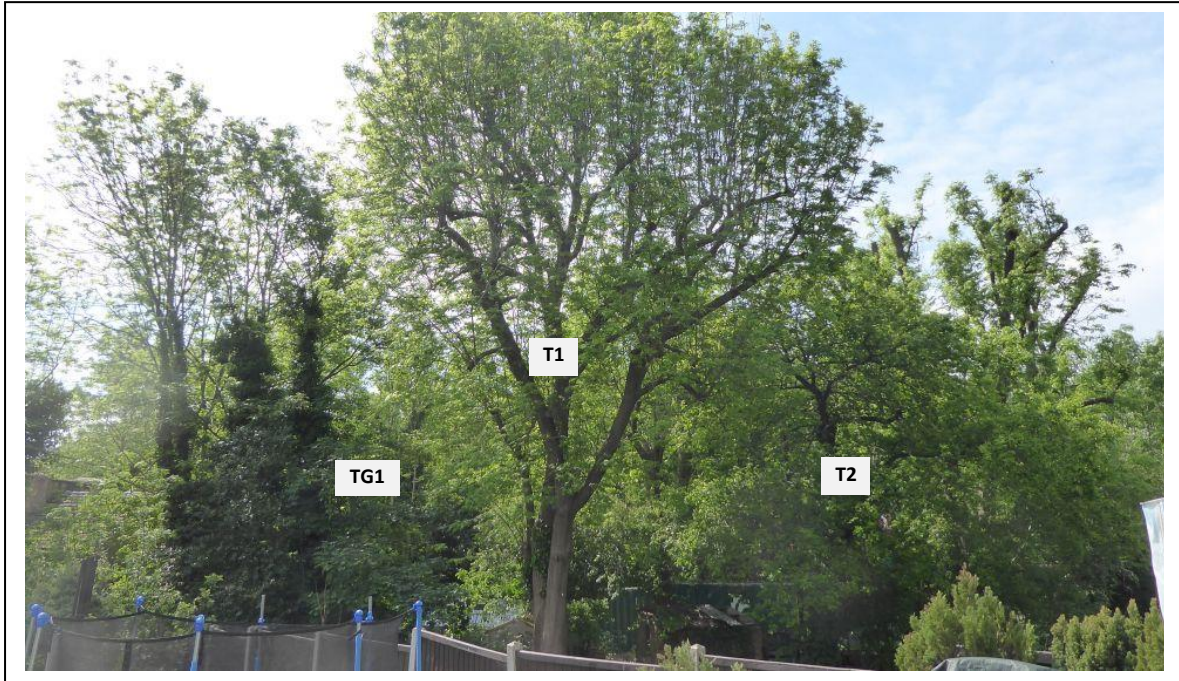
View of T1 Ash, T2 Oak and TG1 group

| Tree No. | Species | Ht (m) | Dia (mm) | Crown Spread (m) | Dist. to building (m) | Age Classification | Ownership |
|---|---|---|---|---|---|---|---|
| Recommendation | | Re-pollard to previous points and thereafter re-pollard on a triennial cycle to maintain at broadly reduced dimensions. | | | | | |
| Recommendation | | Maintain broadly at no more than current dimensions by periodic pruning. | | | | | |

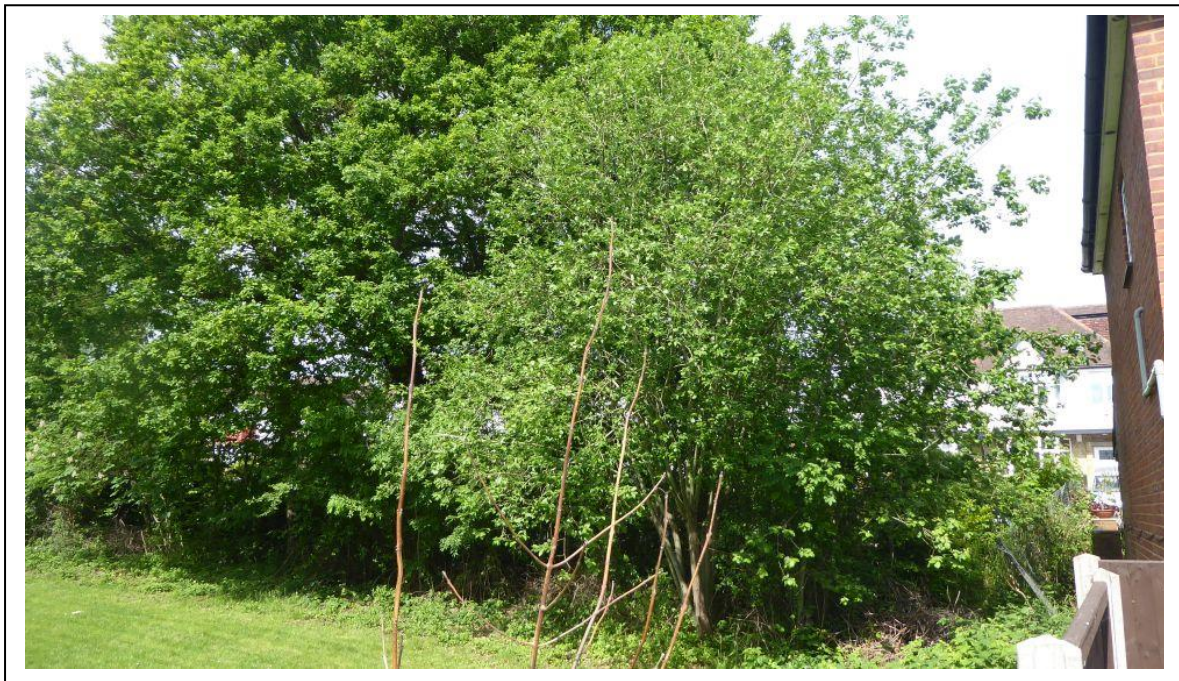
View of nearby Goat Willow within TG1 group – treat stump to inhibit regrowth
