**TECHNICAL REPORT ON A SUBSIDENCE CLAIM**

**Crawford Reference: SU2003608**

**27 Woodfield Way  
London, N11 2NP**

**SUBSIDENCE CLAIM**

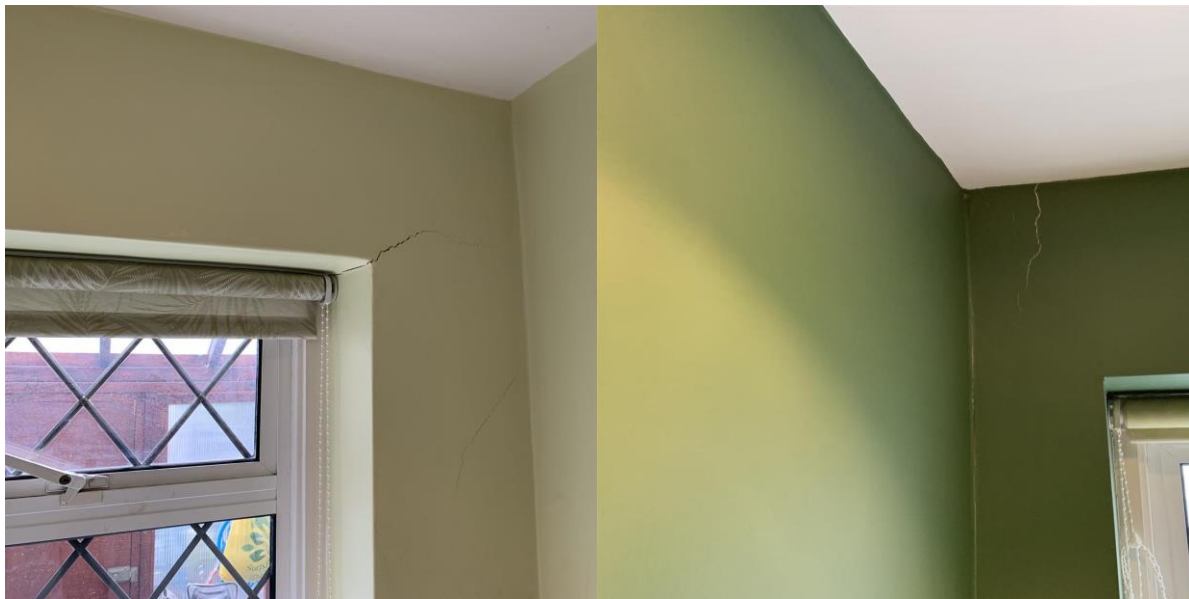
Utility Room - rear wall

Toilet rear wall

Vertical crack below and diagonal crack above right side of window.  
Crack in floor tiles at junction of extension with original house.  
Cracking at internal wall/ceiling junction.  
Window frame out of square and window sticking when trying to open.

Vertical crack above rear window.  
Vertical crack at rear left corner.

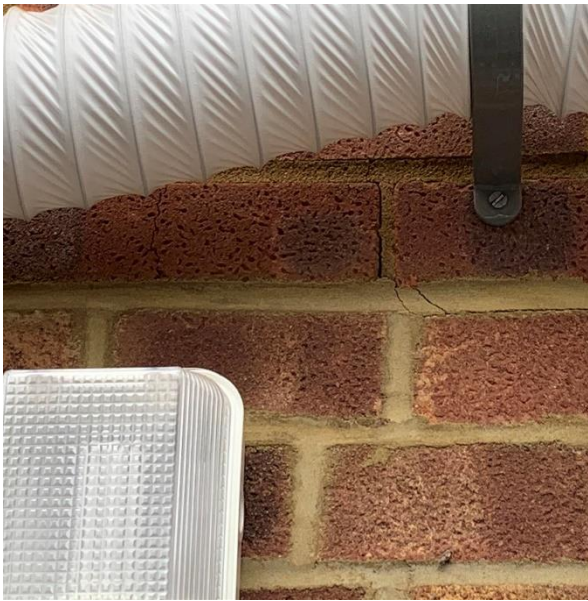
Above toilet window on rear wall

Stepped and horizontal cracks above and below Utility and Toiler windows.

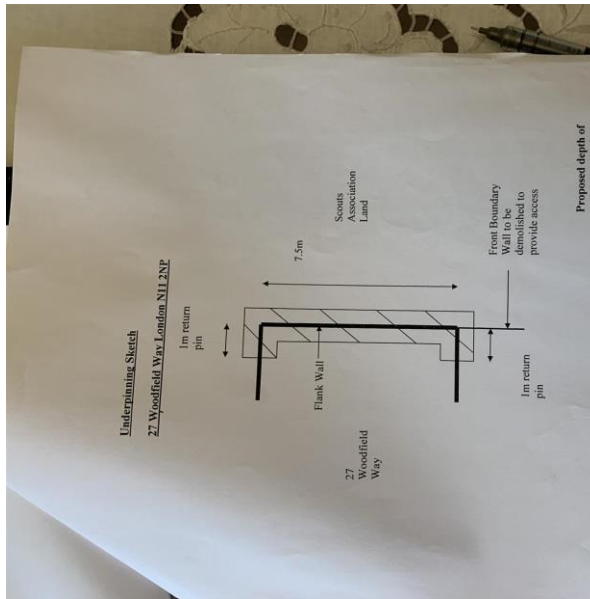
Previous underpinning plan

Two storey semi-detached house of traditional construction with part rendered brick walls surmounted by a gabled and hipped tiled roof. There is a two storey extension to the right side and a single storey extension to the front of this. At the rear, there is a lean-to. The property was subject to a previous subsidence claim which resulted in underpinning the flank wall of the side extension. The underpinning is shown on the drawings to be mass concrete to a depth of 3m.

In addition, a claim should be lodged under the ASUC Underpinning Guarantee in the event that further site investigations find that the previous underpinning was not carried out correctly to specification.

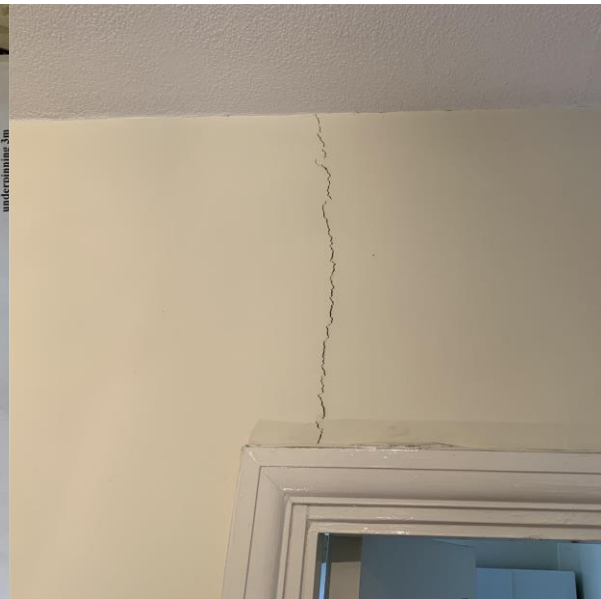
Vertical crack above door to front right bedroom.

Landing - vertical crack above bedroom door

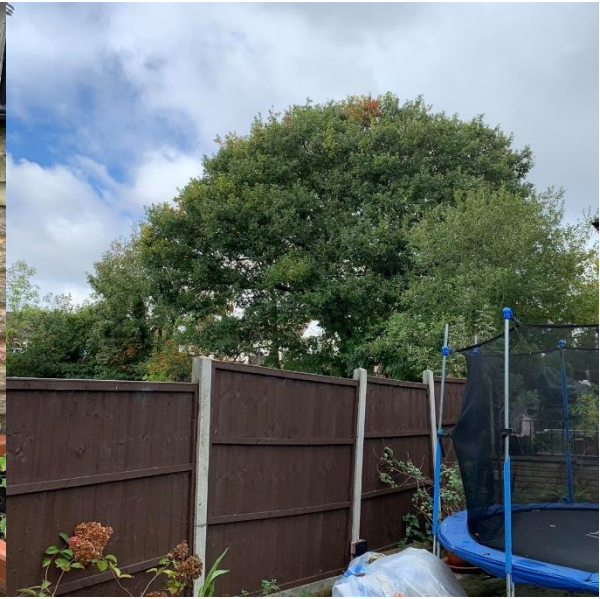
| Type | Height | Distance | Ownership |
|---|---|---|---|
| T1 Oak | 18 m | 16 m | The Scout Association |

The pattern and nature of the cracks is indicative of an episode of subsidence. The cause of movement appears to be clay shrinkage beneath the existing underpinning of the side extension.

The timing of the event, the presence of shrinkable clay beneath the foundations and the proximity of vegetation where there is damage indicates the shrinkage to be root induced. This is a commonly encountered problem and probably accounts for around 70% of subsidence claims notified to insurers.

Although the cause of the movement needs to be dealt with, we note the vegetation is subject to a Preservation Order. Current legislation requires certain investigations to be carried out to support an application for the tree works.

Typically, these investigations would involve trial pit(s) to determine the depth and type of footings, boreholes to determine the nature of the subsoil/influence of any roots and monitoring to establish the rate and pattern of movement. The monitoring data provided must be sufficient to show a pattern of movement consistent with the influence of the vegetation and therefore it may be necessary to carry out the monitoring for up to a 12 month period. It will also be necessary to obtain a specialist Arboricultural Report.

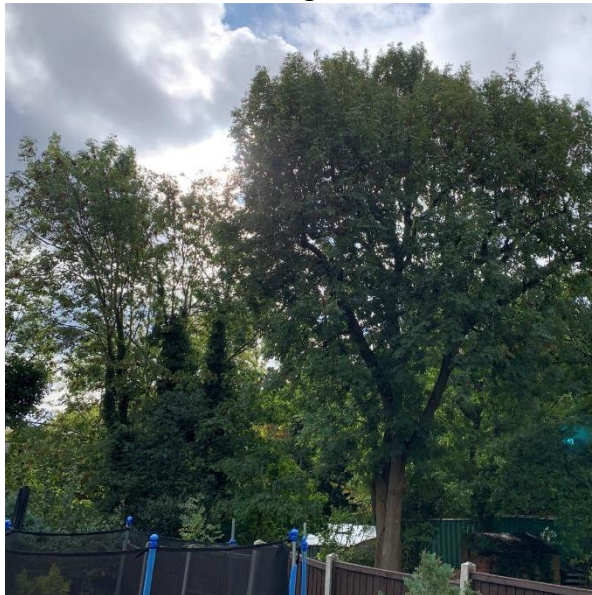
| Type | Height | Distance | Ownership |
|---|---|---|---|
| T3 Deciduous | 20 m | 18 m | The Scout Association |

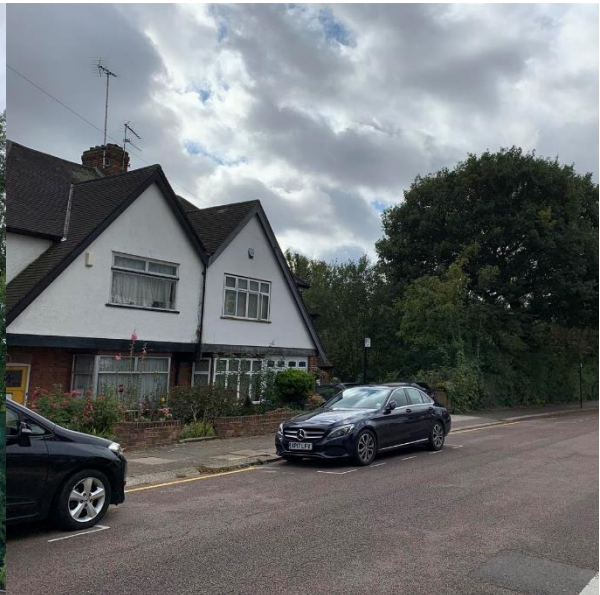
T1 Oak and T2 Deciduous

| Type | Height | Distance | Ownership |
|---|---|---|---|
| T2 Deciduous | 9 m | 5 m | The Scout Association |
