# Hutton + Rostron Environmental Investigations Limited

## Hornsey Town Hall, Broadway Annex: Window Condition Investigation

Site note 11 for October and November 2022, job no. 405-73

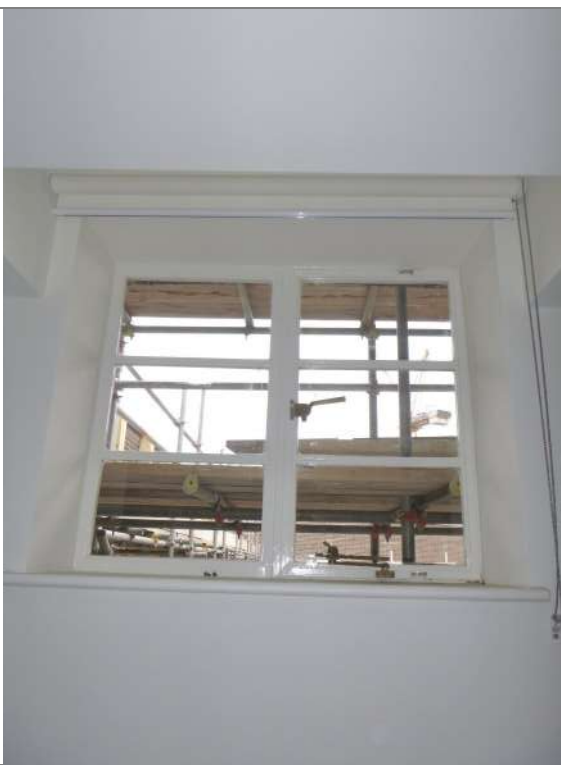
| Condition | Generally good with no evidence of structurally significant decay visible. Minor cracking/warping of glazing bar beads to pane A3 and B3 and apparent evidence of previous repairs | Once reason for warping has been determined, rubbing down and refinishing of beads to be undertaken. In the event that timber is beyond repair, replacement with matching dimensions is acceptable | |
| Glazing | Apparently original throughout. Superficial abrasion damage to a number of panes, likely from refurbishment | - | |

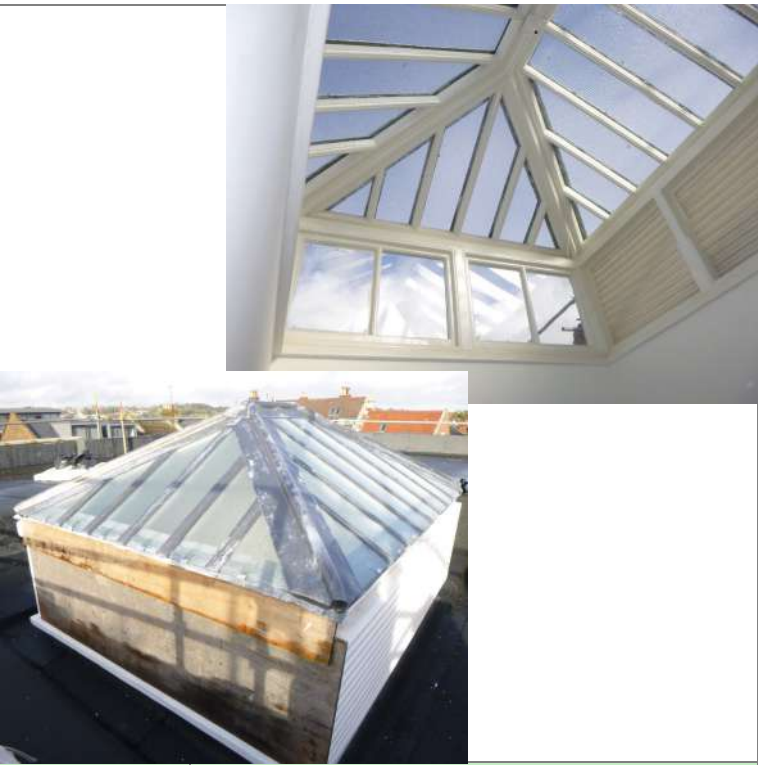
Historic softwood lantern with replacement glazed roof and upstands. External decoration and installation of glazed casements was yet to be completed. The eaves abutment of the glazed roof had insufficient overhang to shed water clear of the joinery below which raised risk of decay in future (and explained previous decay issues recently filled and decorated-over)
