JOB TITLE:  
**BRUCE GROVE  
YOUTH SPACE**

DRAWING TITLE:  
**NO. 10 BRUCE GROVE - CONDITION  
FABRIC REPAIRS**

| JOB CODE:<br><b>001550</b> | DRAWING NUMBER:<br><b>ADP-00-ZZ-DR- A-1220</b> | REVISION:<br><b>4</b> |

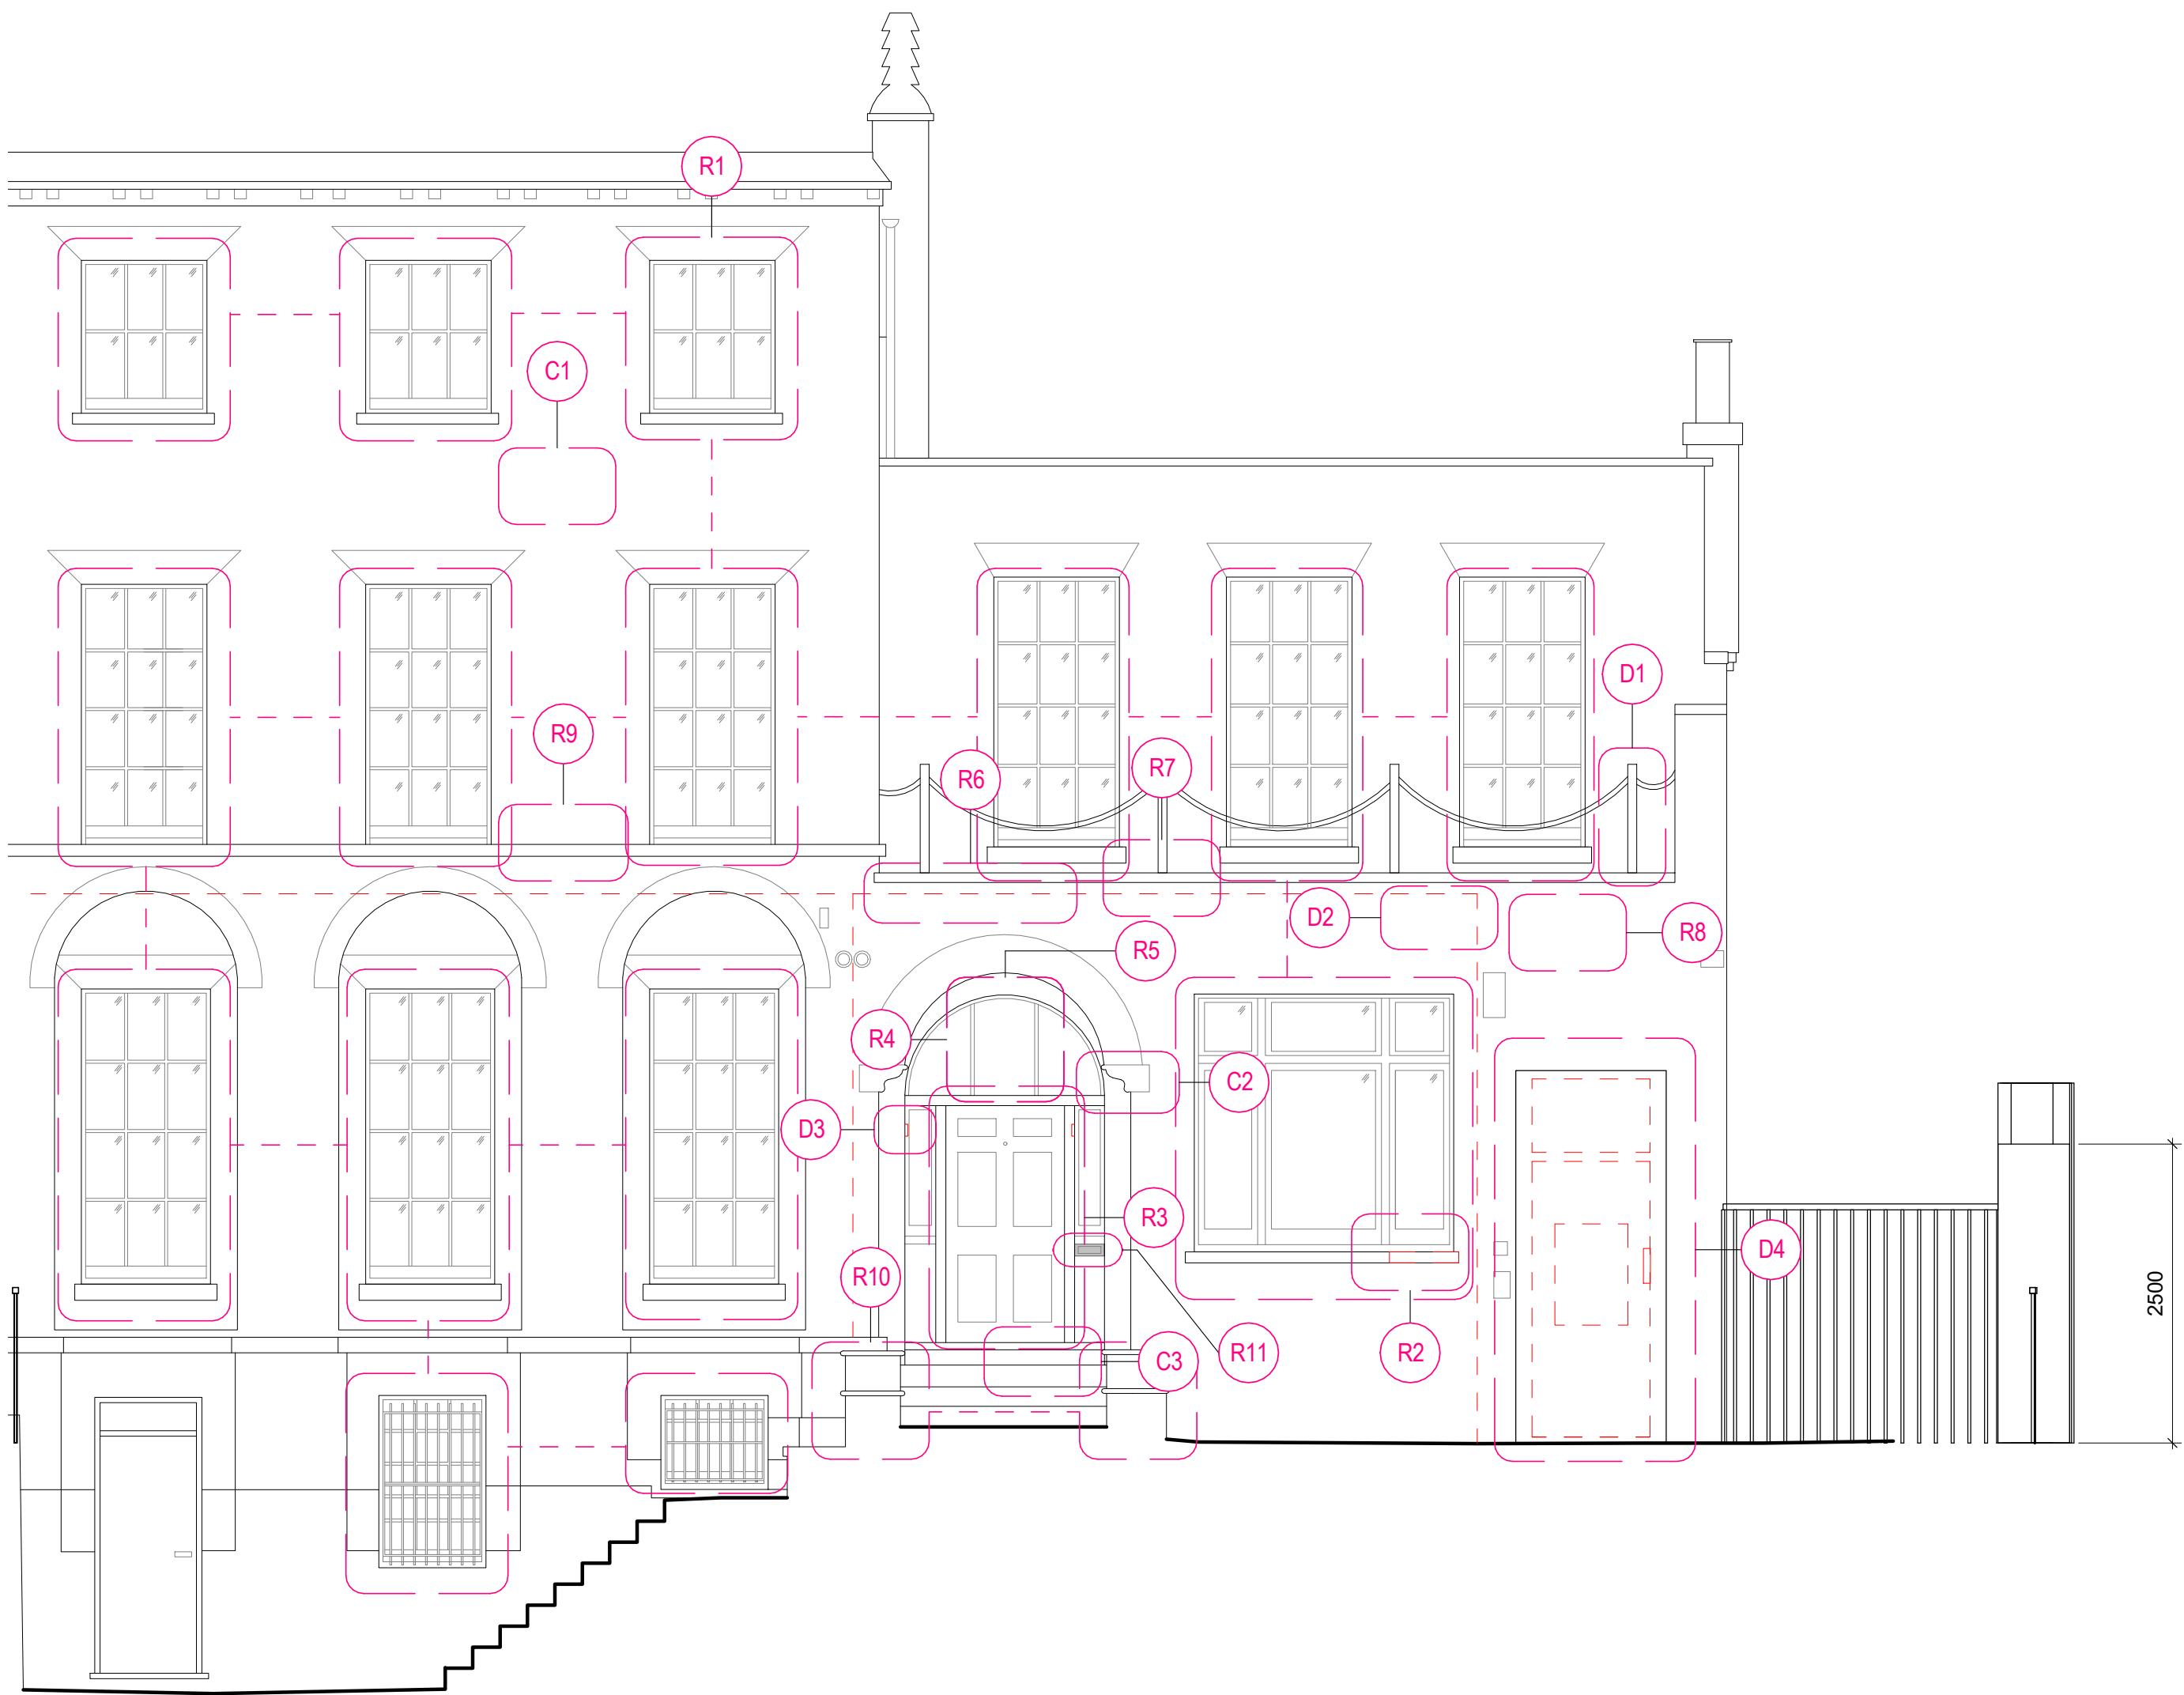
1 NO. 10 BRUCE GROVE FRONT ELEVATION  
1 : 50

| Condition Notes | | | |
|---|---|---|---|
| C1 | Pollution and algae on brickwork and mortar | Conservation clean front and rear elevations using Stonehealth 'Doff' system. Sample area to rear to be agreed with CA prior to clean of whole building | Aesthetic / Environmental |
| C2 | Decaying paintowrk to stone/recon stone capitals | Clean paint from stone/ recon stone capitals to either side of front door | Aesthetic |
| C3 | Poor conditon of steps | Clean steps to entrance | Aesthetic |
| D1 | Post and railing not in line with proposal | Remove posts and chain link rail to flat roof | Aesthetic |
| D2 | Trailing cables | Remove trailing cables from front elevations | Aesthetic |
| D3 | Light fitting not inline with proposal | Remove light fittings to either side of door and replace | Aesthetic |
| D4 | Poor quality side door | Remove side door and frame from external side passage. Replace with new gate to allow visibility through | Aesthetic |
| R1 | Window frames in generally poor condition | Prepare and redecorate windows generally colour to match existing, improve visibility, and approach to Youth Space in consideration of Secure by Design | Aesthetic |
| R2 | Rotten areas of window frame | Cut out rotten timber to bottom rail of sash and scarf in new hardwood timber piece and decorate to match existing | Water ingress |
| R3 | Door in poor condition | Prepare and redecorate front door. Colour TBC | Aesthetic |
| R4 | Front door fan lights and sidelight frames in poor condition | Prepare and redecorate side lights and fanlight to front door | Aesthetic |
| R5 | Poor quality glazing to door side lights and fan lights | Replace Georgian wired glass to side lights and fanlight with clear toughened glass | Aesthetic |
| R6 | Blocked drainage on flat roof and vegetation growth | Clear and repair roof covering to flat roof. Clear outlet and add leaf guard. | Water ingress |
| R7 | Water damaged soffit above front door | Prepare and redecorate soffit above front door where water damaged from blocked outlet to flat roof | Water ingress |
| R8 | Unknown condition of RWP within side passage | Repair RWP within side passage as necessary | Drainage |
| R9 | Stucco band at first floor in disrepair | Prepare and redecorate stucco band below first floor windows and coping stone to roof and lower ground external wall. | Aesthetic |
| R10 | Cracked walls to side of entrance steps | Prepare and redecorate low walls to side of entrance steps | Aesthetic |
| R11 | Letterbox in poor condition | Replace with new brass letterbox | Aesthetic |
