REF: 9659386

## SITE RECORD DETAILS

ADDRESS: 81 Hillfield Avenue, LONDON, N8 7DS

DATE 26 October 2022

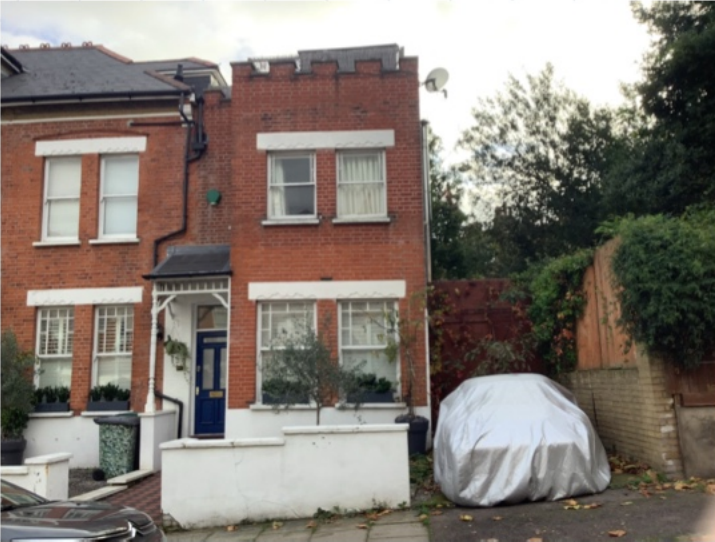
The damage is located to the front elevation of No.80 with internal cracks to the entrance hallway, lounge, landing, front bedroom and first floor corridor.

Front elevation

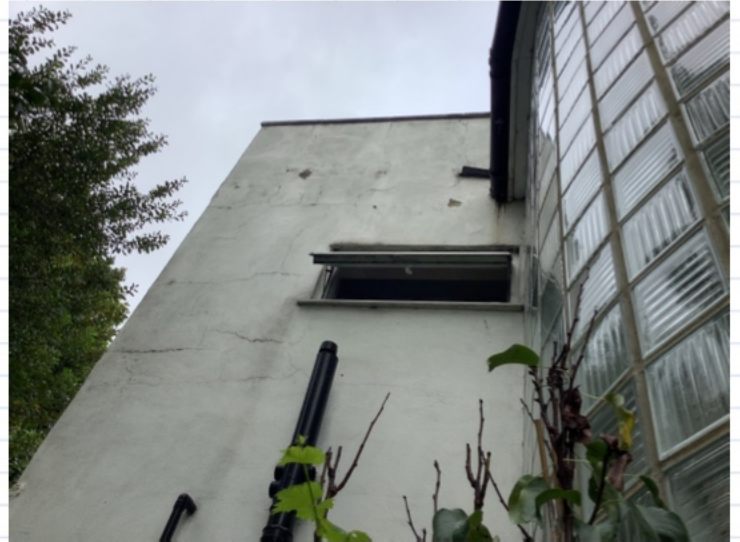
Rear elevation historic render cracks

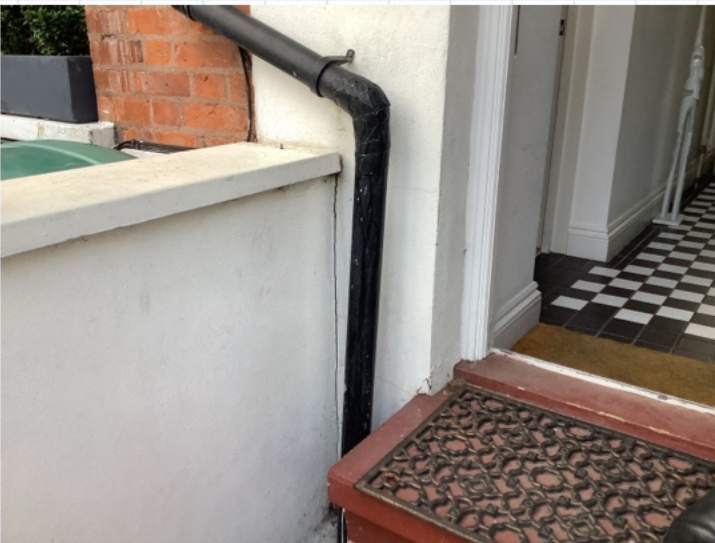
Low level render crack by front door

Spot drill cracks to render, redecorate area.

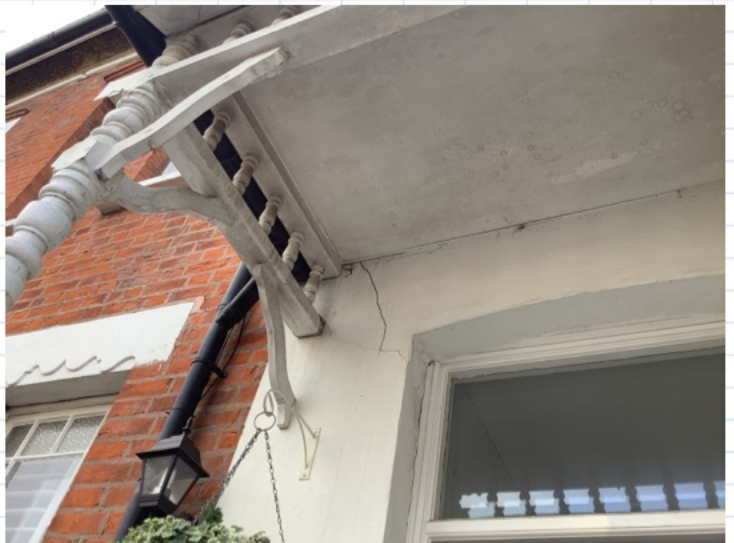
Crack to render above front door

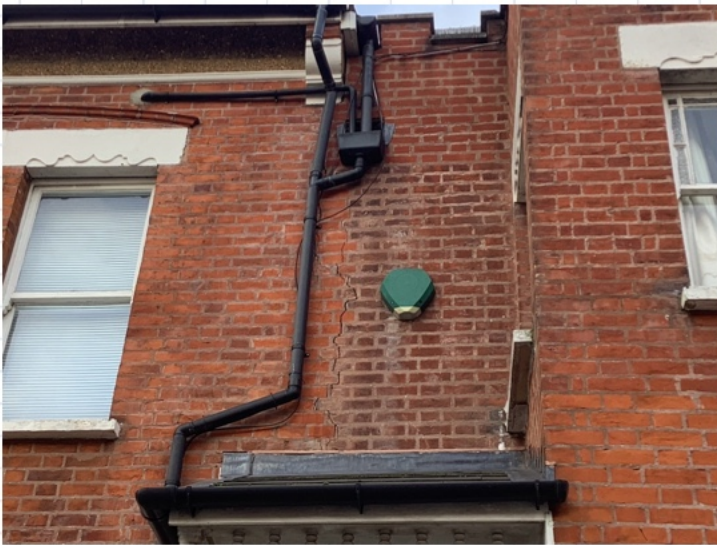
Front elevation crack to line of extension

Rake out and repoint circa 5lm. PS for 5 helical bars if damage worsens.

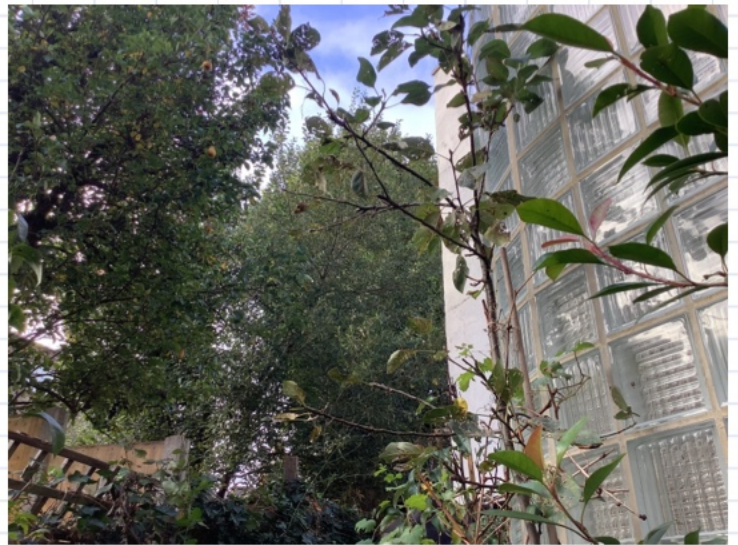
The BGS map suggests the area is clay. A drain run is located to the front elevation. Multiple PTP owned trees sits to the right elevation of the property. Full site investigation is required to confirm cause of damage with appropriate mitigation.

PTP trees to rear

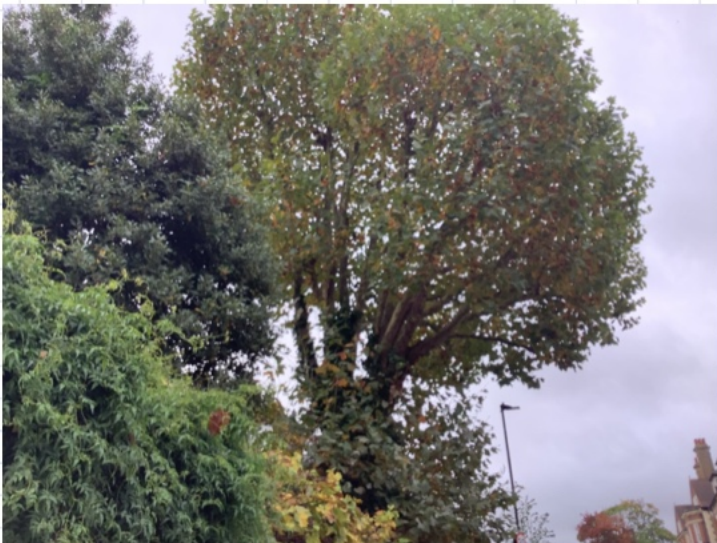
PTP tree to No.30

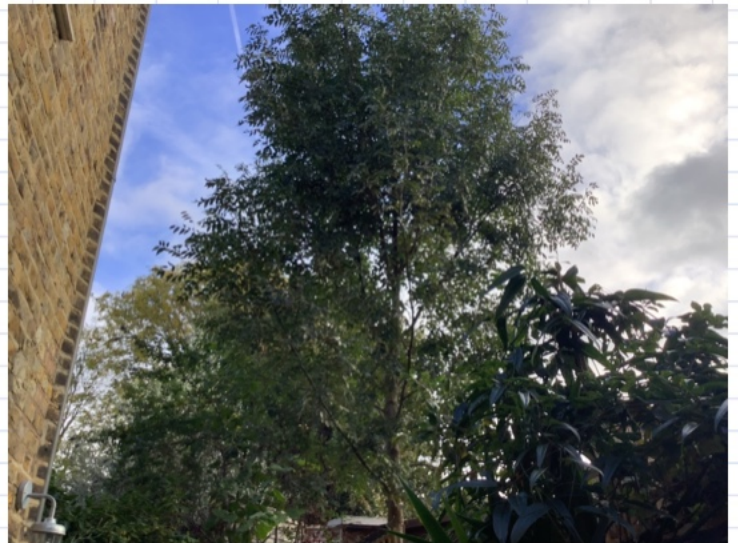
PTP tree to No.28

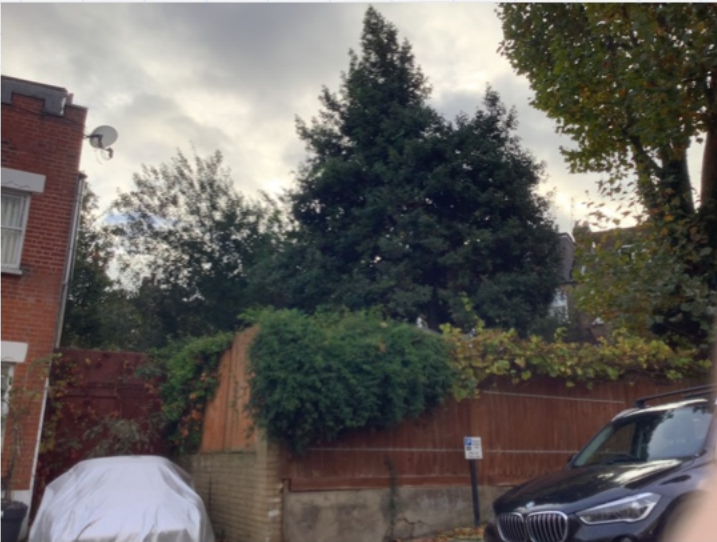
PTP tree to No.30

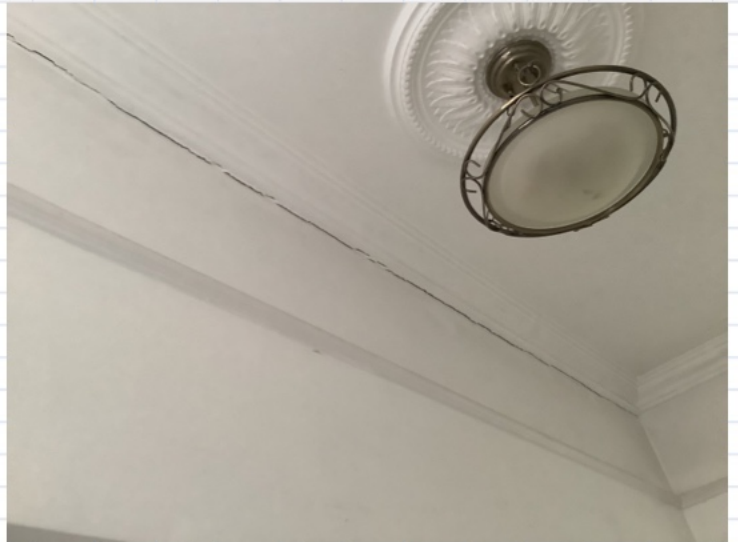
Junction crack to entrance hallway

Rake out, caulk gap to coving and make good area.

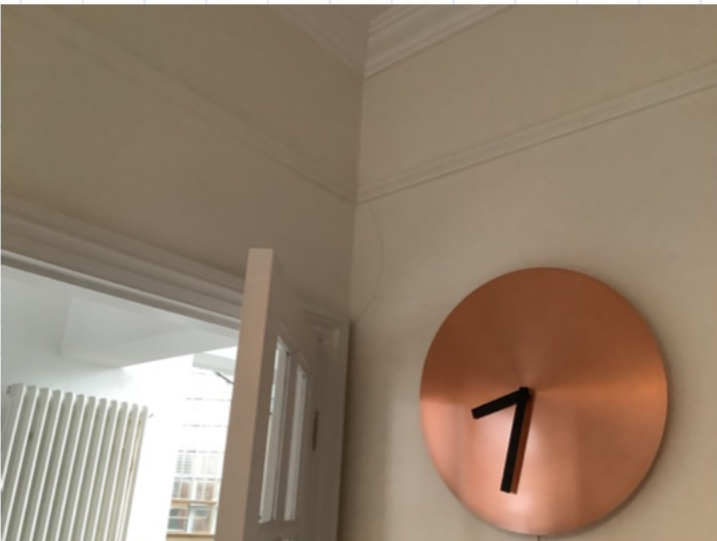
Wall crack to lounge

Lounge - 4.2 x 2.8 x 2.8 - rake out and repoint circa 2lm, redecorate walls.

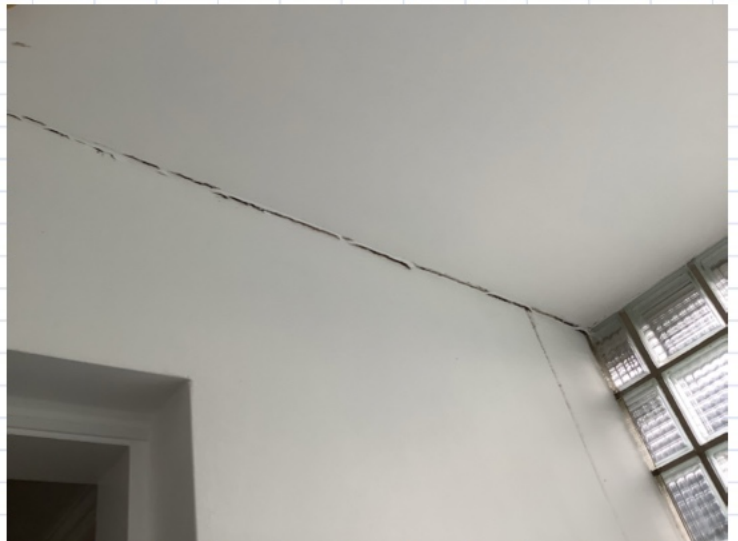
Gap to junction of landing

Rake out, fix EML 9lm, repoint and make good walls and ceiling.

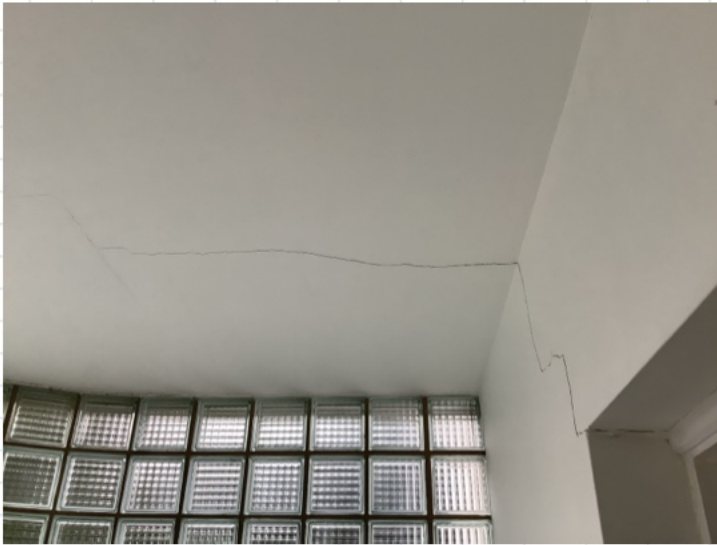
Crack continuing to ceiling of landing

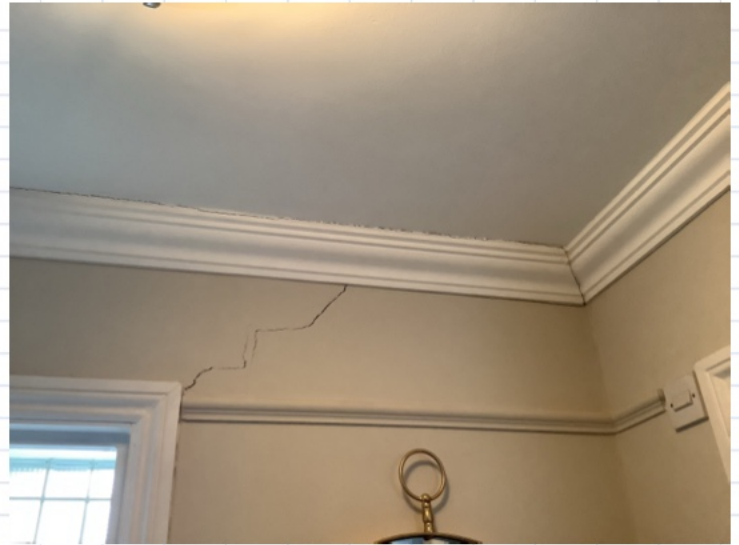
Bedroom wall crack

Front bedroom - 4.8 x 4.2 x 2.4 - rake out, caulk gap to coving fix EML circa 2lm, redecorate walls.

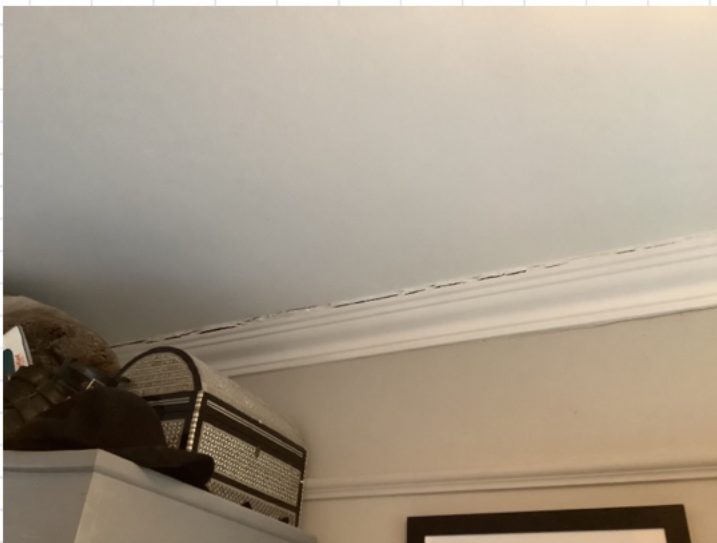
Gap evident to coving in bedroom

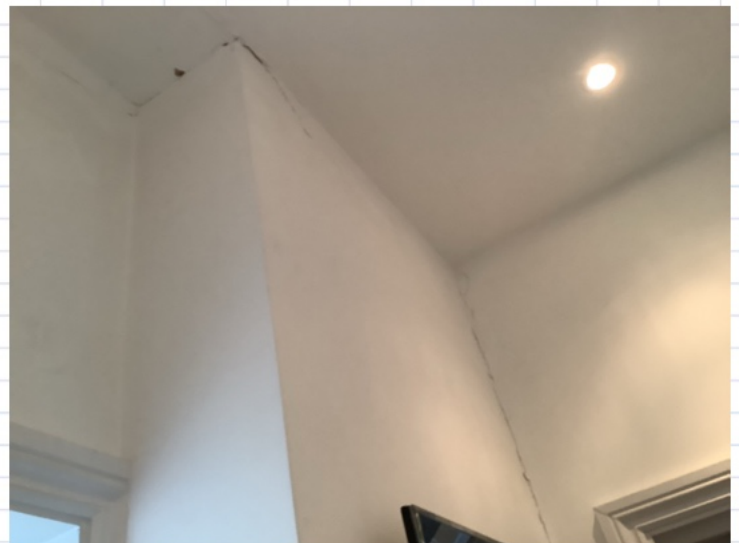
Crack to corridor

Corridor - 1.5 x 1.8 x 2.7 - rake out and repoint circa 2lm. Redecorate walls.
