# ARBORICULTURAL ASSESSMENT REPORT

81, 81A & 81B Hillfield Avenue, London, N8 7DS

**PRI Ref:** 254283

**Survey Date:** 07/03/2023

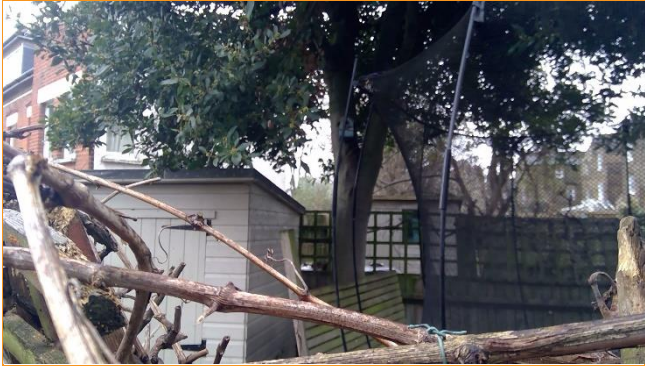
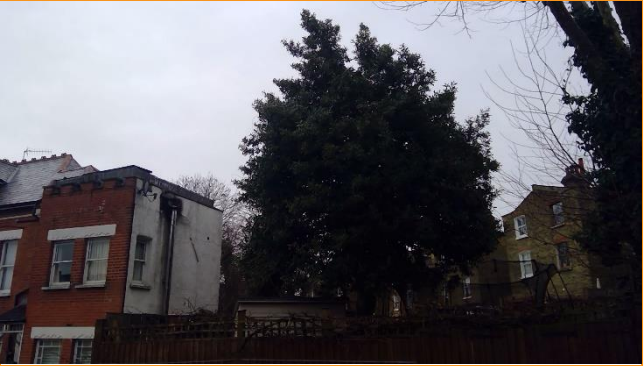
T1 - Laurel (Bay)

| Tree No | Common Name | Age Class | Condition | Height (m) | Crown Spread (m) | Stem diam. (mm) | Dist to bldg. (m) | Roots Implicated | Pruning history | Recommendation | Tree work constraints | Notes | Owner address | Owner |
|---|---|---|---|---|---|---|---|---|---|---|---|---|---|---|
| T1 | Laurel (Bay) | Mature | Fair | 9.6 | 5.4 | 320* | 8.48 | N | Subject to past management. No significant recent management. | Fell and treat stump with eco plugs (broadleaved). | Obstructions sheds/greenhouses. | | 26 Harold Road<br>Hornsey<br>London<br>N8 7DE | P3P |

| Tree No: | Species | Works Required |
|---|---|---|
| T1 | Laurel (Bay) | Fell and treat stump with eco plugs (broadleaved). |

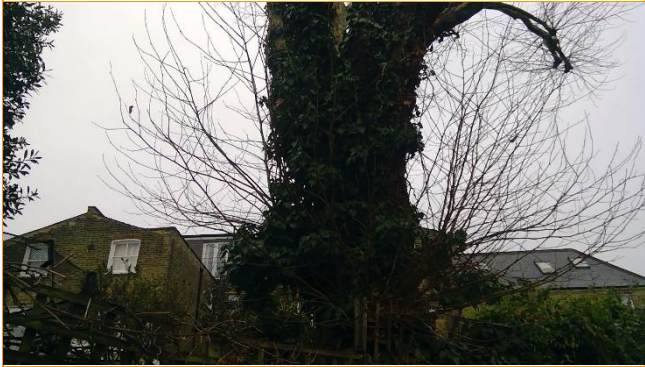
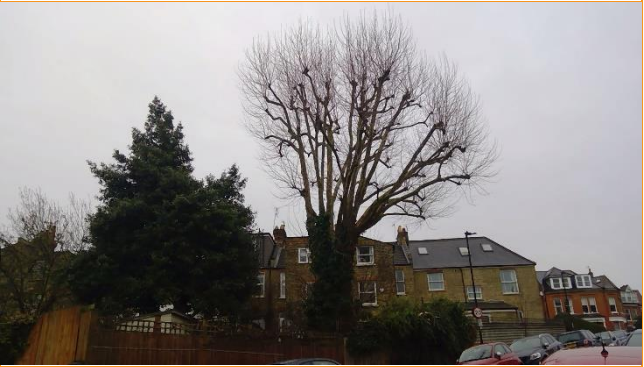
T2 - Plane (London)

| Tree No | Common Name | Age Class | Condition | Height (m) | Crown Spread (m) | Stem diam. (mm) | Dist to bldg. (m) | Roots Implicated | Pruning history | Recommendation | Tree work constraints | Notes | Owner address | Owner |
|---|---|---|---|---|---|---|---|---|---|---|---|---|---|---|
| T2 | Plane (London) | Mature | Fair | 13.8 | 10.6 | 640* | 15.03 | N | Pollarded with approximately 3 years regrowth. | Fell and treat stump with eco plugs (broadleaved). | Pre cone/signage/ barriers action required - footpaths/public access. Adjacent to highway - traffic management required. | Ivy clad stem to crownbreak. | 26 Harold Road<br>Hornsey<br>London<br>N8 7DE | P3P |

| Tree No: | Species | Works Required |
|---|---|---|
| T2 | Plane (London) | Fell and treat stump with eco plugs (broadleaved). |

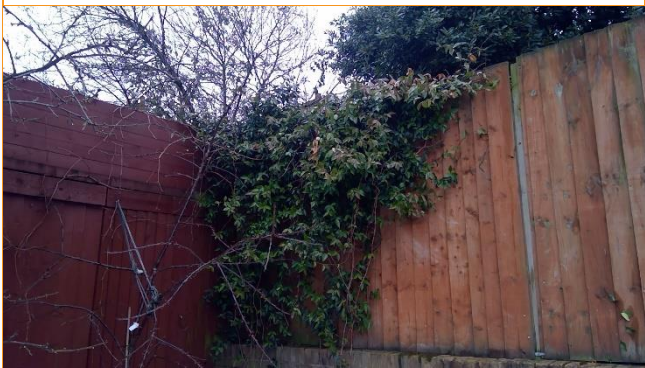
C1 - Jasmine

| Tree No | Common Name | Age Class | Condition | Height (m) | Crown Spread (m) | Stem diam. (mm) | Dist to bldg. (m) | Roots Implicated | Pruning history | Recommendation | Tree work constraints | Notes | Owner address | Owner |
|---|---|---|---|---|---|---|---|---|---|---|---|---|---|---|
| C1 | Jasmine | Mature | Fair | 2.9 | 1.2* | 20* | 2.7 | N | Subject to past management. No significant recent management. | No work required. | | | 24 Harold Road<br>Hornsey<br>London<br>N8 7DE | P3P |

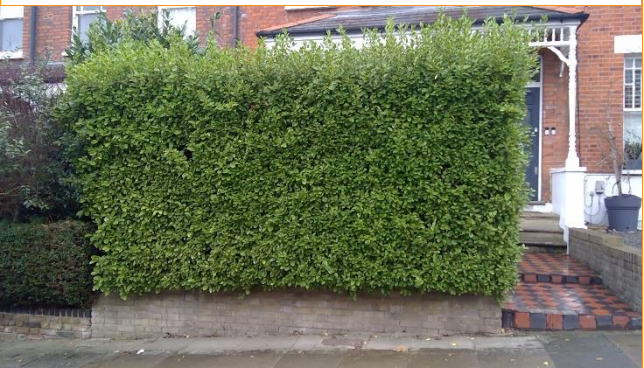
H1 - Griselinia

| Tree No | Common Name | Age Class | Condition | Height (m) | Crown Spread (m) | Stem diam. (mm) | Dist to bldg. (m) | Roots Implicated | Pruning history | Recommendation | Tree work constraints | Notes | Owner address | Owner |
|---|---|---|---|---|---|---|---|---|---|---|---|---|---|---|
| H1 | Griselinia | Mature | Fair | 3 | 1.0 | 30* | 5.6 | N | Managed as a hedge. | No work required. | | | 79 Hillfield Avenue<br>London<br>N8 7DS | P3P |

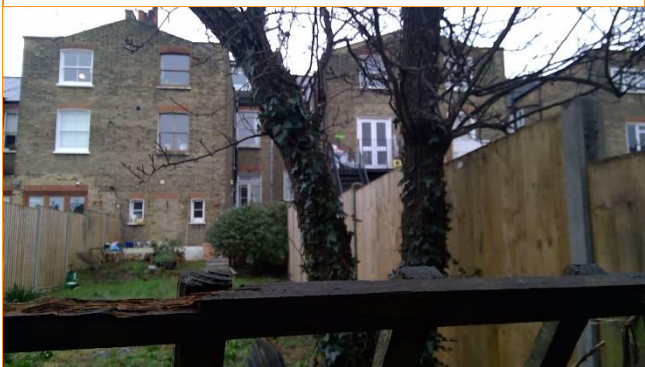
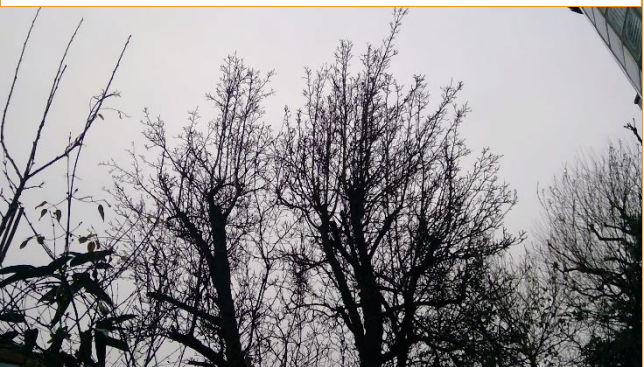
T3 - Pear

| Tree No | Common Name | Age Class | Condition | Height (m) | Crown Spread (m) | Stem diam. (mm) | Dist to bldg. (m) | Roots Implicated | Pruning history | Recommendation | Tree work constraints | Notes | Owner address | Owner |
|---|---|---|---|---|---|---|---|---|---|---|---|---|---|---|
| T3 | Pear | Mature | Fair | 7 | 4 | 300* | 3.65 | N | Subject to past management. No significant recent management. | No work required. | | | 22 Harold Road<br>Hornsey<br>London<br>N8 7DE | P3P |

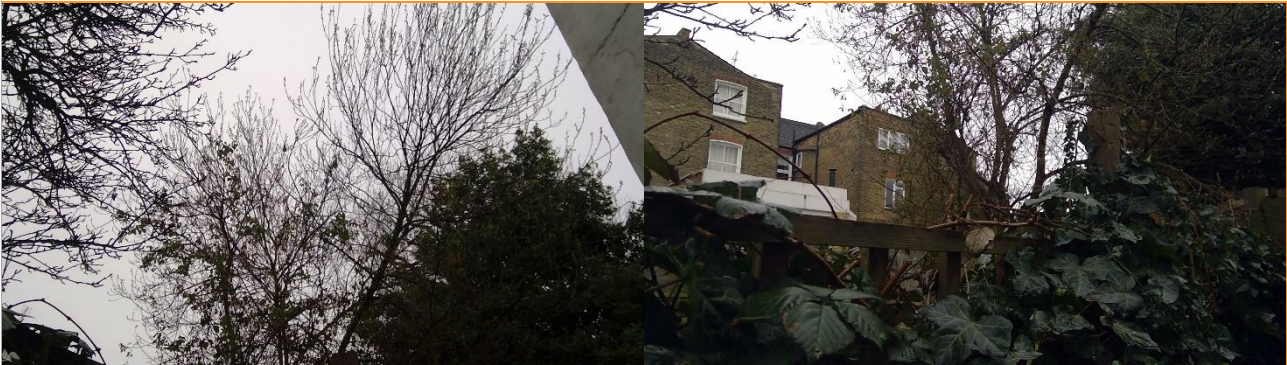
T4 - Willow

| Tree No | Common Name | Age Class | Condition | Height (m) | Crown Spread (m) | Stem diam. (mm) | Dist to bldg. (m) | Roots Implicated | Pruning history | Recommendation | Tree work constraints | Notes | Owner address | Owner |
|---|---|---|---|---|---|---|---|---|---|---|---|---|---|---|
| T4 | Willow (Goat) | Mature | Fair | 8 | 8* | 250 | 5.77 | N | Subject to past management. No significant recent management. | No work required. | | | 24 Harold Road<br>Hornsey<br>London<br>N8 7DE | P3P |
