Building Services  
Engineering &  
Environmental Design

## APPENDIX A - CONDITION SURVEY DRAWINGS AND SCHEDULES

## Condition Survey Schedules

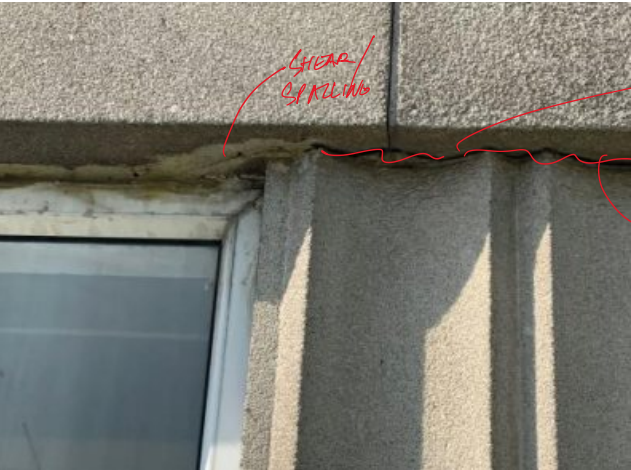
CRACK / SPALLING

OPEN JOINT.

OPEN TO 1/2 WAY ALONG PANEL.

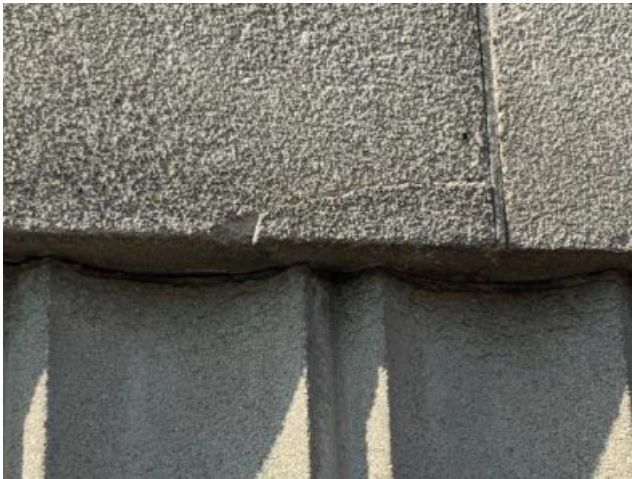
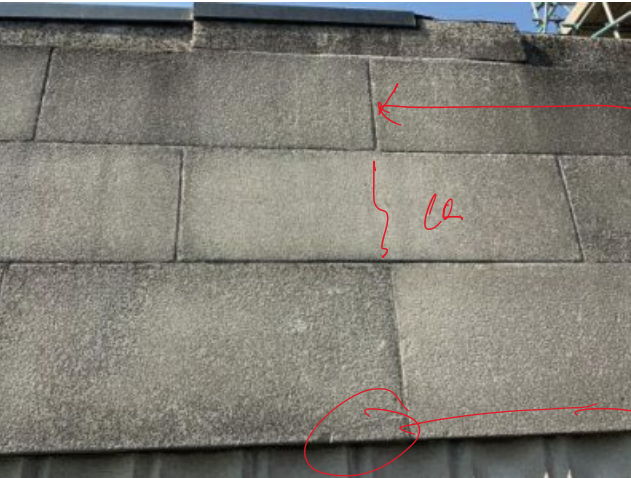
OPEN JOINT

CR

SPALLING

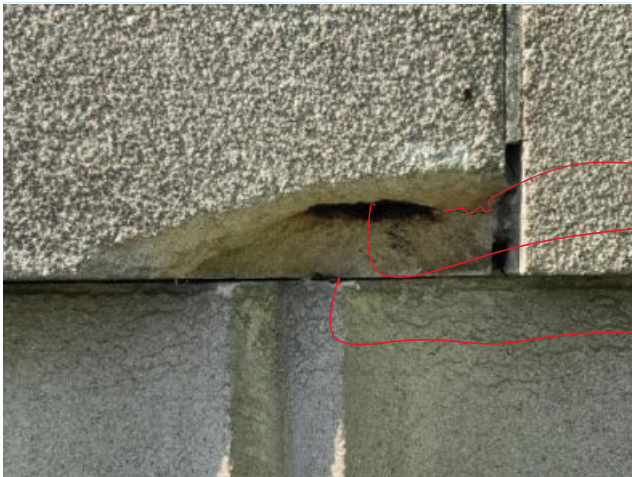
CRACK

OPEN
