## Condition Survey Photos

Condition Survey Schedules

**Roger Mears Architects LLP**

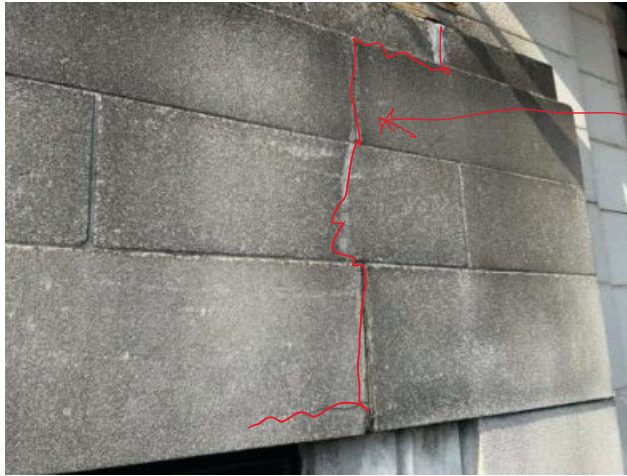
CRACK /  
LOAD  
PARTY?

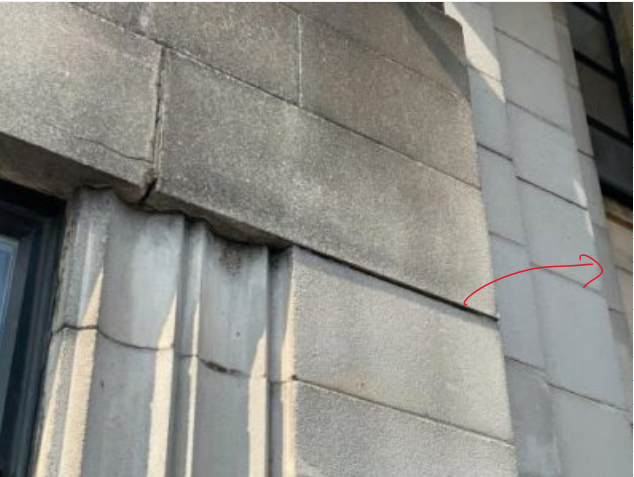
WHOLE  
CORNER  
PROTRUDING

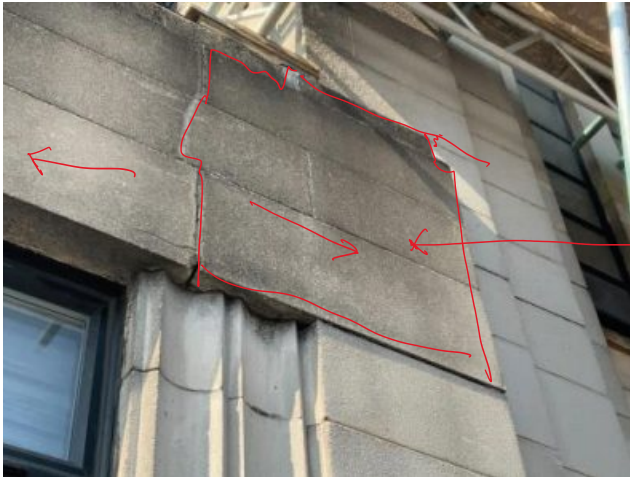
BLOCK  
FALLING  
OUT

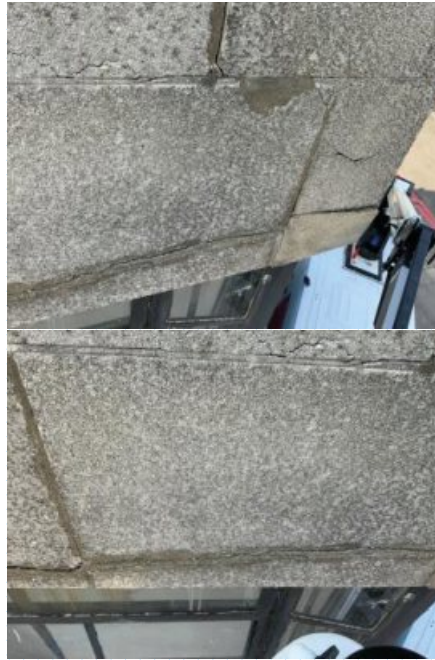
CORRODED  
REINFORCE

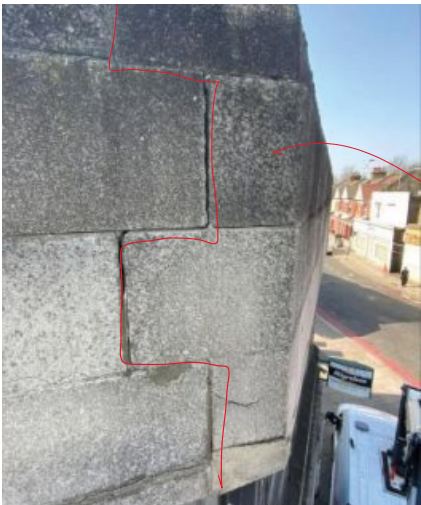
FRONT  
OUT.

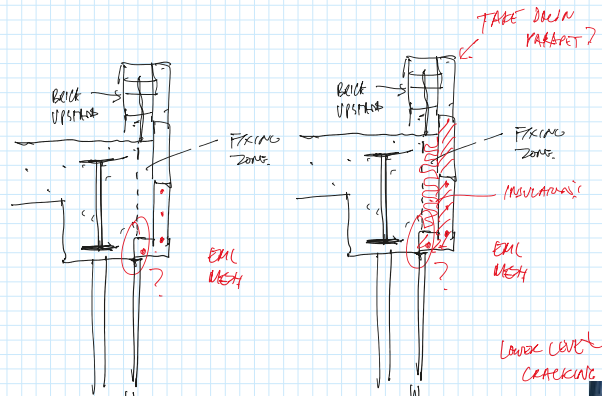
LOW-LEVEL  
CRACKING

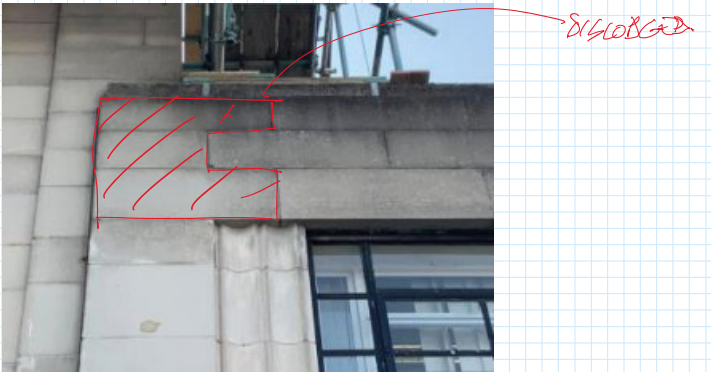
DISLOBBED

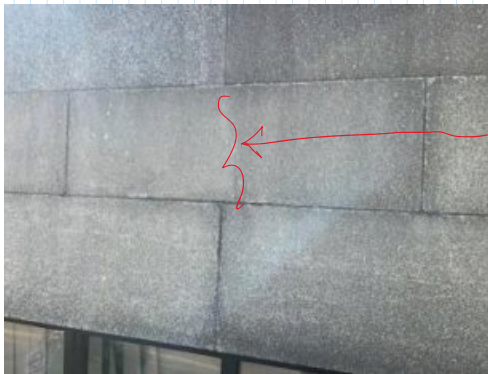
CRACK

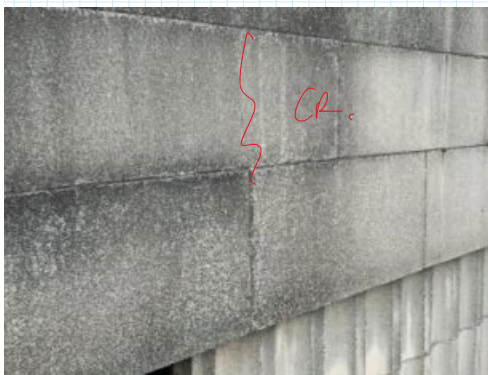
CRACK

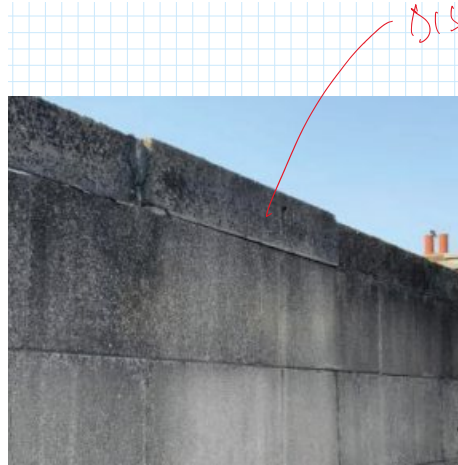
CR.

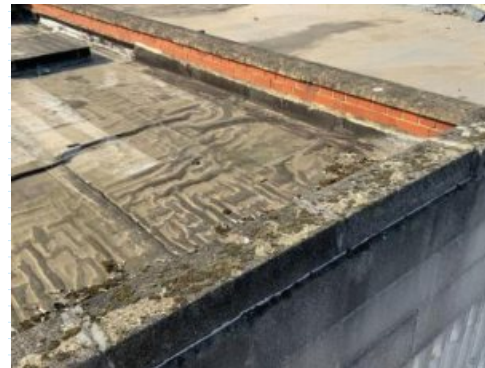
DISLODGED

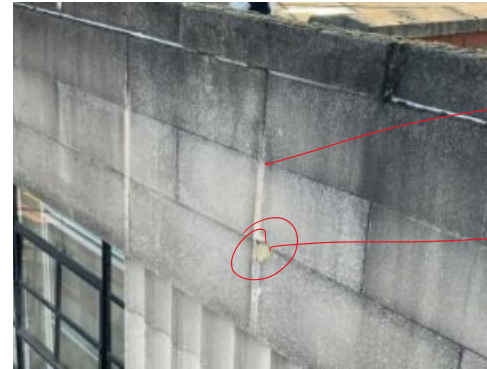
DISLODGED  
- OVER HEATED CURE

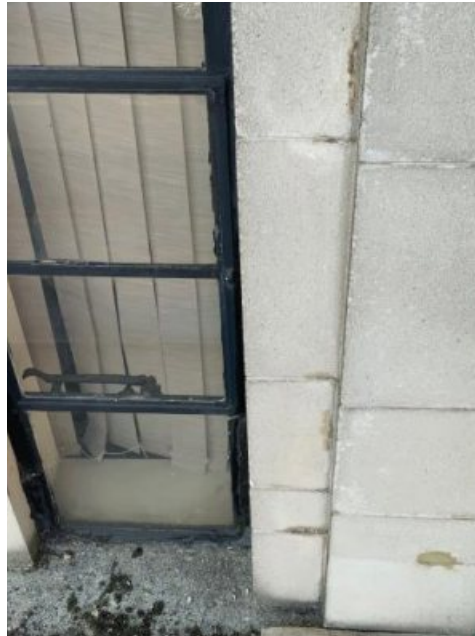
MOSS ON  
CILL  
- COARDED  
PLANT
