46 Vallance Road  
London  
N22 7UB

**INSURANCE CLAIM  
CONCERNING SUSPECTED SUBSIDENCE  
ENGINEERING APPRAISAL REPORT**

Date: 03/04/2023

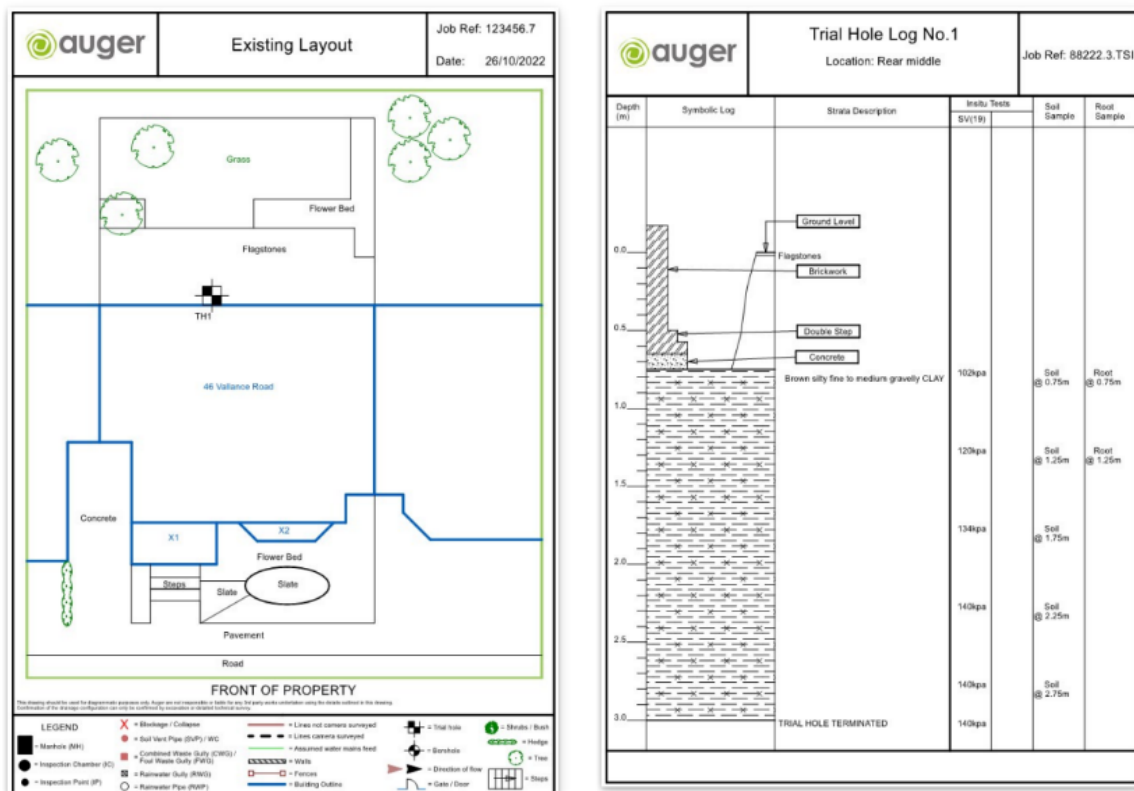
TP/BH1 – rear elevation;

The foundation took bearing at 750mm below ground level into stiff brown fine to medium gravelly Clay with plasticity indices of between 38% and 53%, the Clay therefore being classified as having high volume change potential. The moisture content at foundation underside 600mm depth e.g. within the zone of root activity, was 28% compared with values of 33% for samples taken at 2000mm depth.

There were roots retrieved at the underside of the foundation down to 1250mm depth.

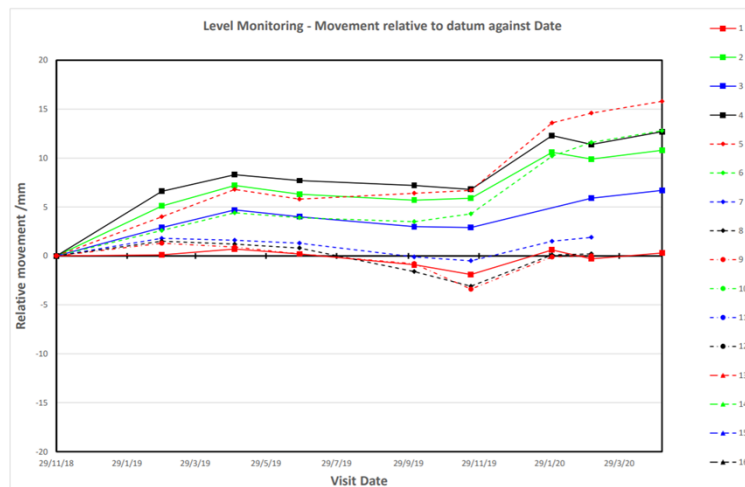
### 3. MONITORING

Previous level monitoring was undertaken during the period 29/11/2018 – 29/1/2020 as noted in the above data.

Due to the reoccurring damage, I have instructed the level monitoring to recommence and await the results.

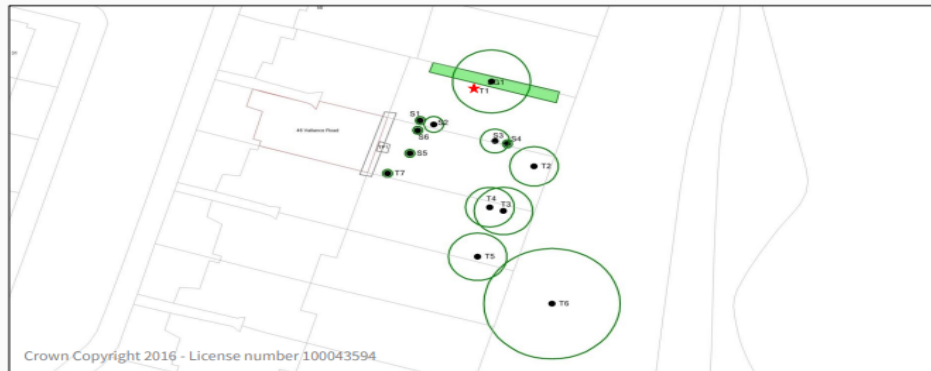
**7.0 APPENDIX 2: SITE PLAN**

Vegetation noted below, for which the adjoining private Third Party is responsible, is contributing toward the cause of the further damage. We believe the vegetation is also subject to conservation restrictions which is under review.

| Tree No: | Species | Works Required |
|---|---|---|
| T1 | Oak (English) | Fell and treat stump with eco plugs (broadleaved). |
