# ARBORICULTURAL ASSESSMENT REPORT

46 Vallance Road, London, N22 7UB

**PRI Ref:** 252204

**Survey Date:** 21/02/2023

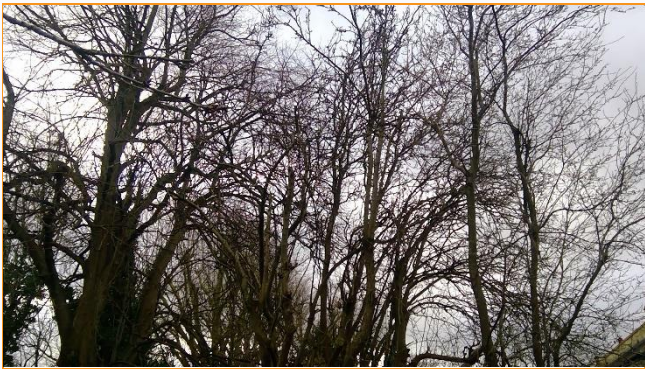
T3 - Pear

| Tree No | Common Name | Age Class | Condition | Height (m) | Crown Spread (m) | Stem diam. (mm) | Dist to bldg. (m) | Roots Implicated | Pruning history | Recommendation | Tree work constraints | Notes | Owner address | Owner |
|---|---|---|---|---|---|---|---|---|---|---|---|---|---|---|
| T3 | Pear | Mature | Fair | 9 | 6 | 340 | 13.6 | N | No significant past tree works. | No work required. | | | 44 Vallance Road<br>London<br>N22 7UB | P3P |

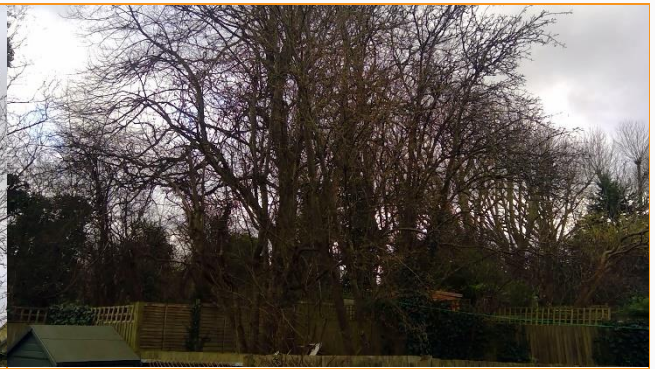
T4 - Plum

| Tree No | Common Name | Age Class | Condition | Height (m) | Crown Spread (m) | Stem diam. (mm) | Dist to bldg. (m) | Roots Implicated | Pruning history | Recommendation | Tree work constraints | Notes | Owner address | Owner |
|---|---|---|---|---|---|---|---|---|---|---|---|---|---|---|
| T4 | Plum | Semi-Mature | Good | 9 | 5.0 | 100 | 11.3 | N | No significant past tree works. | No work required. | | | 44 Vallance Road<br>London<br>N22 7UB | P3P |

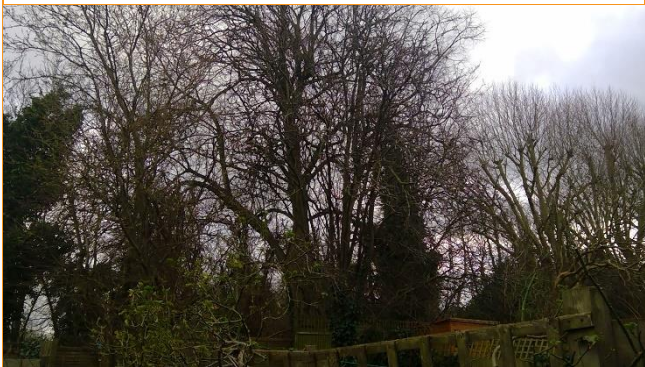
T5 - Pear

| Tree No | Common Name | Age Class | Condition | Height (m) | Crown Spread (m) | Stem diam. (mm) | Dist to bldg. (m) | Roots Implicated | Pruning history | Recommendation | Tree work constraints | Notes | Owner address | Owner |
|---|---|---|---|---|---|---|---|---|---|---|---|---|---|---|
| T5 | Pear | Mature | Fair | 10 | 6 | 400* | 15.3 | N | No significant past tree works. | No work required. | | | 44 Vallance Road<br>London<br>N22 7UB | P3P |

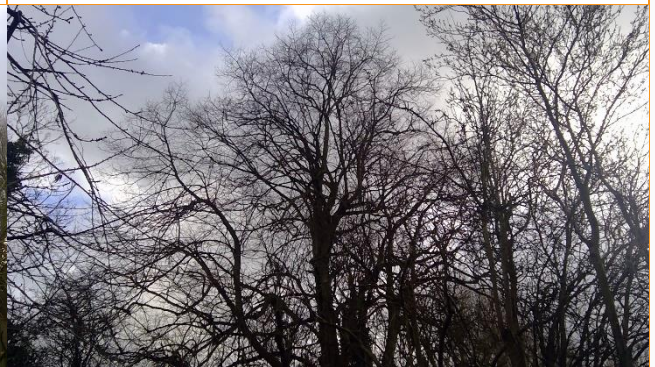
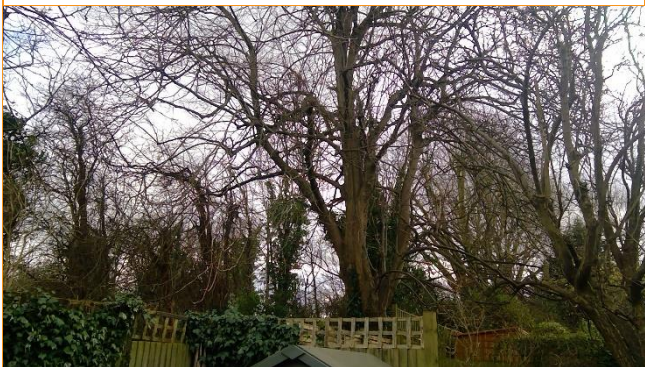
T6 - Lime

| Tree No | Common Name | Age Class | Condition | Height (m) | Crown Spread (m) | Stem diam. (mm) | Dist to bldg. (m) | Roots Implicated | Pruning history | Recommendation | Tree work constraints | Notes | Owner address | Owner |
|---|---|---|---|---|---|---|---|---|---|---|---|---|---|---|
| T6 | Lime | Mature | Good | 23 | 14 | 800* | 22.8 | N | No significant past tree works. | No work required. | | | Unknown Address | UKN |

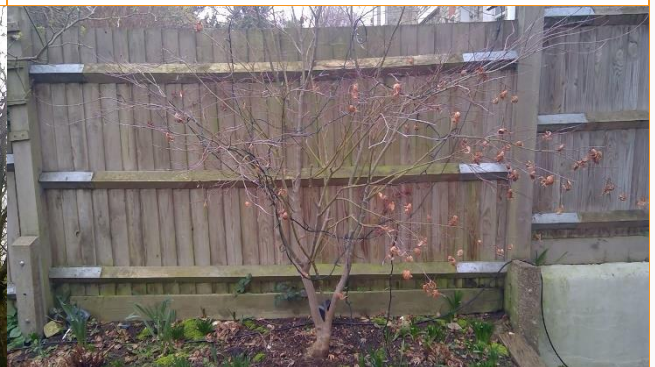
T7 - Acer

| Tree No | Common Name | Age Class | Condition | Height (m) | Crown Spread (m) | Stem diam. (mm) | Dist to bldg. (m) | Roots Implicated | Pruning history | Recommendation | Tree work constraints | Notes | Owner address | Owner |
|---|---|---|---|---|---|---|---|---|---|---|---|---|---|---|
| T7 | Acer | Semi-Mature | Fair | 2 | 1.0 | 40 | 2.6 | N | No significant past tree works. | No work required. | | | 46 Vallance Road<br>London<br>N22 7UB | PH |

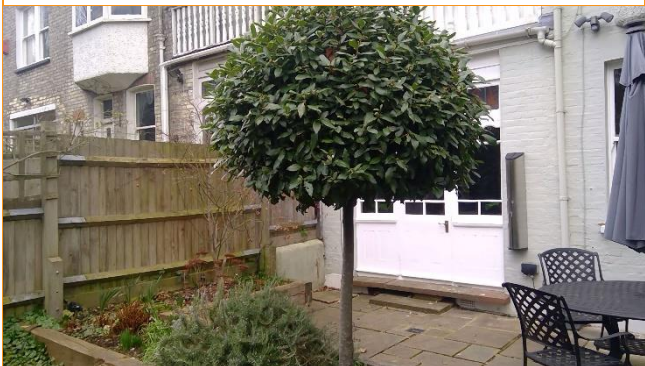
S5 - Laurel (Bay)

| Tree No | Common Name | Age Class | Condition | Height (m) | Crown Spread (m) | Stem diam. (mm) | Dist to bldg. (m) | Roots Implicated | Pruning history | Recommendation | Tree work constraints | Notes | Owner address | Owner |
|---|---|---|---|---|---|---|---|---|---|---|---|---|---|---|
| S5 | Laurel (Bay) | Young | Good | 2 | 1.0 | 40 | 3.8 | N | Subject to past management. | No work required. | | | 46 Vallance Road<br>London<br>N22 7UB | PH |

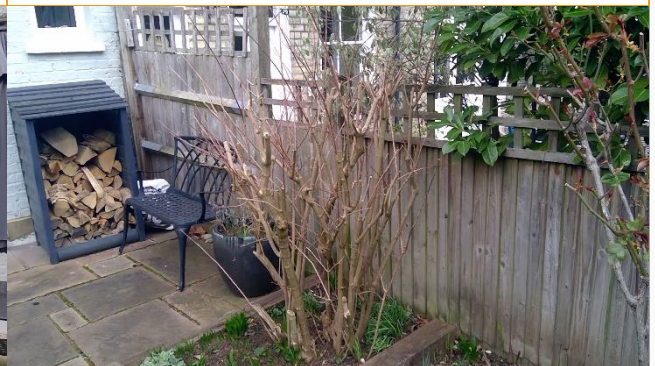
S6 - Weigela

| Tree No | Common Name | Age Class | Condition | Height (m) | Crown Spread (m) | Stem diam. (mm) | Dist to bldg. (m) | Roots Implicated | Pruning history | Recommendation | Tree work constraints | Notes | Owner address | Owner |
|---|---|---|---|---|---|---|---|---|---|---|---|---|---|---|
| S6 | Weigela | Mature | Fair | 2 | 1.0 | 20 | 3.8 | N | Subject to past management. | No work required. | | | 46 Vallance Road<br>London<br>N22 7UB | PH |

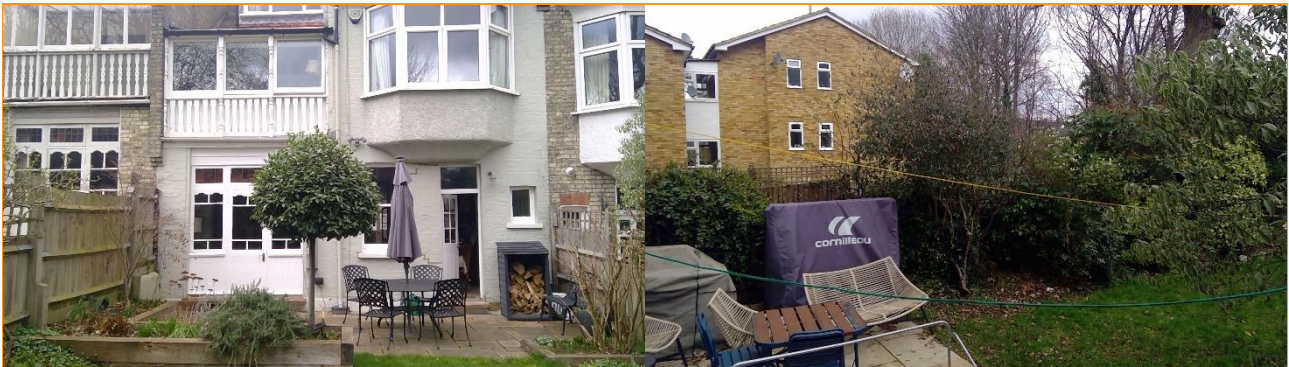
SG1 - Mixed species shrubs

| Tree No | Common Name | Age Class | Condition | Height (m) | Crown Spread (m) | Stem diam. (mm) | Dist to bldg. (m) | Roots Implicated | Pruning history | Recommendation | Tree work constraints | Notes | Owner address | Owner |
|---|---|---|---|---|---|---|---|---|---|---|---|---|---|---|
| SG1 | Mixed species shrubs | Mature | Good | 2 | 1.0 | 20 | 8 | N | Subject to past management. | No work required. | | | 48 Vallance Road<br>London<br>N22 7UB | P3P |
