# Arboricultural Appraisal Report

## Subsidence Damage Investigation at:

Cufos Building  
Alexandra Palace  
London  
N22 7AY

| MWA REF: | SUB221206-11595 |

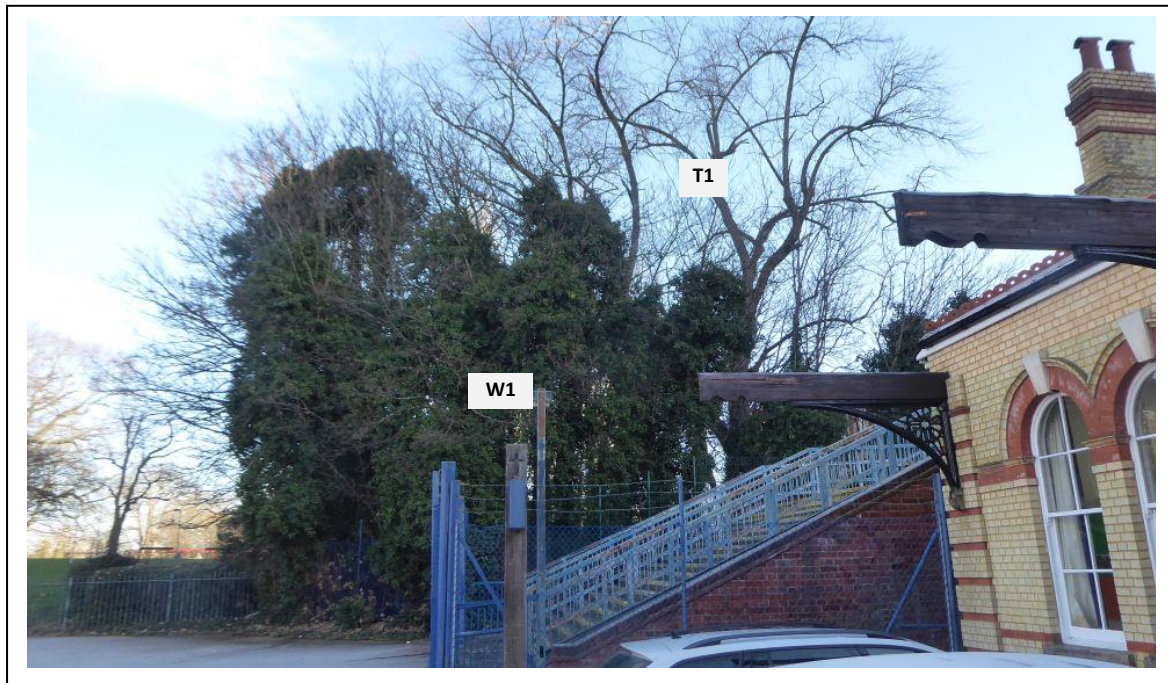
Roots were observed to a depth of 2.0m bgl in TP/BH1, and recovered samples have been positively identified (using anatomical analysis) as *Populus* spp.; the origin of which will be the large T1 Poplar within the adjacent W1 woodland, confirming its influence on the soils below the foundations.

| Tree No. | Species | Ht (m) | Dia (mm) | Crown Spread (m) | Dist. to building (m) | Age Classification | Ownership |
|---|---|---|---|---|---|---|---|
| T1 | Poplar | 22.0 | 800 Ms * | 24.5 | 23.6 | Younger than Property | Policy Holder |

View from frontage of T1 Poplar within W1 mixed spp. woodland

| Tree No. | Species | Ht (m) | Dia (mm) | Crown Spread (m) | Dist. to building (m) | Age Classification | Ownership |
|---|---|---|---|---|---|---|---|
| Recommendation | | Remove (fell) to near ground level and treat stump to inhibit regrowth. | | | | | |

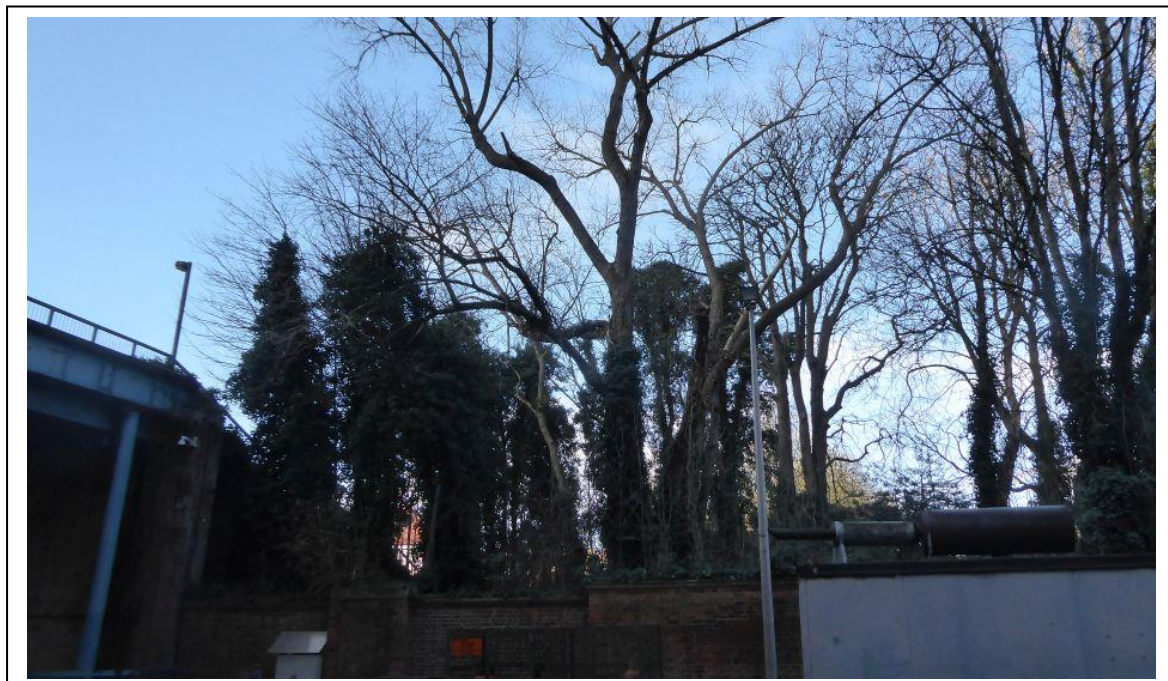
View from rear of T1 Poplar within W1 mixed spp. woodland

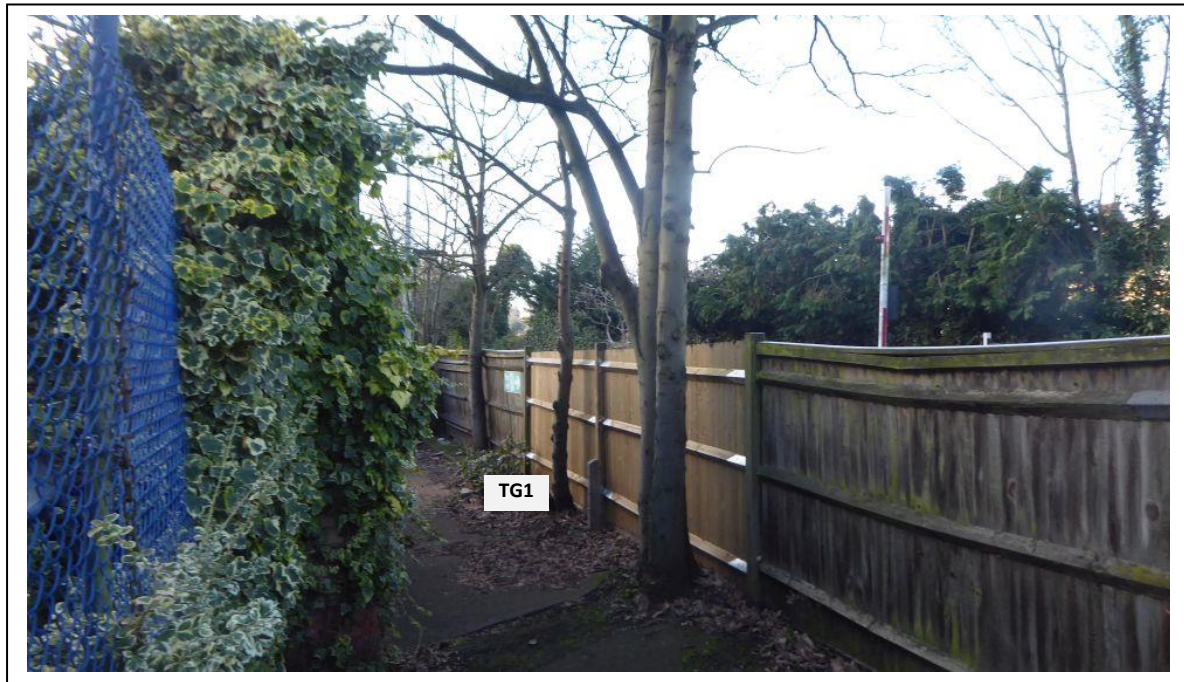
| Tree No. | Species | Ht (m) | Dia (mm) | Crown Spread (m) | Dist. to building (m) | Age Classification | Ownership |
|---|---|---|---|---|---|---|---|
| TG1 | Sycamore group | 9.5 | 240 Ms * | 8.5 | 10.8 | Younger than Property | Policy Holder |

View of TG1 Sycamore group beyond right-hand flank

| Tree No. | Species | Ht (m) | Dia (mm) | Crown Spread (m) | Dist. to building (m) | Age Classification | Ownership |
|---|---|---|---|---|---|---|---|
| Recommendation | | Maintain broadly at no more than current dimensions by periodic pruning. | | | | | |
