# Arboricultural Consultancy for Lloyds Bank

| Insured | Ms Sally Eichner | Address | 36 Grasmere Road, London, N10 2DJ | | |

**36 Grasmere Road, London, N10 2DJ**

Client: Subsidence Management Services  
Client Contact: Ian Domigan  
Client Ref: IFS-LBG-SUB-22-0102137  
Policy Holder: Ms Sally Eichner  
Report Date: 28 October 2022  
Our Ref: C65817G29864

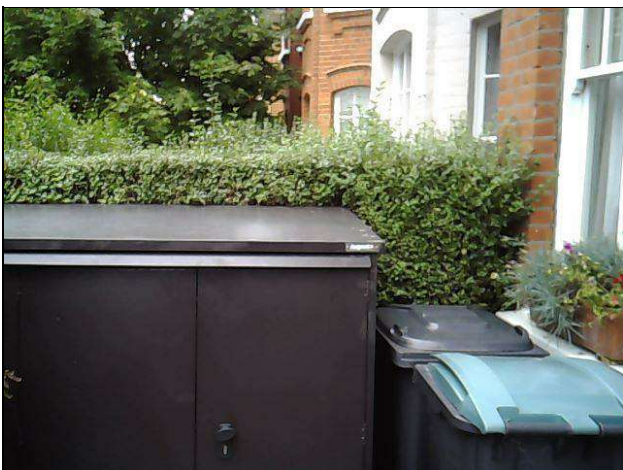
H4 - Privet

H4 (Privet) and C1 (Wisteria) are also considered to retain a contributory influence, albeit in a secondary capacity when compared to the above.

| Tree No. | Species | Age Cat | Approx. Height (m) | Distance to Building (m) * | Ownership | Action | Requirement |
|---|---|---|---|---|---|---|---|
| H4 | Privet | 1 | 2 | 0.8 | A - Third Party | Maintain as detailed | Remove section of hedge to achieve a minimum clearance of 3m to the insured property. Maintain retained section thereafter at broadly current dimensions by way of regular pruning. |

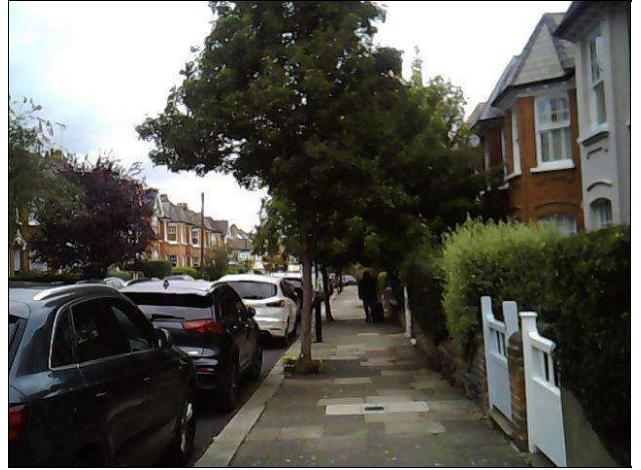
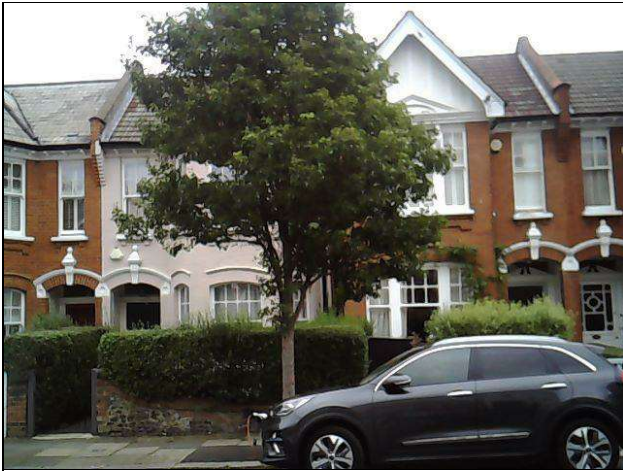
T1 - Pear

With due regards to species profile, size and proximity, T1 (Pear) is considered the dominant feature proximate to the focal area of movement and accordingly, where vegetation is confirmed as being causal, we have identified them as the primary cause of the current subsidence damage.

| Tree No. | Species | Age Cat | Approx. Height (m) | Distance to Building (m) * | Ownership | Action | Requirement |
|---|---|---|---|---|---|---|---|
| T1 | Pear | 1 | 7.5 | 5.5 | B - Local Authority | Remove | Remove close to ground level and treat stump to inhibit regrowth. |

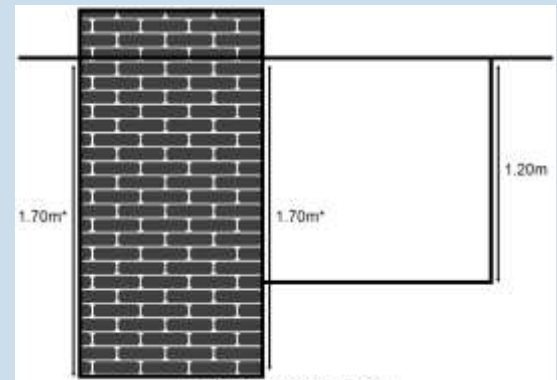
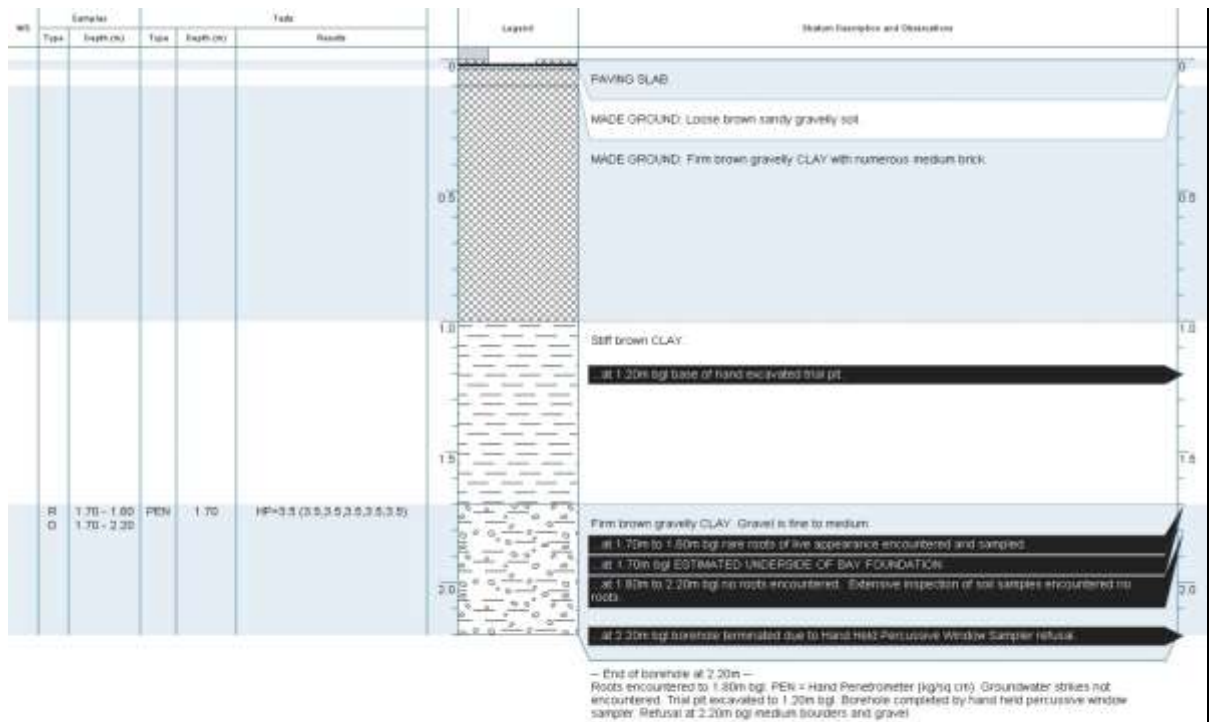
## TP/BH1 Foundation Detail and Borehole Log

Bay foundation comprised of brick wall to an estimated depth of 1700mm bgl with no projection. Underside of foundation was estimated by pushing a probe from ground surface, approximately 100mm back from the face of the foundation, at an angle with no apparent contact with the face of the foundation beyond the estimated depth.

At 1.70m to 1.80m bgl rare roots of live appearance encountered and sampled in TP/BH1.
