# ARBORICULTURAL ASSESSMENT REPORT

150 Crouch Hill, London, N8 9DX

**PRI Ref:** 253952

**Survey Date:** 07/03/2023

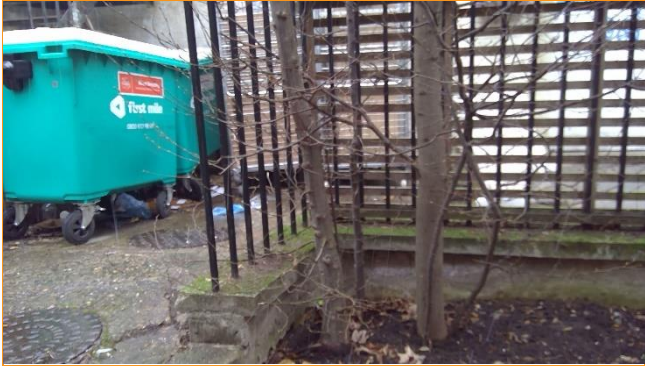
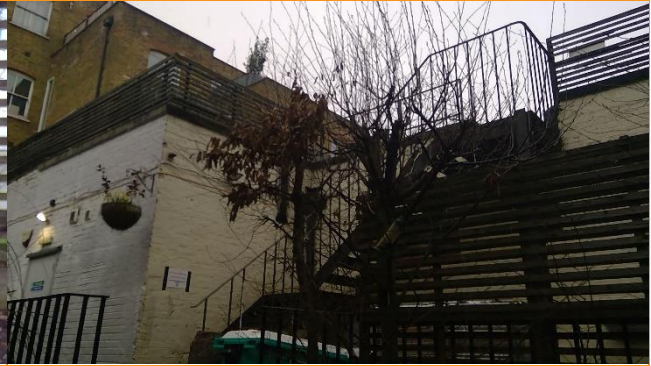
T1 - Hornbeam

| Tree No | Common Name | Age Class | Condition | Height (m) | Crown Spread (m) | Stem diam. (mm) | Dist to bldg. (m) | Roots Implicated | Pruning history | Recommendation | Tree work constraints | Notes | Owner address | Owner |
|---|---|---|---|---|---|---|---|---|---|---|---|---|---|---|
| T1 | Hornbeam | Mature | Fair | 3 | 1.6 | 45 | 2.87 | N | Subject to past management. No significant recent management. | No work required. | | | 150 Crouch Hill<br>London<br>N8 9DX | PH |

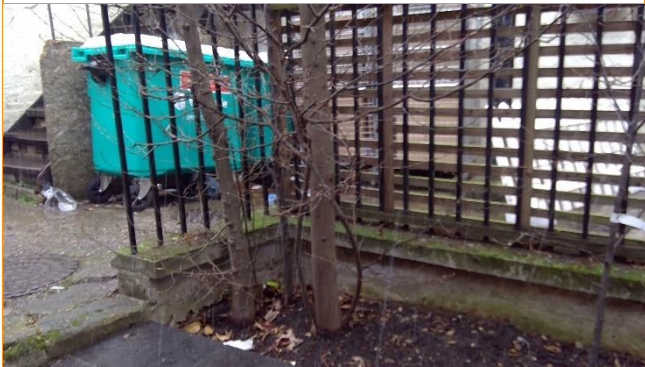
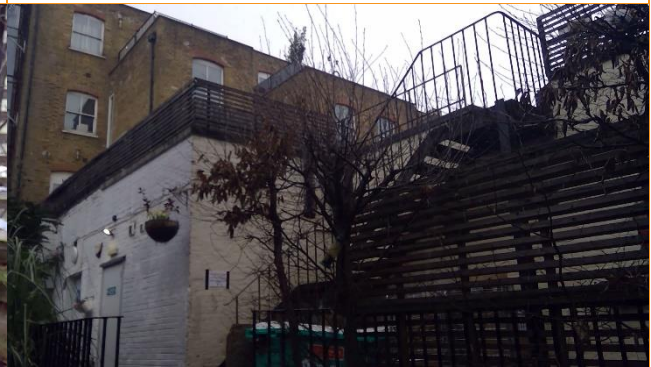
T2 - Hornbeam

| Tree No | Common Name | Age Class | Condition | Height (m) | Crown Spread (m) | Stem diam. (mm) | Dist to bldg. (m) | Roots Implicated | Pruning history | Recommendation | Tree work constraints | Notes | Owner address | Owner |
|---|---|---|---|---|---|---|---|---|---|---|---|---|---|---|
| T2 | Hornbeam | Mature | Fair | 3 | 1.6 | 45 | 3 | N | Subject to past management. No significant recent management. | No work required. | | | 150 Crouch Hill<br>London<br>N8 9DX | PH |

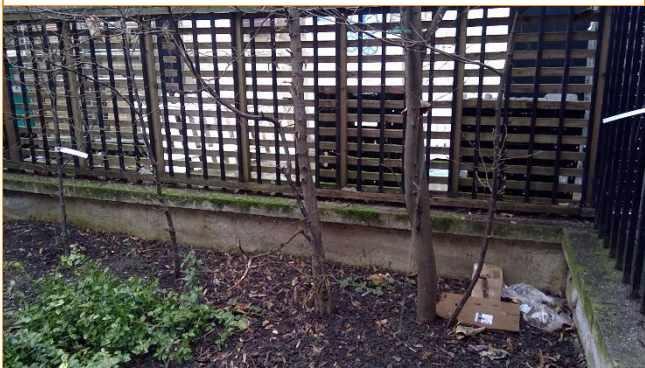
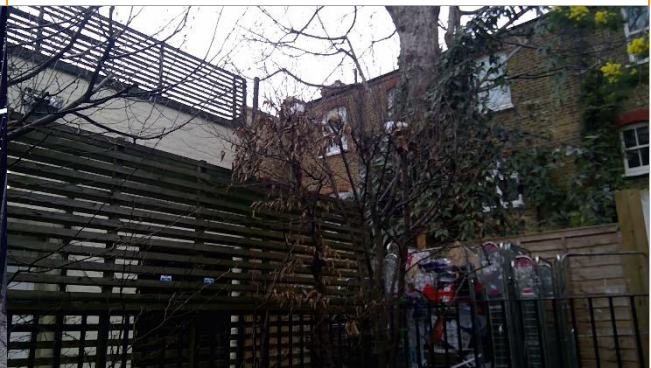
T3 - Hornbeam

| Tree No | Common Name | Age Class | Condition | Height (m) | Crown Spread (m) | Stem diam. (mm) | Dist to bldg. (m) | Roots Implicated | Pruning history | Recommendation | Tree work constraints | Notes | Owner address | Owner |
|---|---|---|---|---|---|---|---|---|---|---|---|---|---|---|
| T3 | Hornbeam | Mature | Fair | 3 | 1.6 | 45 | 3 | N | Subject to past management. No significant recent management. | No work required. | | | 150 Crouch Hill<br>London<br>N8 9DX | PH |

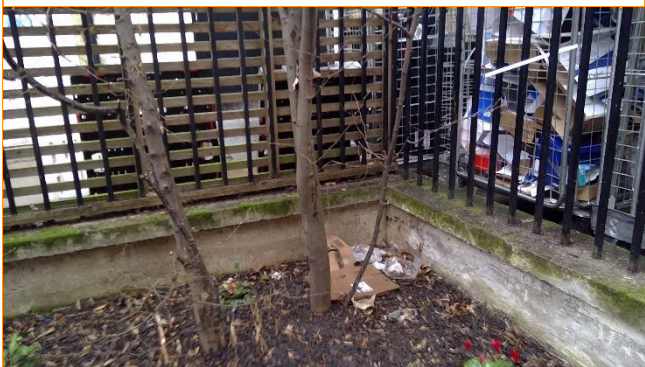
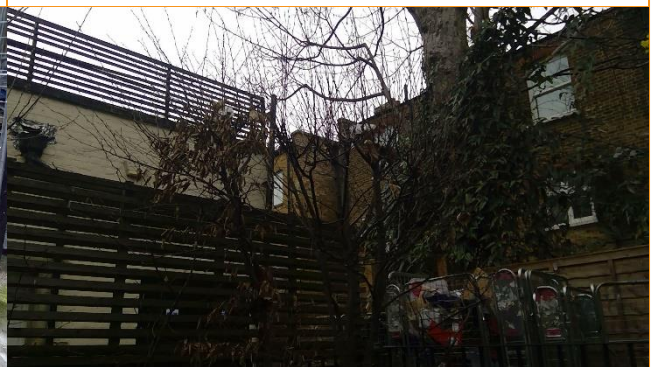
T4 - Hornbeam

| Tree No | Common Name | Age Class | Condition | Height (m) | Crown Spread (m) | Stem diam. (mm) | Dist to bldg. (m) | Roots Implicated | Pruning history | Recommendation | Tree work constraints | Notes | Owner address | Owner |
|---|---|---|---|---|---|---|---|---|---|---|---|---|---|---|
| T4 | Hornbeam | Mature | Fair | 3 | 1.6 | 45 | 3 | N | Subject to past management. No significant recent management. | No work required. | | | 150 Crouch Hill<br>London<br>N8 9DX | PH |

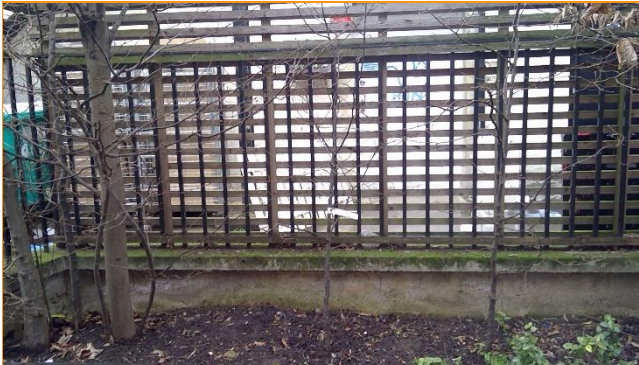
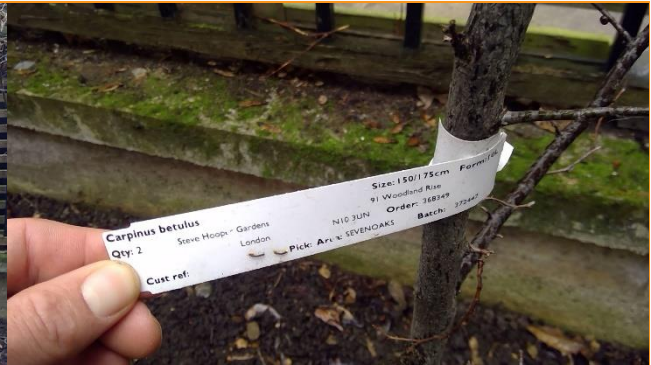
T5 - Hornbeam

| Tree No | Common Name | Age Class | Condition | Height (m) | Crown Spread (m) | Stem diam. (mm) | Dist to bldg. (m) | Roots Implicated | Pruning history | Recommendation | Tree work constraints | Notes | Owner address | Owner |
|---|---|---|---|---|---|---|---|---|---|---|---|---|---|---|
| T5 | Hornbeam | Young | Fair | 1.4 | 1.0 | 15 | 3 | N | No significant past tree works. | No work required. | | | 150 Crouch Hill<br>London<br>N8 9DX | PH |

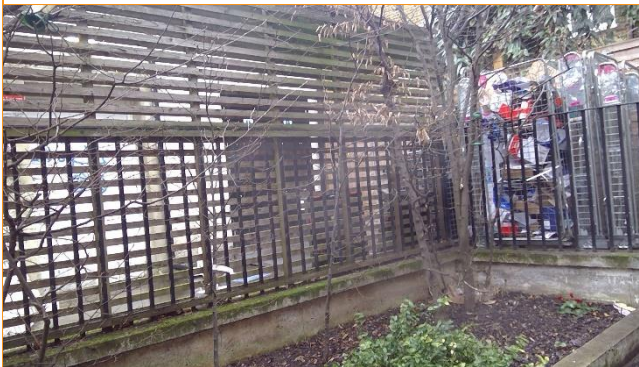
T6 - Hornbeam

| Tree No | Common Name | Age Class | Condition | Height (m) | Crown Spread (m) | Stem diam. (mm) | Dist to bldg. (m) | Roots Implicated | Pruning history | Recommendation | Tree work constraints | Notes | Owner address | Owner |
|---|---|---|---|---|---|---|---|---|---|---|---|---|---|---|
| T6 | Hornbeam | Young | Fair | 1.4 | 1.0 | 15 | 3 | N | No significant past tree works. | No work required. | | | 150 Crouch Hill<br>London<br>N8 9DX | PH |

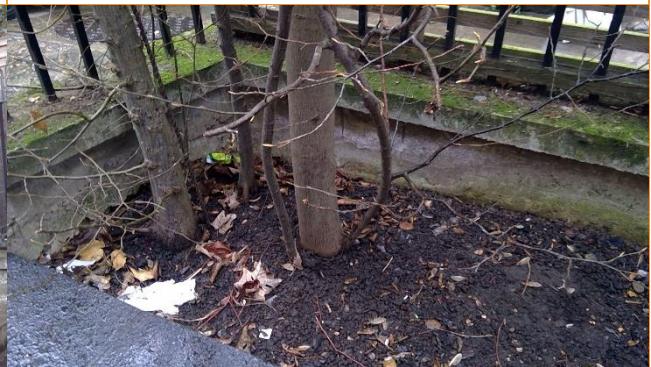
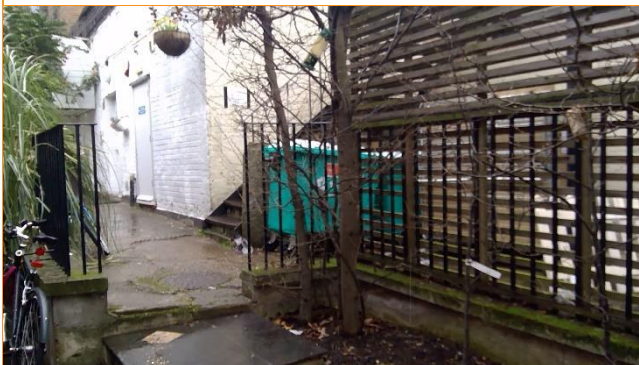
T7 - Hornbeam

| Tree No | Common Name | Age Class | Condition | Height (m) | Crown Spread (m) | Stem diam. (mm) | Dist to bldg. (m) | Roots Implicated | Pruning history | Recommendation | Tree work constraints | Notes | Owner address | Owner |
|---|---|---|---|---|---|---|---|---|---|---|---|---|---|---|
| T7 | Hornbeam | Young | Fair | 1.4 | 1.0 | 15 | 3 | N | No significant past tree works. | No work required. | | | 150 Crouch Hill<br>London<br>N8 9DX | PH |

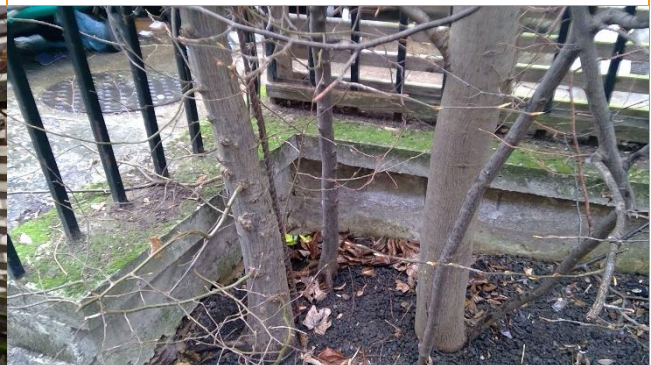
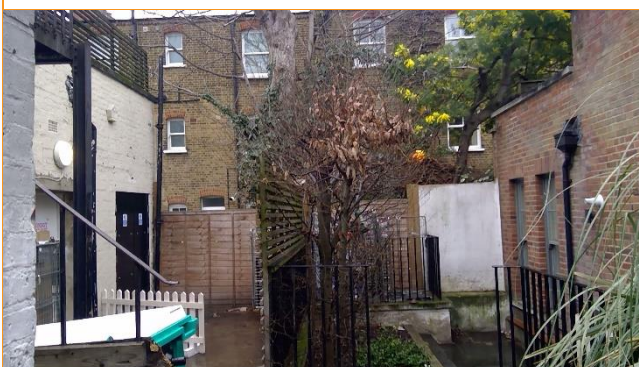
T8 - Hornbeam

| Tree No | Common Name | Age Class | Condition | Height (m) | Crown Spread (m) | Stem diam. (mm) | Dist to bldg. (m) | Roots Implicated | Pruning history | Recommendation | Tree work constraints | Notes | Owner address | Owner |
|---|---|---|---|---|---|---|---|---|---|---|---|---|---|---|
| T8 | Hornbeam | Semi-Mature | Fair | 1.4 | 1.0 | 30 | 3 | N | No significant past tree works. | No work required. | | | 150 Crouch Hill<br>London<br>N8 9DX | PH |

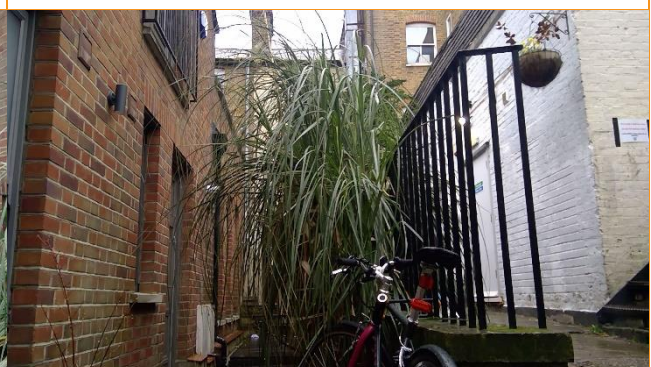
S1 - Pampass grass

| Tree No | Common Name | Age Class | Condition | Height (m) | Crown Spread (m) | Stem diam. (mm) | Dist to bldg. (m) | Roots Implicated | Pruning history | Recommendation | Tree work constraints | Notes | Owner address | Owner |
|---|---|---|---|---|---|---|---|---|---|---|---|---|---|---|
| S1 | Pampas grass | Mature | Fair | 2 | 1.2 | 10 | 1.5 | N | Subject to past management. No significant recent management. | No work required. | | | 150 Crouch Hill<br>London<br>N8 9DX | PH |

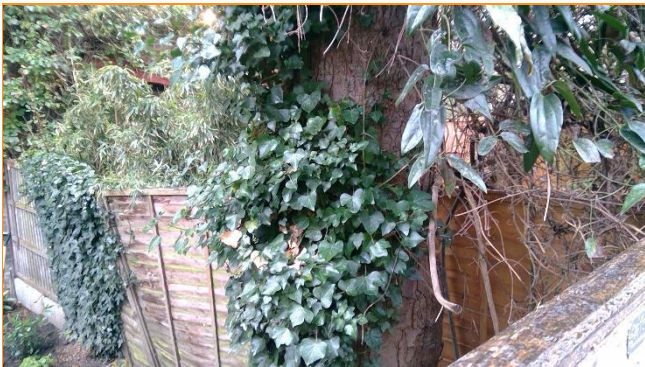
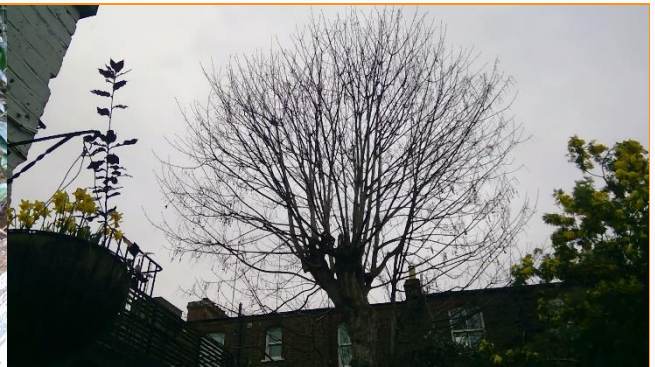
T9 - Sycamore

| Tree No | Common Name | Age Class | Condition | Height (m) | Crown Spread (m) | Stem diam. (mm) | Dist to bldg. (m) | Roots Implicated | Pruning history | Recommendation | Tree work constraints | Notes | Owner address | Owner |
|---|---|---|---|---|---|---|---|---|---|---|---|---|---|---|
| T9 | Sycamore | Mature | Fair | 12 | 9.2 | 440* | 4.53 | N | Subject to past pollard management. No significant recent management. | Fell and treat stump with eco plugs (broadleaved). | Restricted access. | Ivy and clematis growing up stem | 5 Hatherley Gardens<br>London<br>N8 9JH | P3P |

| Tree No: | Species | Works Required |
|---|---|---|
| T9 | Sycamore | Fell and treat stump with eco plugs (broadleaved) |

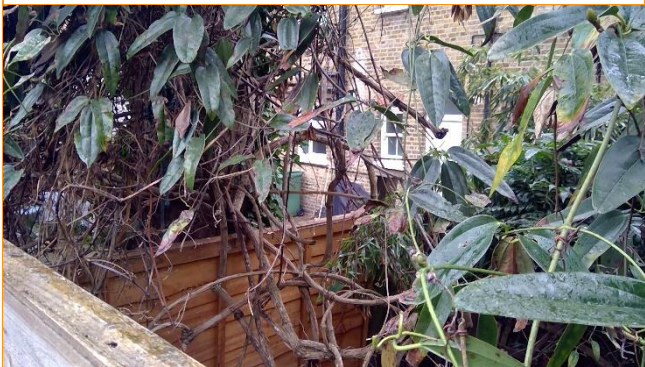
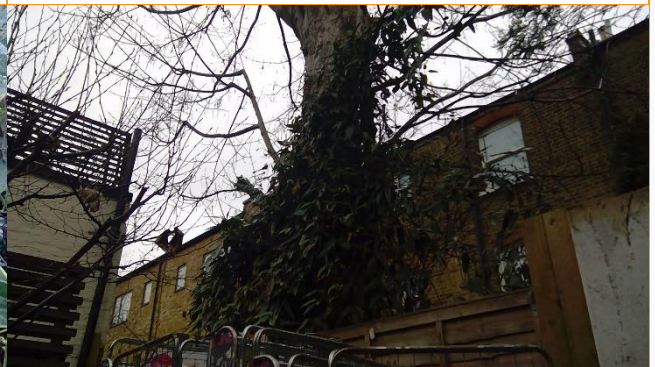
C1 - Clematis

| Tree No | Common Name | Age Class | Condition | Height (m) | Crown Spread (m) | Stem diam. (mm) | Dist to bldg. (m) | Roots Implicated | Pruning history | Recommendation | Tree work constraints | Notes | Owner address | Owner |
|---|---|---|---|---|---|---|---|---|---|---|---|---|---|---|
| C1 | Clematis | Mature | Fair | 4.8 | 2 | 25* | 3.6* | N | No significant past tree works. | No work required. | | | 3 Hatherley Gardens<br>London<br>N8 9JH | P3P |

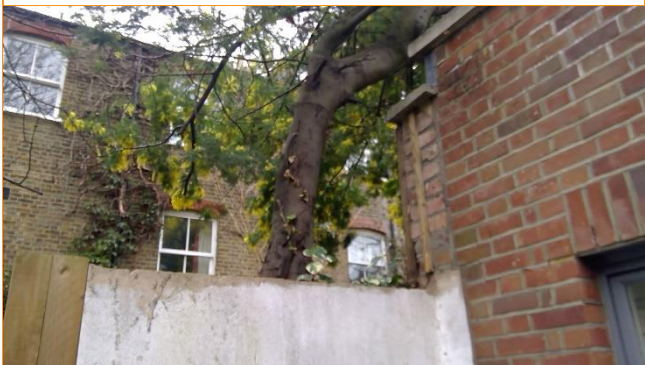
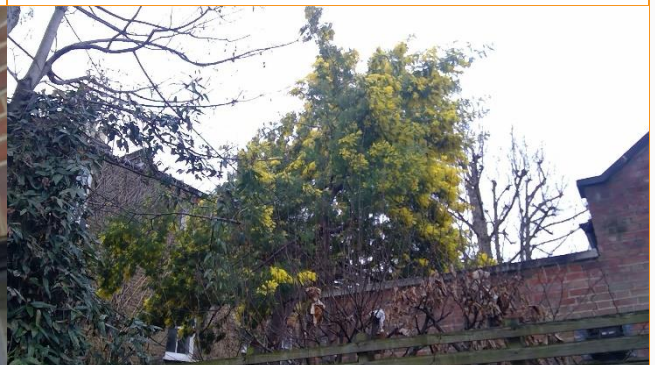
T10 - Mimosa

| Tree No | Common Name | Age Class | Condition | Height (m) | Crown Spread (m) | Stem diam. (mm) | Dist to bldg. (m) | Roots Implicated | Pruning history | Recommendation | Tree work constraints | Notes | Owner address | Owner |
|---|---|---|---|---|---|---|---|---|---|---|---|---|---|---|
| T10 | Mimosa | Mature | Fair | 6.3 | 6.2 | 270* | 0.8 | N | Subject to past management. No significant recent management. | Fell and treat stump with eco plugs (broadleaved). | | | 3 Hatherley Gardens<br>London<br>N8 9JH | P3P |

| Tree No: | Species | Works Required |
|---|---|---|
| T10 | Mimosa | Fell and treat stump with eco plugs (broadleaved) |
