# ARBORICULTURAL ASSESSMENT REPORT

150 Crouch Hill, London, N8 9DX

**Client:** Sedgwick International UK  
**Insurer:** Direct Line 4B

**Survey Date:** 07/03/2023

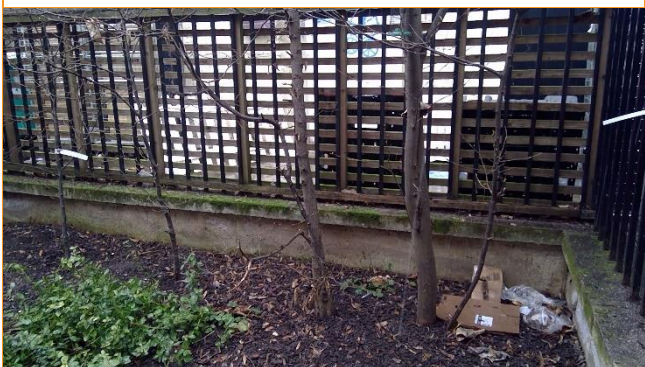
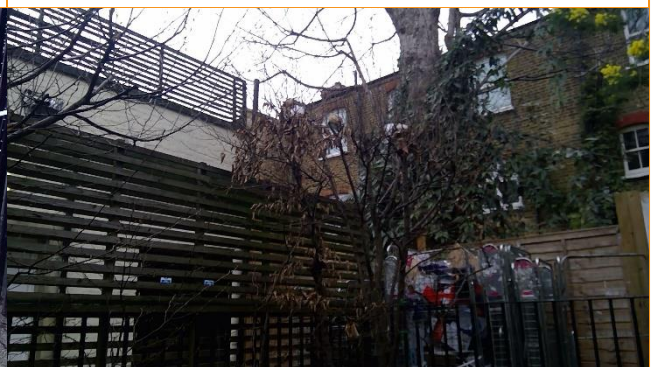
T3 - Hornbeam

| Tree No | Common Name | Age Class | Condition | Height (m) | Crown Spread (m) | Stem diam. (mm) | Dist to bldg. (m) | Roots Implicated | Pruning history | Recommendation | Tree work constraints | Notes | Owner address | Owner |
|---|---|---|---|---|---|---|---|---|---|---|---|---|---|---|
| T3 | Hornbeam | Mature | Fair | 3 | 1.6 | 45 | 3 | N | Subject to past management. No significant recent management. | No work required. | | | 150 Crouch Hill<br>London<br>N8 9DX | PH |

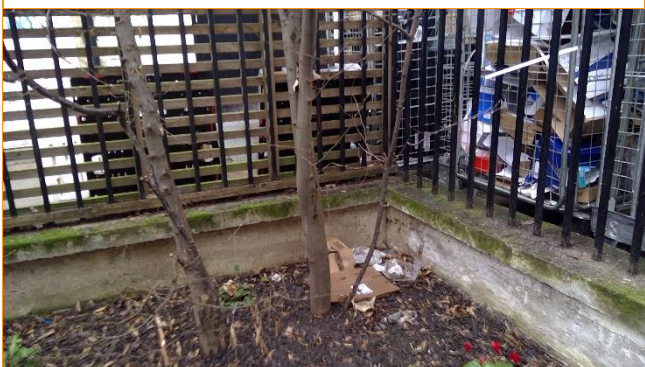
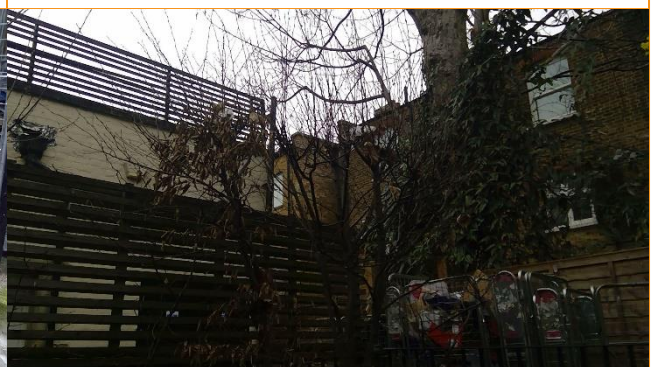
T4 - Hornbeam

| Tree No | Common Name | Age Class | Condition | Height (m) | Crown Spread (m) | Stem diam. (mm) | Dist to bldg. (m) | Roots Implicated | Pruning history | Recommendation | Tree work constraints | Notes | Owner address | Owner |
|---|---|---|---|---|---|---|---|---|---|---|---|---|---|---|
| T4 | Hornbeam | Mature | Fair | 3 | 1.6 | 45 | 3 | N | Subject to past management. No significant recent management. | No work required. | | | 150 Crouch Hill<br>London<br>N8 9DX | PH |
