Ref: cracks-mt01  
9<sup>th</sup> February 2023

**Re: LYNTON GRANGE**  
**Cracking in 3 & 4**

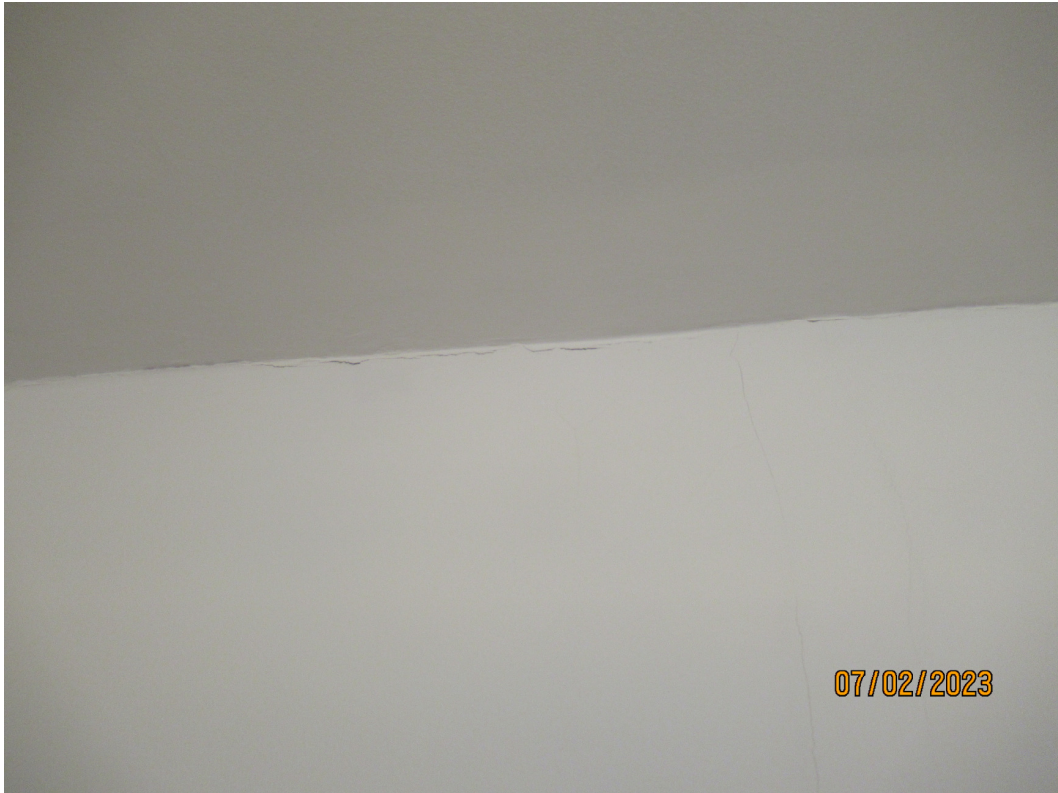
The cracks in both 3 and 4 are minor, mostly hairline and not serious. They do show some slight movement but none are serious at present. In No. 4 there is a larger horizontal crack in the plaster above a window opening but the lessee reported that this had occurred during window replacement and the crack does not relate to any building movement.

*It is therefore more likely that the cause of the cracking is movement of the floor slabs and these could be raked out and a flexible sealant installed suitable for decorating or alternatively a coving installed*

Crack between wall & ceiling in 3

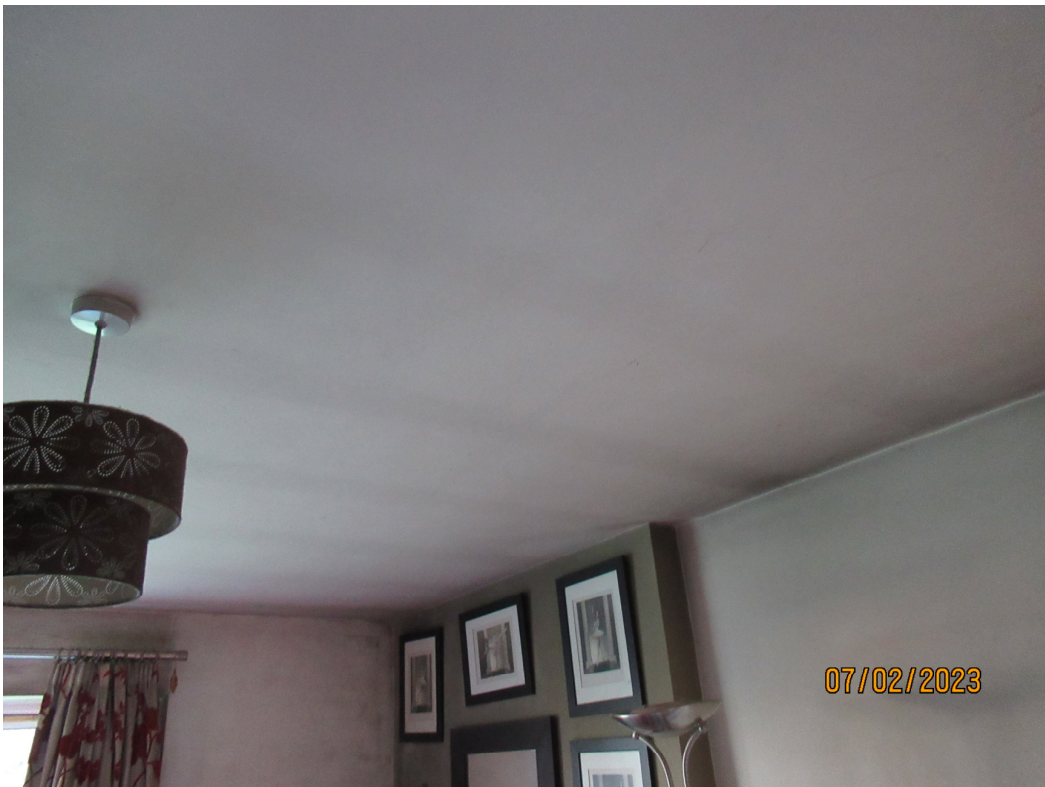
*"Having looked at the photographs I think that this is certainly likely to be a concrete framed building with beam and block upper floors."*

Ceiling pattern in 4, probably beam & block floor above

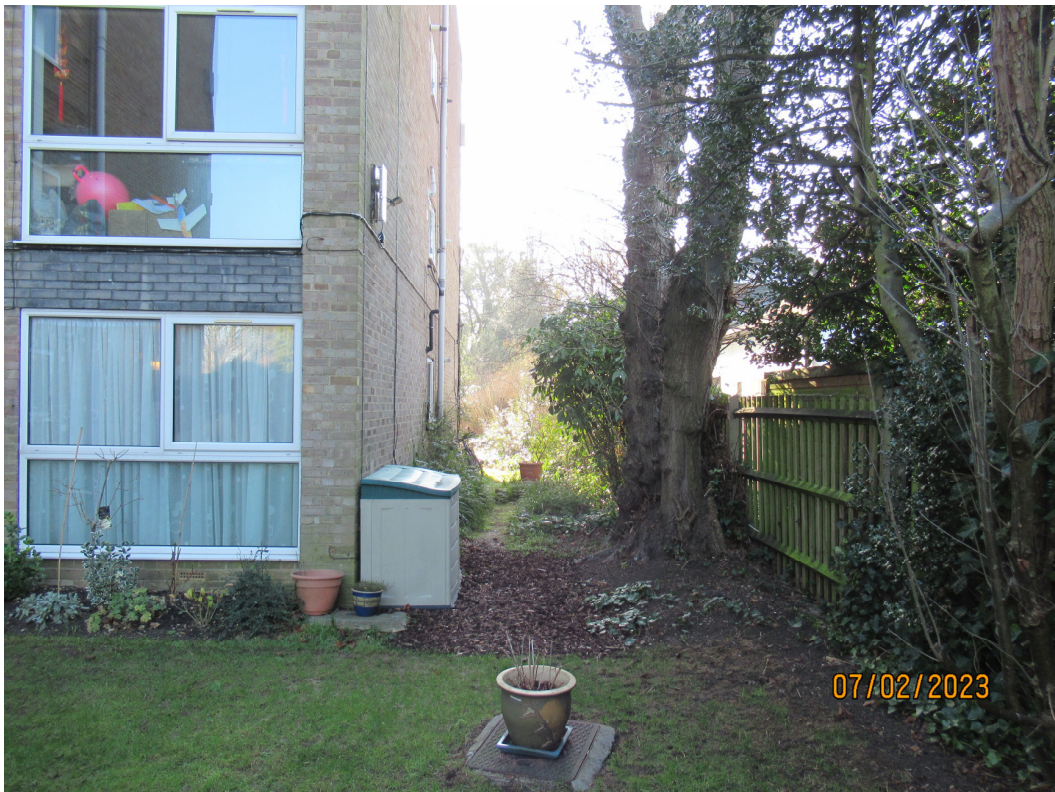
I inspected externally and noted that there are 2 large trees growing just inside the west boundary fence less than 3m from the side wall of Lynton Grange. These trees have been trimmed in the recent past.

Between the tree trunks and the wall of the building a sewer runs between two inspection chambers.

It is possible that the tree roots have damaged the drains and that they are also affecting the building causing some movement.

Trees within 3m of west wall, Drain inspection chambers under large terra cotta pots

1. Check the drains for possible damage from tree roots and repair if necessary. The examination should be carried out by a specialist drain inspection contractor.
2. Cut down the two tree trunks. Even if they are not affecting the drains or building during summer months they keep all light of a large part of the west side of the building.
3. Carry out minor brick repairs, including repointing as part of the forthcoming external repair & repainting works.

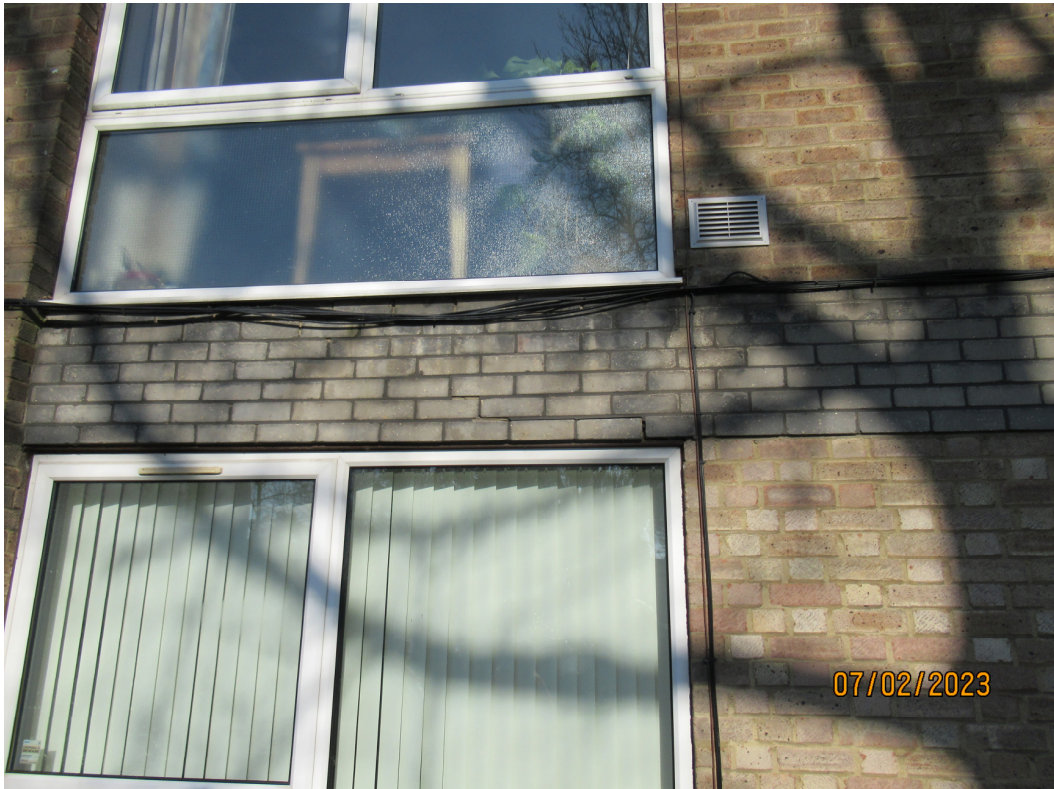
On the external walls of the building there are a number of minor cracks in the brickwork at ground and 1<sup>st</sup> floor levels. Many of these appear to be associated with window replacement but building movement cannot be ruled out as a possible cause of these cracks.

Typical cracking of brick joints above right end of window
