# **Simon Pryce Arboriculture**

## **Report**

**Site:** 59 Cromwell Avenue, Highgate, London, N6 5HP

**Subject:** Decay assessment of mature oak

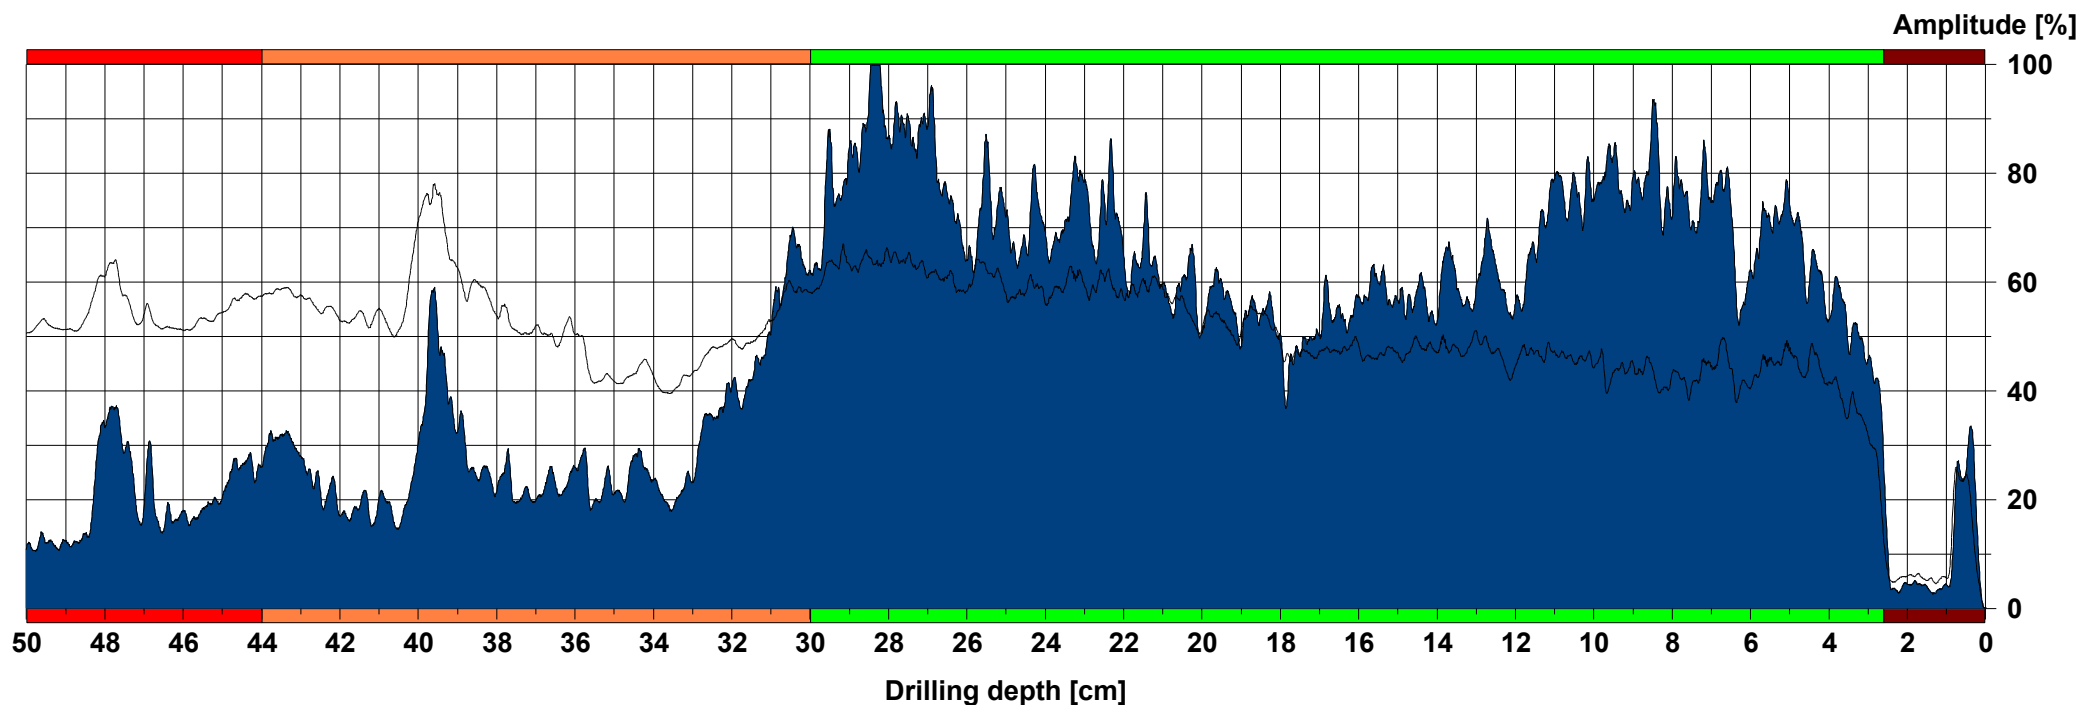
| Measurement no. : | 1 | Needle speed : | 2500 r/min | Diameter : | 60,0 cm |

| From | 0,0 cm | to | 2,6 cm | : | Bark |
| From | 2,6 cm | to | 30,0 cm | : | Sound wood |
| From | 30,0 cm | to | 44,0 cm | : | Early decay |
| From | 44,0 cm | to | 50,0 cm | : | Decay |

From N (left) at ground level. Mainly sound wood to about 30cm, nearly half way into the trunk. Resistance drops after that but serrated profile shows that the grain texture is still present. That becomes less apparent after 44cm

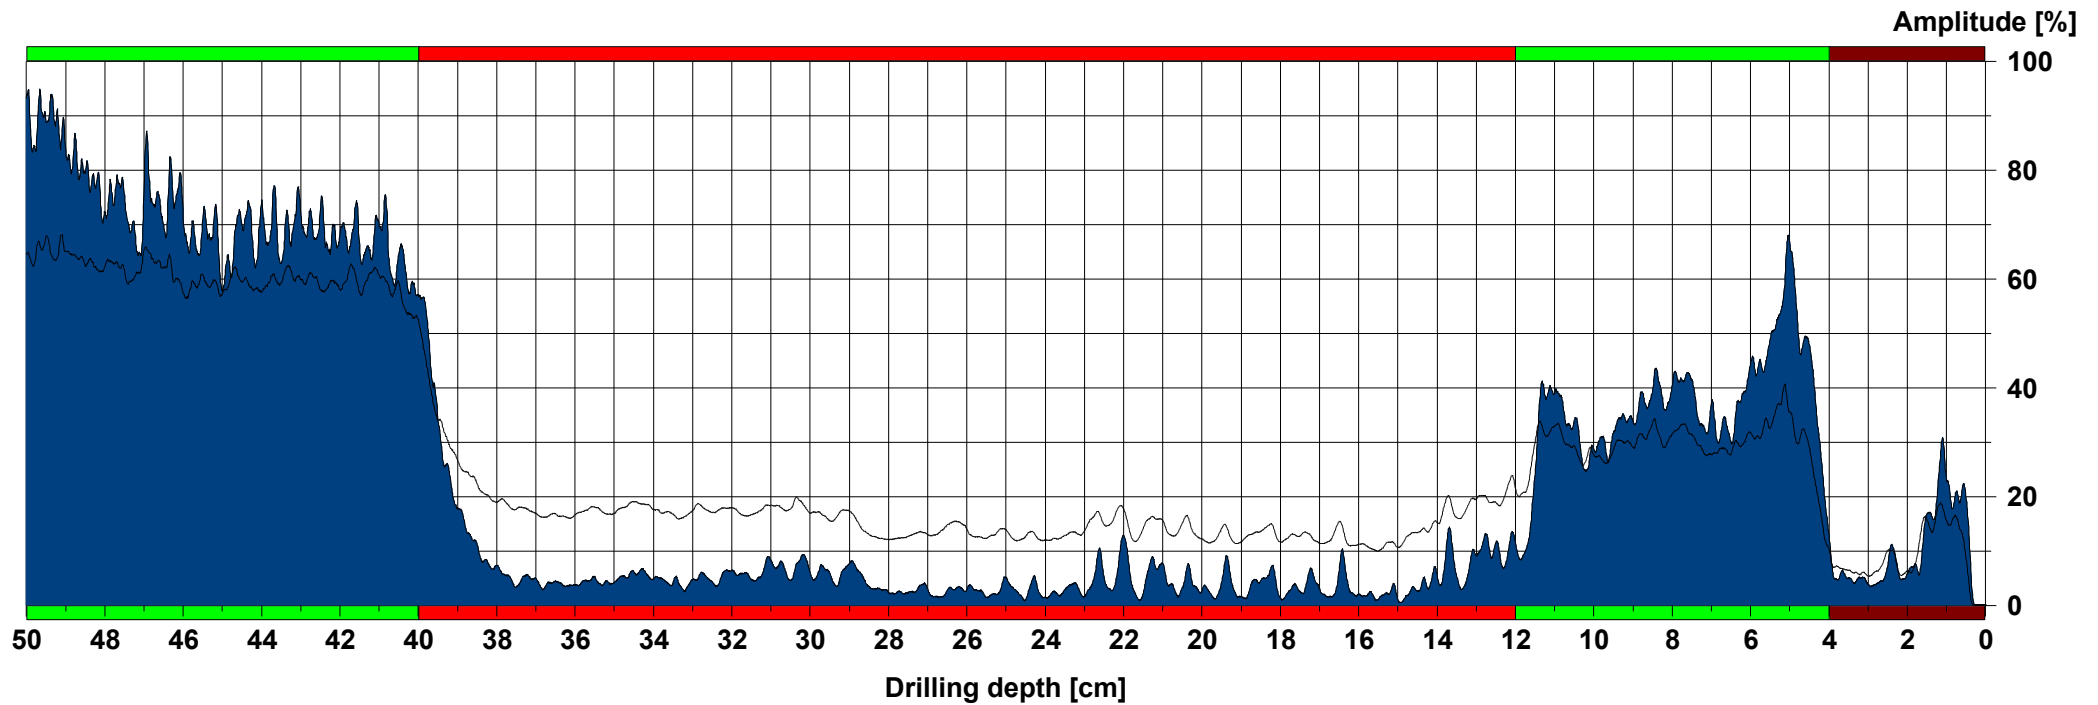
| Measurement no. : | 2 | Needle speed : | 2500 r/min | Diameter : | 60,0 cm |

| From | 0,0 cm | to | 4,0 cm | : | Bark |
| From | 4,0 cm | to | 12,0 cm | : | Sound wood |
| From | 12,0 cm | to | 40,0 cm | : | Decay |
| From | 40,0 cm | to | 50,0 cm | : | Sound wood |

From S (right), angled down. Significant pocket of decay, but the steep transition from sound wood, particularly at about 40cm indicates that the tree is compartmentalising to resist its spread

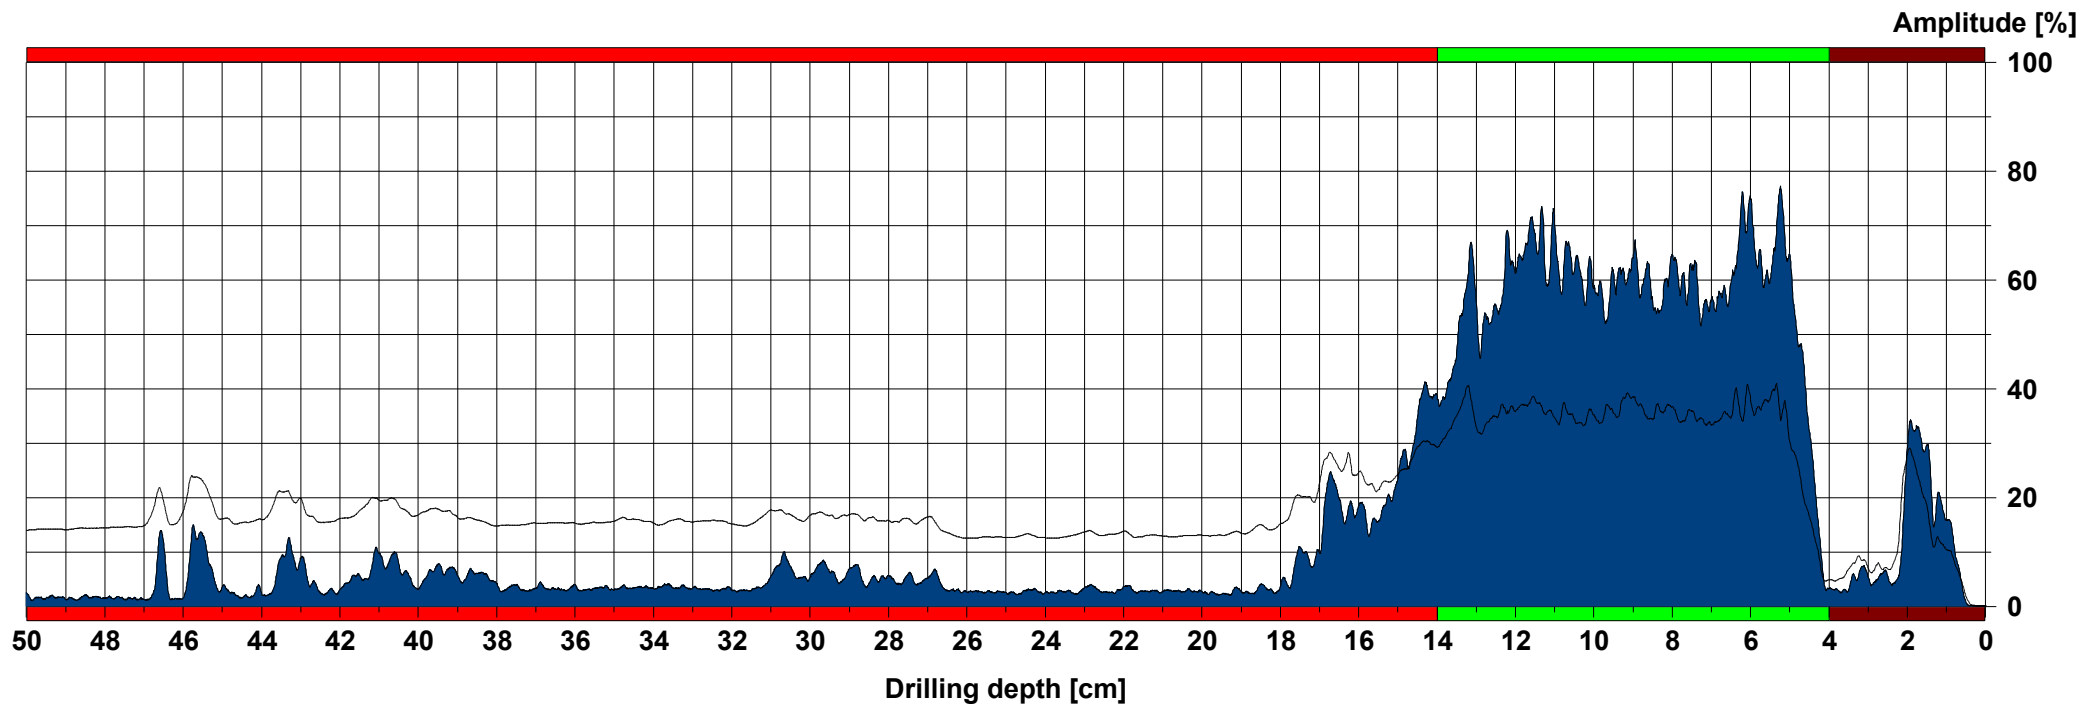
| Measurement no. : | 3 | Needle speed : | 2500 r/min | Diameter : | 60,0 cm |

| From | 0,0 cm | to | 4,0 cm | : | Bark |
| From | 4,0 cm | to | 14,0 cm | : | Sound wood |
| From | 14,0 cm | to | 50,0 cm | : | Decay |

East (far side) at ground level. Sound wood reasonably well compartmentalised, then advanced decay.

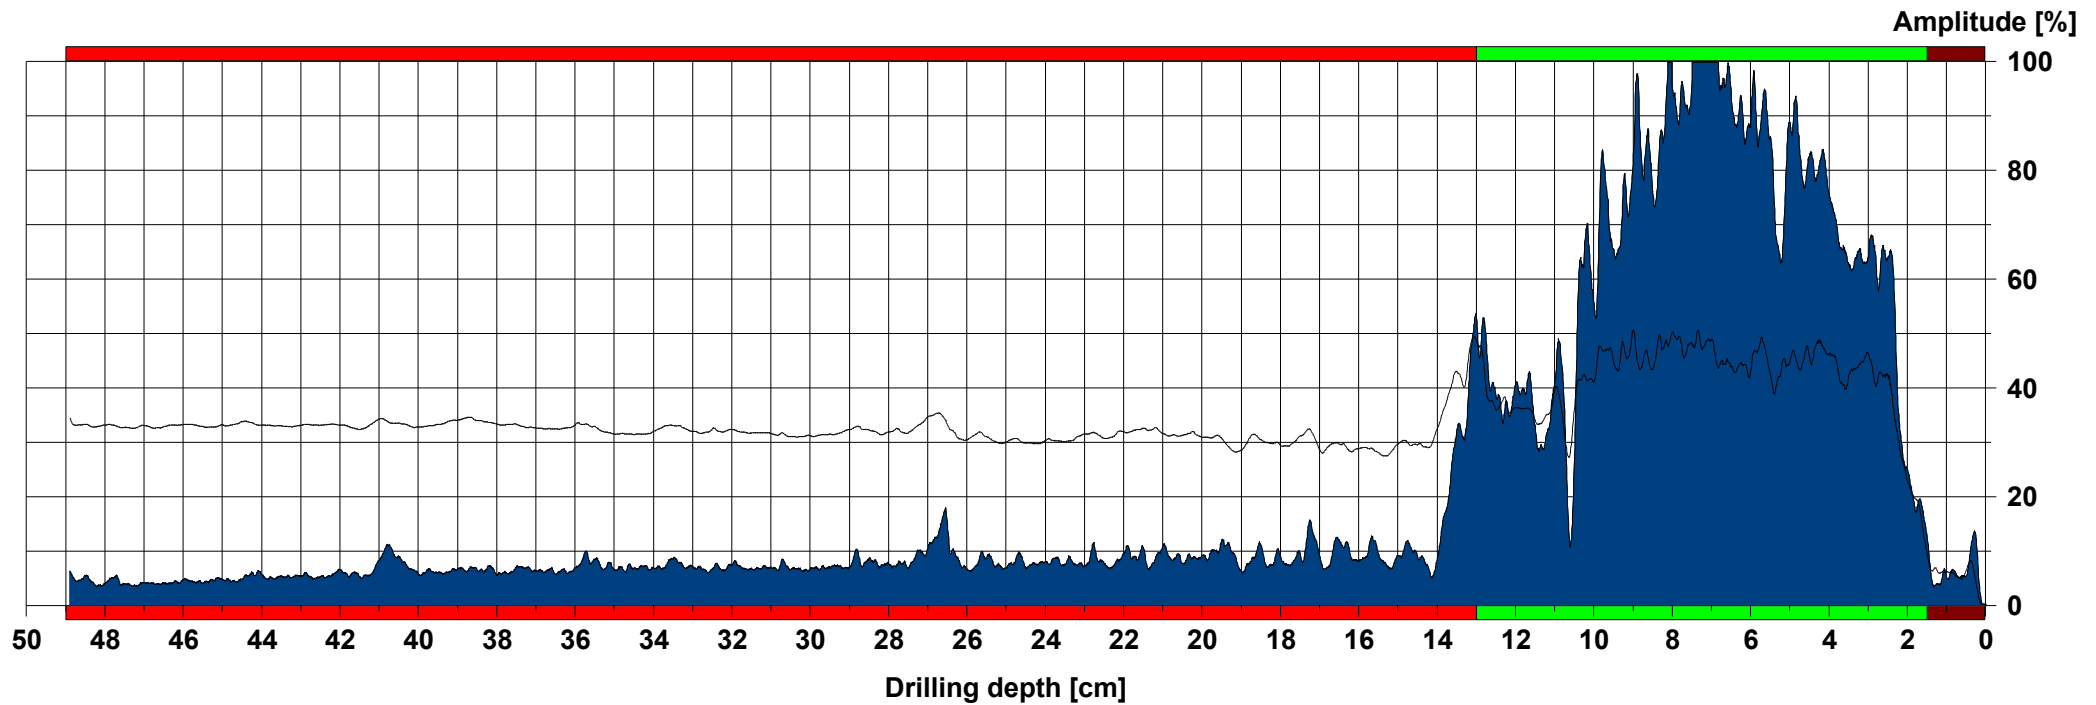
| Measurement no. : | 4 | Needle speed : | 2500 r/min | Diameter : | 60,0 cm |

| ■ | From | 0,0 cm | to | 1,5 cm | : | Bark |
| ■ | From | 1,5 cm | to | 13,0 cm | : | Sound wood |
| ■ | From | 13,0 cm | to | 49,0 cm | : | Decay |

From west (near side), right of fungus. Sound wood followed by internal decay, steep transition indicates that the tree is compartmentalising although there is a sharp dip at 10.5cm.

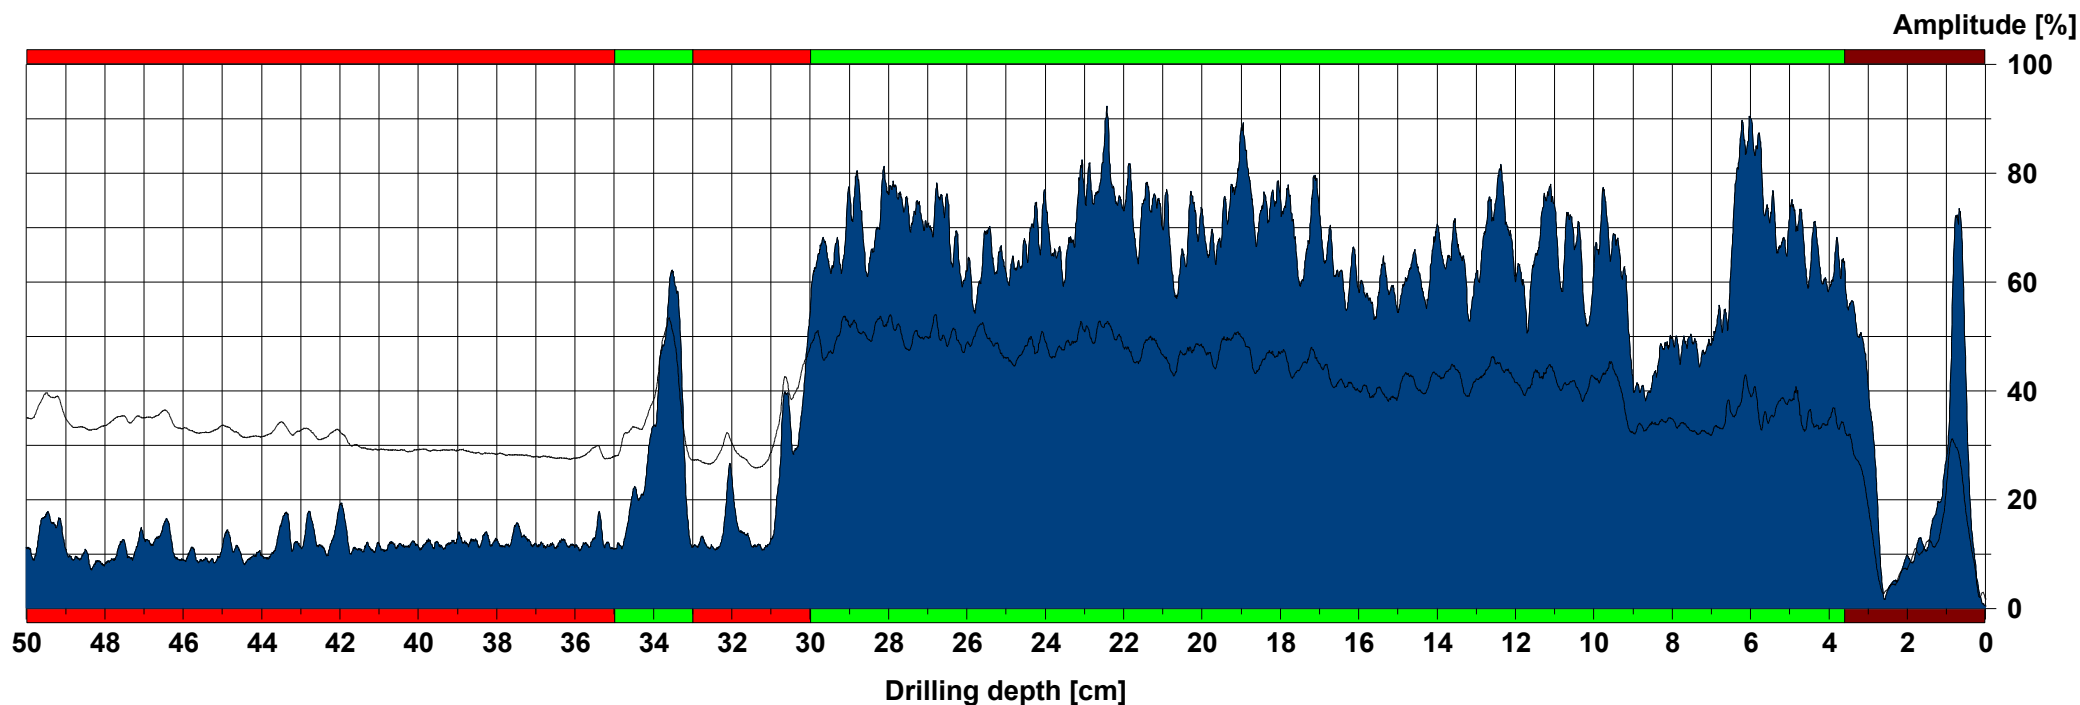
| Measurement no. : | 5 | Needle speed : | 2500 r/min | Diameter : | 60,0 cm |

| ■ | From | 0,0 cm | to | 3,6 cm | : | Bark |
| ■ | From | 3,6 cm | to | 30,0 cm | : | Sound wood |
| ■ | From | 30,0 cm | to | 33,0 cm | : | Decay |
| ■ | From | 33,0 cm | to | 35,0 cm | : | Sound wood |
| ■ | From | 35,0 cm | to | 50,0 cm | : | Decay |

W right of the fungus, near reading 4, but shallower angle. Thicker shell of sound wood. Spike at 34 looks like small piece of sound wood, but not likely to make a big difference to strength.

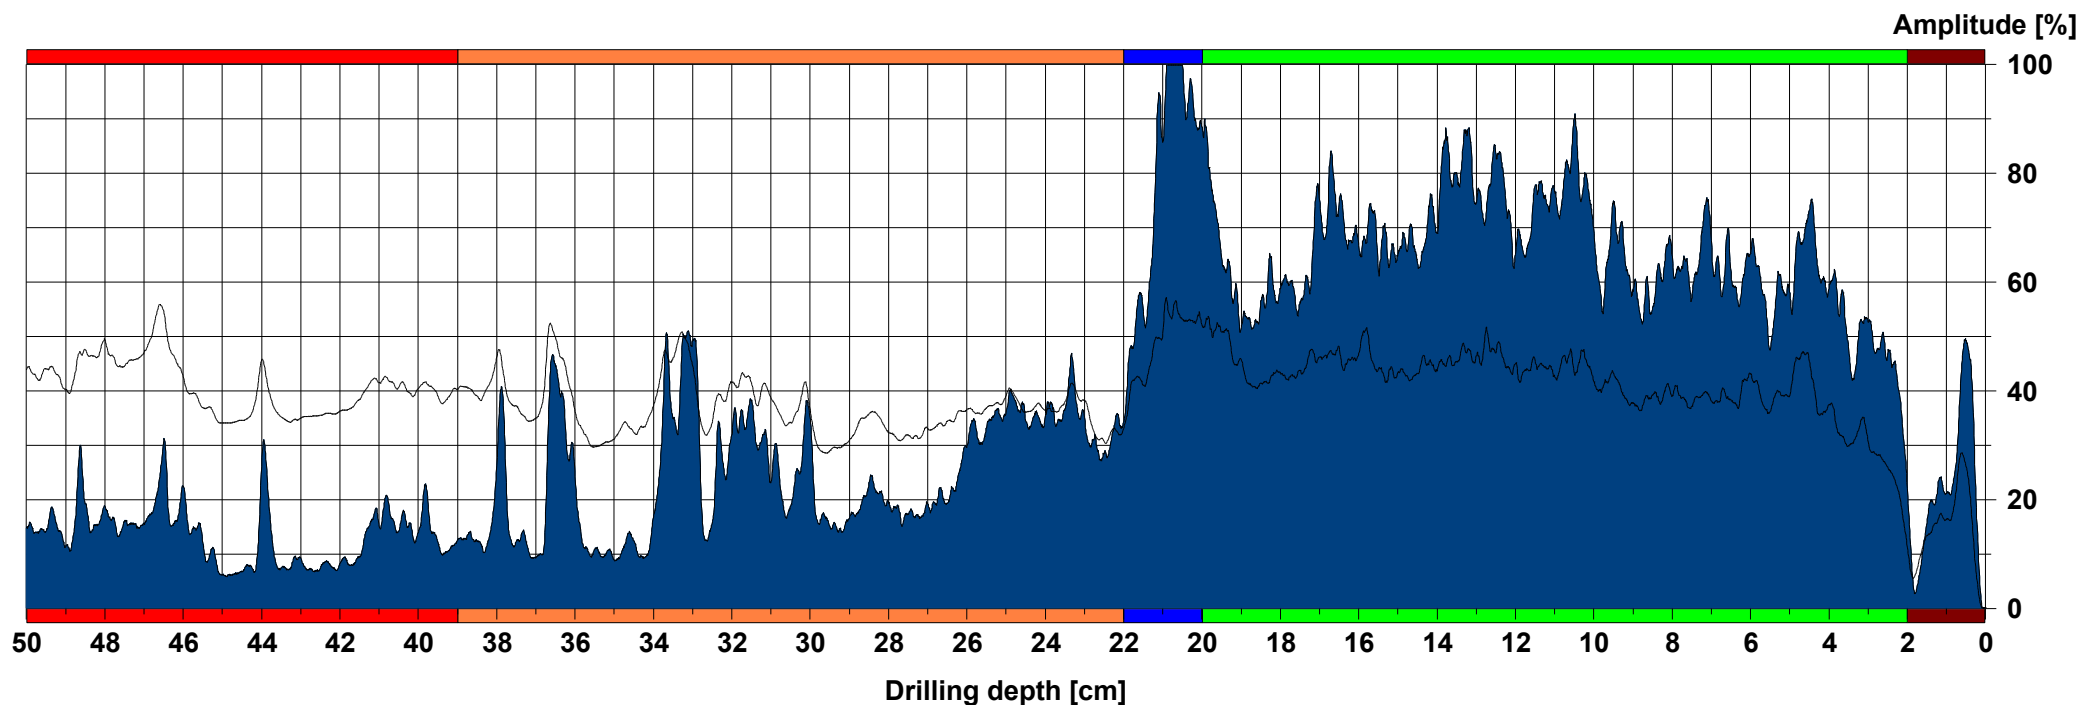
| Measurement no. : | 6 | Needle speed : | 2500 r/min | Diameter : | 60,0 cm |

| From | 0,0 cm | to | 2,0 cm | : | Bark |
| From | 2,0 cm | to | 20,0 cm | : | Sound wood |
| From | 20,0 cm | to | 22,0 cm | : | Reaction zone |
| From | 22,0 cm | to | 39,0 cm | : | Early decay |
| From | 39,0 cm | to | 50,0 cm | : | Decay |

NW at ground level. Sound wood to at least 21cm. Spike there could be reaction zone to the decay. Multiple spikes after that indicate gradual spread of the decay.
