# DESIGN AND ACCESS STATEMENT

12 Wood Lane Highgate,  
London,  
N6 5UB

Repair of historic lath and plaster ceilings on the Ground, 1<sup>st</sup> and 2<sup>nd</sup> Floor, southern side rooms, damaged as a result of a burst pipe in the attic.

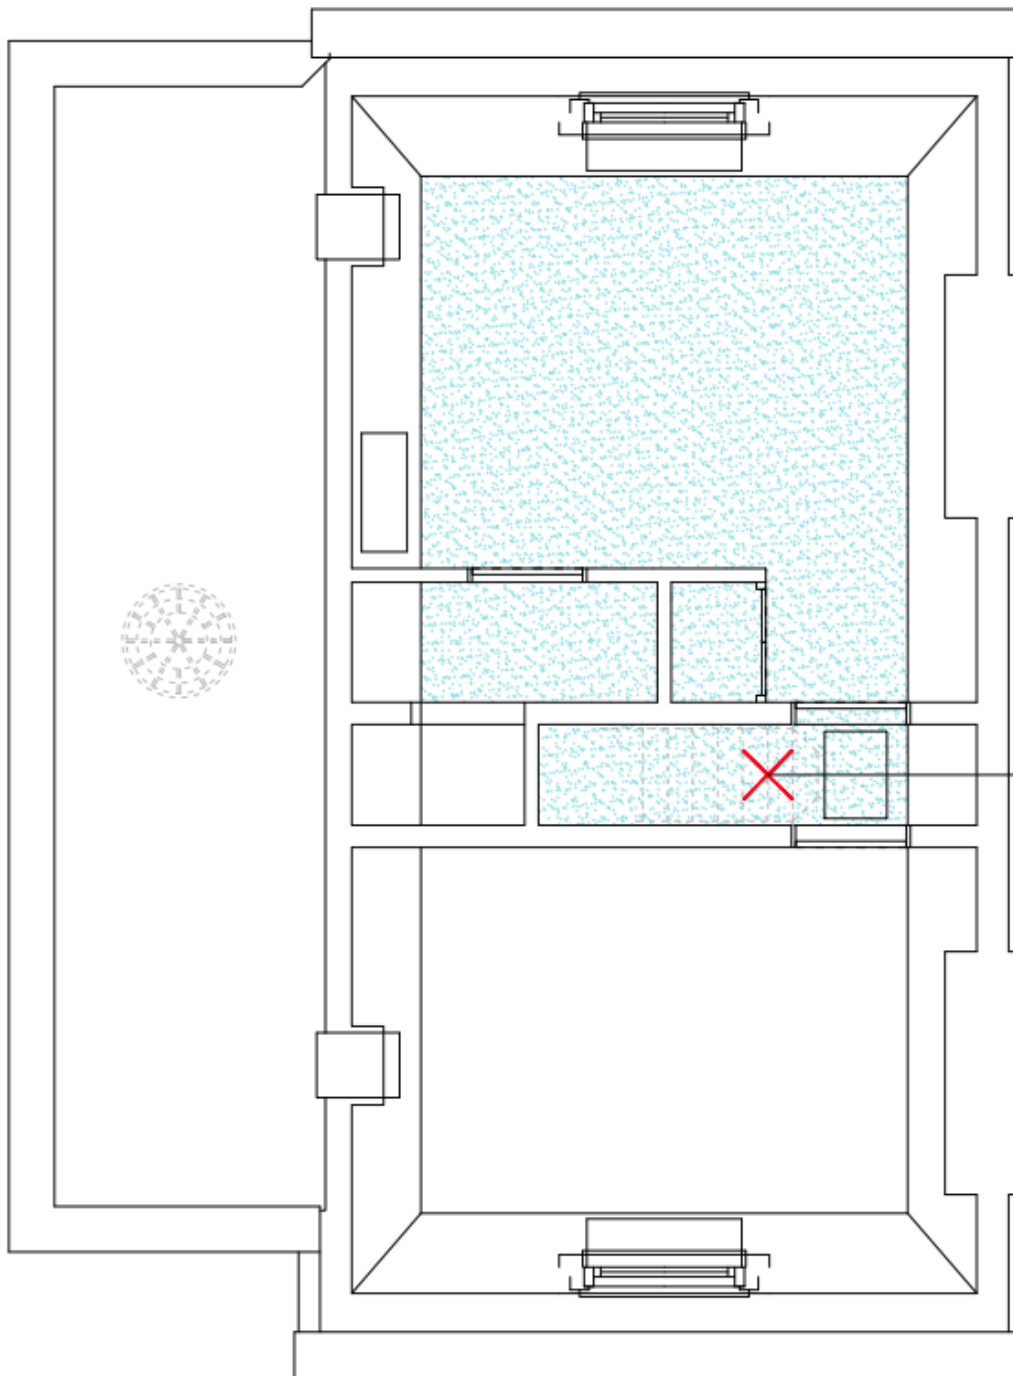
### 12 Wood Lane Second Floor

Area of ceiling damaged by water from the flood and determined to be unsound. This section of ceiling to be replaced in lath and plaster. Lath and plaster is a like for like repair, preserves the character of the Listed Building, allows for curvatures in the ceiling structure and allows for flexibility in the structure.

Location of the leak to the cold water feed in the attic. Ceiling configuration resulted in the majority of the water flowing towards the Southern garden side.

All ceilings on this floor are lath and plaster. In the Southern, garden side bedroom approx 2/3 of the ceiling appeared live at the time of engineer's inspection. The part of the ceiling nearer to the staircase was most affected. The ceilings of the stairwell (directly under the flood) and the central bathroom were also live. The damaged condition of the ceiling presents a safety risk, the repair works are urgent.

It was agreed at Pre-App stage that all the flat bed of the worst affected ceiling should be replaced in lath and plaster, including new timber laths with stainless steel fixings.

The rooms are built into the roof and have sloping soffits. The sloping areas of ceiling appear sound and are to be retained.

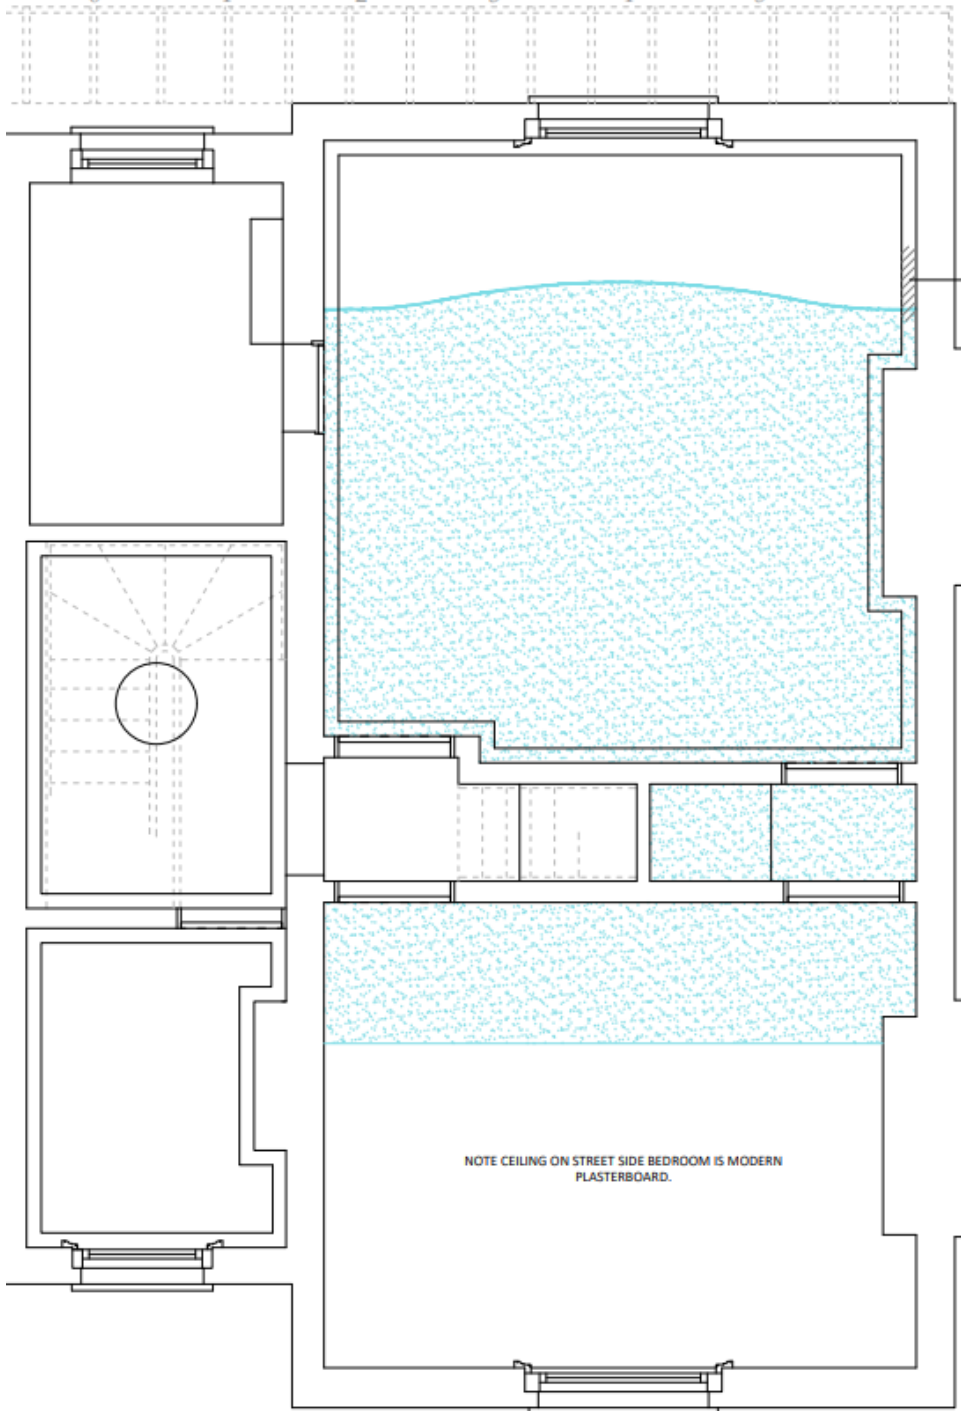
#### First Floor

Area of ceiling damaged by water from the flood and determined to be unsound. Unsound section of ceiling to be replaced in lath and plaster. Mouldings of the existing cornice are to be taken and matching cornice to be formed as part of the repair work, note this detail is in part inset into the bed of the ceiling. This will preserve the character of the Listed Building, allow for curvatures in the ceiling structure and allow for flexibility in the structure.

Original, reeded perimeter cornice to be modelled from site, moulded cast and refixed where required.

In the Southern, garden side bedroom approx  $\frac{3}{4}$  of the ceiling appeared live, and  $\frac{1}{4}$  had collapsed at the time of engineer's inspection. The part of the ceiling nearer to the staircase was most affected. The condition of the ceiling presents a safety risk, the repair works are urgent.

It was agreed at Pre-App stage that all unsound areas of ceiling should be replaced in lath and plaster, including new timber laths with stainless steel fixings. Given that cutting around the cornice would leave much of the cornice fixed on unsupported ends of laths it was agreed that where this was the case the cornice could also be replaced.

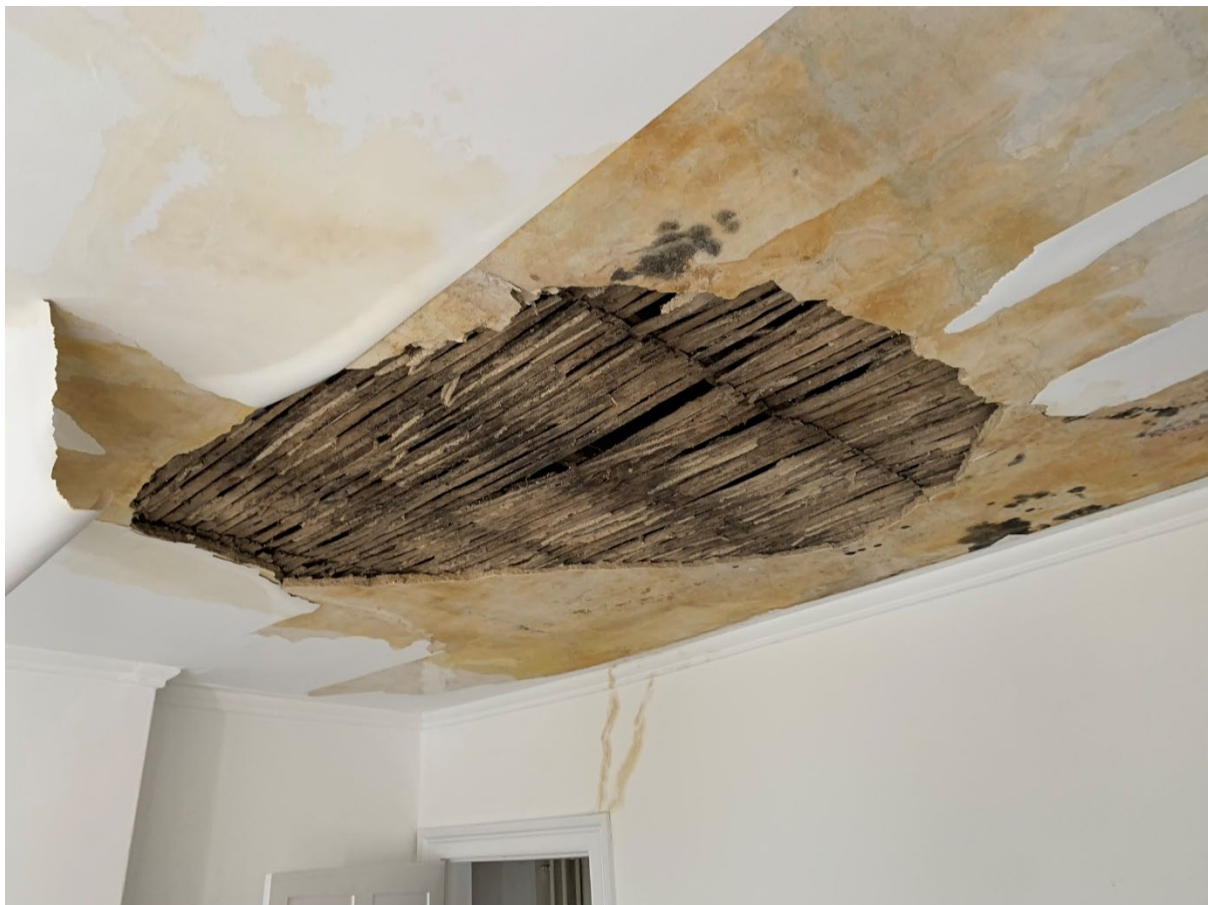
**Fig.01 – Area of collapse adjacent to central stairwell.**

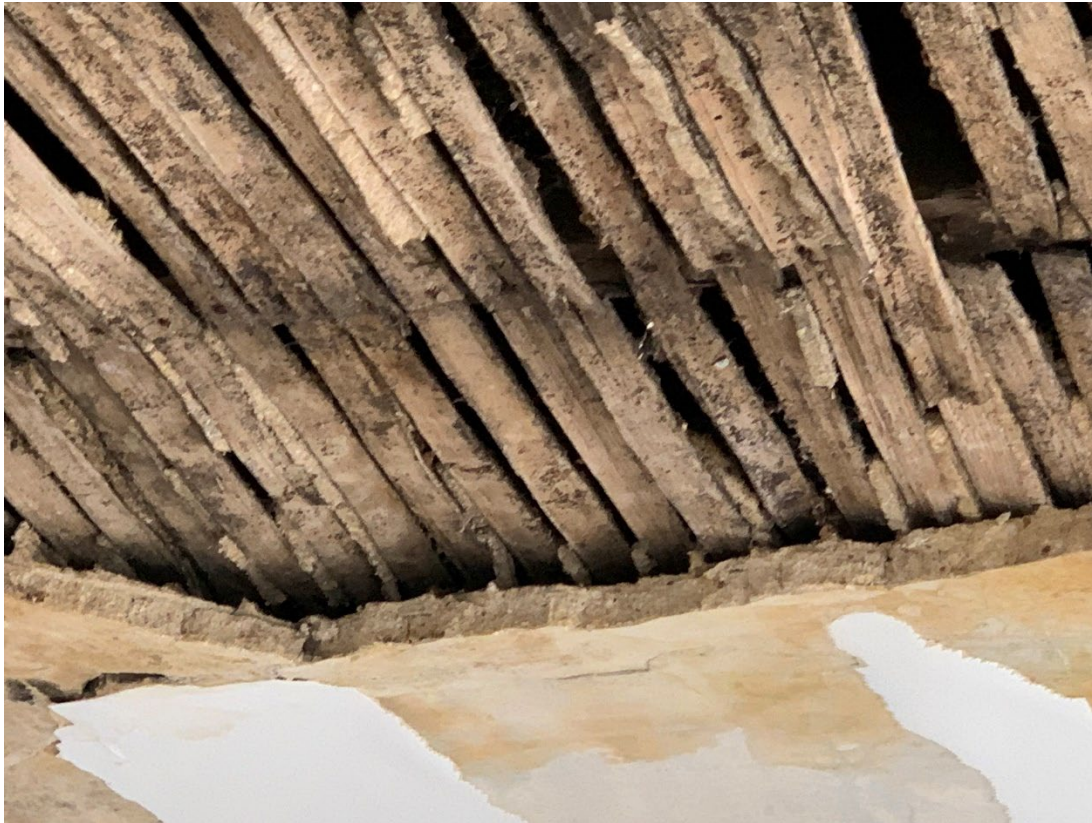
**Fig.02 – Sawn oak laths, evidence of corrosion to fixings and broken key between plaster and laths.**

The existing laths are in sawn oak and new sawn oak laths, matching the existing are to be fixed to the existing timber ceiling joists with stainless steel fixings.

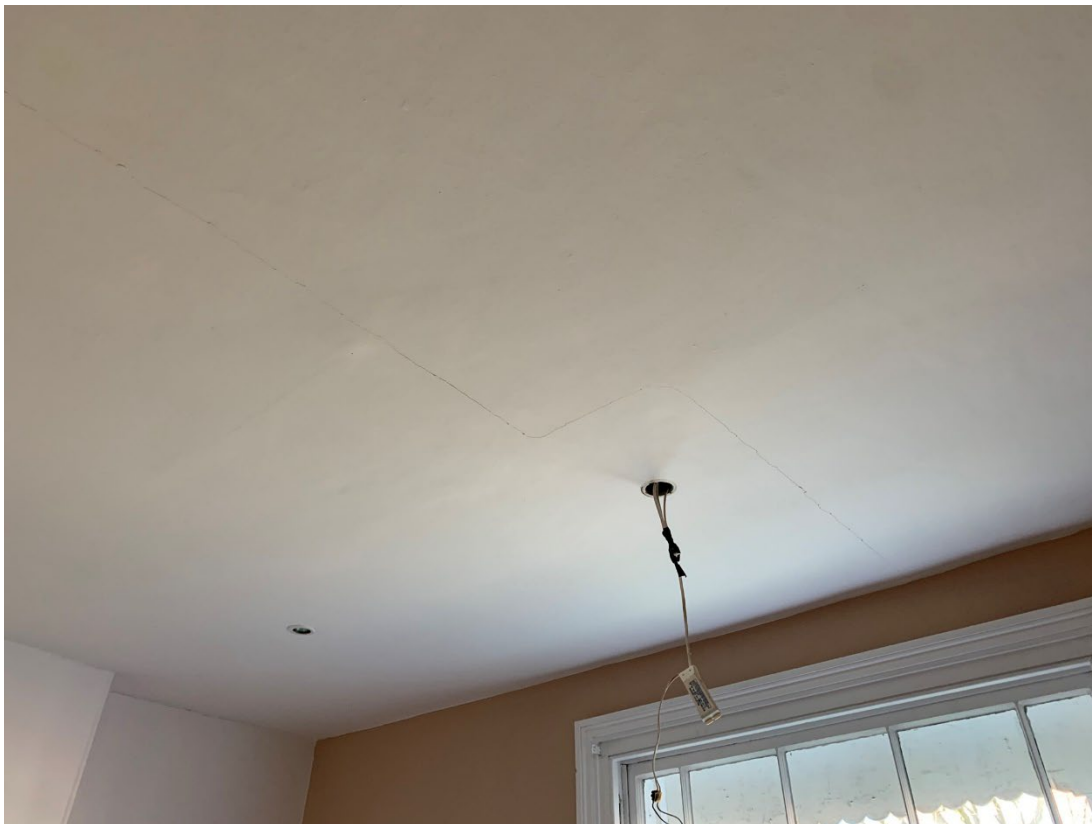
In the front bedroom has a replacement plasterboard ceiling and this was also water damaged. The engineer advised that dampness will have affected the grip of the plasterboard nails and recommended that this ceiling was under-boarded with screwed fixings up into the joists. This was agreed at Pre-app stage.

**Fig.03 – Evidence of movement in the modern plasterboard ceiling on the street side bedroom**

Ceiling to be under-boarded in plasterboard with screwed fixings up into the joists.

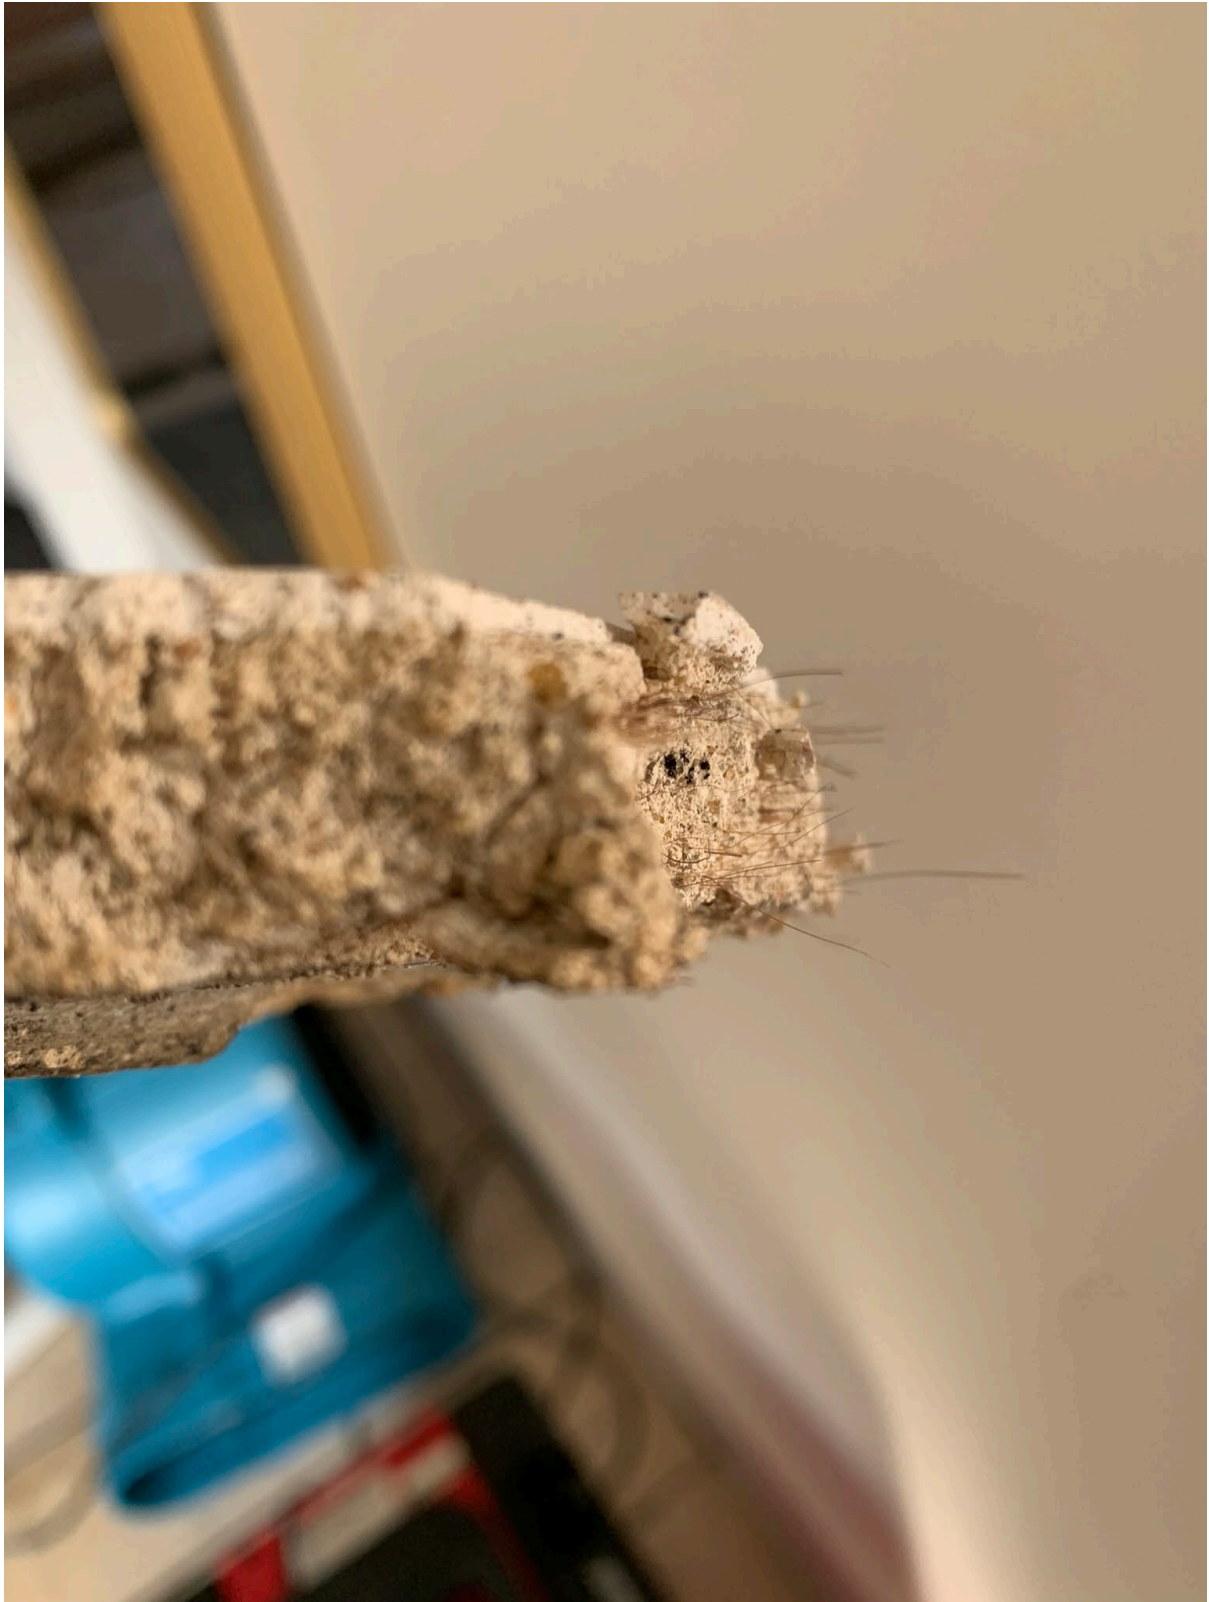
**Fig.04 – Detail of existing plaster showing the hair content**

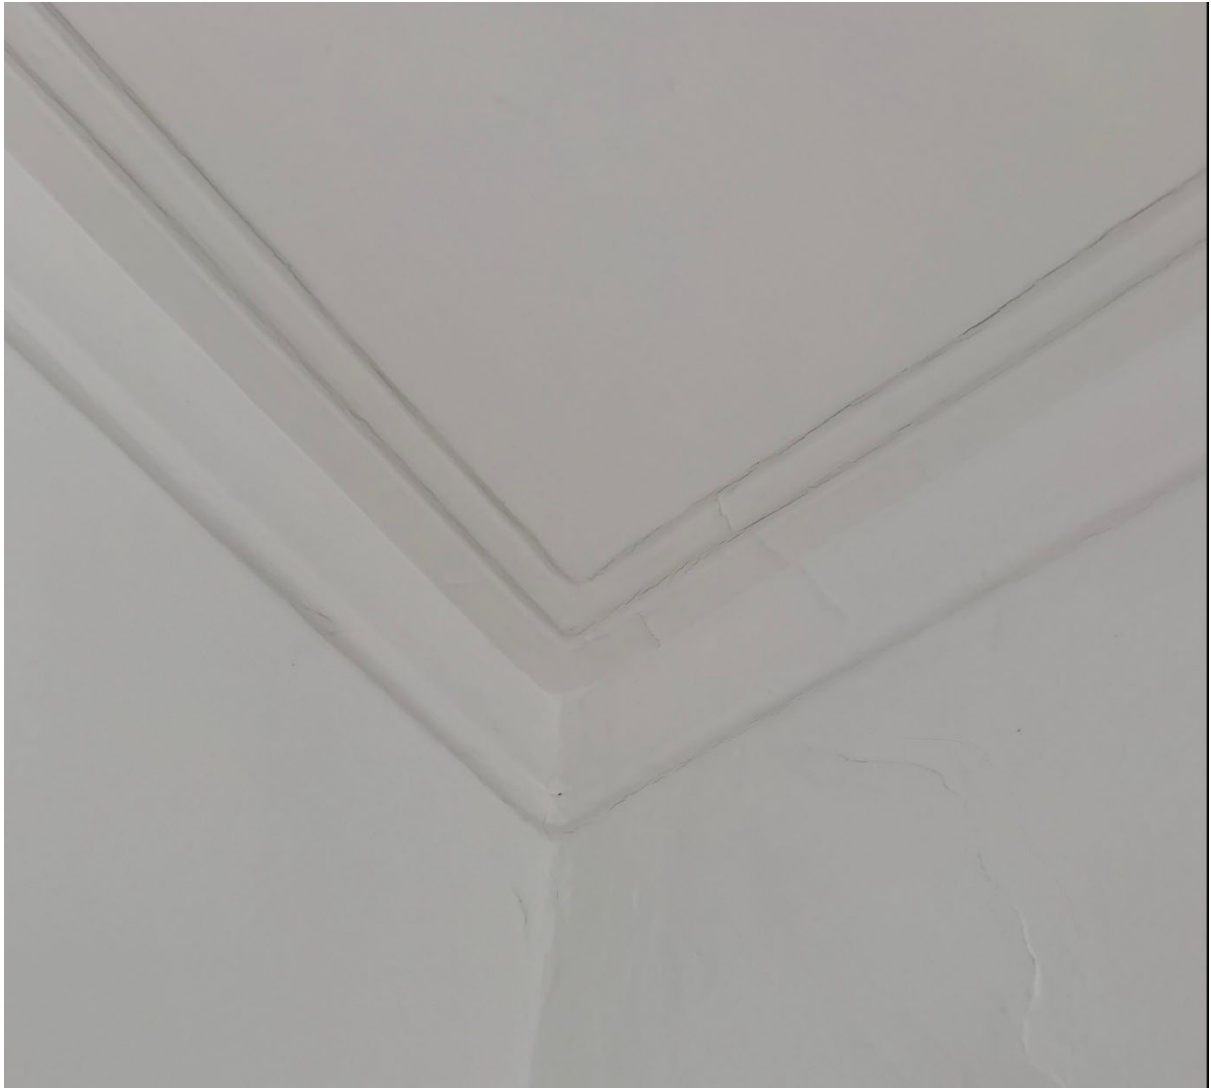
**Fig.05 – Survey photo taken in 2022 for other proposals showing the original cornice to be copied including inset detailing.**

Model, mould, cast and fix cornice and ceiling details to match existing noting that the reeded cornice here is partially inset into the ceiling bed.

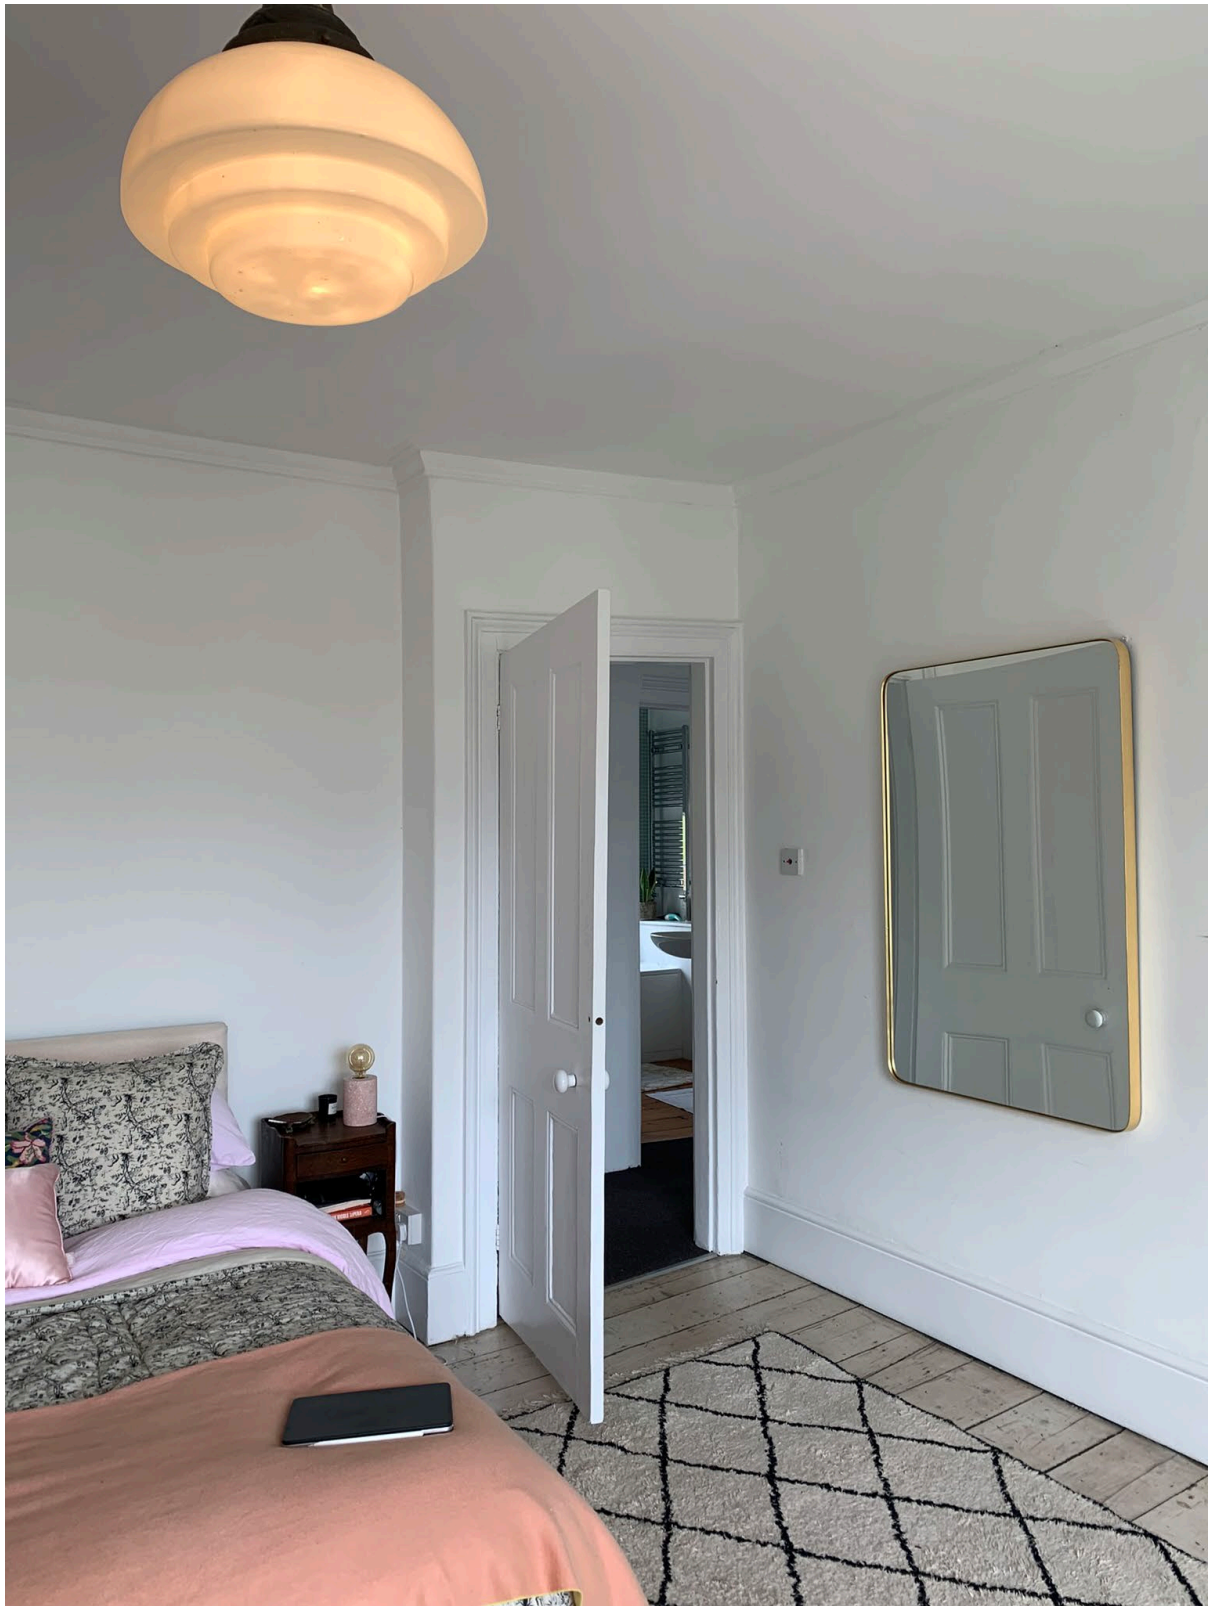
**Fig.06 – Survey photo taken in 2022 showing the original cornice to be copied.**

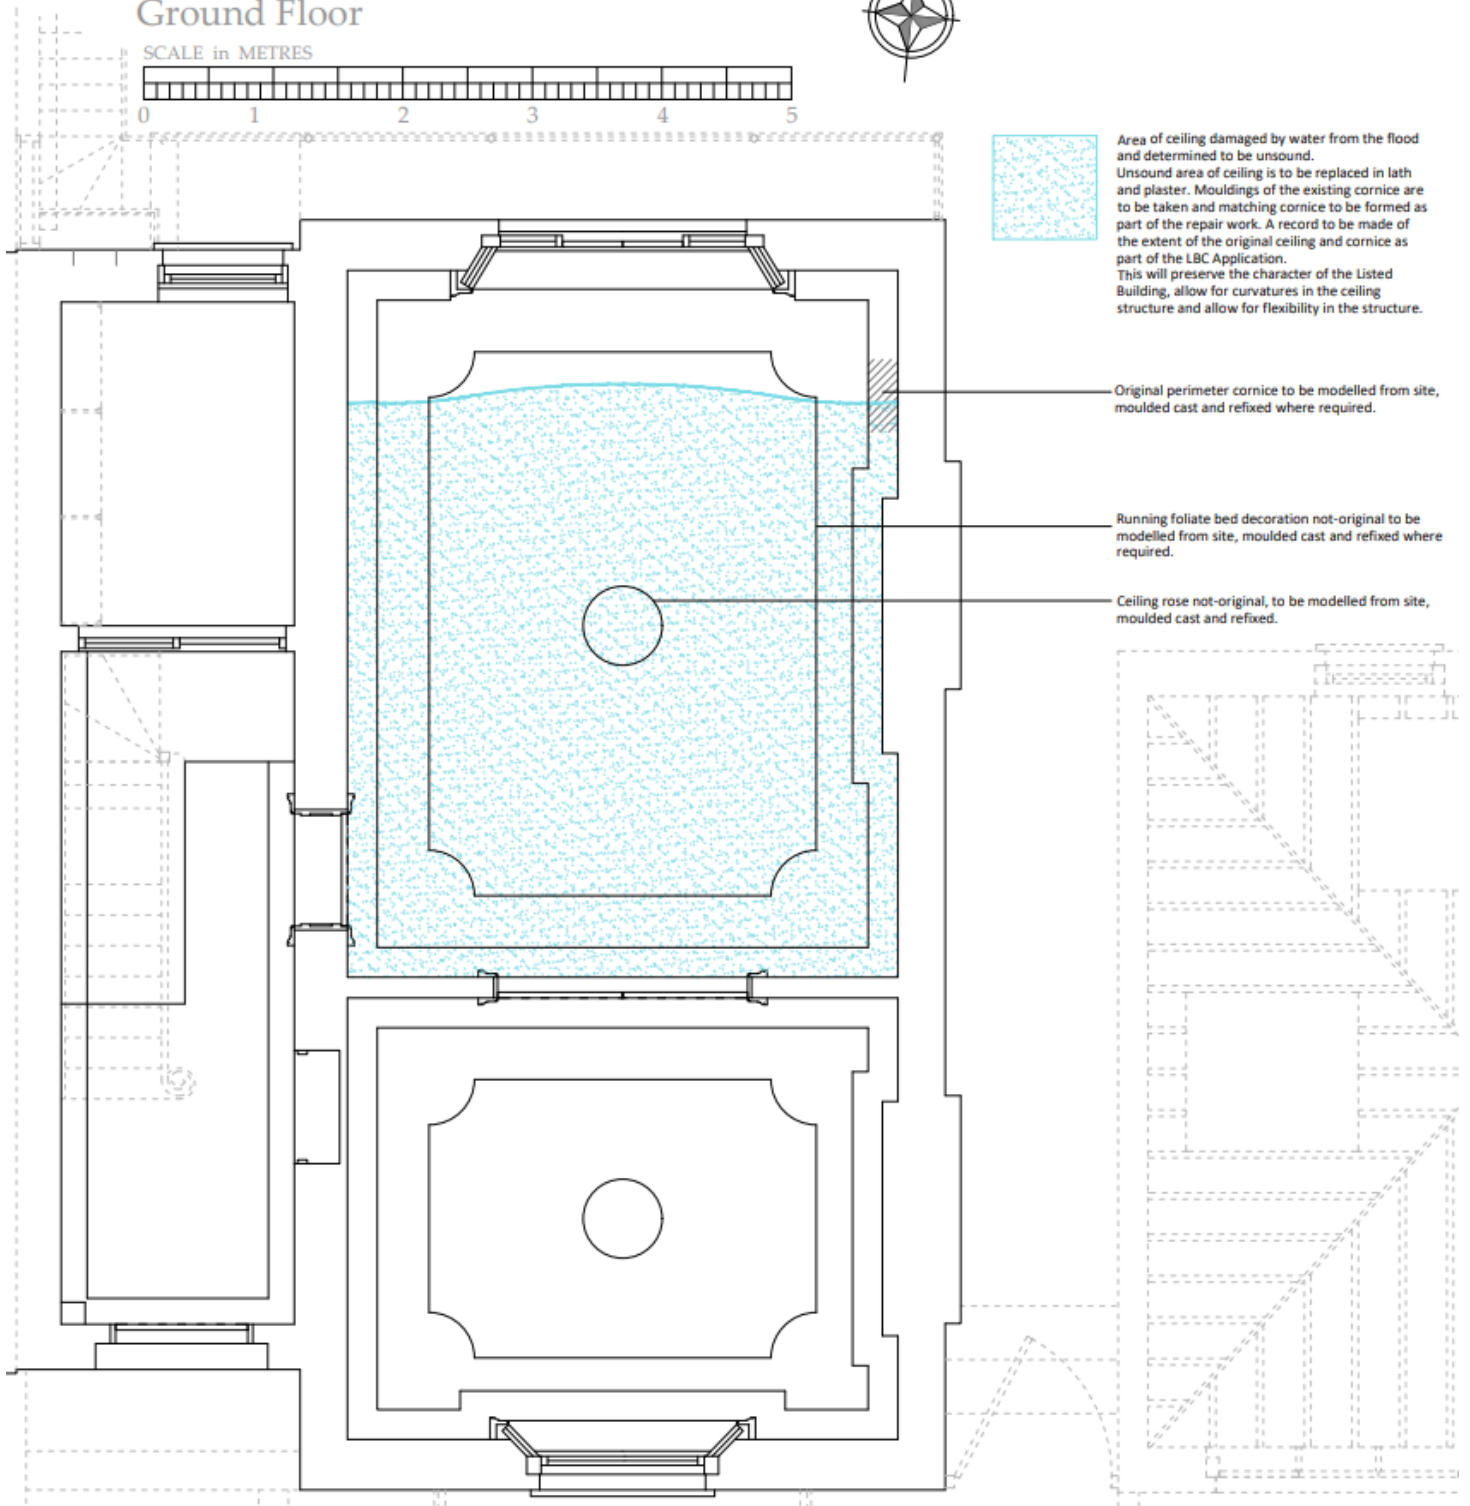
### 12 Wood Lane Ground Floor

Area of ceiling damaged by water from the flood and determined to be unsound. Unsound area of ceiling is to be replaced in lath and plaster. Mouldings of the existing cornice are to be taken and matching cornice to be formed as part of the repair work. A record to be made of the extent of the original ceiling and cornice as part of the LBC Application. This will preserve the character of the Listed Building, allow for curvatures in the ceiling structure and allow for flexibility in the structure.

Original perimeter cornice to be modelled from site, moulded cast and refixed where required.

Running foliate bed decoration not-original to be modelled from site, moulded cast and refixed where required.

Ceiling rose not-original, to be modelled from site, moulded cast and refixed.

In the Southern, garden side reception room approximately 80% of the ceiling was live and unkeyed, leaving only about 20% nearest to the rear wall unaffected. The damaged condition of the ceiling presents a safety risk, the repair works are urgent.

It was agreed at Pre-App stage that all unsound areas of ceiling should be replaced in lath and plaster, including new timber laths with stainless steel fixings.

Given that cutting around the cornice would leave much of the cornice fixed on the unsupported ends of laths it was agreed that, where this was the case, the cornice could also be replaced.

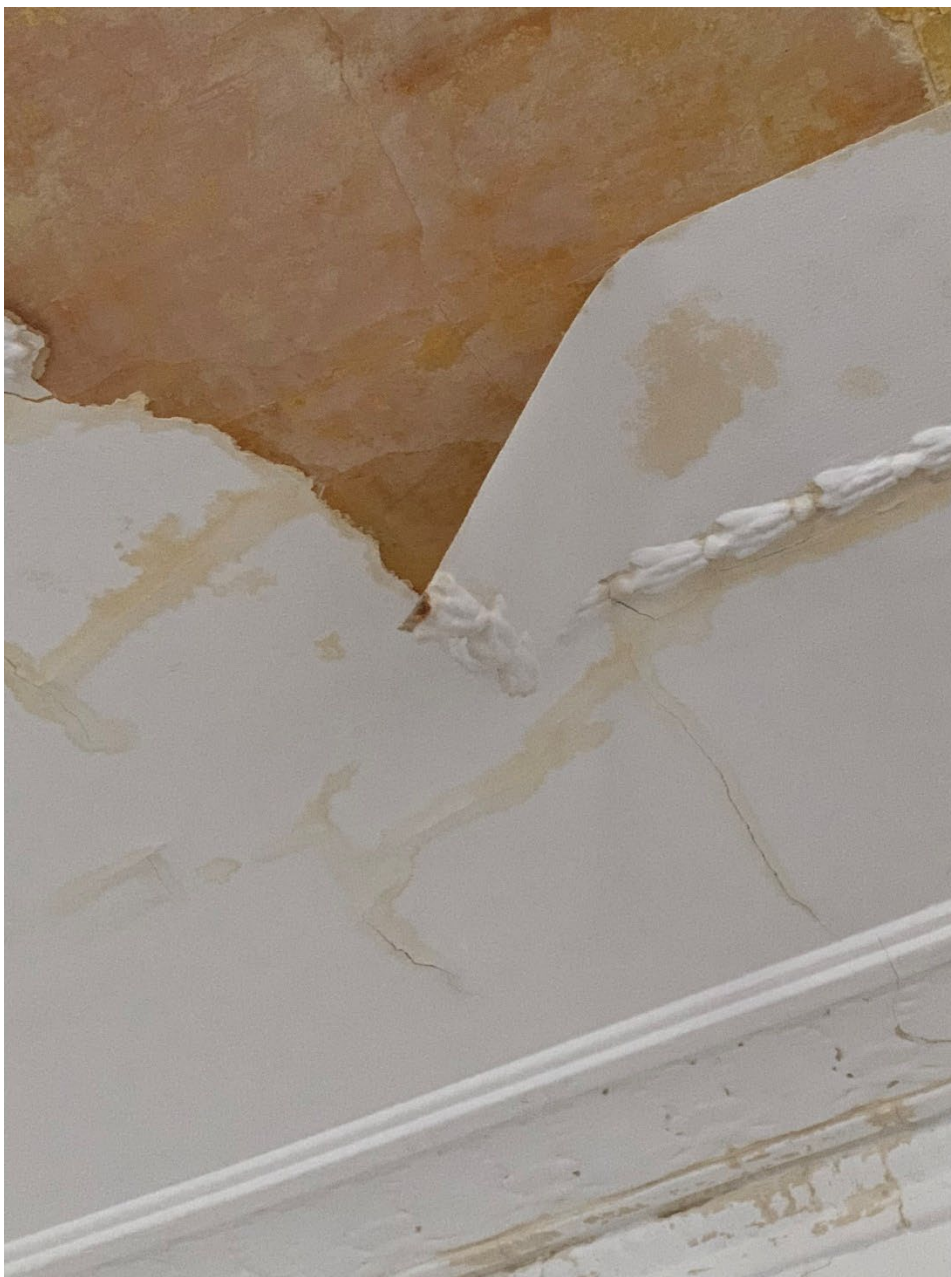
**Fig.07 – Water damage to G Floor ceiling. Note the running foliate decoration is not original and is adhered to the lining paper.**

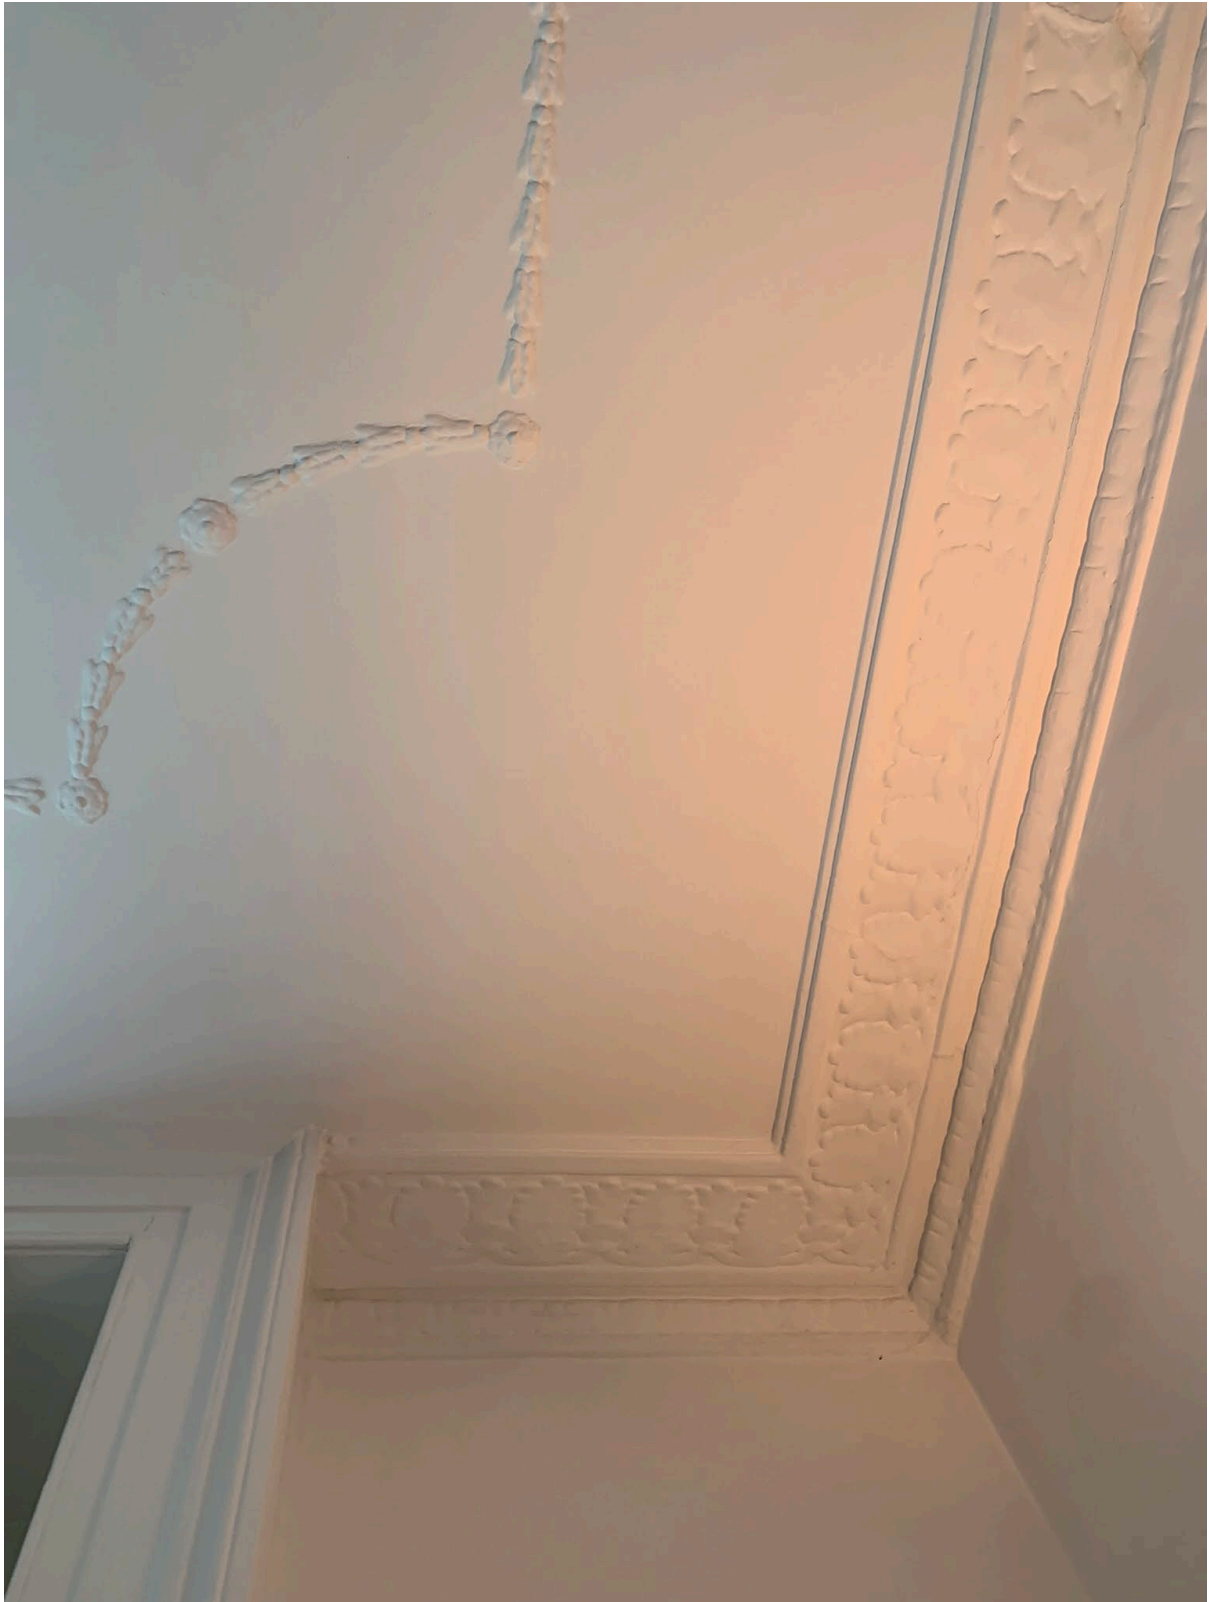
**Fig.07 – Pre-flood damage house survey photograph showing original perimeter cornice and modern running foliate detail, both to be replaced to match existing where lost.**

Model, mould, cast and fix cornice and ceiling details to match existing where necessary.

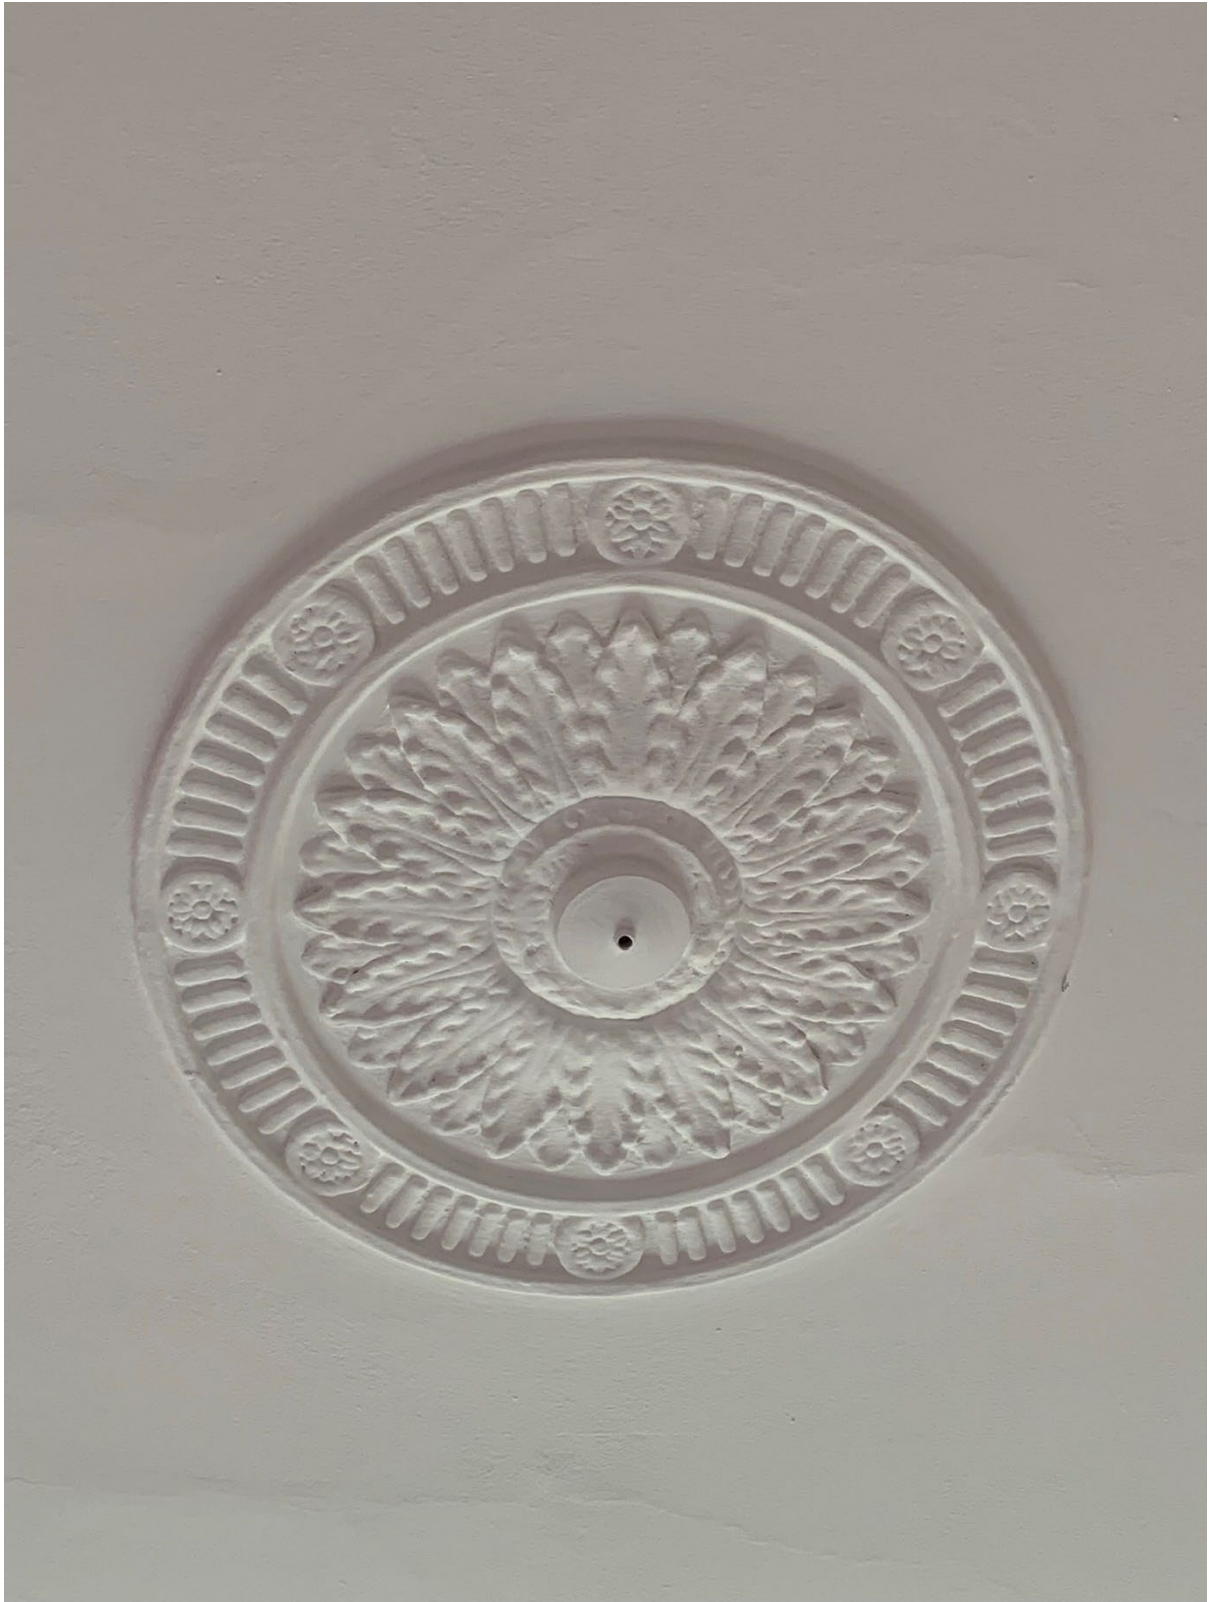
**Fig.07 – Pre-flood damage house survey photograph showing modern ceiling rose. Although not original and adhered to the lining paper this is to be replaced to match existing.**
