# 12 Wood Lane

Project  
EXISTING PLAN  
Ceiling Repairs

Drawing Title  
Second Floor  
Reflected Ceiling Plan

Drawing Number  
**255-12WL-FD03**

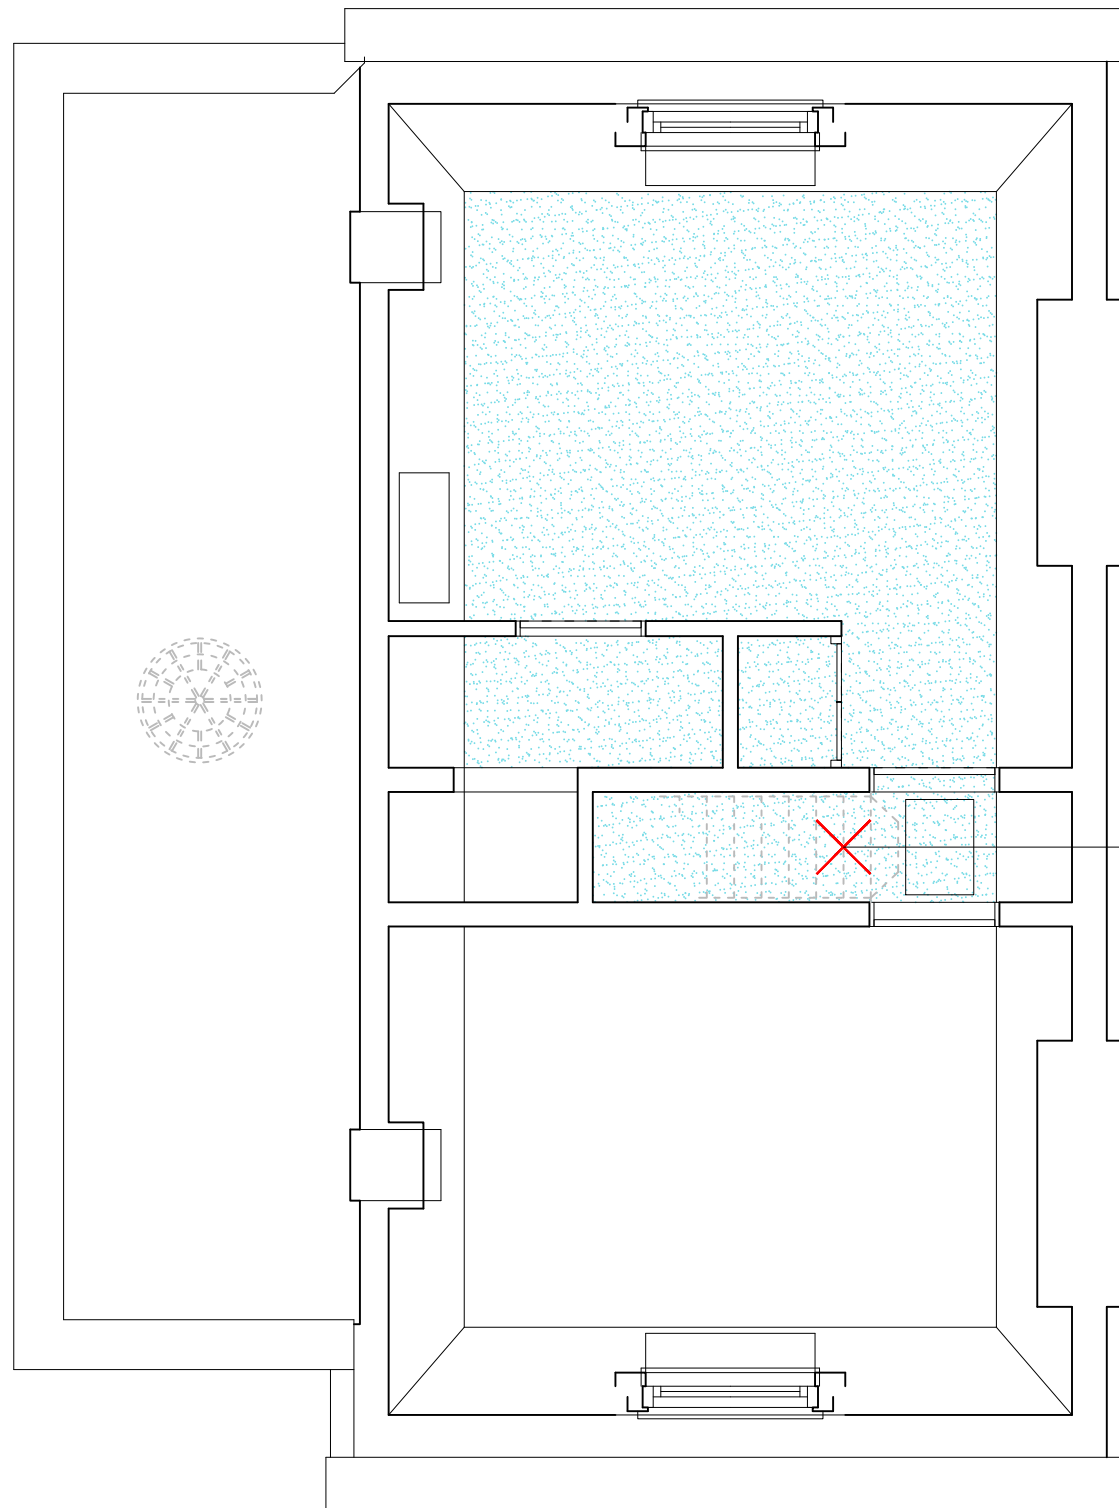
Area of ceiling damaged by water from the flood and determined to be unsound. This section of ceiling to be replaced in lath and plaster. Lath and plaster is a like for like repair, preserves the character of the Listed Building, allows for curvatures in the ceiling structure and allows for flexibility in the structure.

Location of the leak to the cold water feed in the attic. Ceiling configuration resulted in the majority of the water flowing towards the Southern garden side.
