# Arboricultural Appraisal Report

## Subsidence Damage Investigation at:

1 Bishops Road  
London  
N6 4HP

| MWA REF: | SUB201201-7975 |

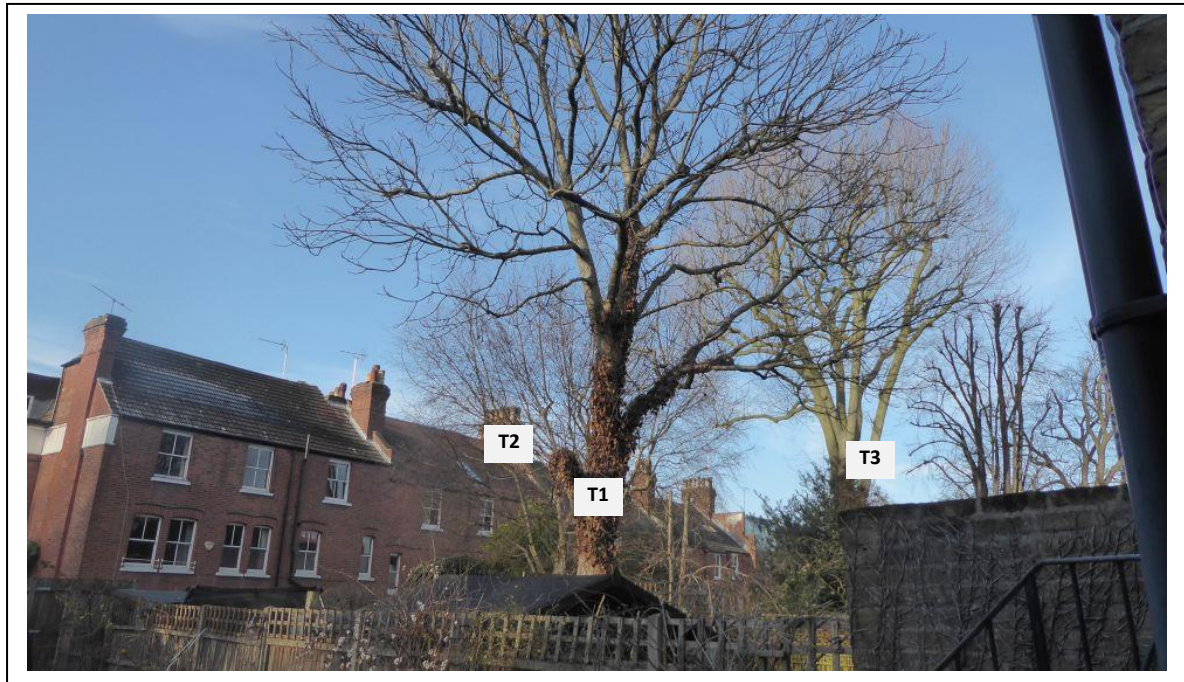
Irrespective of the identification of recovered root samples, our survey has identified additional vegetation within influencing distance of the building with a current potential to influence soil volumes below foundation level, the most significant of which is the policy holders T1 Walnut. There is also a likely localised influence from the adjacent third party *Callicarpa* and most proximal Japanese maple of TG1 group.

| Tree No. | Species | Ht (m) | Dia (mm) | Crown Spread (m) | Dist. to building (m) | Age Classification | Ownership |
|---|---|---|---|---|---|---|---|
| T1 | Walnut | 15.5 | 490 | 8.0 | 10.4 | Younger than Property | Policy Holder |

View of T1 Walnut to foreground with T2 Birch and T3 London Plane visible beyond

If an arboricultural solution is to be implemented to mitigate the influence of the implicated trees/vegetation we recommend that T1 Walnut is reduced along with the removal of the *Callicarpa* and nearest Japanese Maple of TG1 group [as identified on site photos]. Other vegetation recorded presents a potential future risk to building stability and management is therefore recommended. Recommended tree works may however be subject to change upon receipt of additional information.

| Tree No. | Species | Ht (m) | Dia (mm) | Crown Spread (m) | Dist. to building (m) | Age Classification | Ownership |
|---|---|---|---|---|---|---|---|
| Recommendation | | Reduce to previous reduction points and remove regrowth on a triennial cycle. | | | | | |

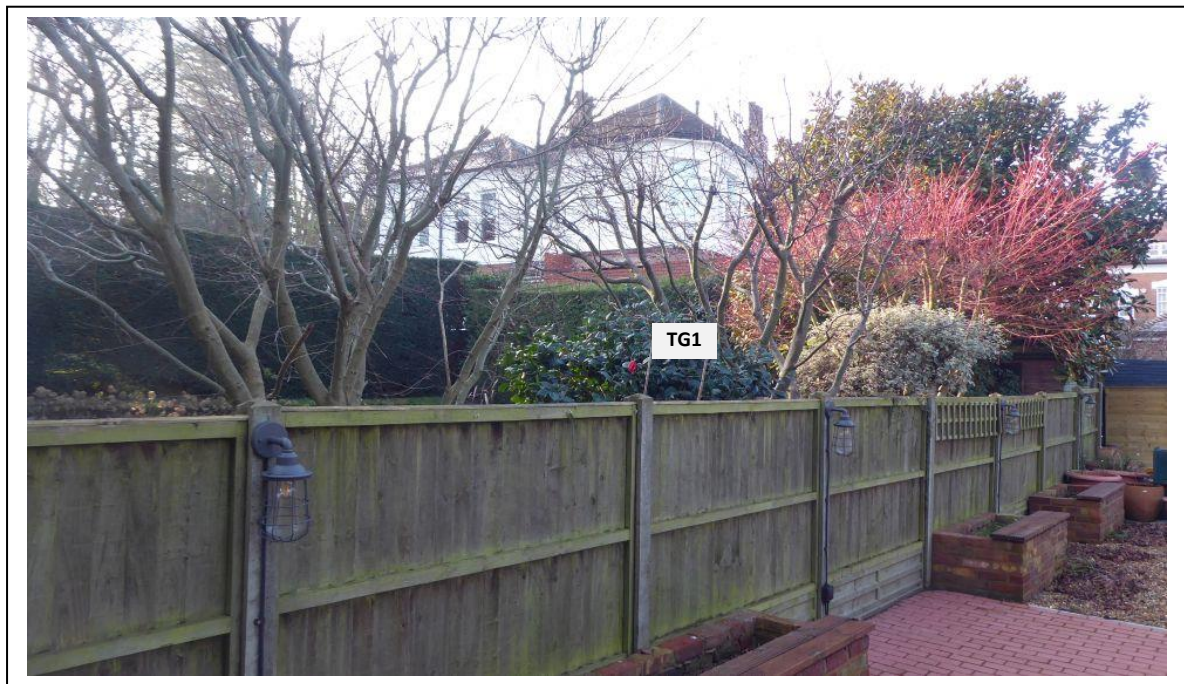
| Tree No. | Species | Ht (m) | Dia (mm) | Crown Spread (m) | Dist. to building (m) | Age Classification | Ownership |
|---|---|---|---|---|---|---|---|
| TG1 | Mixed spp. group of mostly Callicarpa, Japanese maple, Camelia and Pittosporum, | 3.5 | 120 Ms * | 3.0 | 1.7 | Younger than Property | Third Party<br>5 The Park<br>N6 4EU |

View of TG1 group

| Tree No. | Species | Ht (m) | Dia (mm) | Crown Spread (m) | Dist. to building (m) | Age Classification | Ownership |
|---|---|---|---|---|---|---|---|
| Recommendation | | Remove (fell) nearby Callicarpa and closest Japanese Maple to building to near ground level and remove any regrowth as it emerges [Herbicide translocation risk] | | | | | |

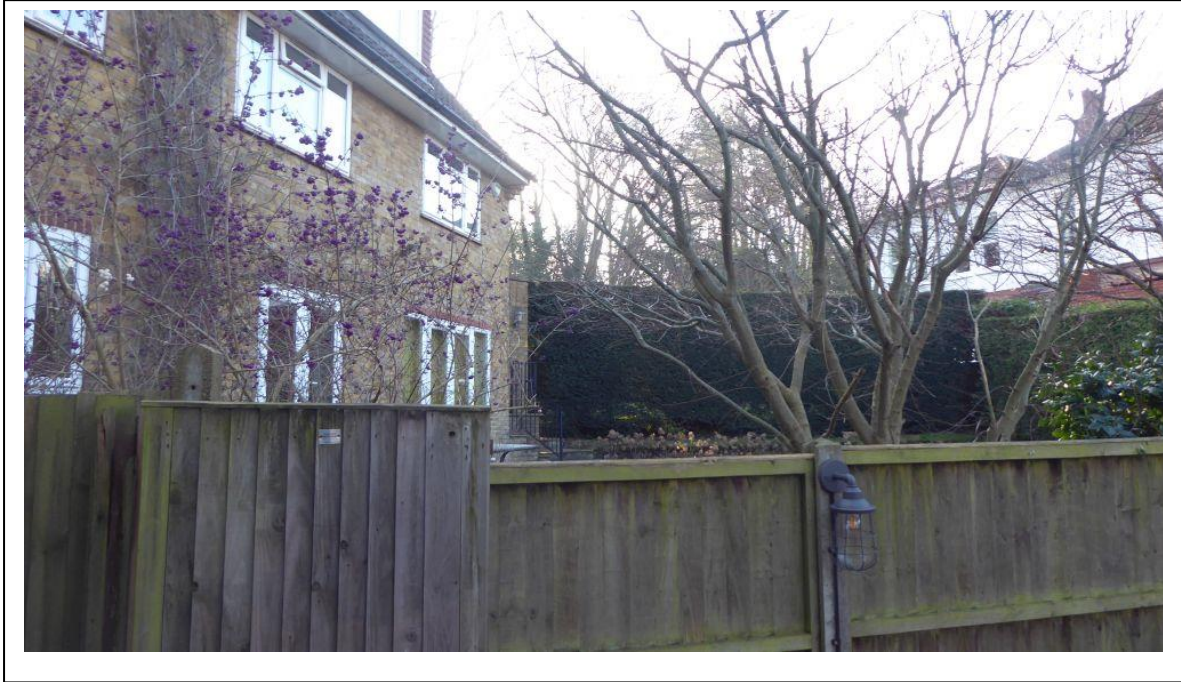
Given the tentative nature of the identification and the absence of any nearby *Tilia* spp, *Prunus* spp. or *Ribes* spp. vegetation, the most likely origin of the retrieved samples is the nearby third party *Callicarpa* shrub.

View of nearby Callicarpa and Japanese Maple of TG1 group to be removed
