## **Specific Structural Report**

**Flat 4, 1 Bishops Road, Highgate London N6 4HP**

**Dated June 2020**

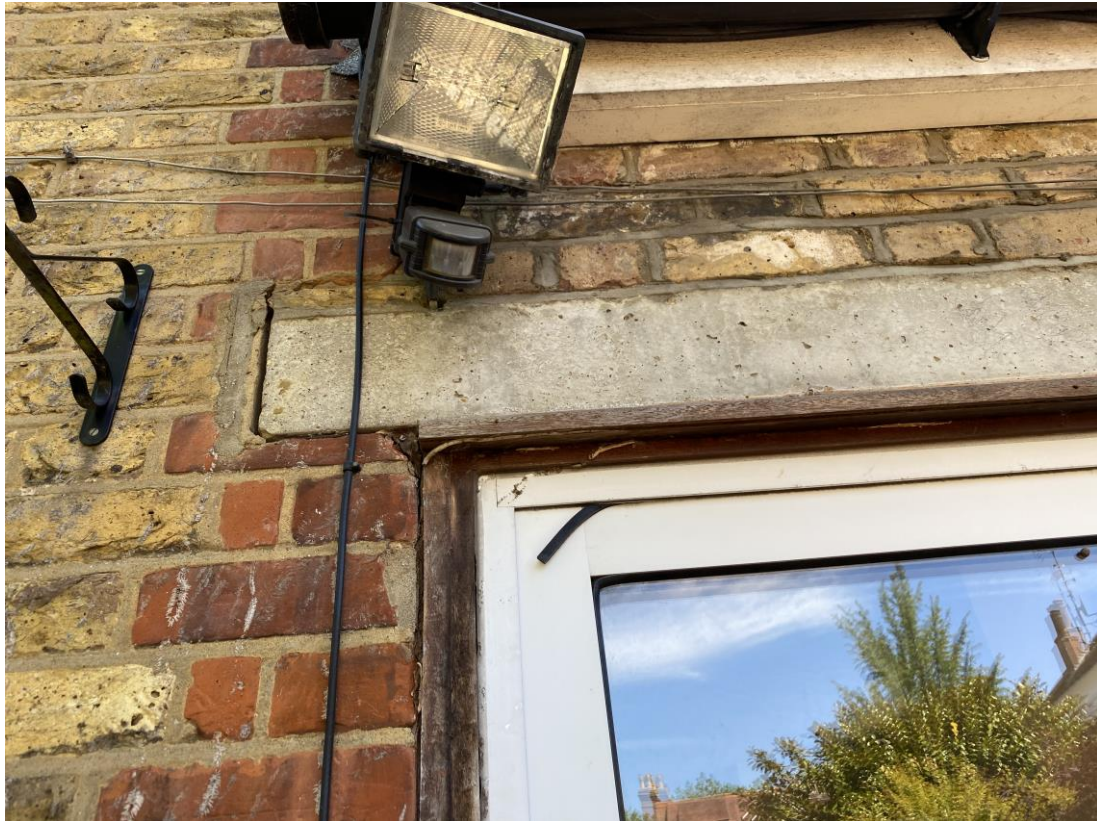
10mm wide crack in rear right corner adjacent to precast lintel.

The damage to the kitchen area of the subject flat is considered to have occurred as a result of subsidence.

This is evidenced by the size, location, orientation and the tapering aspect of the cracks, together with the fact that they occur on both wall faces and indicate a clear mechanism of downward movement of the foundations.

Photo 1 Cracking over rhs kitchen door

For cracking to external brickwork use the same procedure as internal crack repair. If the wall is rendered remove render at least 150mm either side of the cracks and proceed as indicated above.

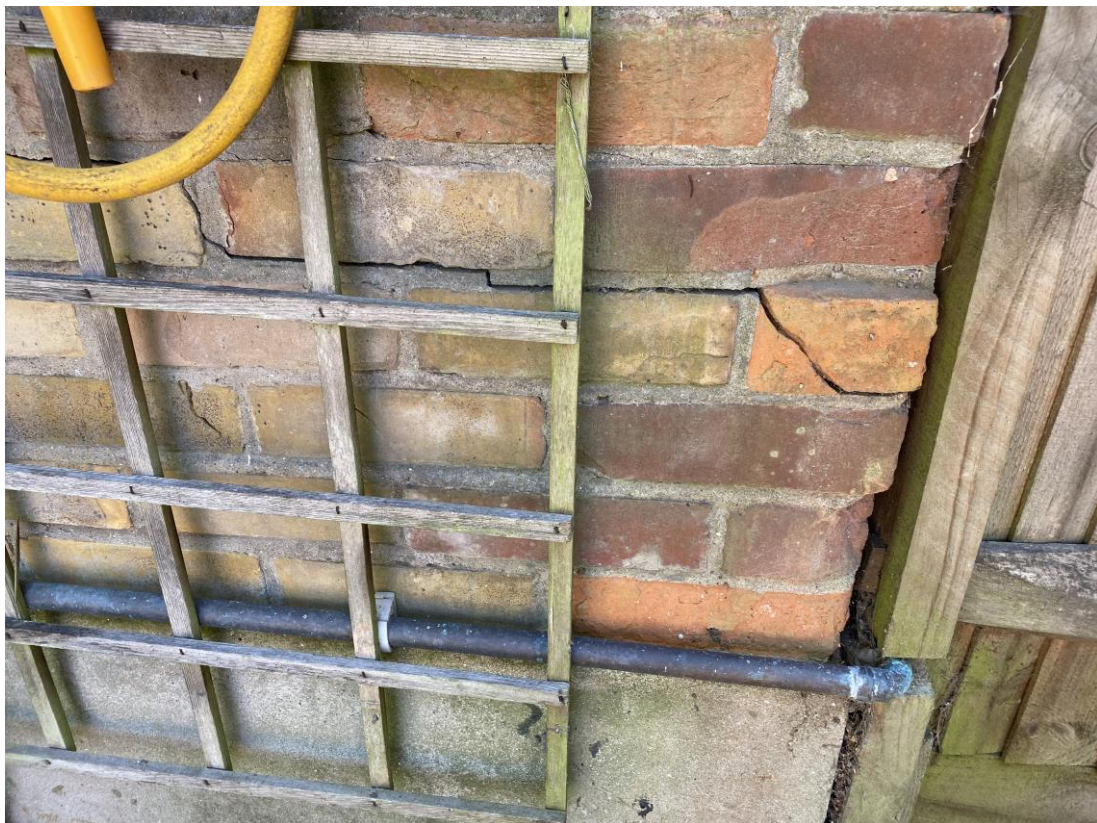
Low level horizontal cracking 5mm wide in rear left corner of the extension, continues to left wall at low level.

As the soils are sandy, non-cohesive, we suspect that water inundation and saturation is the principal cause of the damage. There is a rainwater down pipe RWDP located in the rear left corner of the extension that runs to ground (ie does not have gulley or drainage outfall). The RWDP drains the flat roof to the extension being approximately 2m x1.5m in area. It is our view that inundation of water over time from the pipework directly into the ground is the principal cause of the damage. A water butt is not an effective drainage outlet.

Photo 2 Low level cracks rear left corner

- a) re-direct RWDP to fixed drains away from the soil close to foundations or to a soakaway at least 5m from the property and
- b) check outside tap for leaks and
- c) Regular maintenance of vegetation.

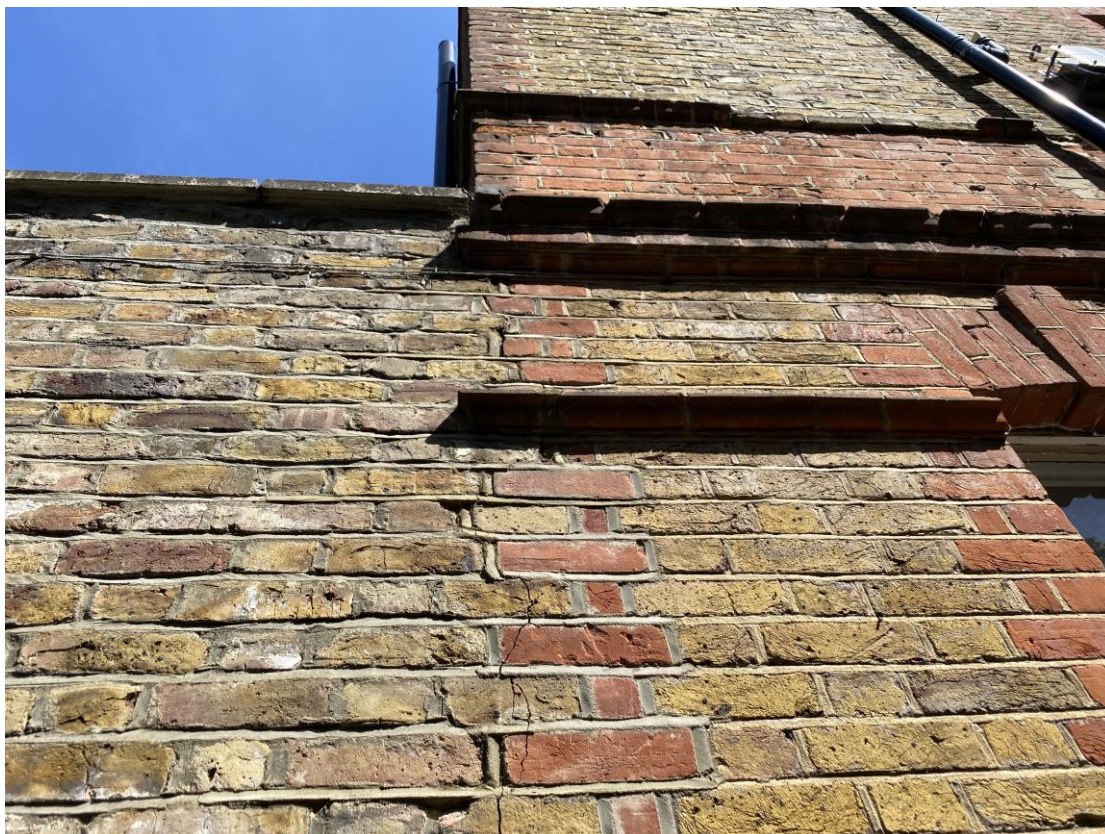
Vertical tapering crack at junction with main house (and cellar) 5mm wide at roof level.

We also noted that the main house benefits from deep foundations forming a basement and the foundations to the single storey extension may be shallower than the main house foundations. A firm diagnosis however can only be made following opening of the structure and investigation. We are unable to confirm whether the damage caused is progressive or not without having the opportunity to monitor the cracking further.

Photo 3 Cracking to left wall at junction with main house

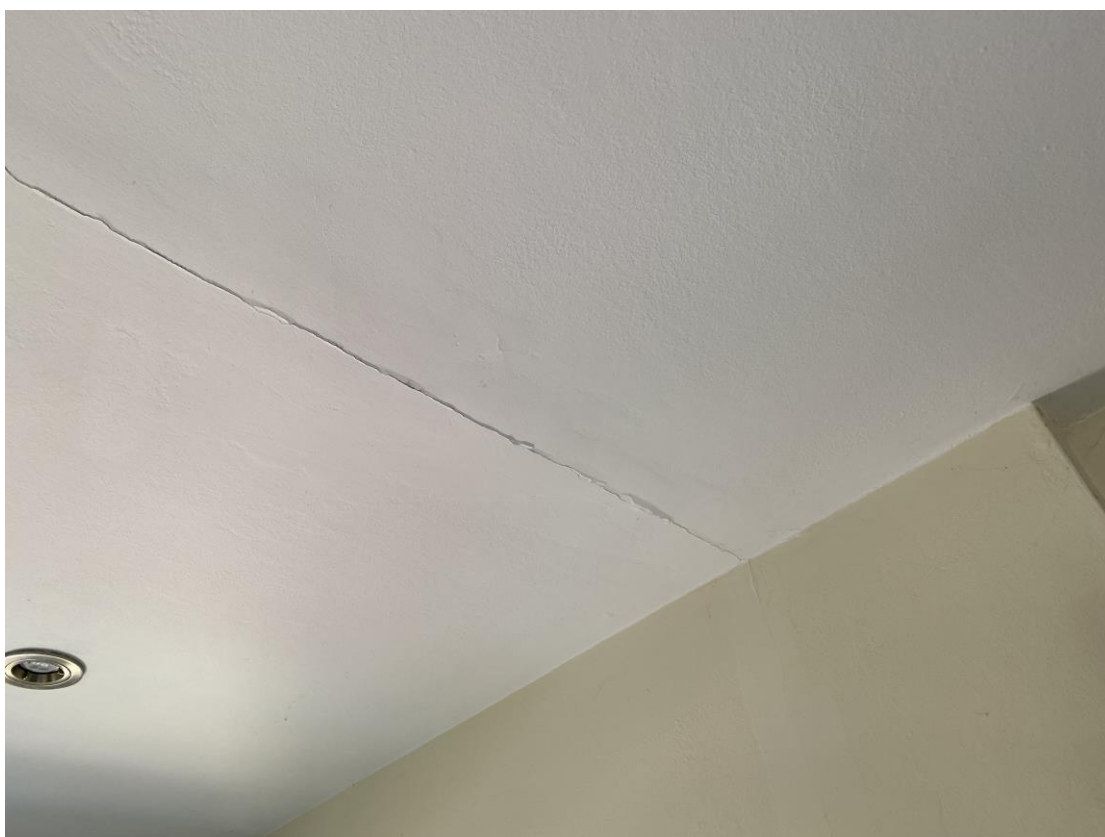
Hairline crack on the right side wall towards the rear approx. 1m from the rear wall  
Associated crack continues across ceiling 2mm wide to left wall and progresses down left wall 2mm becoming hairline behind wall tiles.

Photo 4 Kitchen crack across ceiling

Structural cracks, usually over 2mm in width, are best repaired by removing plaster a minimum of 75mm both sides of the cracking. Expose cracks in underlying brick or block and repair cracking to the underlying brickwork/blockwork by resin injection techniques.

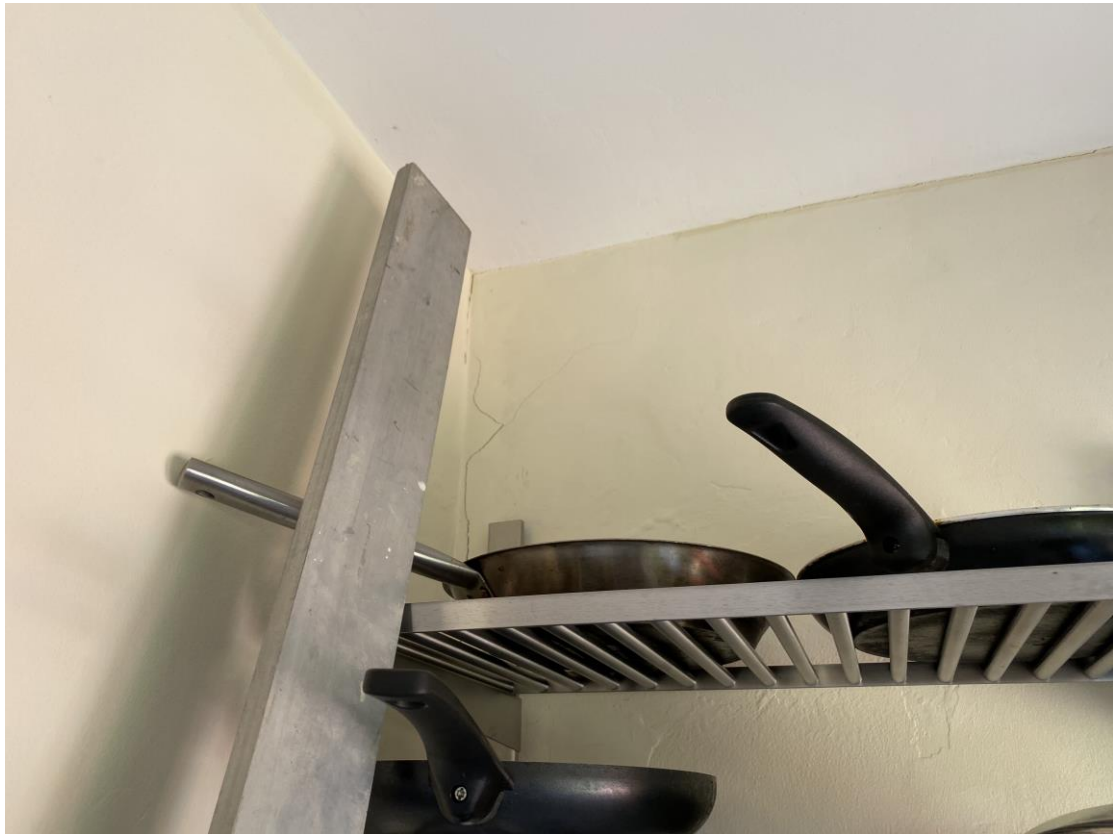
Photo 5 Cracking left wall

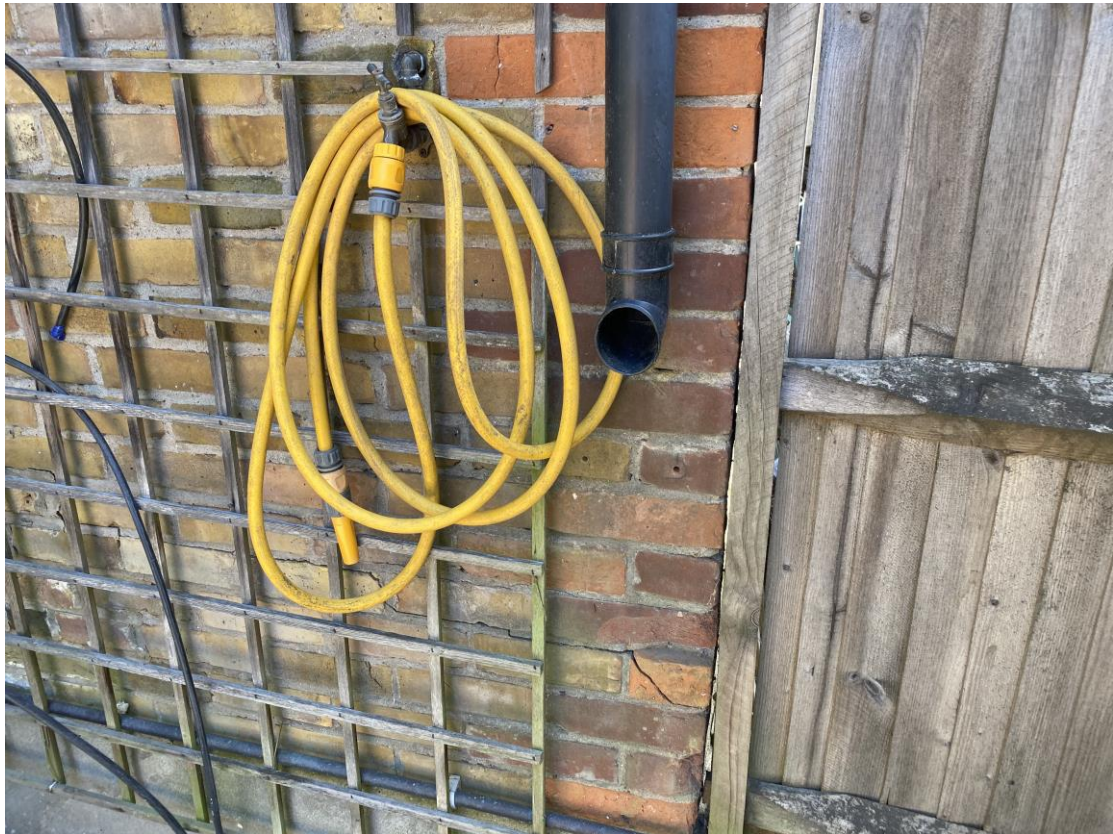
We also noted an outside water tap adjacent to the RWDP and if this tap has been leaking in the past then the same effect can result. Over time water entering suspected predominantly sandy soils close to the foundations of the rear left extension will result in softening and washing out of fine material with consequent loss of strength and downwards movement. This type of movement is usually permanent and once movement has occurred the building will not return to its original position.

Photo 7 RWDP and outside tap rear left corner

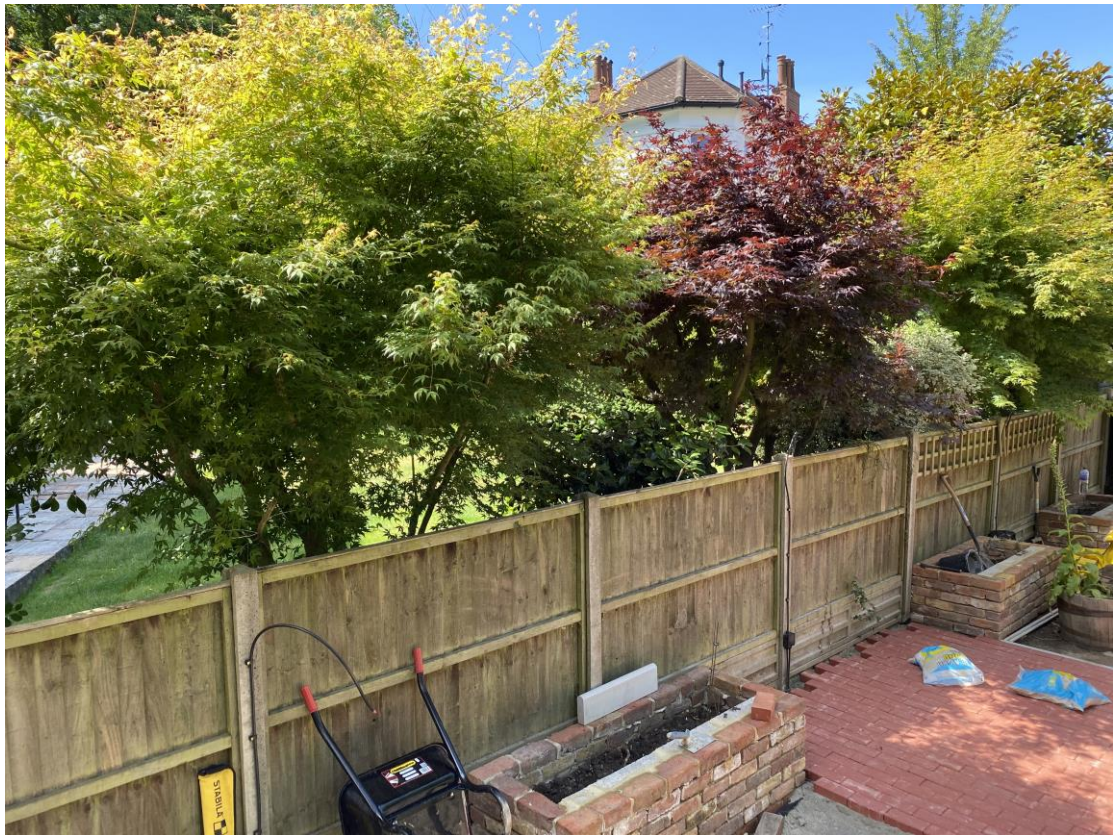
There are trees nearby such as large Horse Chestnut 12m distant in the rear garden and smaller trees up to 3m high and 2m distant in the neighbours garden. Whilst not directly implicated at this stage in the damage due to suspected sandy soils these trees can cause problems on clayey elements of the soil that may be present and precautionary works such as regular pruning are advised.

Photo 8 View of neighbours trees

Regular tree maintenance.
