# **Dilapidation Survey**

**Marquis Road, Haringey**

**19<sup>th</sup> May 2023**

**Doc Ref: SCP/220339/0001**

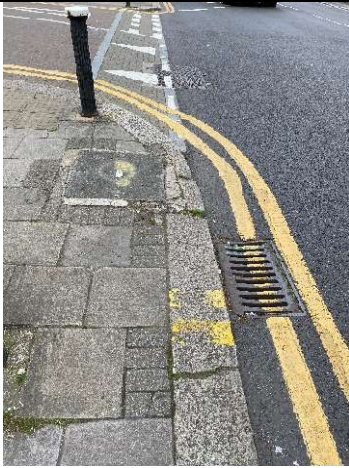
Photo 1

Damaged kerbs, utility cover surround  
damaged

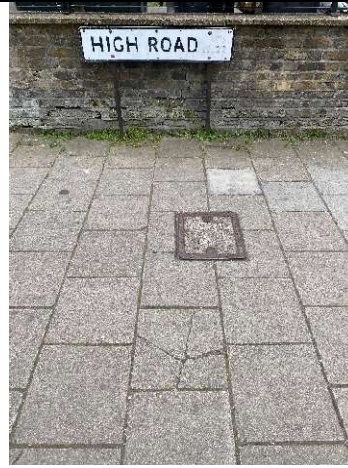
Photo 2

Footway cracking

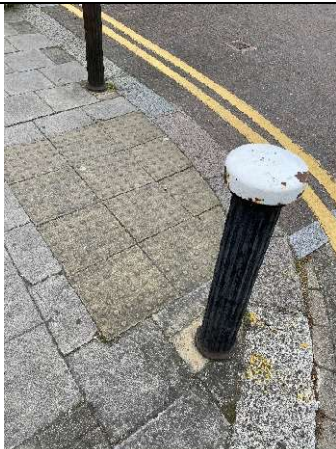
Photo 3

Rusting on bollard

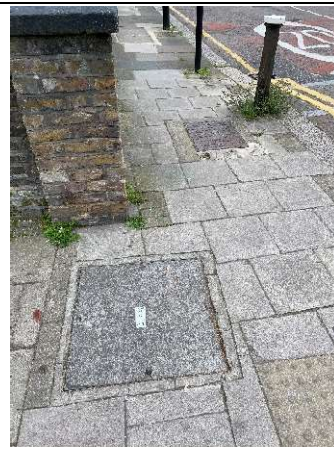
Photo 4

Sunken utility cover, surround cracking

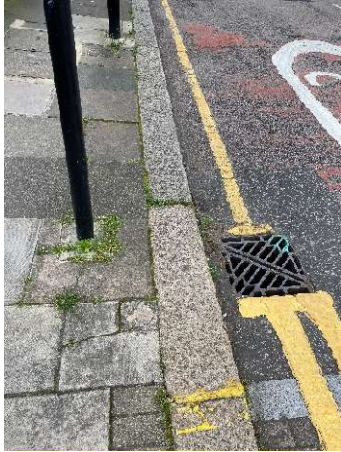
Photo 5

Footway cracking

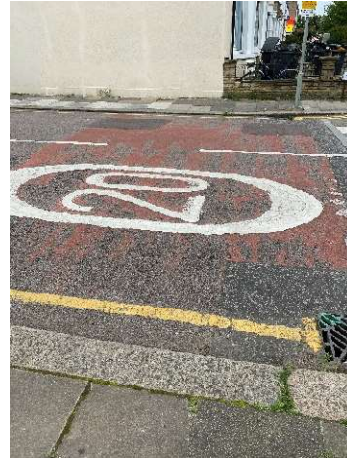
Photo 6

Road surface dressing significantly worn,  
carriageway scarring

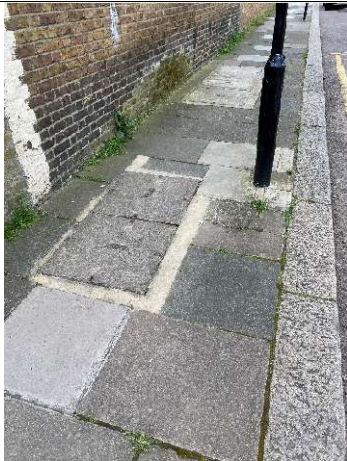
Photo 7

Footway cracking

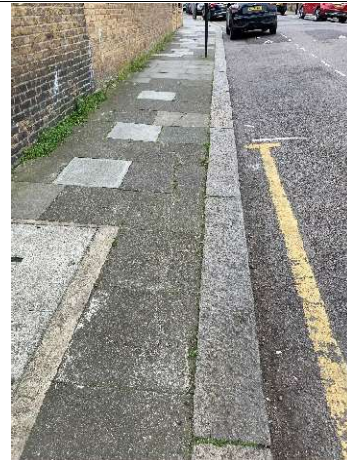
Photo 8

Footway cracking

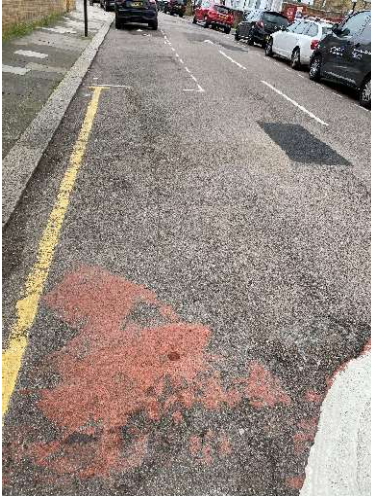
Photo 9

Carriageway scarring, road markings  
significantly worn

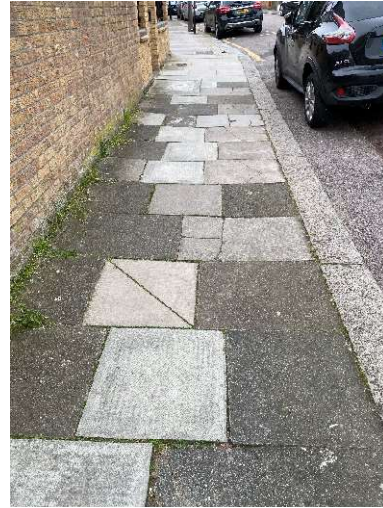
Photo 10

Footway cracking

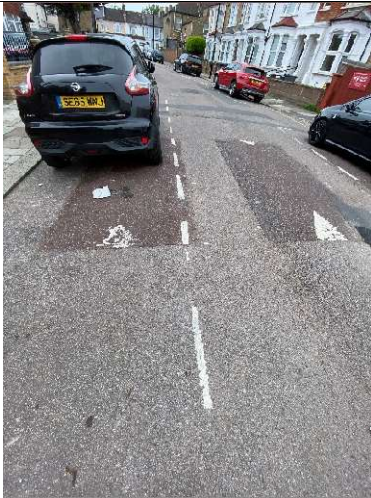
Photo 11

Longitudinal cracking, road markings  
significantly worn

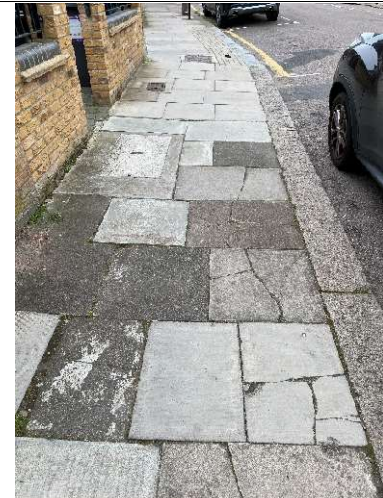
Photo 12

Footway cracking

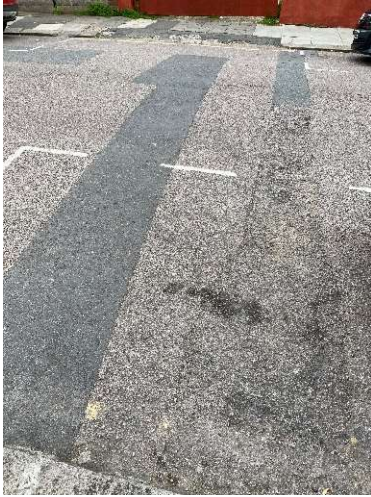
Photo 13  
Carriageway scarring

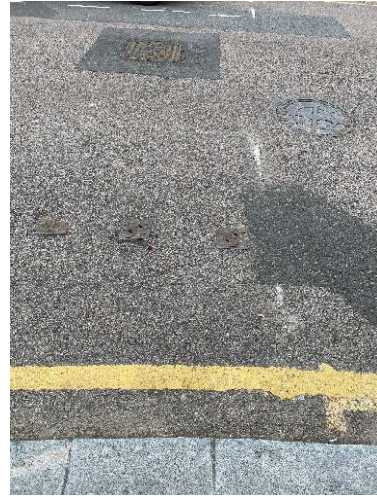
Photo 14  
Carriageway scarring

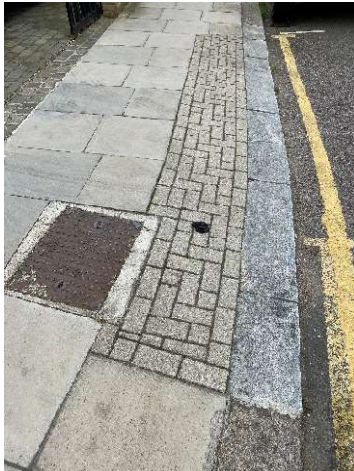
Photo 15  
Utility cover surround damaged

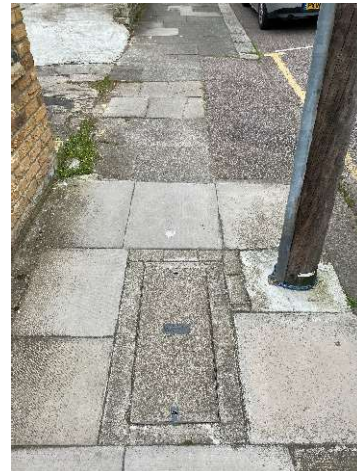
Photo 16  
Footway cracking, utility cover surround damaged

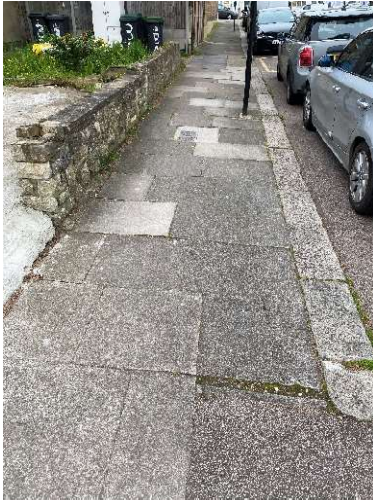
Photo 17

Footway cracking, partially damaged private wall

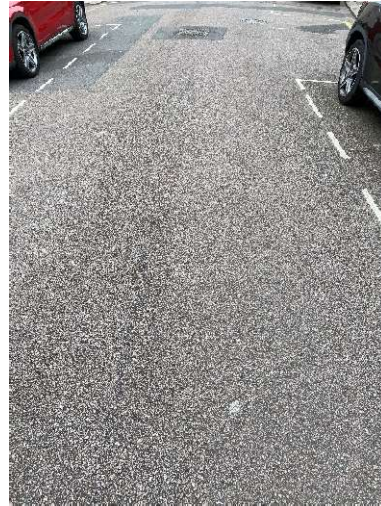
Photo 18

Carriageway scarring, longitudinal cracking

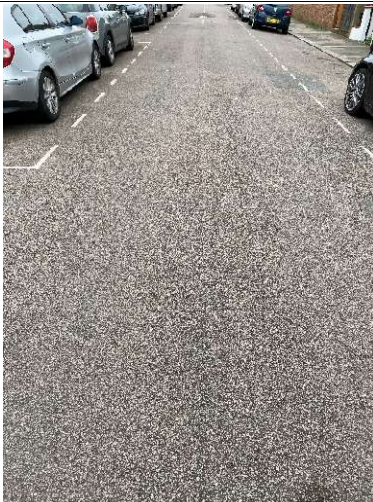
Photo 19

Carriageway scarring, longitudinal cracking

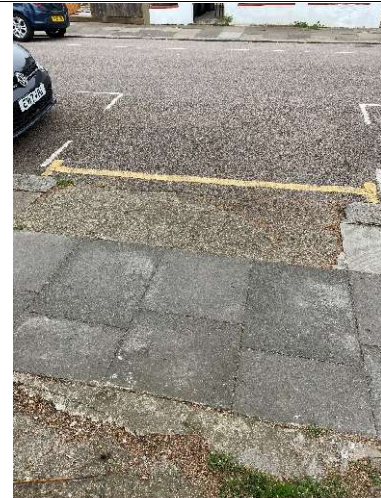
Photo 20

Footway cracking

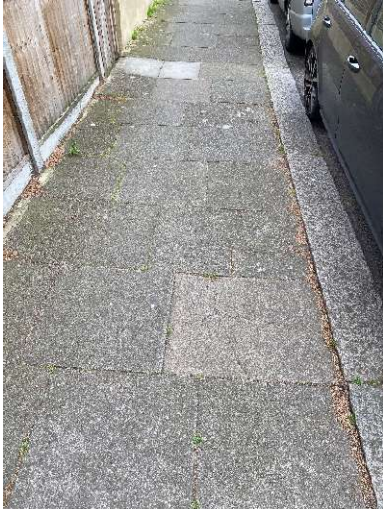
Photo 21

Footway cracking

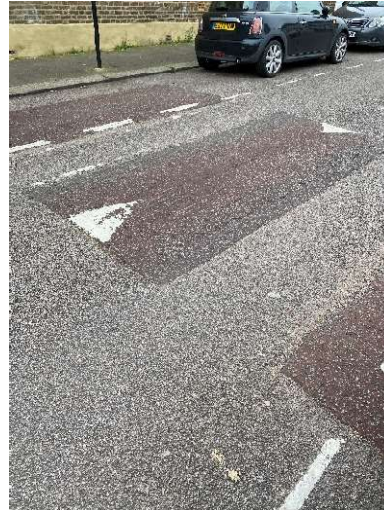
Photo 22

Longitudinal cracking, significantly worn road markings

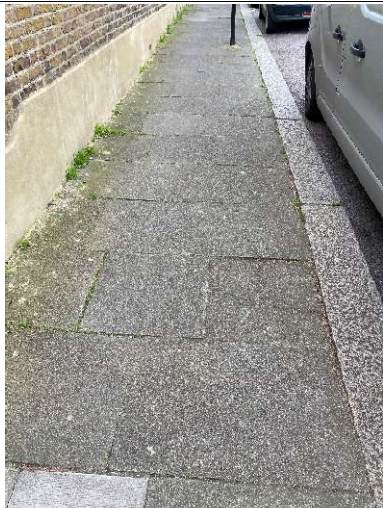
Photo 23

Footway cracking

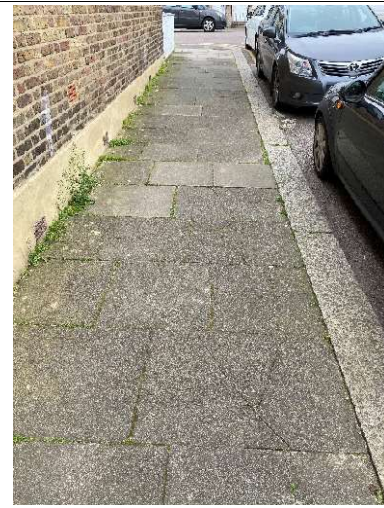
Photo 24

Footway cracking

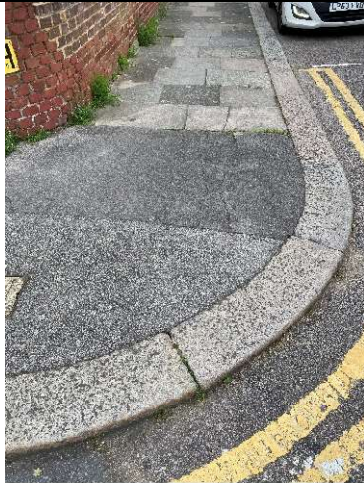
Photo 25

Footway cracking, Footway scarring

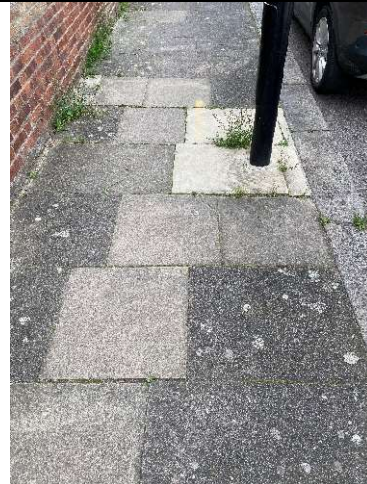
Photo 26

Footway cracking

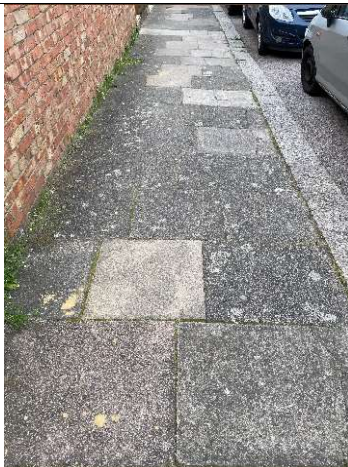
Photo 27

Footway cracking

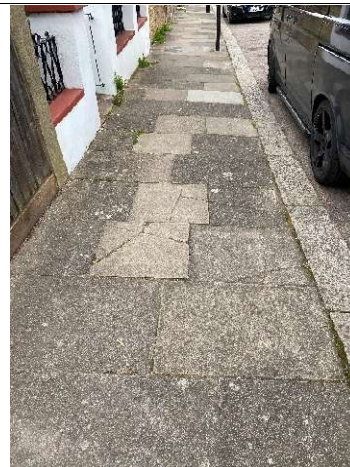
Photo 28

Footway cracking

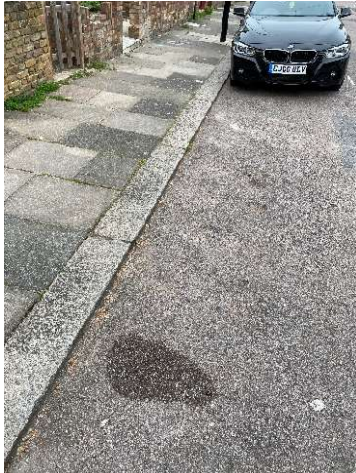
Photo 29  
Footway cracking

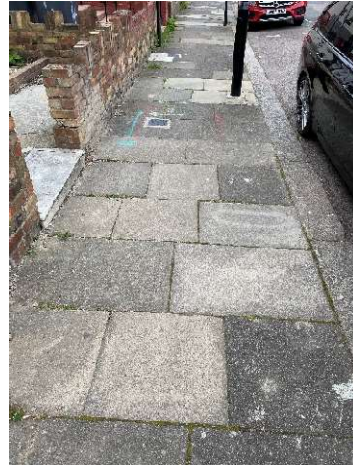
Photo 30  
Partially damaged private wall

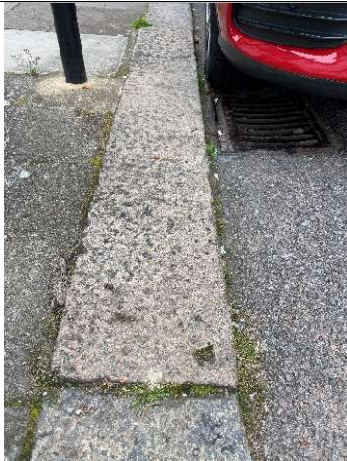
Photo 31  
Sunken gully cover

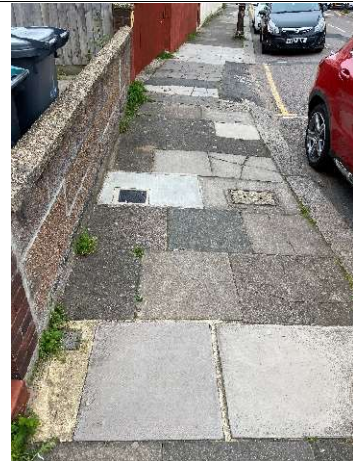
Photo 32  
Footway cracking, footway scarring

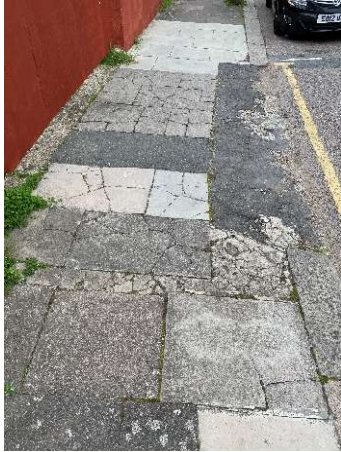
Photo 33

Cracking, footway scarring

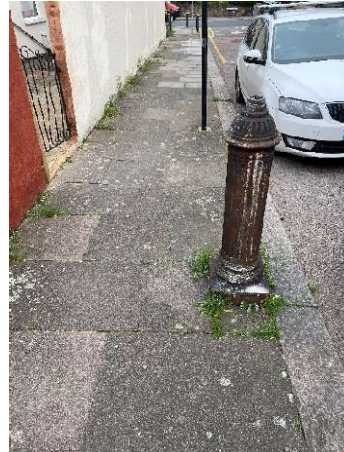
Photo 34

Cracking, rusting sign post base

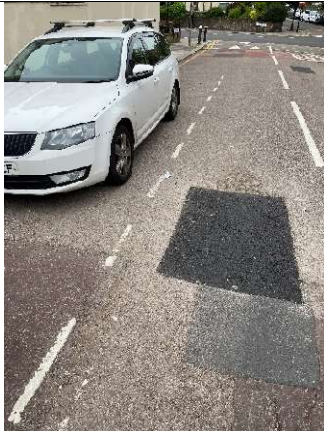
Photo 35

Carriageway scarring, significantly worn road markings, sunken carriageway

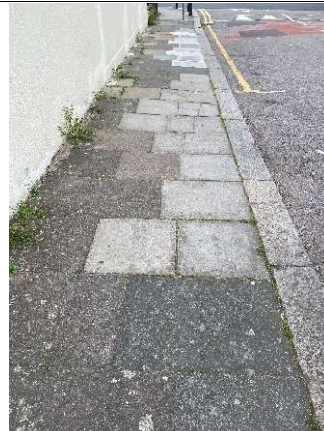
Photo 36

Footway cracking

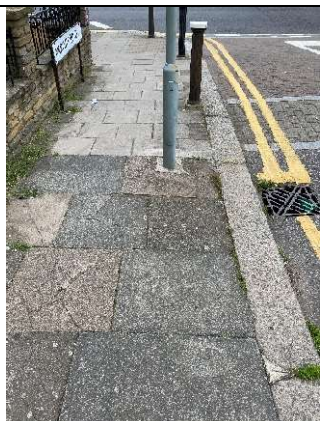
Photo 37

Footway cracking

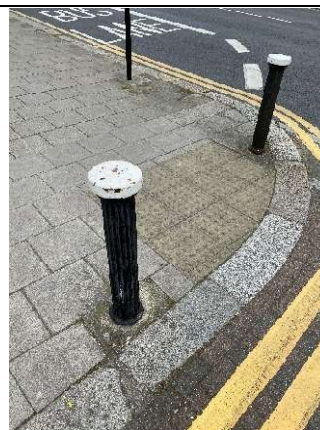
Photo 38

Rusting bollards, footway scarring

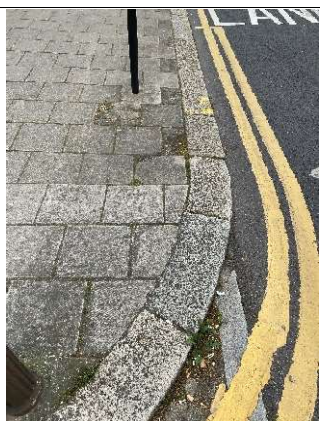
Photo 39

Footway cracking
