Hornsey Library

Supporting Documentation for Fountain Refurbishment

Name: Hornsey Library Fountain

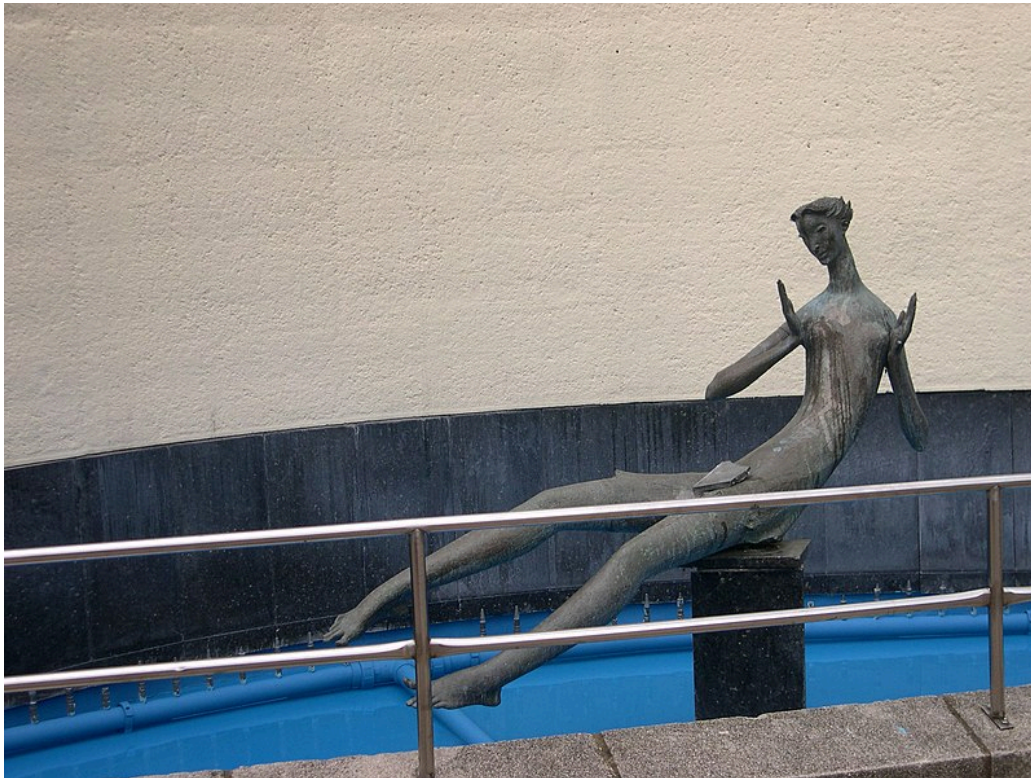
The photograph above, taken in 2009 shows the fountain in much better condition. The paint on the rear wall is still stable and at this time there was only superficial staining on the granite, and the pond and pump system appeared in overall good and operational condition. It appears that some of the granite on the plinth had already been dislodged. This might indicate that the fountain had either been restored previously or that a regular maintenance plan was in place at the time.
