**Haringey Council**

**Schedule of Condition**

**Hornsey Library, Haringey Park, London, N8 9JA**

9 May 2023

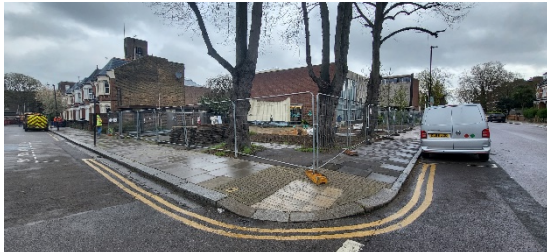
| Item | Description | Condition | Photograph |
|---|---|---|---|
| 2 | Public realm area looking from the corner of Hatherley Gardens and Haringey Park. | Existing footpaths will not form part of the works save for boundary treatment between the two demises. | |

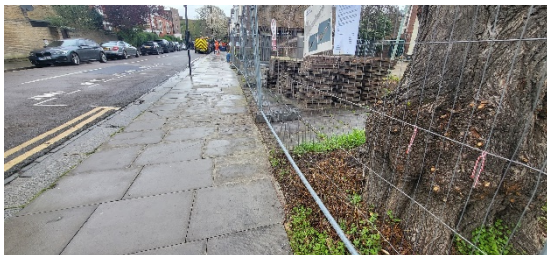
| Item | Description | Condition | Photograph |
|---|---|---|---|
| 3 | Public realm area looking along Hatherley Gardens from Haringey Park. | Boundary treatment required at junction between two sites – potentially new pin edge kerb to be installed. | |

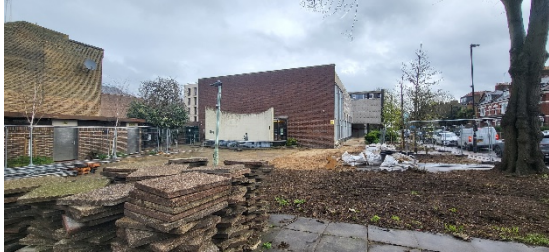
| Item | Description | Condition | Photograph |
|---|---|---|---|
| 4 | Public realm area. | Areas of existing paving have been lifted and retained for re-laying at a later date. Areas of non-listed paving still in-situ awaiting removal. | |

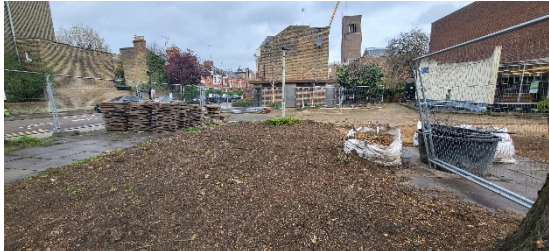
| Item | Description | Condition | Photograph |
|---|---|---|---|
| 5 | Public realm area. | Area of cleared vegetation – previously removed (to be retained) concrete slabs neatly stacked to side. | |

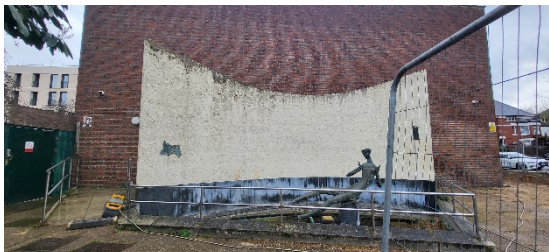
| Item | Description | Condition | Photograph |
|---|---|---|---|
| 6 | Existing fountain and decorative wall to LHS flank elevation of library building. | Fountain has fallen into disrepair and requires work to refurbish, including new lining / pumps / pipework and remedial works to the decorative wall. | |

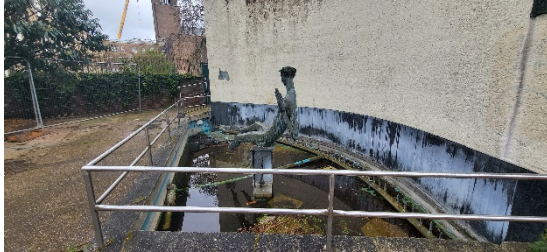
| Item | Description | Condition | Photograph |
|---|---|---|---|
| 7 | Existing fountain. | Existing handrails are to be retained as existing. | |

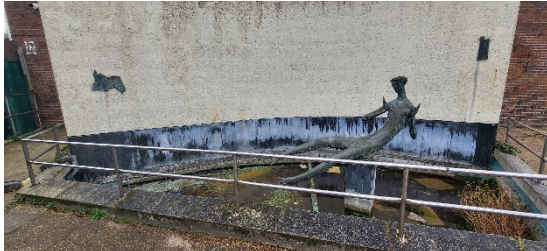
| Item | Description | Condition | Photograph |
|---|---|---|---|
| 8 | Concrete cappings with stainless steel handrails to perimeter of fountain. | A number of the concrete cappings have become dislodged and require lifting and re-setting as part of the refurbishment works. | |

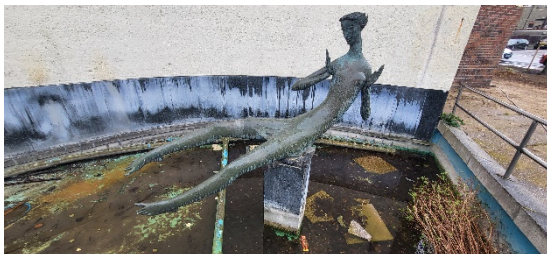
| Item | Description | Condition | Photograph |
|---|---|---|---|
| 9 | Existing structure to fountain area is to be retained and cleaned. | The existing sculpture is to be temporarily removed and cleaned in preparation for re-installation. The existing damaged panelling to the column is to be removed and replaced. | |

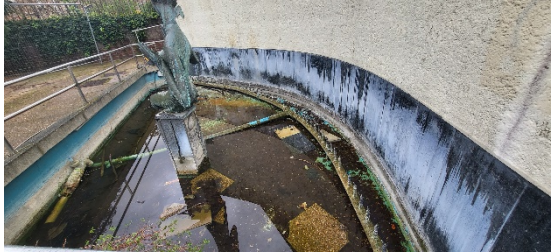
| Item | Description | Condition | Photograph |
|---|---|---|---|
| 10 | Existing panelling to low level at rear of fountain wall. | Existing granite panelling is stained and damaged. The intention would be to remove the granite panels, clean and reinstate after the GRP lining has been installed. Concealed stainless steel brackets / fixings will be fitted, whilst renewing the fountain lining to the rear. | |

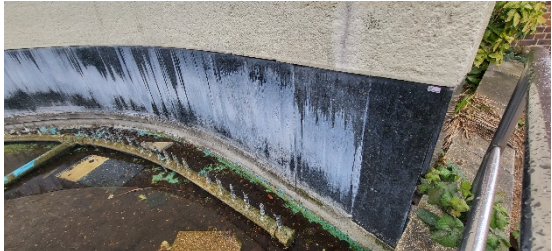
| Item | Description | Condition | Photograph |
|---|---|---|---|
| 11 | Existing panelling to low level at rear of fountain wall. | Existing granite panelling is stained and damaged. The intention would be to remove the granite panels, clean and reinstate after the GRP lining has been installed. Concealed stainless steel brackets / fixings will be fitted, whilst renewing the fountain lining to the rear. | |

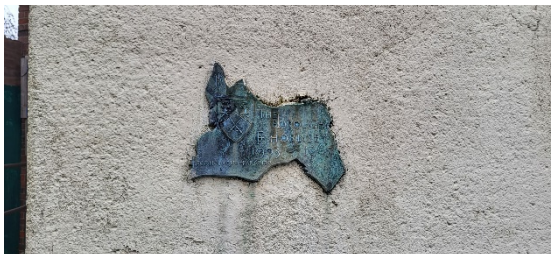
| Item | Description | Condition | Photograph |
|---|---|---|---|
| 12 | Existing plaque fixed to the left hand side of the fountain wall. | Plaque will be temporarily removed to allow works to progress, cleaned and reinstated following remedial works to the rendered wall. | |

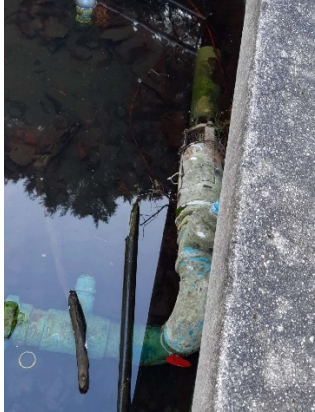
| Item | Description | Condition | Photograph |
|---|---|---|---|
| 13 | Existing pump / fountain pipework. The material makeup of the plumbing is a mixture of uPVC, cast iron, with the jets having a composition of uPVC, copper and rubber. | Pipework is aged and damaged and will be stripped. Pipework will be replaced with new stainless steel, including all water jets to form feature. | |

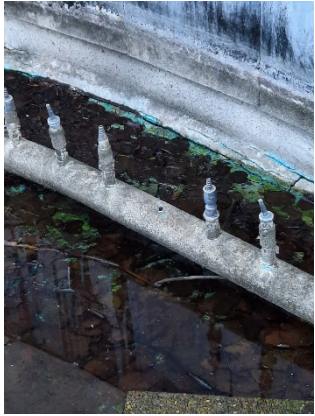
| Item | Description | Condition | Photograph |
|---|---|---|---|
| 14 | Existing pump / fountain pipework. The material makeup of the plumbing is a mixture of uPVC, cast iron, with the jets having a composition of uPVC, copper and rubber. | Pipework is aged and damaged and will be stripped. Pipework will be replaced with new stainless steel, including all water jets to form feature. | |

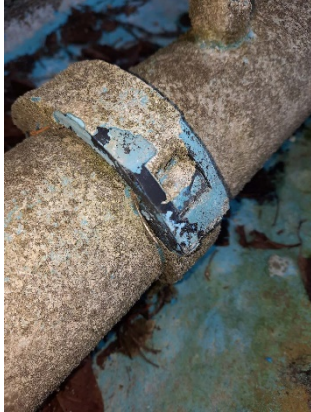
| Item | Description | Condition | Photograph |
|---|---|---|---|
| 15 | Existing pump / fountain pipework. The material makeup of the plumbing is a mixture of uPVC, cast iron, with the jets having a composition of uPVC, copper and rubber. | Pipework is aged and damaged and will be stripped. Pipework will be replaced with new stainless steel, including all water jets to form feature. | |

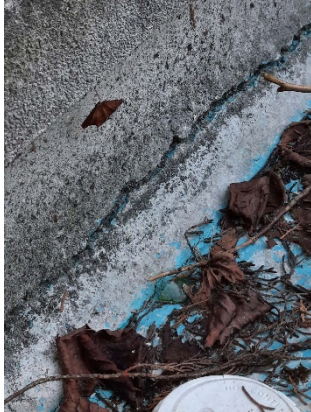
| Item | Description | Condition | Photograph |
|---|---|---|---|
| 16 | Existing pool lining to base of fountain. Existing base is made up of concrete/cement and sand based layer with a liquid membrane as the fountain lining. The base has cracked and moved to the extent that has caused the lining to be void. | Existing pool lining is cracked and damaged in areas and will require stripping out and renewing as part of the refurbishment works. | |

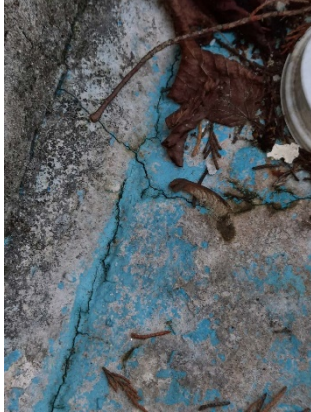
| Item | Description | Condition | Photograph |
|---|---|---|---|
| 17 | Existing pool lining to base of fountain. Existing base is made up of concrete/cement and sand based layer with a liquid membrane as the fountain lining. The base has cracked and moved to the extent that has caused the lining to be void. | Existing pool lining is cracked and damaged in areas and will require stripping out and renewing as part of the refurbishment works. The existing wall panelling is loose and will requires removal / replacing to allow for the new GRP lining to the fountain. The panelling will be reinstated over the existing lining. | |

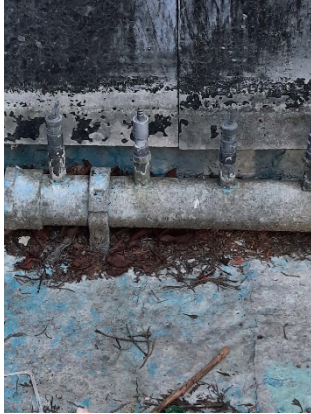
| Item | Description | Condition | Photograph |
|---|---|---|---|
| 18 | Existing pump / fountain pipework. | Pipework is aged and damaged and will be stripped out and replaced with new as part of the proposed refurbishment works. New GRP lining will be installed to match existing blue coloured lining. | |

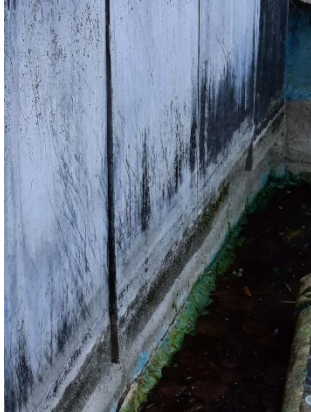
| Item | Description | Condition | Photograph |
|---|---|---|---|
| 19 | Existing wall panelling to the rear face of the fountain. | The existing wall panelling is loose and will require removal / replacing to allow for the new GRP lining to the fountain. The panelling will be reinstated over the existing lining. | |

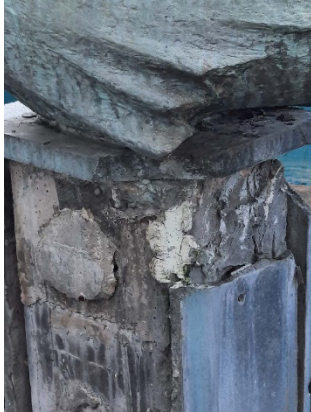
| Item | Description | Condition | Photograph |
|---|---|---|---|
| 20 | Pedestal supporting sculpture in fountain is damaged and requires remedial works. | Sculpture will be temporarily removed to allow for the removal of the damaged panels and replacement prior to re-installation of sculpture. | |

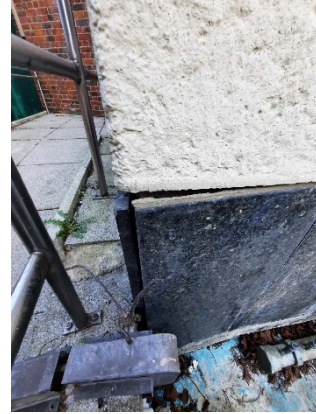
| Item | Description | Condition | Photograph |
|---|---|---|---|
| 21 | Existing wall panelling to the rear face of the fountain. | The existing wall panelling is loose and will require removal / replacing to allow for the new GRP lining to the fountain. The panelling will be reinstated over the existing lining. | |

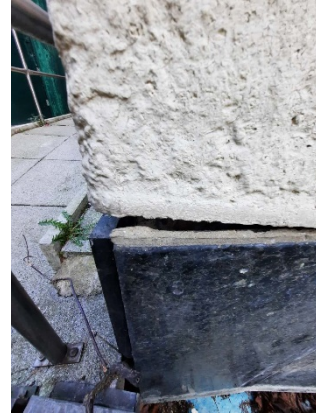
| Item | Description | Condition | Photograph |
|---|---|---|---|
| 22 | Existing wall panelling to the rear face of the fountain. | The existing wall panelling is loose and will require removal / replacing to allow for the new GRP lining to the fountain. The panelling will be reinstated over the existing lining. | |

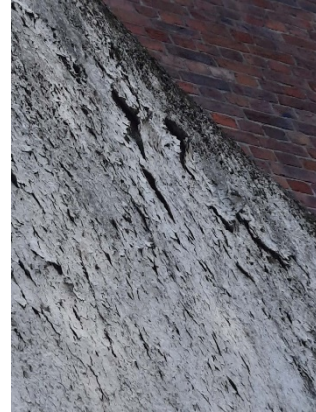
| Item | Description | Condition | Photograph |
|---|---|---|---|
| 23 | Decorations to render on rear wall of fountain. | Decorations are in poor condition and require rubbing back and re-painting with suitable paint. The wall will be DOFF cleaned and prepared for new wall coating. colour to match existing. | |

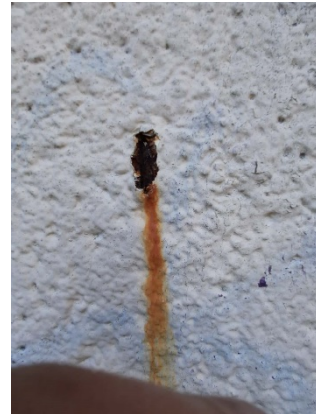
| Item | Description | Condition | Photograph |
|---|---|---|---|
| 24 | Render finish to rear wall of fountain has cracked and allowed oxidation of steel reinforcement to rear wall of fountain | Remedial works will be required to the reinforcement to seal and protect prior to repairing and decorating. The repair is circa 50mm x 15mm. | |

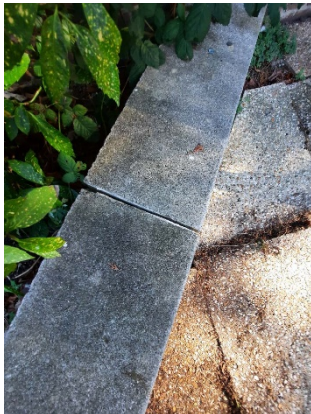
| Item | Description | Condition | Photograph |
|---|---|---|---|
| 25 | Concrete capping stones to perimeter of the fountain pool. | Capping stones are in reasonable condition, however, a number have become dislodged and will require lifting and re-setting / re-pointing as part of the refurbishment works. | |

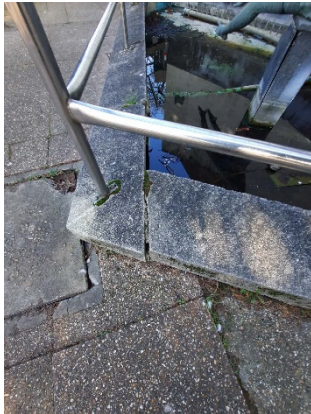
| Item | Description | Condition | Photograph |
|---|---|---|---|
| 26 | Concrete capping stones to perimeter of the fountain pool. | Capping stones are in reasonable condition, however, a number have become dislodged and will require lifting and re-setting / re-pointing as part of the refurbishment works. | |

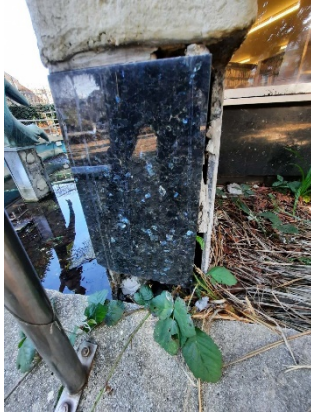
| Item | Description | Condition | Photograph |
|---|---|---|---|
| 27 | Existing wall panelling to the rear face of the fountain. | The existing wall panelling is loose and will require removal / replacing to allow for the new GRP lining to the fountain. The panelling will be reinstated over the existing lining. | A photograph showing a dark, rectangular panel of wall panelling that is loose and tilted away from the wall. It is situated at the base of a structure, possibly a fountain, with some green plants and debris visible at the bottom. |

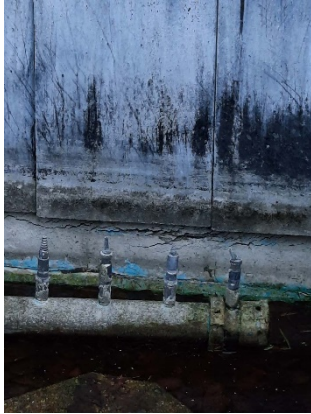
| Item | Description | Condition | Photograph |
|---|---|---|---|
| 28 | Existing pool lining to base of fountain. | Existing base is made up of concrete/cement and sand based layer with a liquid membrane as the fountain lining. The base has cracked and moved to the extent that has caused the lining to be void. | A photograph showing a close-up of the base of a fountain. The surface is a light-colored, textured material (concrete/cement) with visible cracks and a dark, possibly liquid membrane, lining. Several small, dark, cylindrical objects are visible along the edge of the base. |

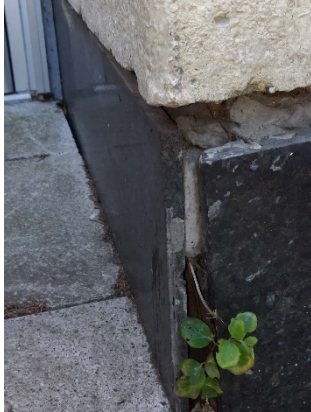
| Item | Description | Condition | Photograph |
|---|---|---|---|
| 29 | Existing wall panelling to the rear face of the fountain. | The existing wall panelling is loose and will require removal / replacing to allow for the new GRP lining to the fountain. The panelling will be reinstated over the existing lining. | |

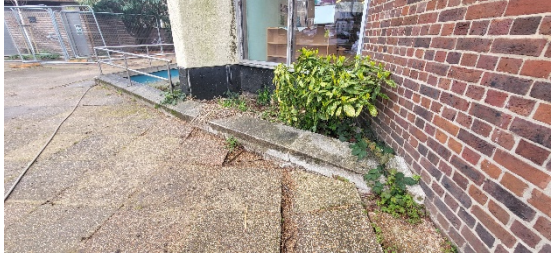
| Item | Description | Condition | Photograph |
|---|---|---|---|
| 30 | Public realm area. | Areas of existing paving have been lifted and retained for re-laying at a later date. Areas of non-listed paving still in-situ awaiting removal. Paving from the Square to be lifted and used to repair the frontage. New pavers to be installed to the square as agreed with the Conservation officer. | |

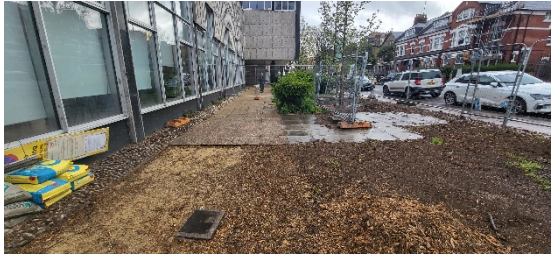
| Item | Description | Condition | Photograph |
|---|---|---|---|
| 31 | Public realm area. | Areas of existing paving have been lifted and retained for re-laying at a later date. Areas of non-listed paving still in-situ awaiting removal. Paving from the Square to be lifted and used to repair the frontage. New pavers to be installed to the square as agreed with the Conservation officer. | |

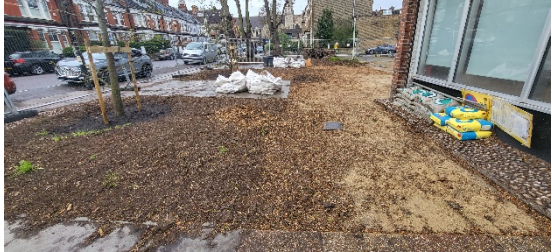
| Item | Description | Condition | Photograph |
|---|---|---|---|
| 32 | Public realm area. | Areas of existing paving have been lifted and retained for re-laying at a later date. Areas of non-listed paving still in-situ awaiting removal. Paving from the Square to be lifted and used to repair the frontage. New pavers to be installed to the square as agreed with the Conservation officer. | |

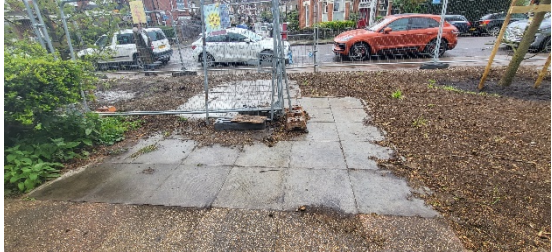
| Item | Description | Condition | Photograph |
|---|---|---|---|
| 33 | Public realm area. | Area of existing paving that is to be lifted and re-laid with the retained listed slabs. Areas to the left of the library, adjacent to the fountain and leading towards Hatherley avenue will be installed with New paving as agreed with the Conservation Officer. | |

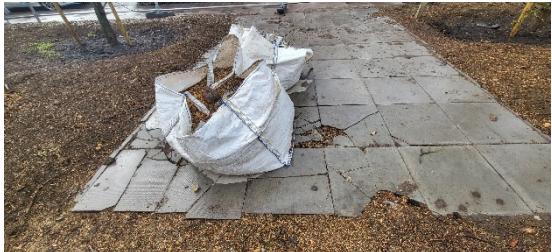
| Item | Description | Condition | Photograph |
|---|---|---|---|
| 34 | Public realm area. | Area of existing paving that is to be lifted and replaced with new slabs as agreed with the Conservation Officer. | |

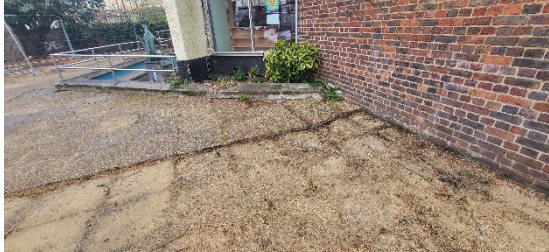
| Item | Description | Condition | Photograph |
|---|---|---|---|
| 35 | Public realm area. | Area of existing paving that is to be lifted and replaced with new slabs as agreed with the Conservation Officer. | |

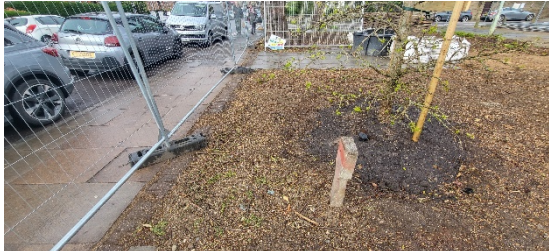
| Item | Description | Condition | Photograph |
|---|---|---|---|
| 36 | Public realm – trees. | A number of large trees on the boundary to Haringey Park have been removed and replaced with new saplings – bark laid to perimeter. Planters to be retained per the existing layout. | |

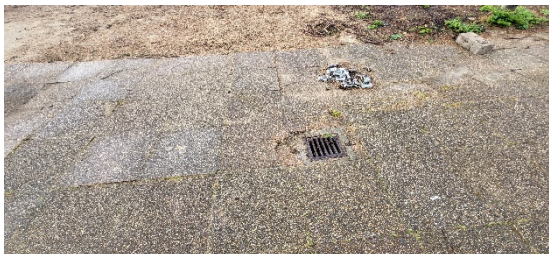
| Item | Description | Condition | Photograph |
|---|---|---|---|
| 37 | Public realm area. | Areas of existing paving have been lifted and retained for re-laying at a later date. Works will include for re-flaunching around road gullies etc. 2 new gullies to be added to the ensure drainage is adequate as area is susceptible to flooding. | |

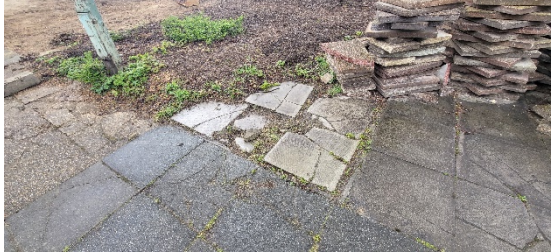
| Item | Description | Condition | Photograph |
|---|---|---|---|
| 38 | Public realm area. | Areas of defective existing paving will be lifted and removed from site. New slabs will be laid in agreement with the Conservation Officer. | |

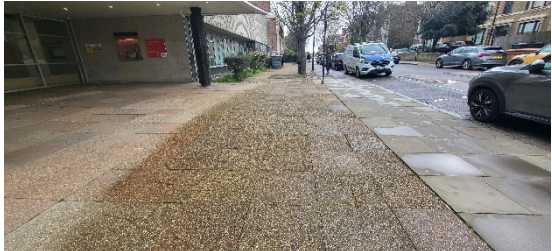
| Item | Description | Condition | Photograph |
|---|---|---|---|
| 39 | Public realm area to front entrance. | Areas of defective existing paving will be lifted and removed from site. Replacement slabs taken from the square will be used to in-fill any spaces to this area in agreement with the Conservation Officer. | |

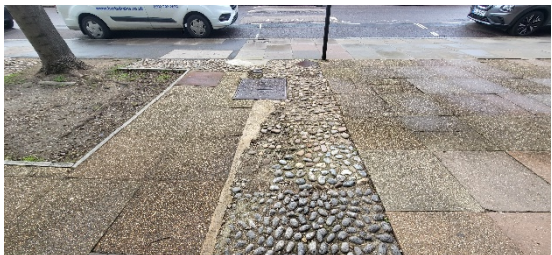
| Item | Description | Condition | Photograph |
|---|---|---|---|
| 40 | Existing cobble stone finish on walkway adjacent to front elevation. | Area of cobble stones in reasonable condition – some areas will be lifted and re-laid to match the original. | |

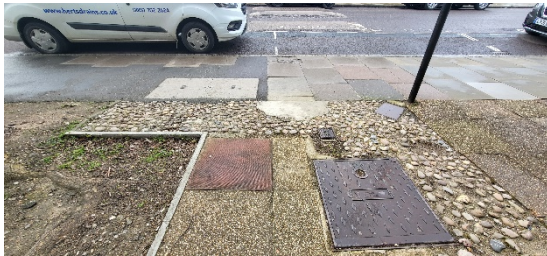
| Item | Description | Condition | Photograph |
|---|---|---|---|
| 41 | Existing cobble stone finish on walkway adjacent to front elevation. | Area of cobble stones in reasonable condition – some areas will be lifted and re-laid to match the original. | |

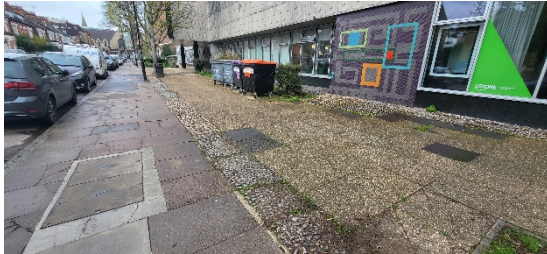
| Item | Description | Condition | Photograph |
|---|---|---|---|
| 42 | Public realm area to front entrance. | Areas of existing paving have been lifted and retained for re-laying at a later date. Any defective slabs in this area will be lifted and replaced with those removed from other areas. | |

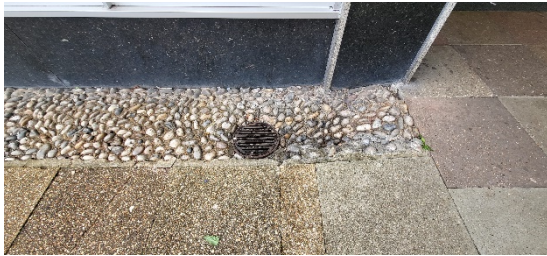
| Item | Description | Condition | Photograph |
|---|---|---|---|
| 43 | Existing cobble stone finish on walkway adjacent to front elevation. | Area of cobble stones in reasonable condition – some areas will be lifted and re-laid to match the original. | |
