**CCTV REPORT FOR: 9 GRAND AVENUE  
LONDON  
N10 3AY**

**Insured:** Mr. John Illman  
**Reference:** LIV-SN-22-005397

**Site Visit:** 20-Jan-23  
**Report Date:** 14-Apr-23

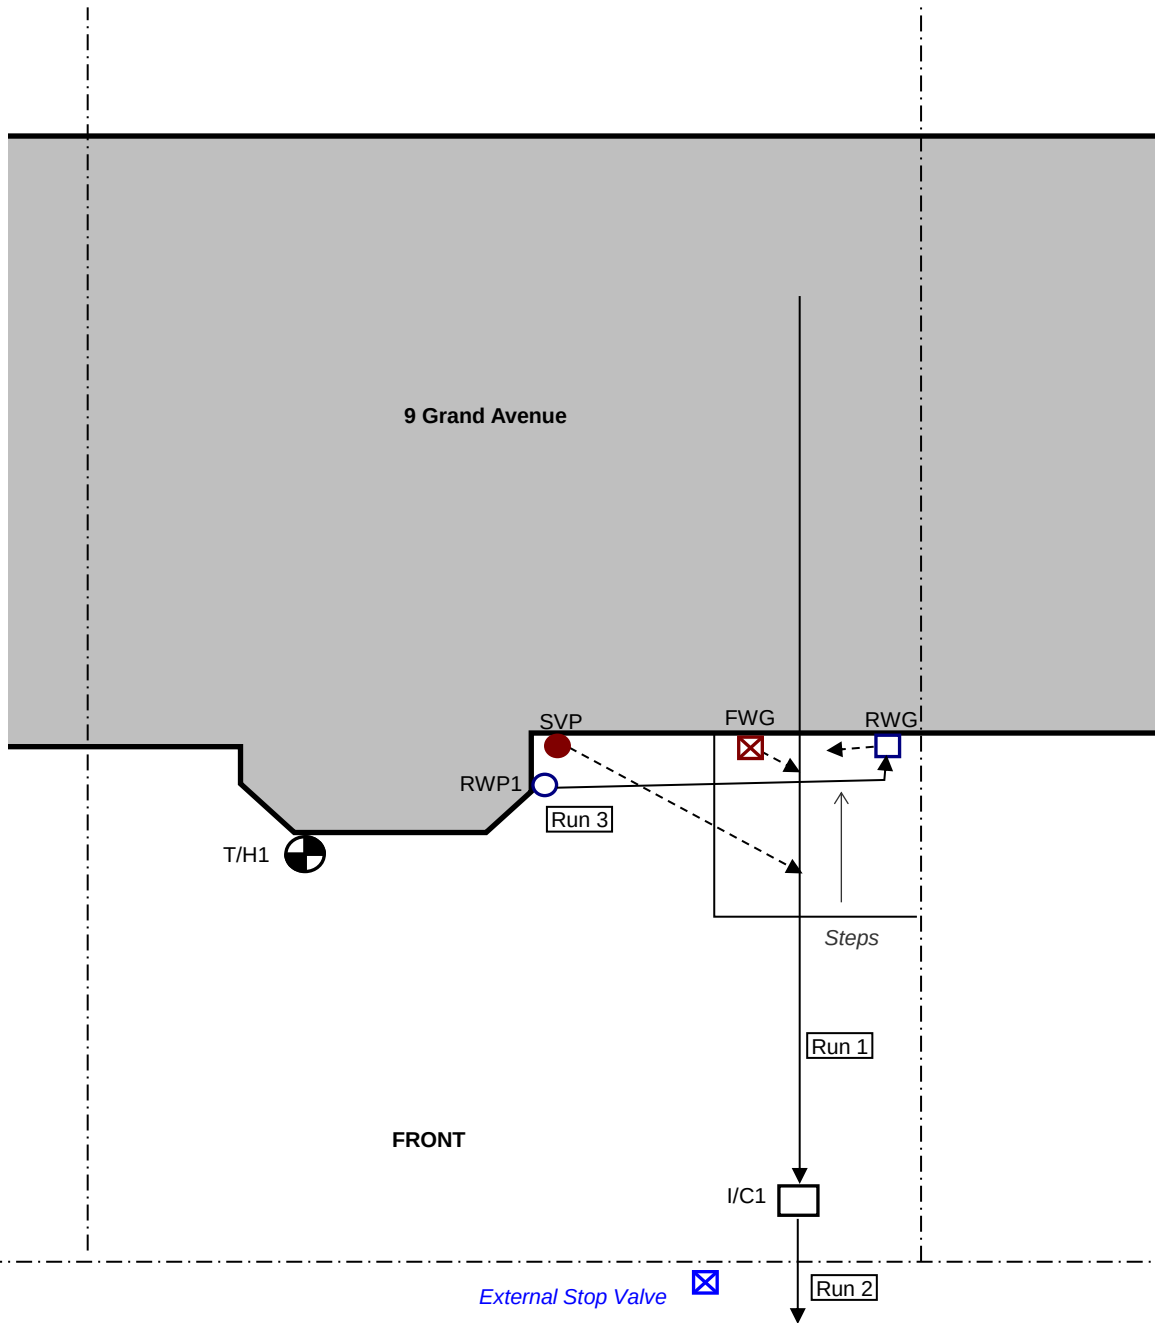
**Key :**  
  = Storm Gully  
  = Storm Pipe  
  = Foul Gully  
  = W/C or Soil Pipe  
  = Inspection Chamber  
 = Rodding Eye  
 = Surveyed pipe indicating flow  
 = Unsurveyed pipe  
 = Exploratory Hole (hand dug pit and/or hand auger)  
 = Boundary line  
 = Hedges & Shrubs  
 = Trees & bushes  
 = Area of damage

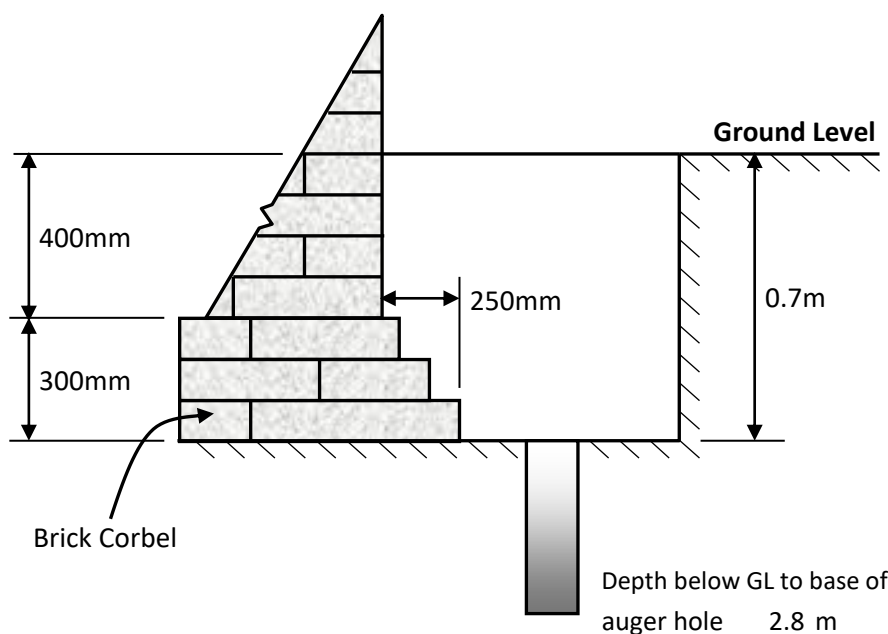
### Foundation Cross Section

**Location:** Front bay window

### Roots Depth & Diameter:

From 0.8m

Down to 2.3m

None observed on site

Hole at instructed depth

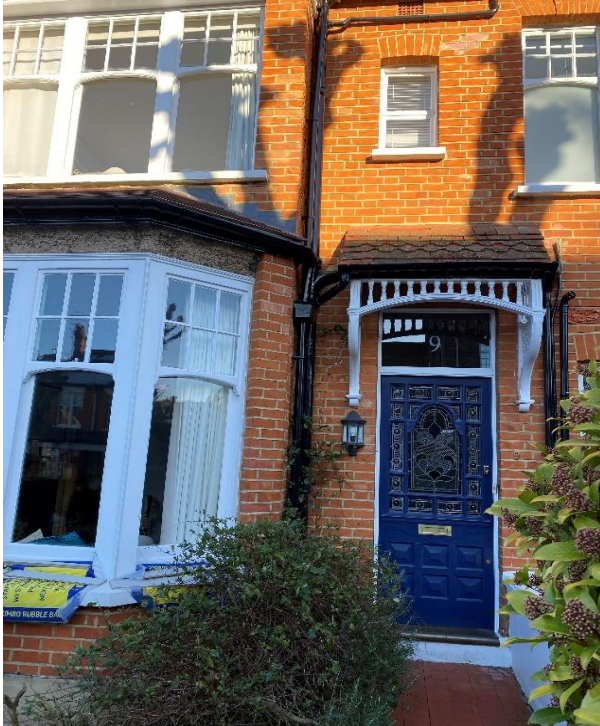
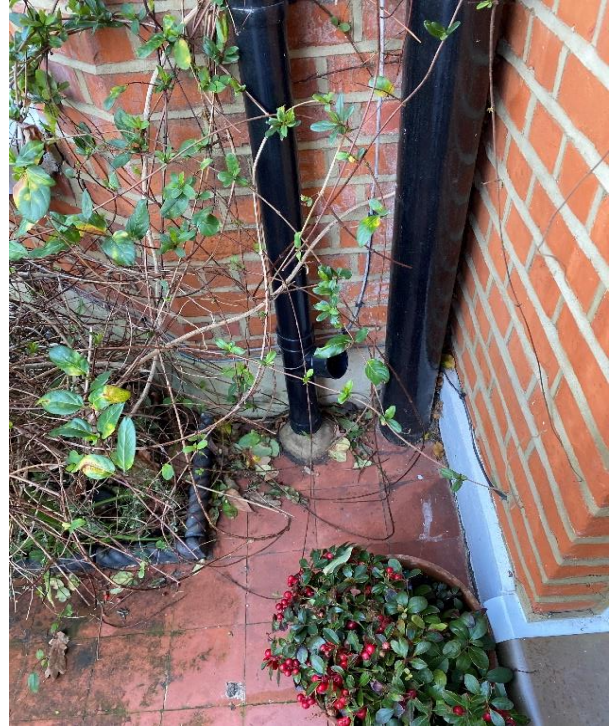
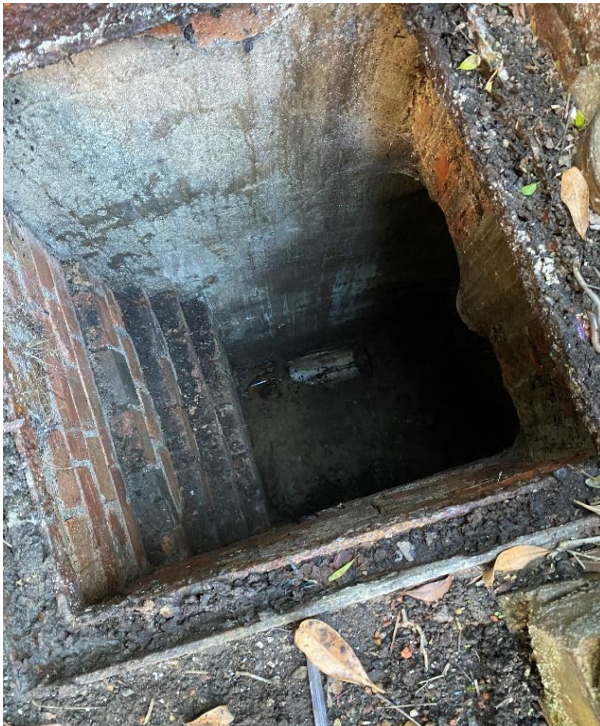
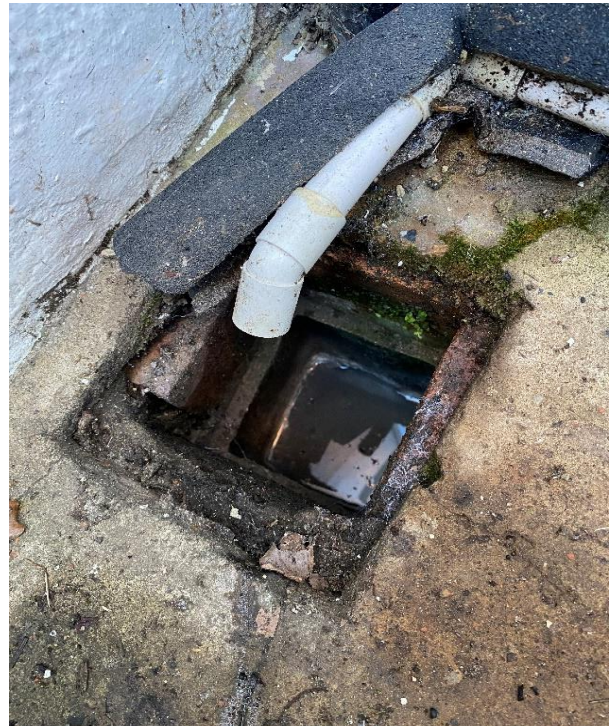
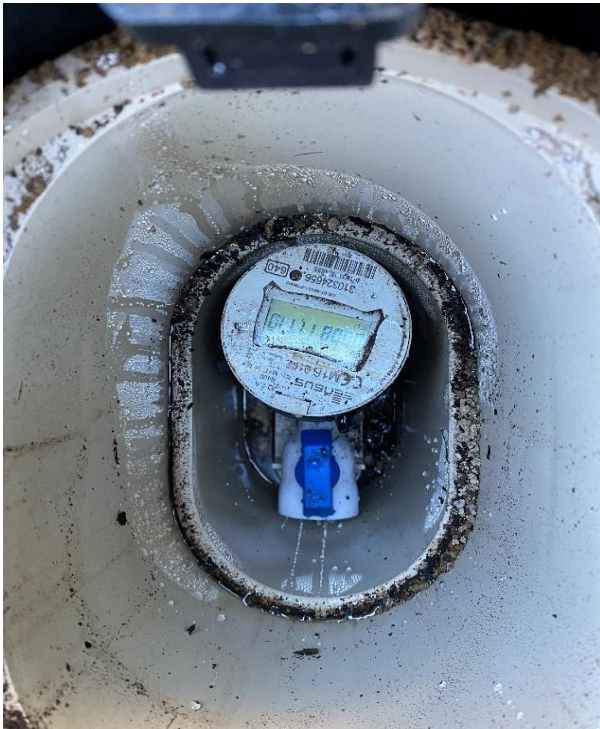
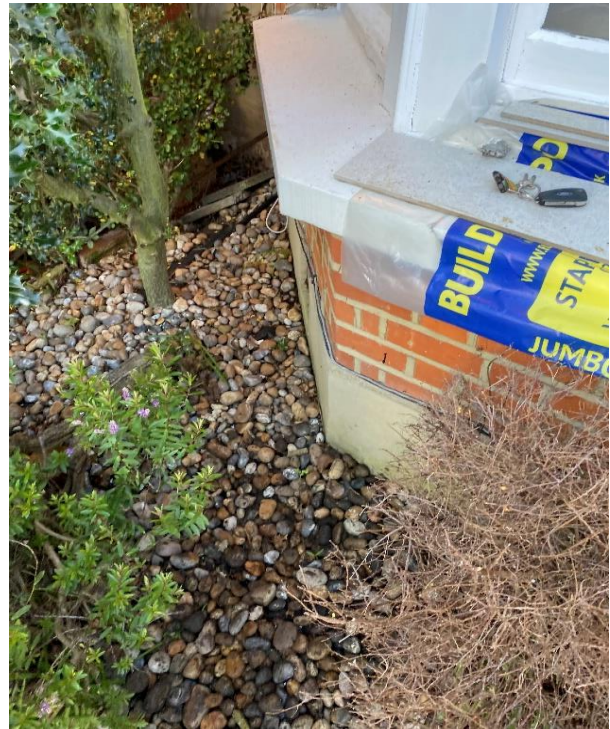
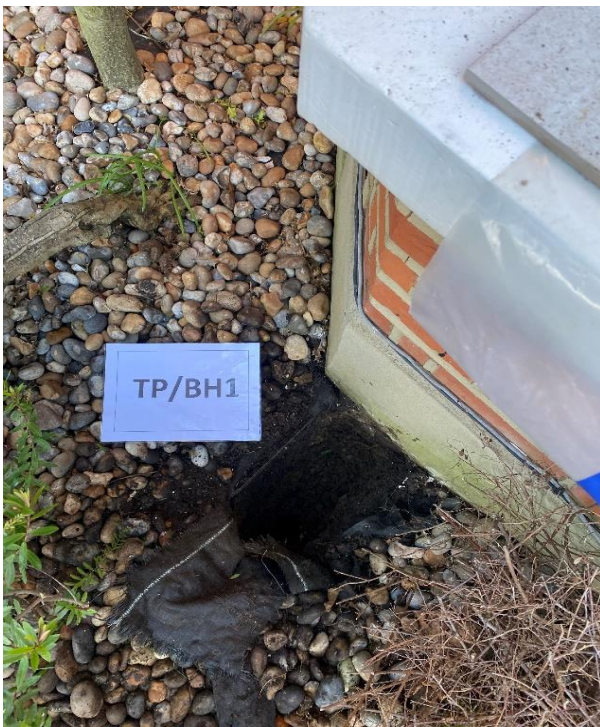
Cracked section

Multiple cracks and large displaced joint

Carry out high pressure water jetting to prepare pipework for lining. Install a patch liner from I/C1 upstream at 9.5m

Carry out high pressure water jetting to prepare pipework for lining. Install a patch liner from I/C1 downstream to the boundary. 150mm patch liner.

Excavate and replace rest bend to RWP allowing for up to 1.0m of pipework downstream  
Carry out high pressure water jetting to prepare pipework for lining. Install a structural liner from excavation downstream for 5m. Flexible liner required.

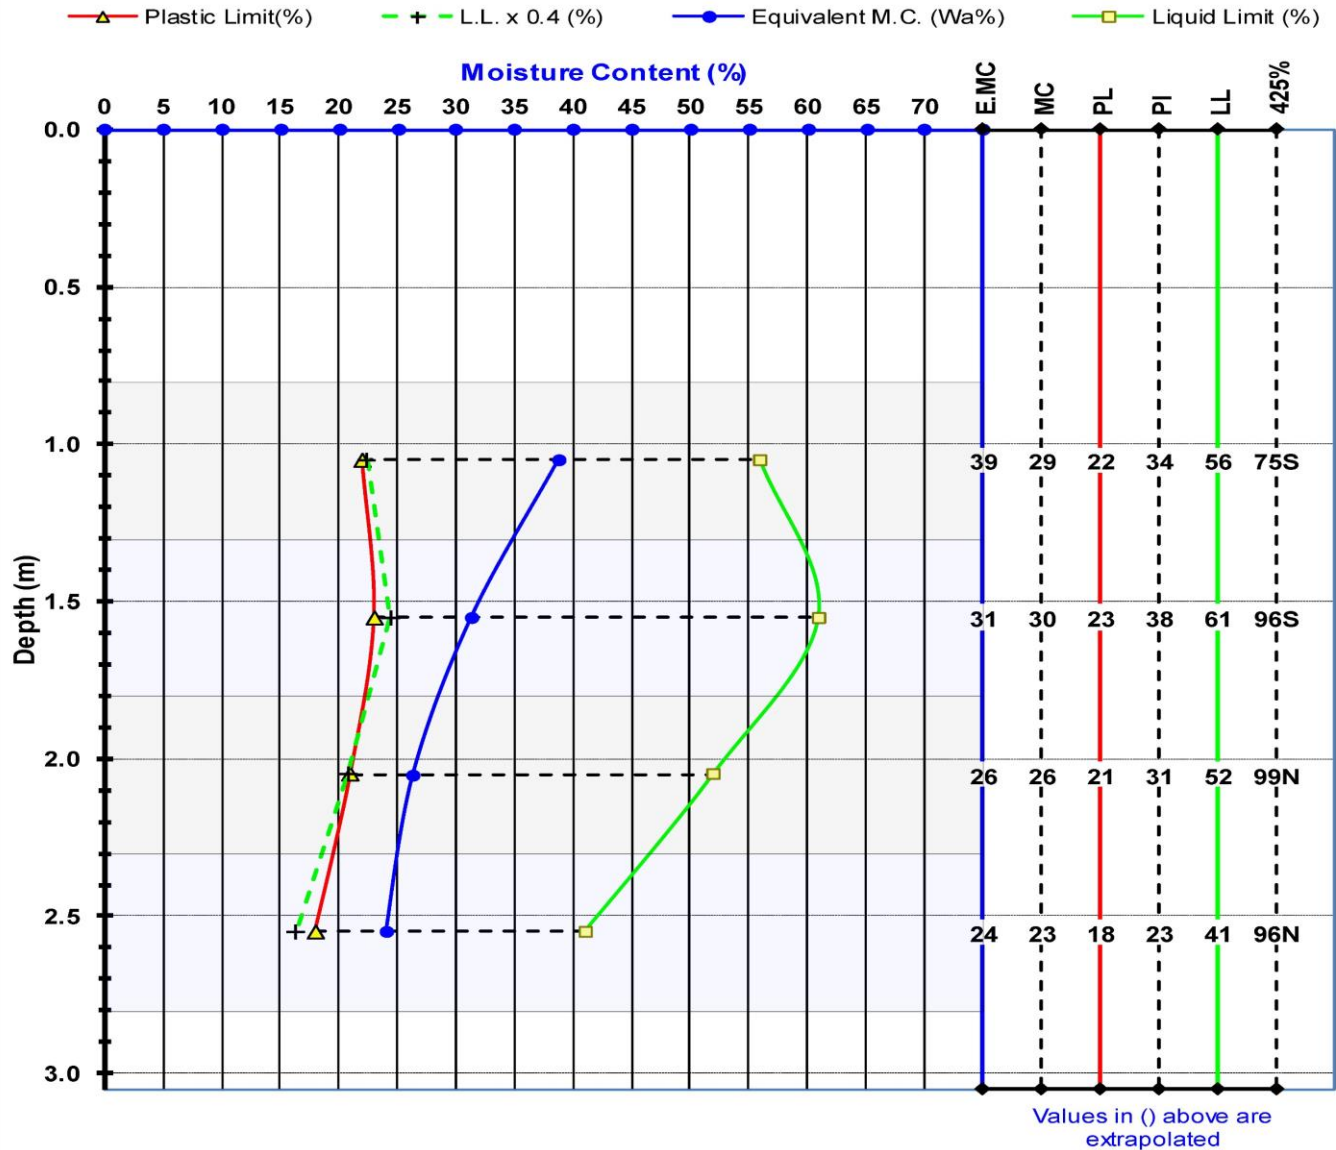
| Depth<br>T (m) | Depth<br>B (m) | 1 - Front bay window | Plasticity<br>(BS 5930) | Volume Change | |
|---|---|---|---|---|---|
| 0.8 | 1.3 | Soft brown slightly sandy CLAY with some medium gravel (inc. (mainly fill ) | High CH | 26% | Medium |
| 1.3 | 1.8 | Soft/firm brown CLAY with occasional medium gravel (inc. fill ) | High CH | 36% | Medium |
| 1.8 | 2.3 | Soft/firm brown CLAY with rare medium gravel | High CH | 31% | Medium |
| 2.3 | 2.8 | Soft/firm brown CLAY with rare medium gravel | Intmd. CI | 22% | Medium |
