## **ARBORICULTURAL SURVEY (Health & Safety)**

| <b>OUR REFERENCE</b> | 183720/PRO |
| <b>SITE</b> | 12 Shepherds Hill, London, N6 5AQ. |
| <b>DATE</b> | 2 <sup>nd</sup> February 2022 |

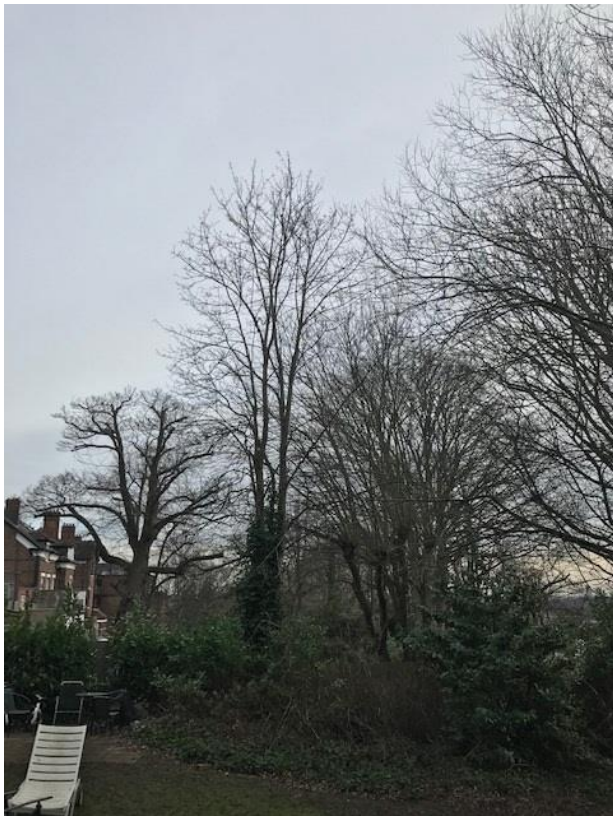
Photograph 1: Showing tree T1

| Survey Comment: Located adjacent to boundary with number 14. Twin stemmed from approximately 0.5m. Ivy dense to a height of 4m. 1 dead branch over shrubs. | | | | | | | | | | | | |
| | | No visual defects | | | Ivy covered | | Minor dead wood | | Normal | | | |

| Tree ID | Common Name | Recommendations | Priority |
|---|---|---|---|
| T1 | Sycamore | Sever and remove a 300mm section to allow for it to naturally die back. | 1 year |

| | | Ivy | | | Sever only | | | | | | 1 year | No |

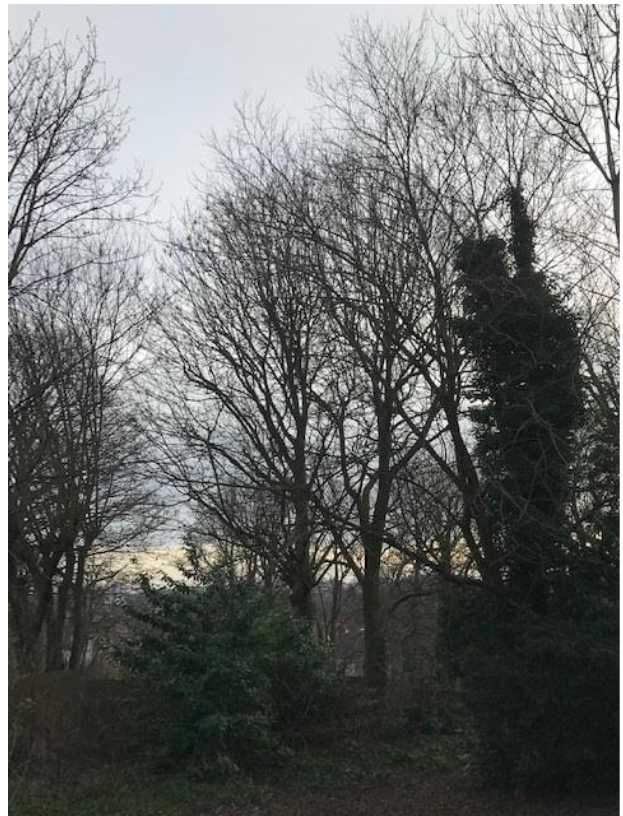
Photograph 2: Showing trees T2 and T3.

| | | | | | | Survey Comment: Located along boundary with number 14. No signs of ill health or significant structural defects. Crown of tree previously reduced with re-growth measuring up to 3m. | | | | | |

| Tree Comment:<br>Survey Comment: Located along boundary with number 14. No signs of ill health or significant structural defects. Crown of tree previously reduced with re-growth measuring up to 4m. | | | | | | | | | | | | |

| Tree ID | Common Name | Recommendations | Priority |
|---|---|---|---|
| T2 | Sycamore | Reduce crown back to previous pruning points leaving the smaller growth to retain foliage. | 2 Years |
| T3 | Common Ash | Reduce crown back to previous pruning points leaving the smaller growth to retain foliage. | 2 Years |

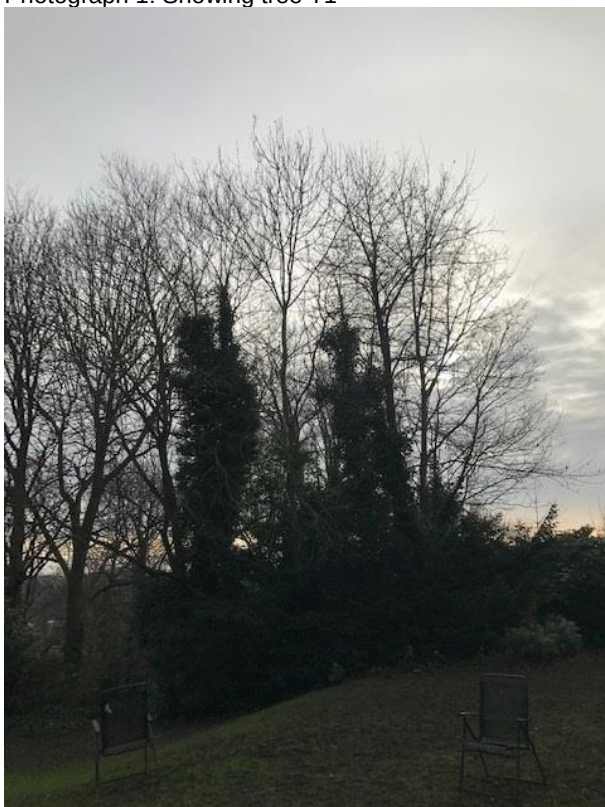
Photograph 3: Showing trees T4 to T11 forming central group.

| Survey Comment: Located on rear perimeter. Dense ivy growing over the whole tree. Evidence of previous stem failure. Fell as most cost effective long term management solution. | | | | | | | | | | | | |

| Survey Comment: Self-set drawn up specimen located to rear of large tree group in shrub bed to rear of site. Ivy becoming dense on trunk. | | | | | | | | | | | | |

| Survey Comment: Dead self set specimen growing up in middle of larger tree group. Dense ivy on stem. Tree within crown of adjacent cherry. | | | | | | | | | | | | |

| Tree ID | Common Name | Recommendations | Priority |
|---|---|---|---|
| T4 | Common Elder | Fell to ground level | 1 year |
| T6 | Sycamore | Sever and remove a 300mm section to allow for it to naturally die back. | 1 year |

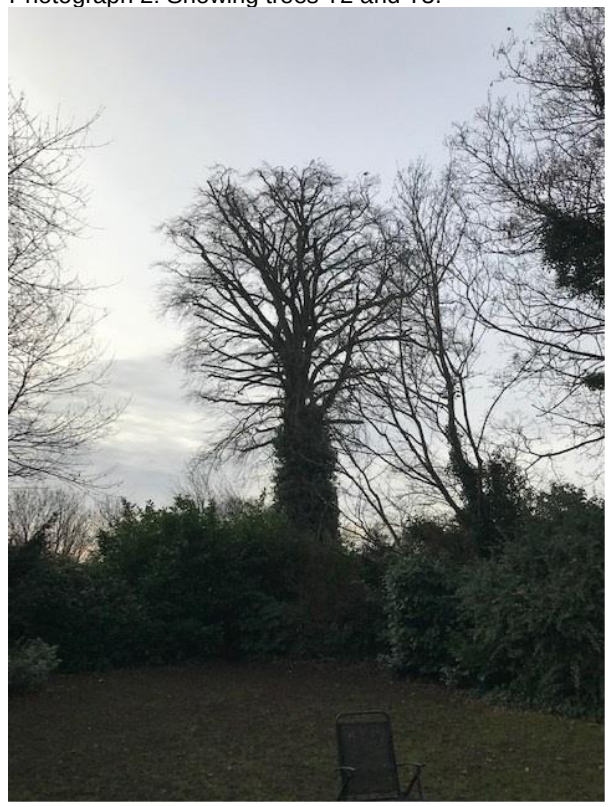
Photograph 4: Showing tree T12

| Tree ID | Common Name | Recommendations | Priority |
|---|---|---|---|
| T12 | Common Beech | Sever ivy and remove to a height of 2m to allow for a full inspection. | 3 Months |

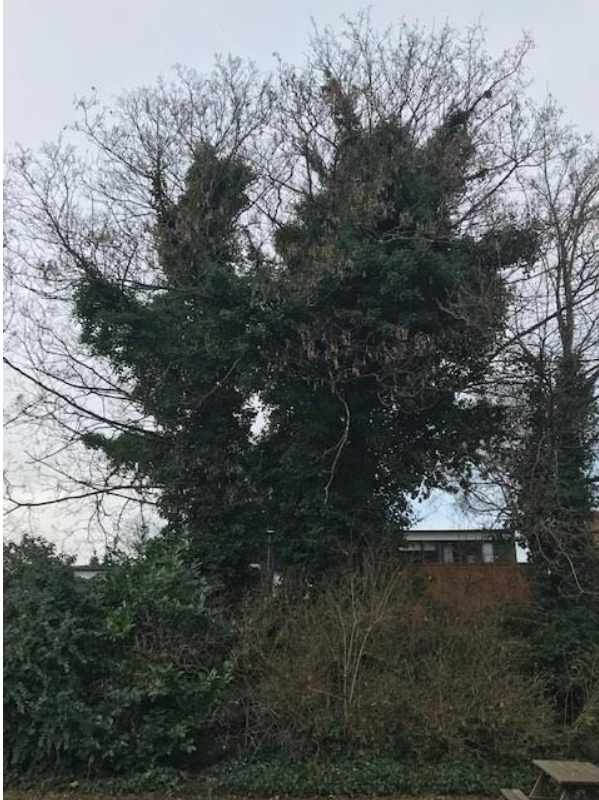
Photograph 5: Showing group G14

| <b>Tree ID: G14</b> | Sycamore<br><i>Acer pseudoplatanus</i> | <b>Tag:</b><br><b>TPO:</b><br><b>Tree Comment:</b><br><b>Survey Comment:</b> 3 no. specimens located along western boundary and adjacent to wall. Dense ivy from base into crown preventing full assessment. Sever ivy and remove up to 1.5m and allow to die back. Once ivy removed and dying g back re-inspect. Wall appears damaged and resting on trunks of trees. | <b>Assessor:</b> Paul Roberts<br><b>Date:</b> 28-Jan-22 |

| Details | Height | Spread | Stems | Ø | Maturity | Bat | Con Area | Prev Insp | Next Due | Condition |
|---|---|---|---|---|---|---|---|---|---|---|
| | No visual defects | Ivy covered | Minor dead wood<br>Ivy in crown | Normal | | | | | | |

| Tree ID | Common Name | Recommendations | Priority |
|---|---|---|---|
| G14 | Sycamore | Sever ivy and remove to a height of 2m to allow for a full inspection. | 3 Months |

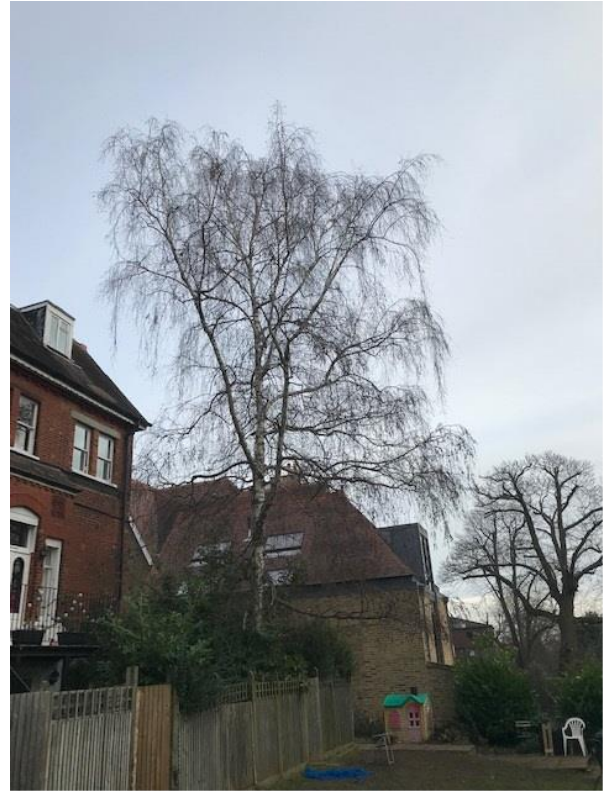
Photograph 5: Showing tree T17
