# Condition 5

## Cleaning trials

### Existing louvred timber turret

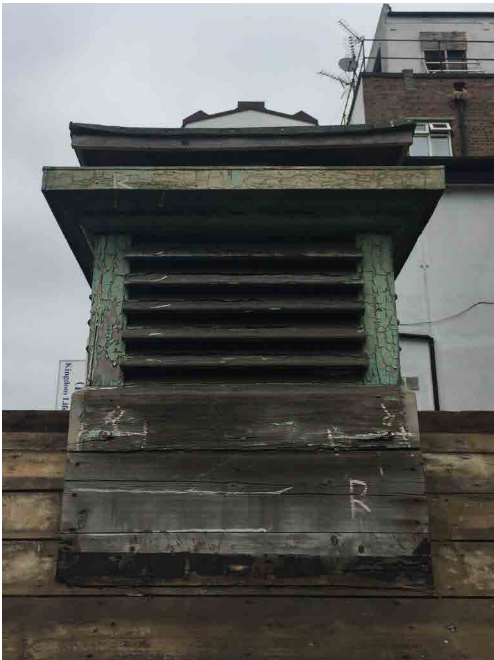
5.1  
South-east elevation  
Timber mostly in sound condition, small  
localised repairs marked  
Paint removal commenced, to be repaired and  
redecorated in line with method statements
