**47 NORTH ROAD, LONDON N6 4BE**  
**SUPPLEMENTARY DESIGN AND ACCESS STATEMENT IN CONNECTION WITH**  
**LISTED BUILDING CONSENT APPLICATION HGY 2022/4382**

This statement was prepared by Jon Bolter BA Arch AA Dip Cons AABC following a site inspection on 11 May 2023. The weather was bright at the time of the inspection.

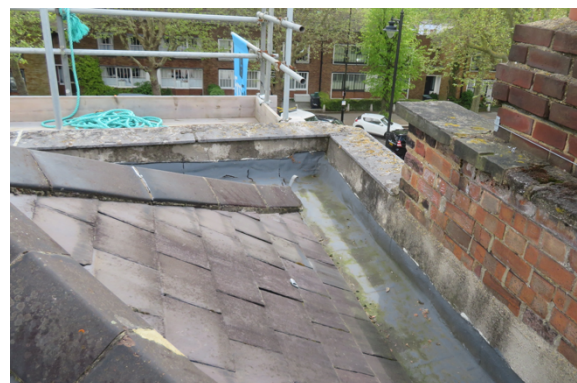
The hipped end of the front roof looking east. Note the Portland stone coping to the front parapet and disturbance to the slating.

The colour of the slates suggests that they are from the Penrhyn quarry. Although there is little decay evident in the slates, a considerable number have been damaged and replacements are now held on clips. The damage appears to have been mechanical damage and is particularly evident in the bottom three courses of the slating suggesting that they were taken up and poorly refixed during repair works to the gutter linings. The limited extent of weathering suggests that the slates were new when installed, probably in the mid to late 20<sup>th</sup> century.

Installation of the lead gutter lining will require the lowest three courses of slates to each roof slope to be removed and refixed. The roof slopes are only seven courses high and so we strongly recommend that all of the slates should be removed, sound slates set aside for reuse and that the roof then be recovered with the set aside slates and new natural slates of similar colour and size. Removing and relaying all of the slates makes it possible to fix all of the slates with two fixings to each slate, which is not possible with partial replacement.

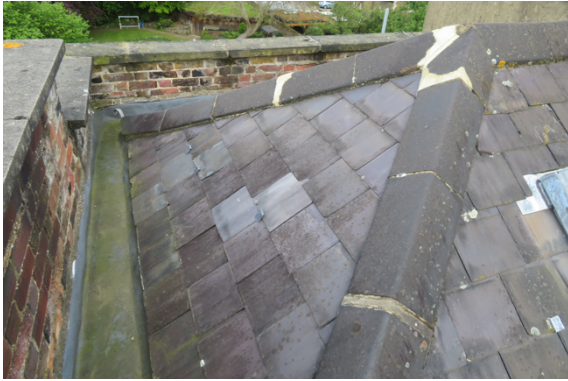
Southern hip to the rear roof looking west. Note York stone parapet copings, mortar infill to the hip tiles and slates held on clips.

The clay hip and ridge tiles are in fair condition but there are a number of areas where missing or damaged parts have been made up in mortar and the junction of the hips with the ridge is poorly formed.

The clay hip and ridge tiles should be removed and reset. It is likely that some will require replacement which should be done with matching tiles.

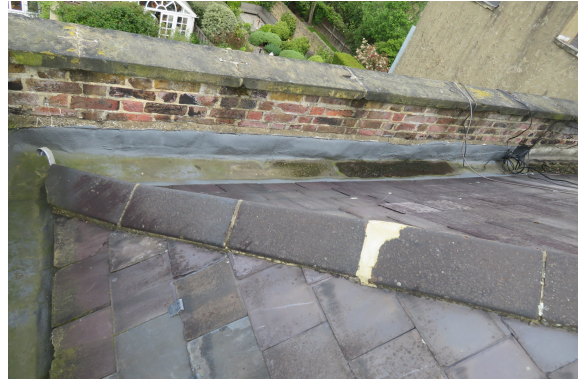
Rear parapet gutter.

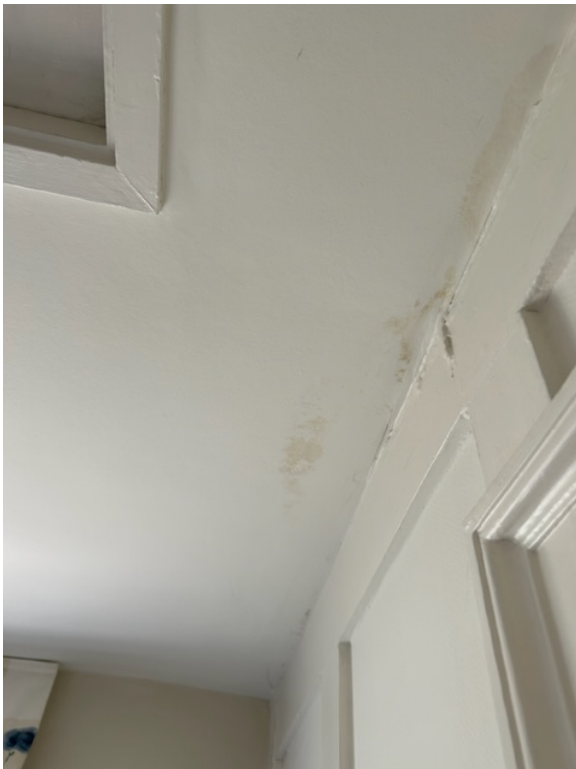
Damp staining on second floor ceilings.

The asphalt has deep cracking. A recent overcoating in bituminous material has proved unsuccessful. Damp staining to the top floor ceilings is generally located below the asphalt linings.

It is clear that the asphalt linings require replacement. There is water damage evident on the ceilings below. Asphalt is not a good material for use on a flexible timber roof such as this and cracking is almost inevitable. The proposal is, therefore, to replace the asphalt coverings with lead. This will require replacement or repositioning of the layboards below the asphalt, which are likely to have been damaged by water penetration through the asphalt, in order to provide the falls and levels required by current guidance on the installation of lead to roofs.

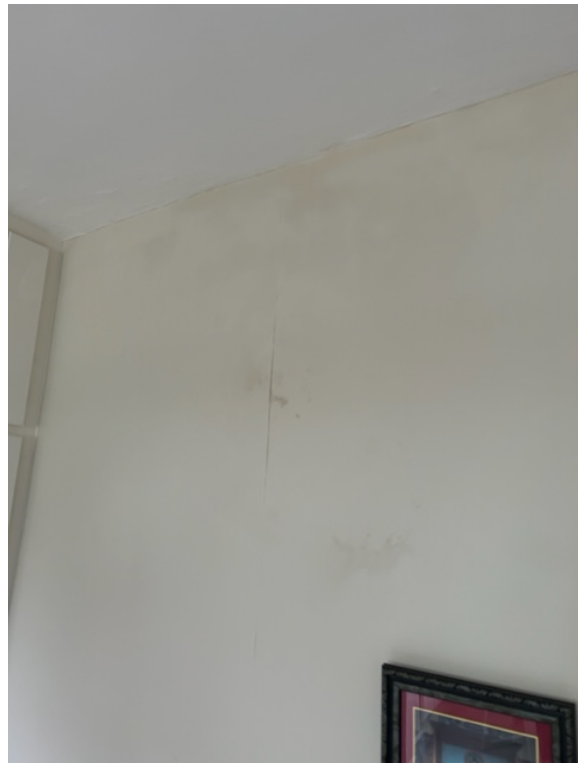
Damp staining extending onto second floor walls.

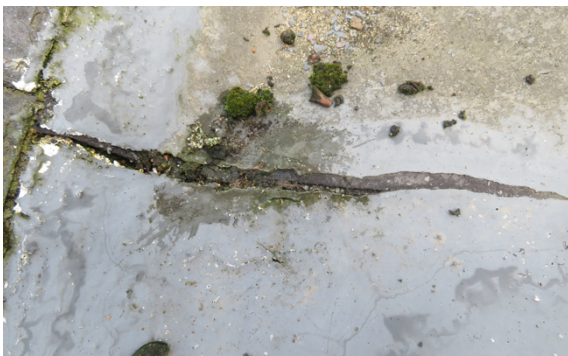
Deep cracks in the asphalt linings

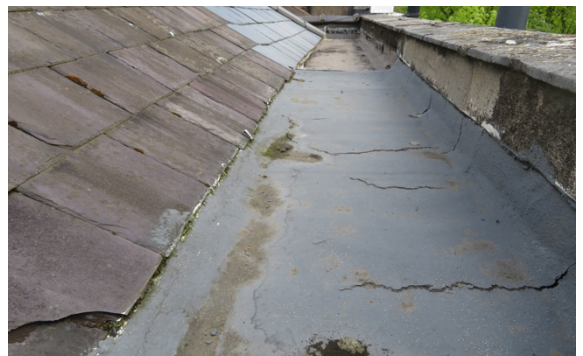
Failure of the recent overcoating of the asphalt to the front gutter

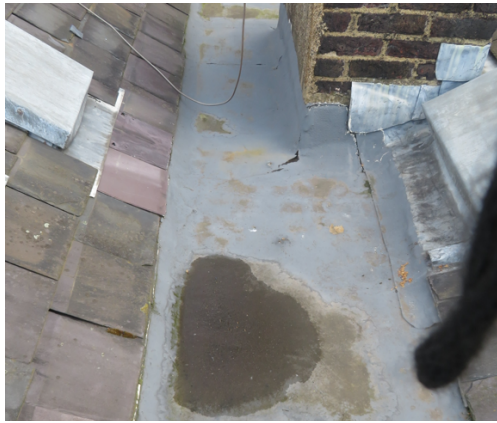
Centre valley looking north. Note the extensive disturbance to slating.

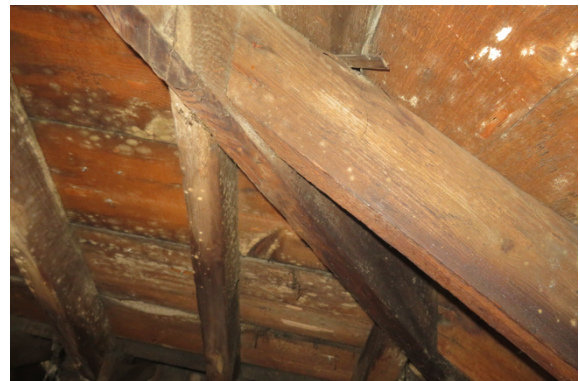
Some of the roof timbers appear to be of oak.

On the limited inspection possible, the roof structure appears sound but does show some signs of mould, likely to be related to condensation within the roof void, exacerbated by high humidity levels because of water penetration through the gutter linings. The condensation results from the lack of ventilation and the use of a vapour resistant underslating membrane. The underside of the sarking boards appears otherwise fair. It was not possible to view the lay boards below the gutters but these are likely to have suffered some damage and are also likely to have to be adjusted to suit the asphalt coverings. At least some parts of the roof structure and boarding appear to be in oak.

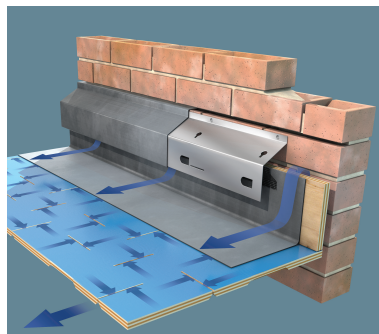
Proprietary perimeter ventilator, clad in lead (Nicholson Airtrak system)

The most suitable way of increasing insulation will be to increase the insulation at ceiling level. The addition of insulation above the sarking boarding would create issues at the division of ownership and the detailing below the lead gutter lining would be difficult. The proposed approach will require the provision of ventilation to the roof void, which we suggest should be provided within the upstand of the lead gutter against the front and rear parapets, as the illustration above. Locations are marked with a green line on the proposed plan above.
