# ARBORICULTURAL ASSESSMENT REPORT

Habiba House, 38 Colney Hatch Lane, London, N10 1DU

**Client:** Sedgwick International UK  
**Insurer:** Covea Insurance

**Survey Date:** 19/05/2023
-

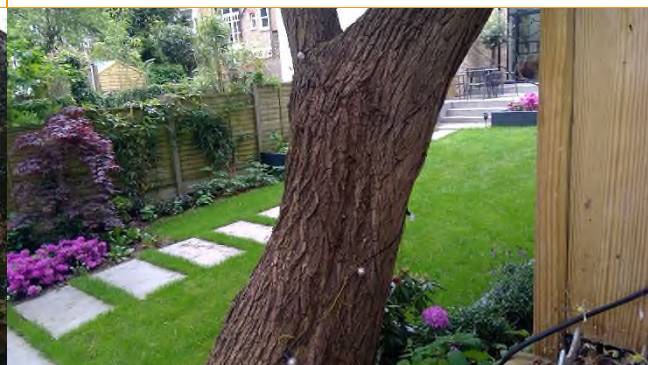
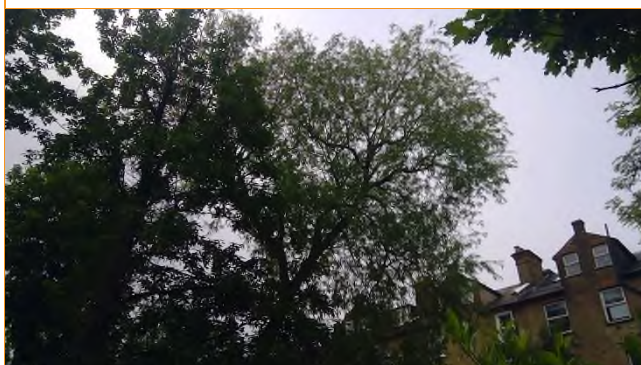
T3 - Willow

| Tree No: | Species | Works Required | CA | TPO | Ownership |
|---|---|---|---|---|---|
| T3 | Willow | Fell and treat stump with eco plugs (broadleaved) | Yes | No | P3P |

| Tree No | Common Name | Age Class | Condition | Height (m) | Crown Spread (m) | Stem diam. (mm) | Dist to bldg. (m) | Roots Implicated | Pruning history | Recommendation | Tree work constraints | Notes | Owner address | Owner |
|---|---|---|---|---|---|---|---|---|---|---|---|---|---|---|
| T3 | Willow | Mature | Fair | 15.4 | 14.2 | 450* | 16.02 | Y | Subject to past management - one stem topped at 5.0m. No significant recent management. | Fell and treat stump with eco plugs (broadleaved). | Access through side/rear gate. Obstructions sheds/greenhouses. | | 36 Colney Hatch Lane<br>London<br>N10 1DU | P3P |
