42 Southwood Lane, N6 5EB

Response to queries from Conservation Officer

## 42 Southwood Lane, London N6 5EB

### Structural Inspection and Assessment 24th March 2023 - Notes

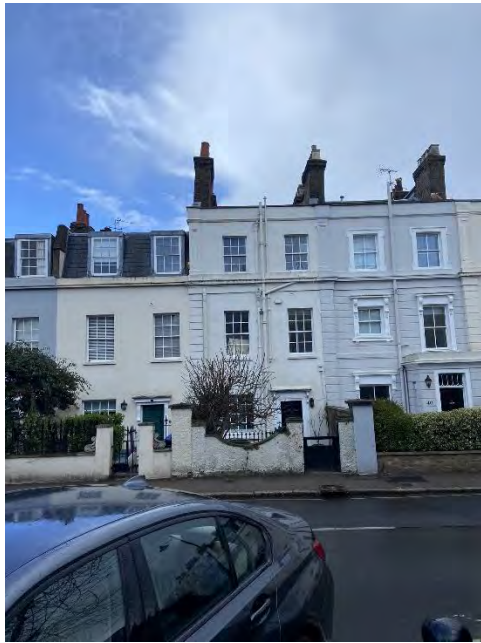
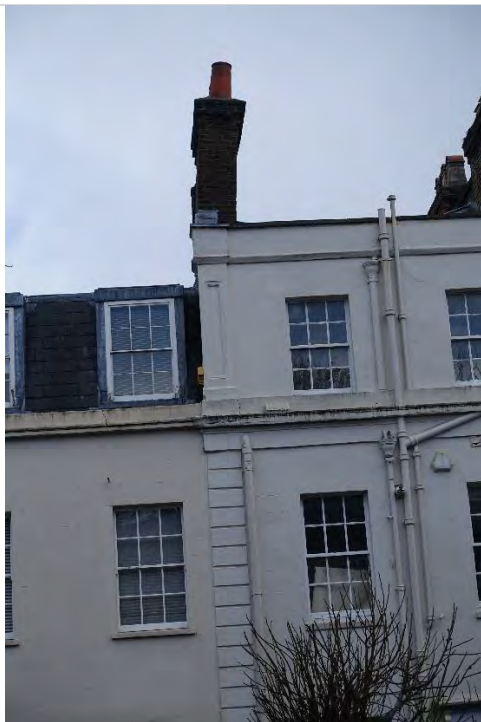
Views of front elevation - Front chimney stack on left hand side (LHS) has significant lean inwards (approx 4-5"). Front elevation shows signs of cracking which suggest historic and recent settlement at foundation level.

The stack is 2½ bricks thick (approx. 570mm) and is approximately 3.2m high. The stack leans by approx. 4"-5" from parapet level. The shaft wall thickness is expected to be ½ brick thick. The lean ratio is significantly higher than the 1mm:100mm limit recommended in the BRE Good Repair Guide 15. Also, the centre of mass of the shaft wall is outside the middle third of its width and as such is unstable.

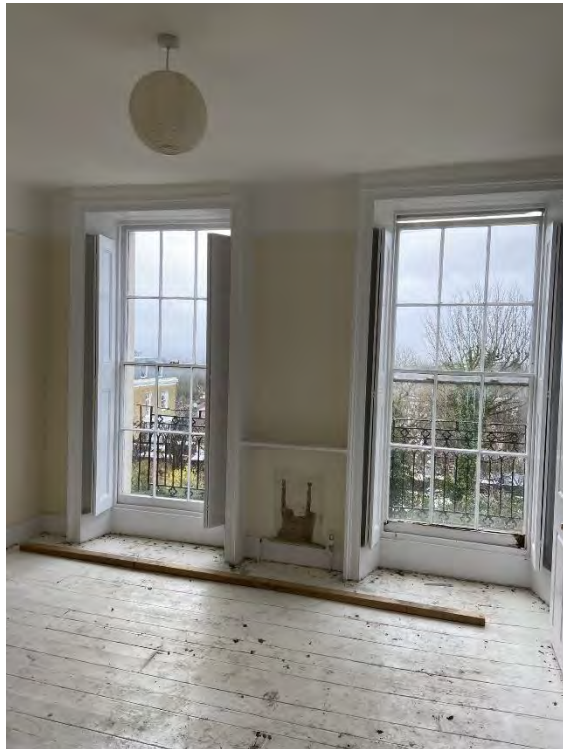
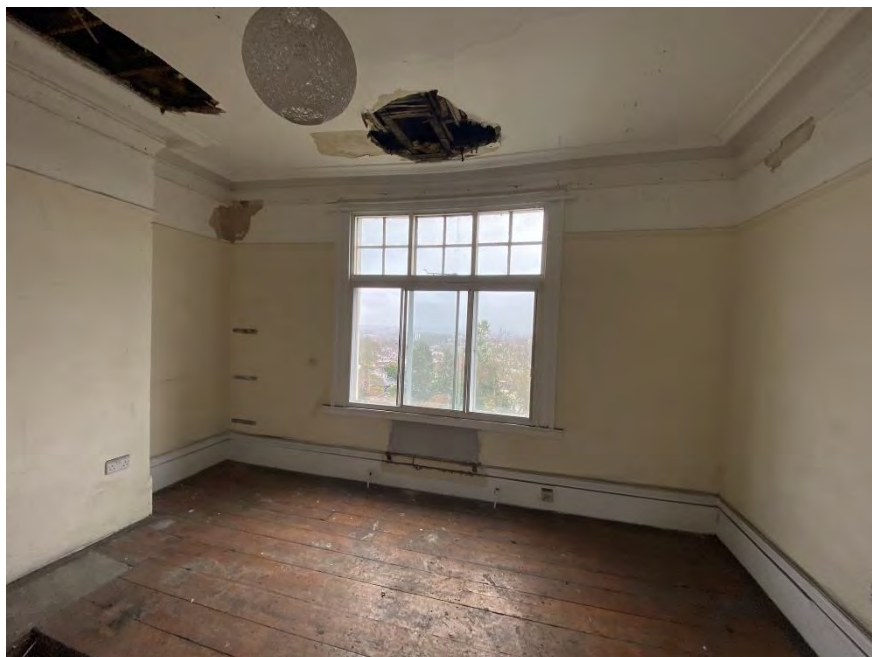
Views of rear rooms at first and second floor levels. Note sag in lintel over window at 2<sup>nd</sup> floor level

Given the condition of the valley beam it is recommended that the entire beam is replaced with a pair of steel PFC beams, cranked at the front to meet the brickwork wall. The lintel over the 2nd floor rear window should be fully exposed as, the level of deflection in it suggests it may be decayed. A replacement precast concrete lintel should be considered. The new steels should be painted along their full length with an enhanced corrosion protection system as their location makes them susceptible to moisture ingress.

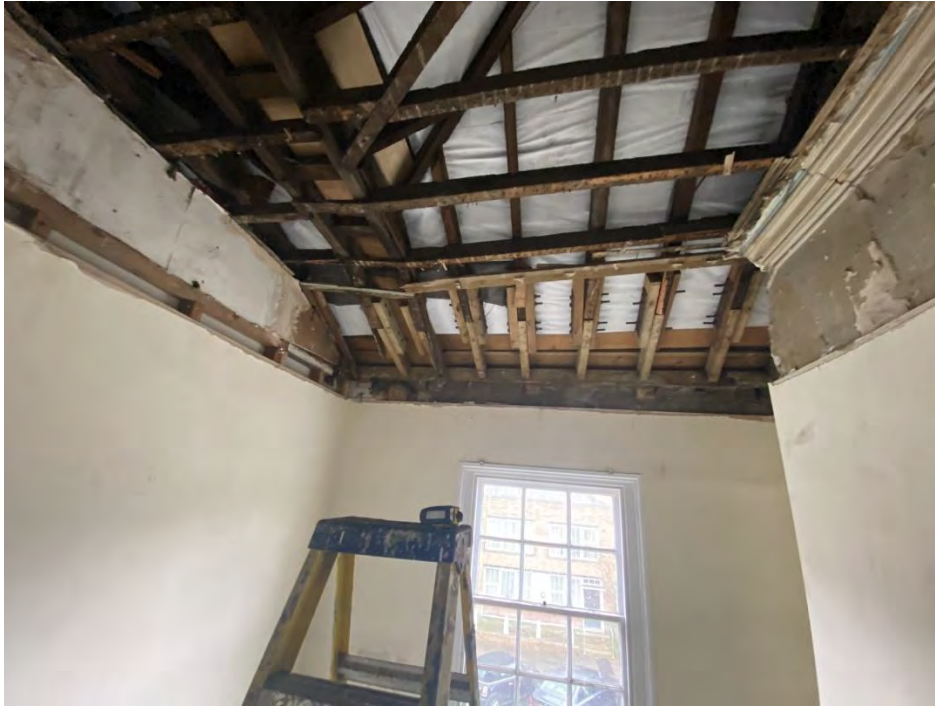
Views of ceiling and roof structure at 2<sup>nd</sup> floor level: general view at front

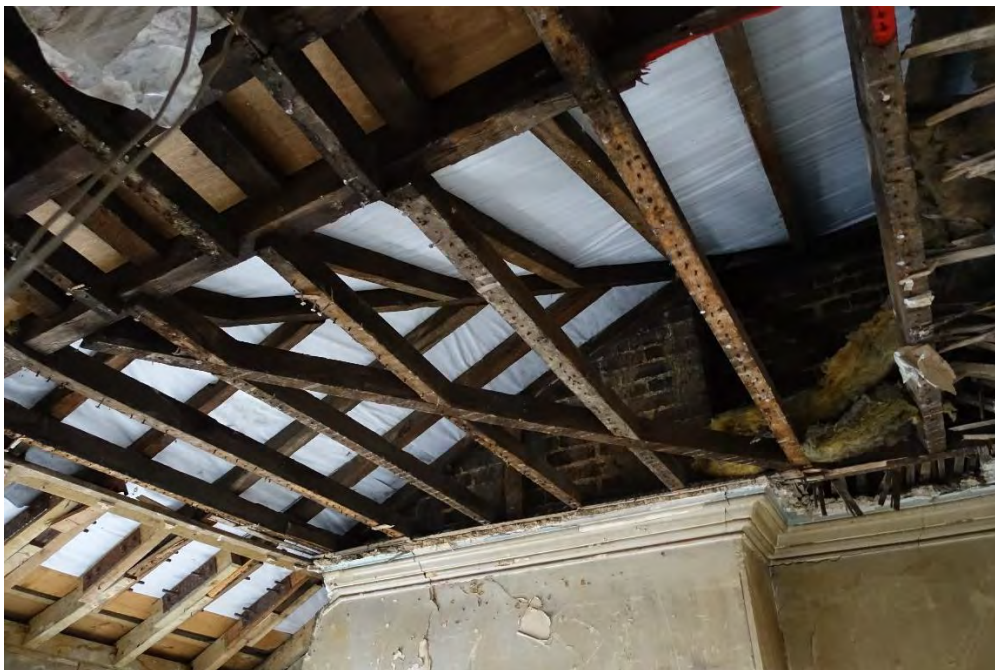
Views of ceiling and roof structure at 2<sup>nd</sup> floor level: Note modern repairs to valley beam and to front gutter.

This member comprises two approx. 190mmx50mm timbers and runs from the rear wall to the front wall, supported near the centre of the span by the spine wall. There is a poorly repaired crank with steel splice plates bolted to the timbers near the front wall where the beam drops down to sit on the brickwork wall. At the rear, the beam sits over a lintel to the rear window which has sagged significantly. There are several areas of visible decay in the beam.

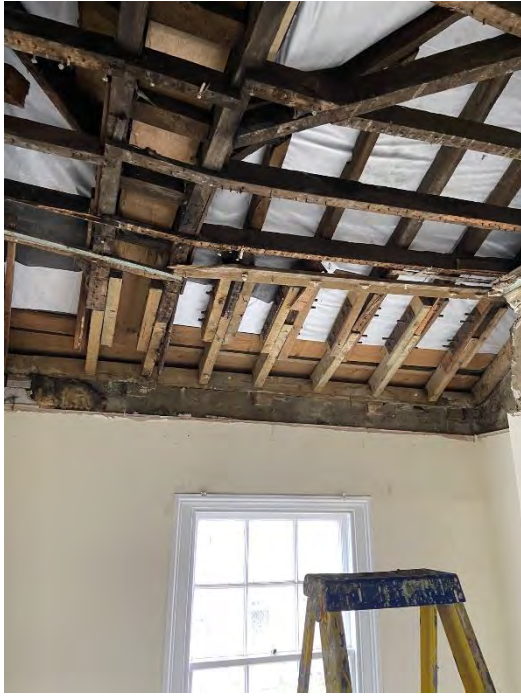
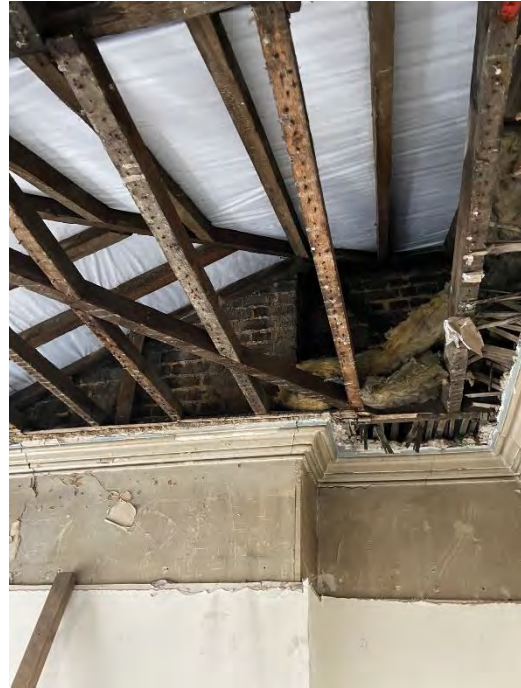
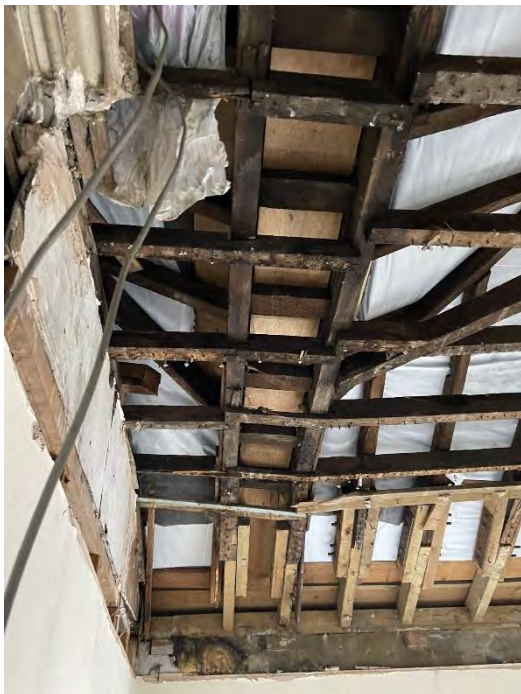
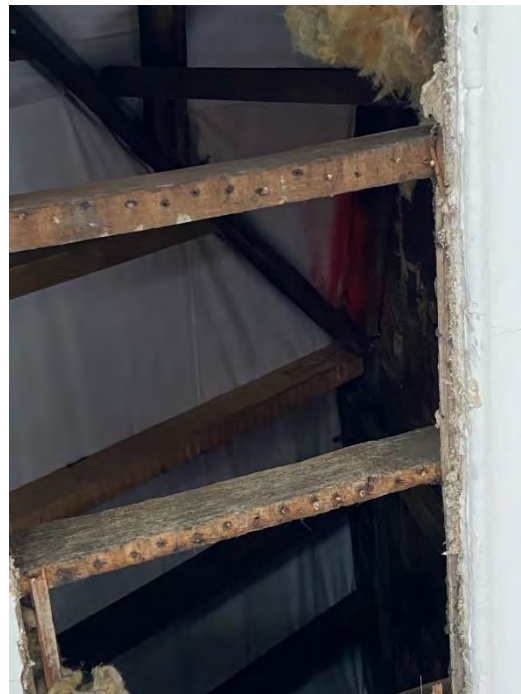
Views of ceiling and roof structure at 2nd floor level: Generally the timber members (common rafters, hip rafters, ceiling joists etc.) look undersized for the spans and show significant deflection. Poor repairs also visible

Where retained, the ceiling members should be cut back and partnered with new deeper (and therefore stiffer) ones, with new joist hangers provided at supports. At wall junctions, it is recommended that the joists are re-supported on joist hangers off new timber wall plates bolted into the wall. Generally, where the timber wall plates are bolted into the masonry wall, they should be separated from the wall with a suitable membrane, in line with the recommendations from the timber condition survey by Hutton and Rostron.

Where retained, the hip rafters should be cut back and partnered with new deeper ones, supported off new joist hangers. At wall junctions, these should be re-supported on joist hangers off new timber wall plates bolted into the wall. The common rafters should be repaired in a similar manner to the ceiling joists with new ones partnered alongside the existing.

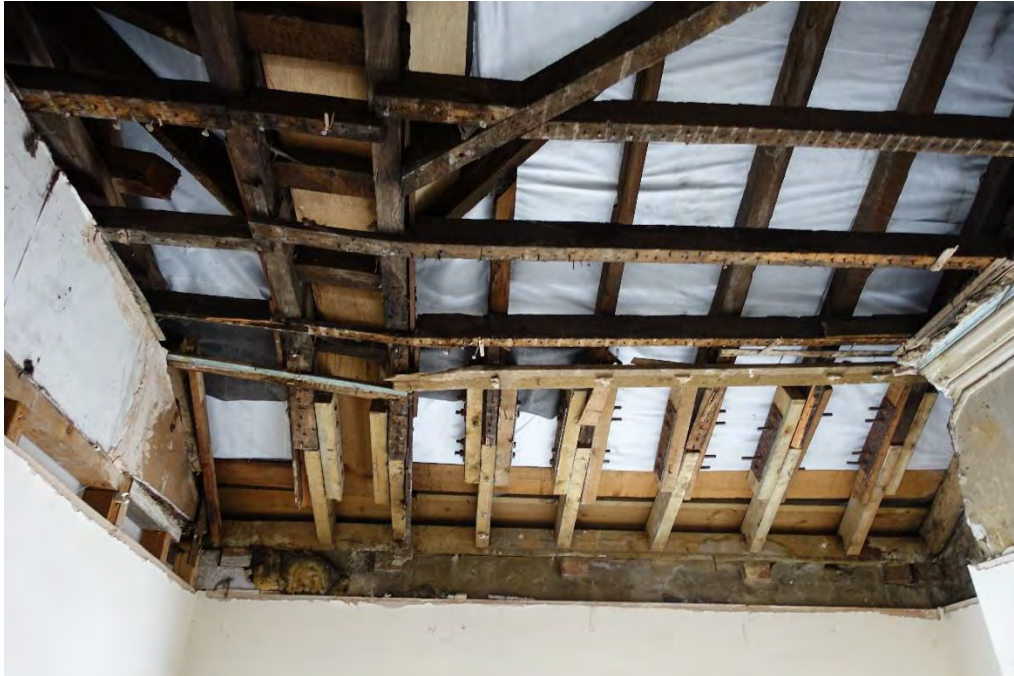
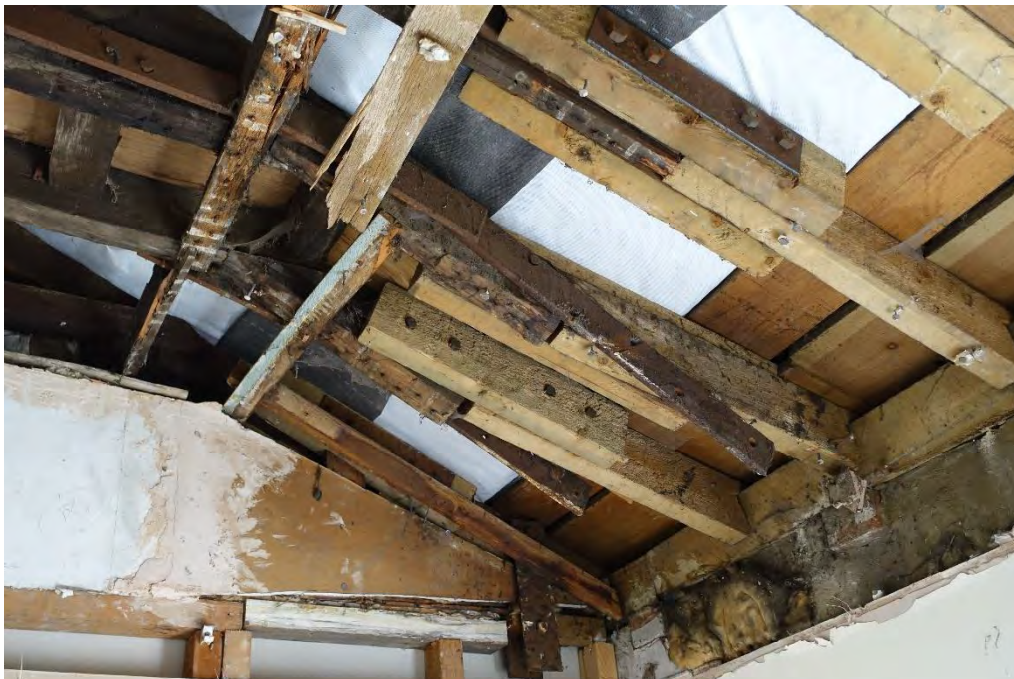
Views of ceiling and roof structure at 2nd floor level: Poor splice repairs to common rafters at front and cranked valley beam.

The roof members comprise common rafters (typically 80mmx50mm) which run from the brickwork walls to the valley beam or to the hip rafters. The hip rafters run diagonally from the party walls to the valley beam. The rafters near the front wall have all been repaired with poorly installed splice plates.

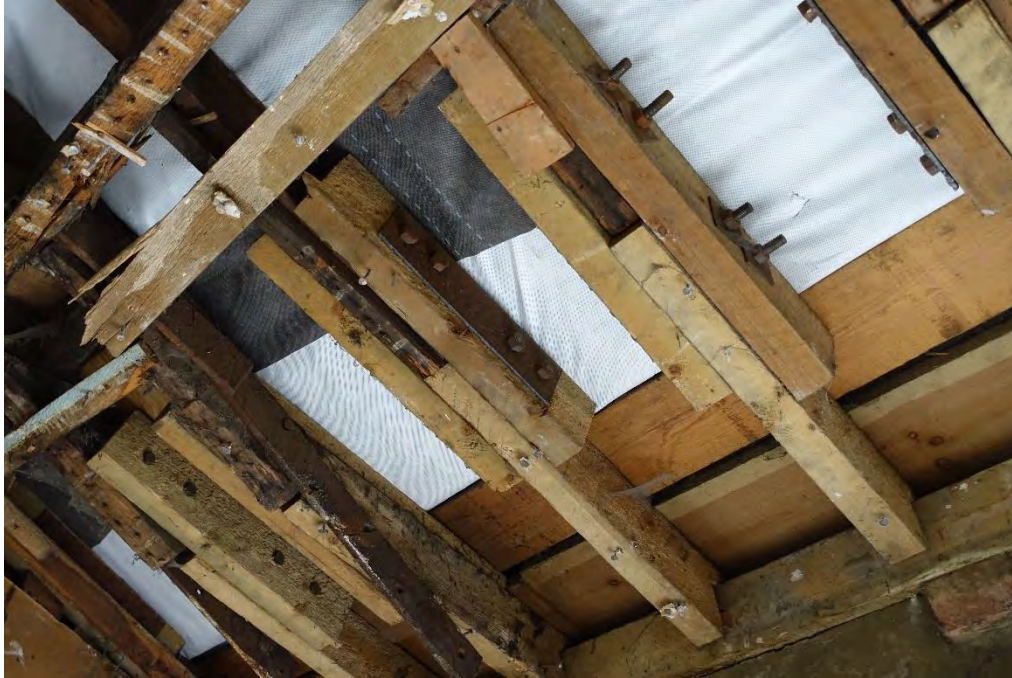
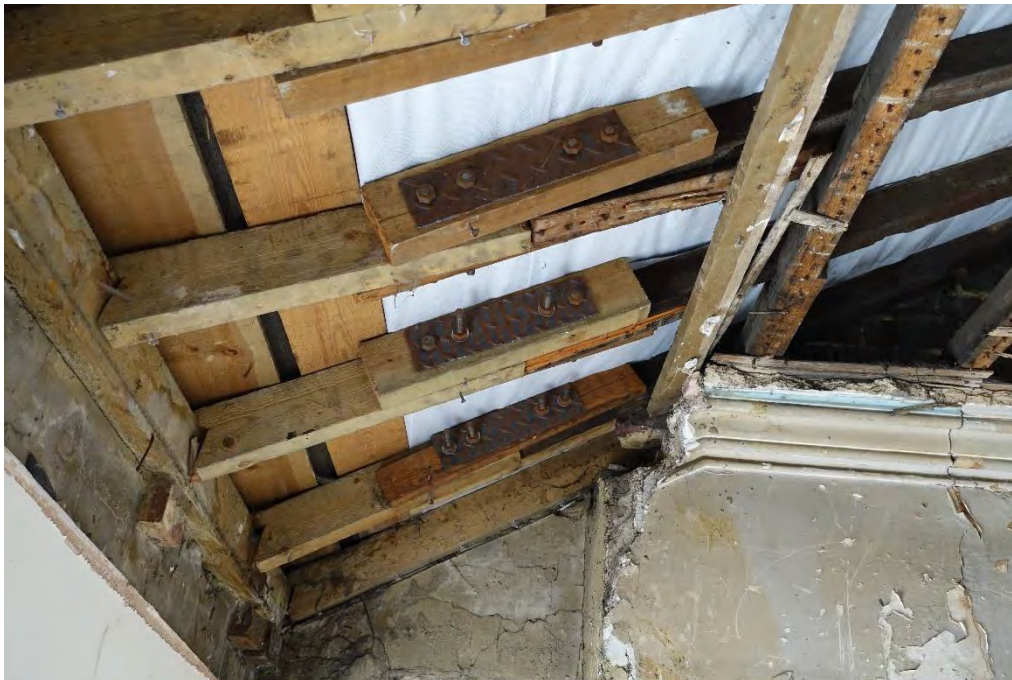
Views of ceiling and roof structure at 2nd floor level: Poor splice repairs to common rafters at front and cranked valley beam.

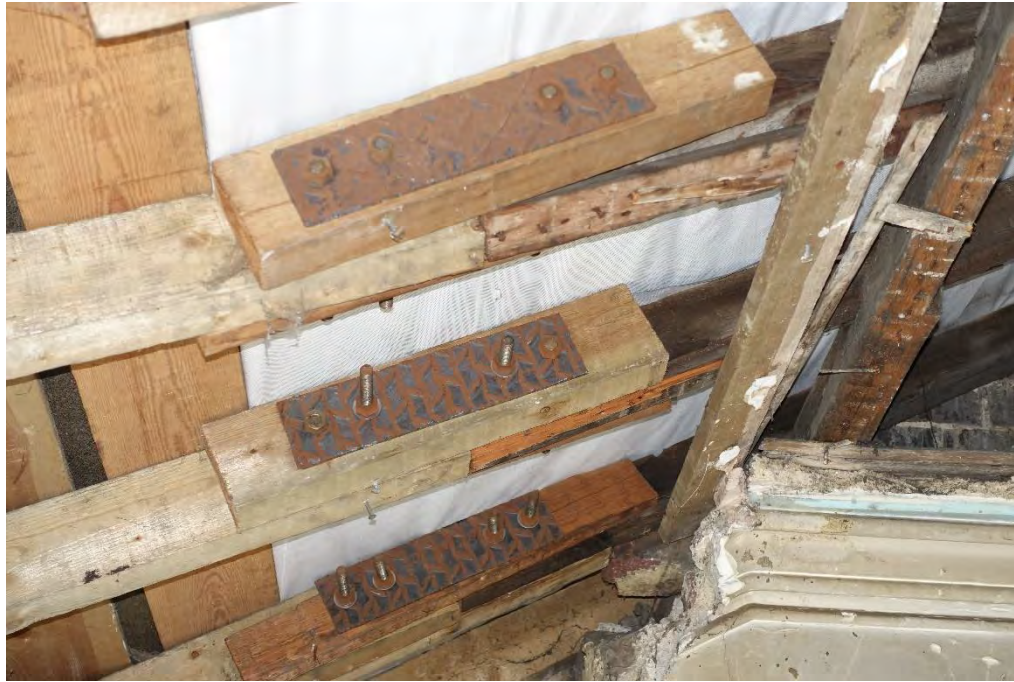
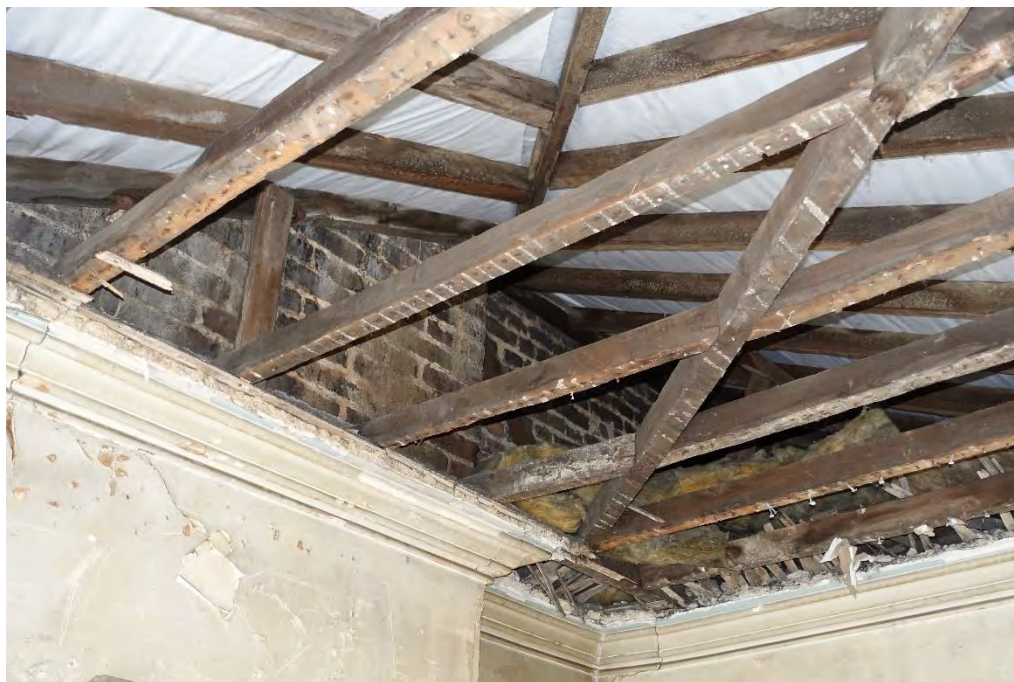
Views of ceiling and roof structure at 2nd floor level:

Poor splices.

Rafters and ceiling joists look undersized for spans. Timber support/connections at wall look poor and some have slipped.

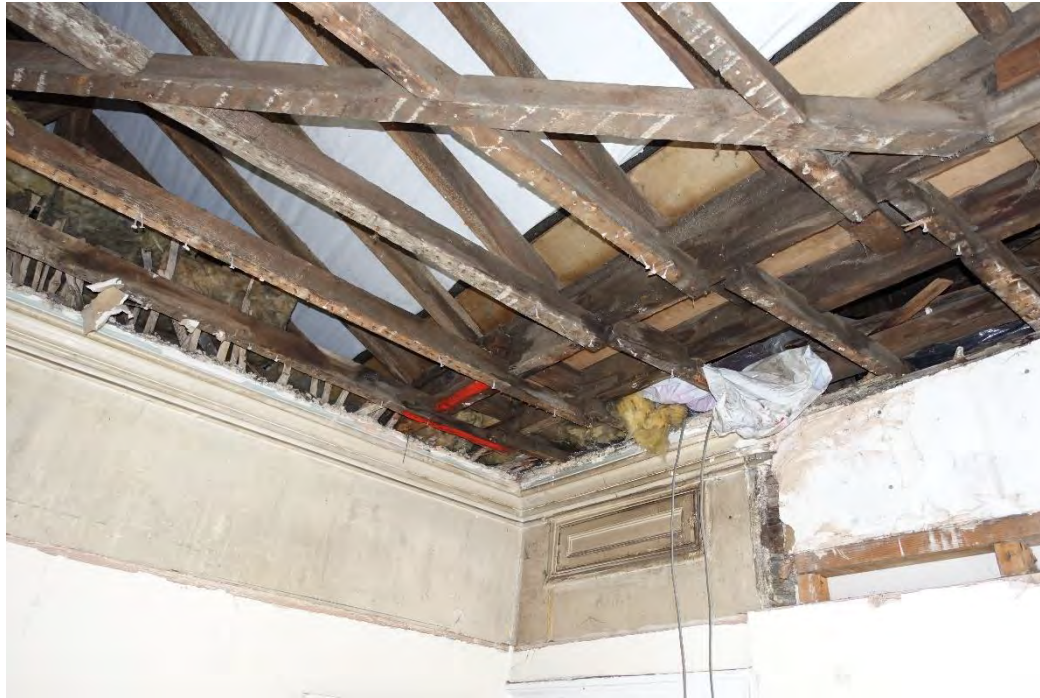
Views of ceiling and roof structure at 2nd floor level: front wall LHS

There appears to have been historic settlement in the front wall which may have affected the timber members supported by the front wall. The cracking noted in the front wall suggests some movement in recent years. Further investigations should be considered. A CCTV survey of the nearby below ground drainage and an inspection of the rainwater gully are recommended to establish their condition.

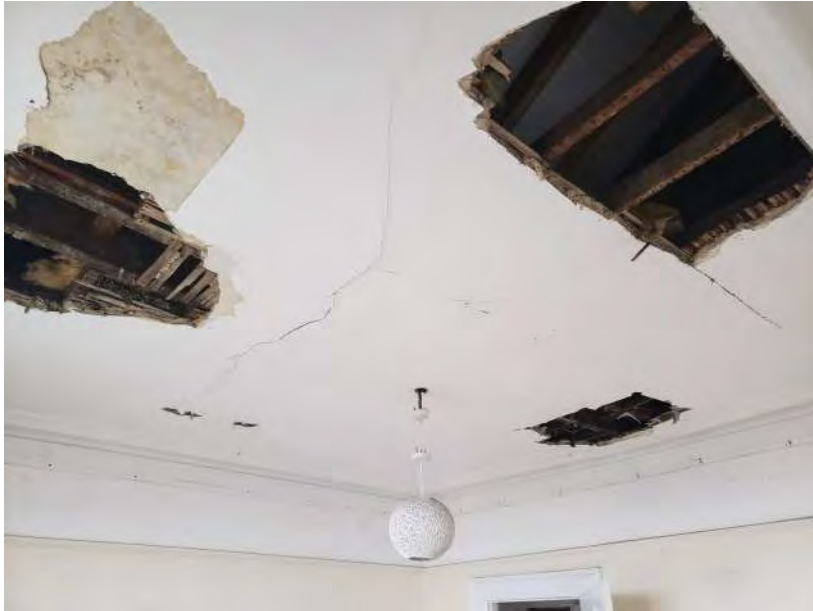
**Fig 3:**

Internal, second floor; showing a general view of the ceiling of the west room. Note the positioning of localised cavities exposing structural elements and the general deformation and cracking of the ceiling cladding

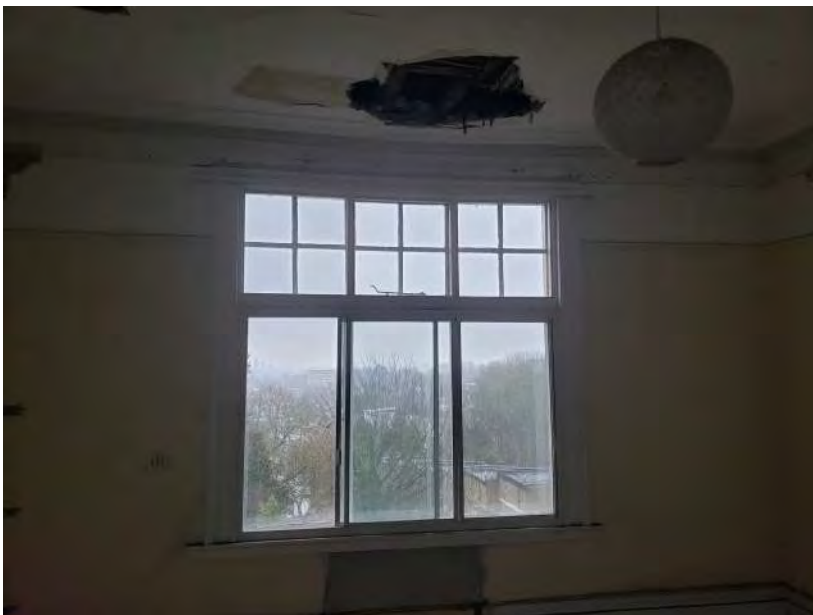
**Fig 4:**

Internal, second floor; showing a general view of the west side of the west room. Note the positioning of the cavity and the deflection to the ceiling and the window. Consideration should be made for further investigations into the condition of lintels within the property

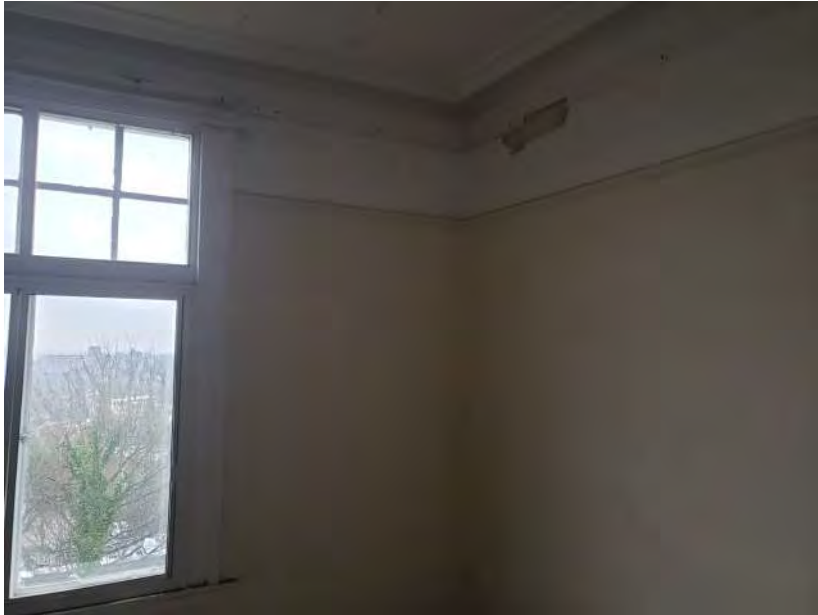
**Fig 5:**

Internal, second floor; showing a view of localised damage to internal plasterwork within the west room, likely due to historic failings of the external gutter allowing excessive moisture to saturate masonry, leading to the decay and damage of subsequent materials

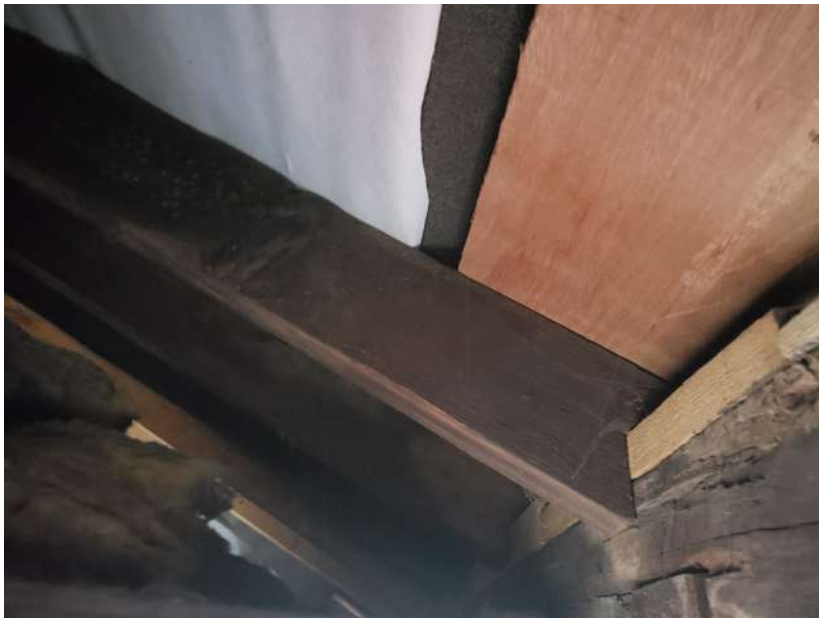
**Fig 7:**

Internal, roof void; showing the condition and structural arrangement of timber elements within the roof void at the south-west. Note the presence of several contemporary elements indicated recent remedial works had been undertaken, likely to replace decayed elements forming the roof and external gutter

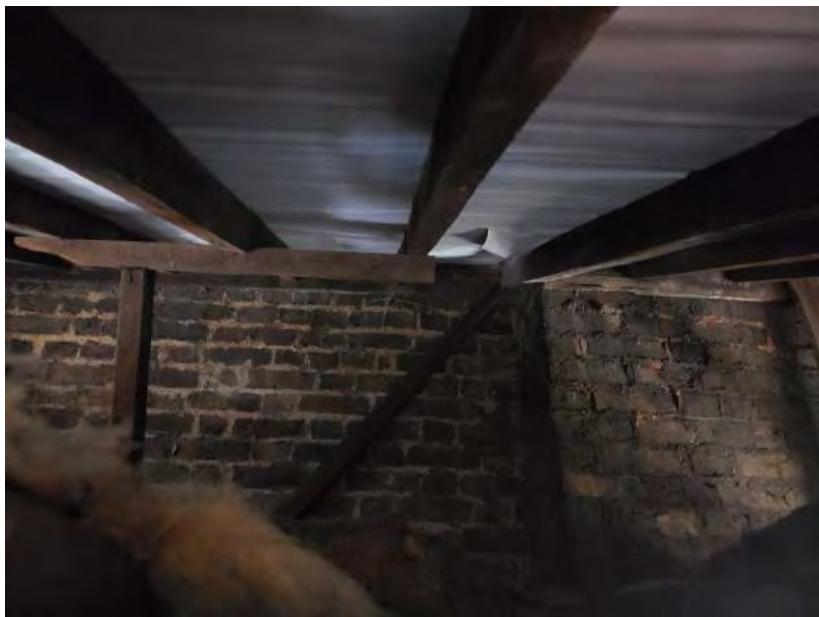
**Fig 8:**

Internal, roof void; showing a general view of the structural arrangement of the roof structure. Note the positioning of timber elements in close proximity and contact with likely damp affected masonry

New timbers should be isolated from any damp or potentially damp masonry with a damp proof material or ventilated air gap

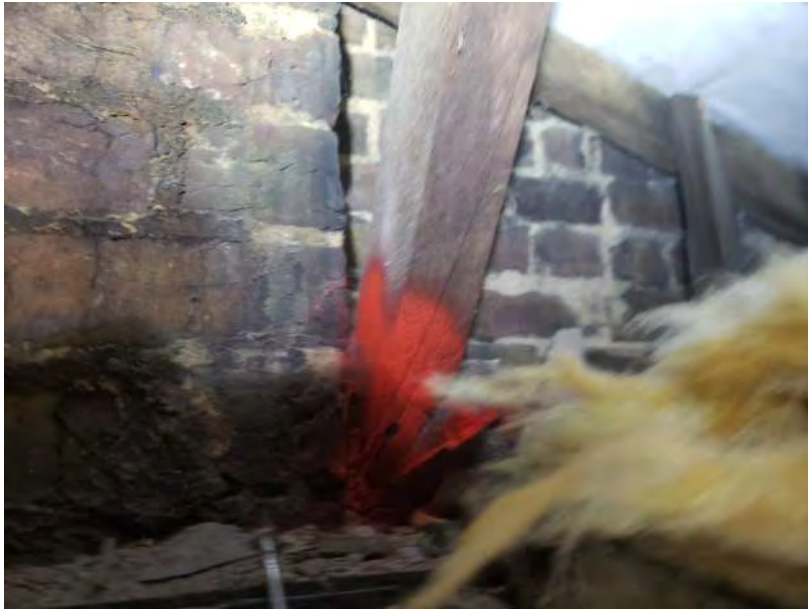
**Fig 9:**

Internal, roof void; showing a focused view of the bottom end of a diagonal strut that was found to be decayed where it had been embedded into the brickwork, at the south-west of the roof void

*No chemical remedial treatments are required or recommended. All decayed timber members should be replaced or repaired using a suitable partner or scarf joint detail and suitable mechanical fixings and using a timber of a similar species. All vulnerable timber elements should be isolated from likely damp affected masonry and other materials using a damp-proof membrane and ventilated air gap of ~20/25mm. All remedial works should follow guidance from a structural engineer. H+R can provide further advice if instructed*

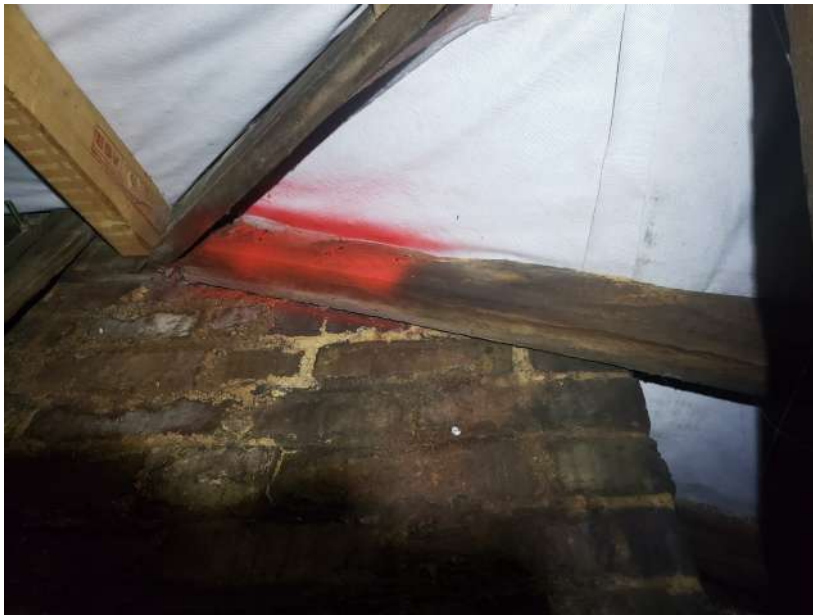
**Fig 10:**

Internal, roof void; showing a common rafter at the south-west of the roof structure, in contact with the masonry chimneybreast. Note the common rafter was found to be decayed at its top end for ~400mm

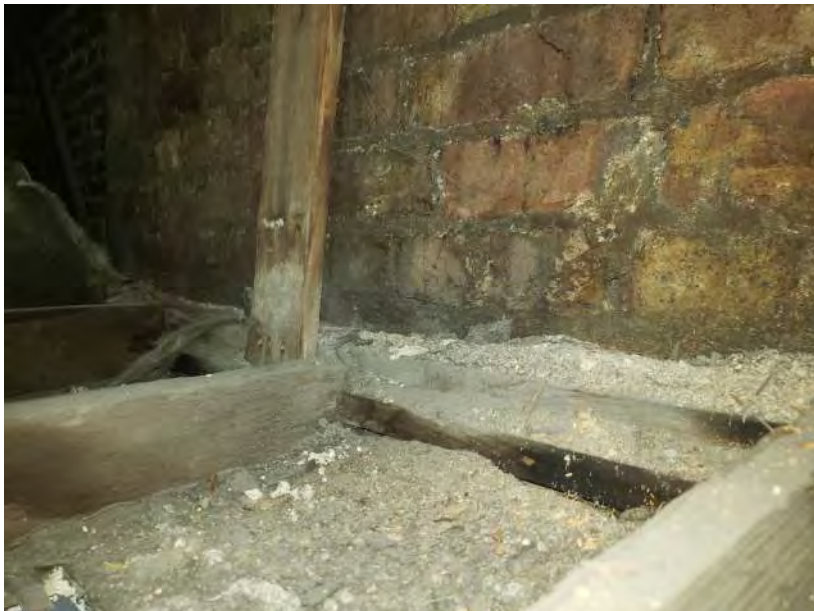
**Fig 11:**

Internal, roof void; showing a focused view of the notched jointing of ceiling joists to the corresponding joist plate at the south-west of the roof structure. Depending on the future purpose of the ceiling joists after refurbishment this arrangement may be inadequate to support significant loads

*The adequacy of all structural elements and their jointing should be assessed by a structural engineer. Allowances should be made for their replacement or re-support using contemporary hardware such as joist hangers and additional mechanical fixings where it is deemed necessary. Further allowances should be made for the possible introduction of additional elements to reduce the span of subsequent members. H+R can provide further advice if instructed*

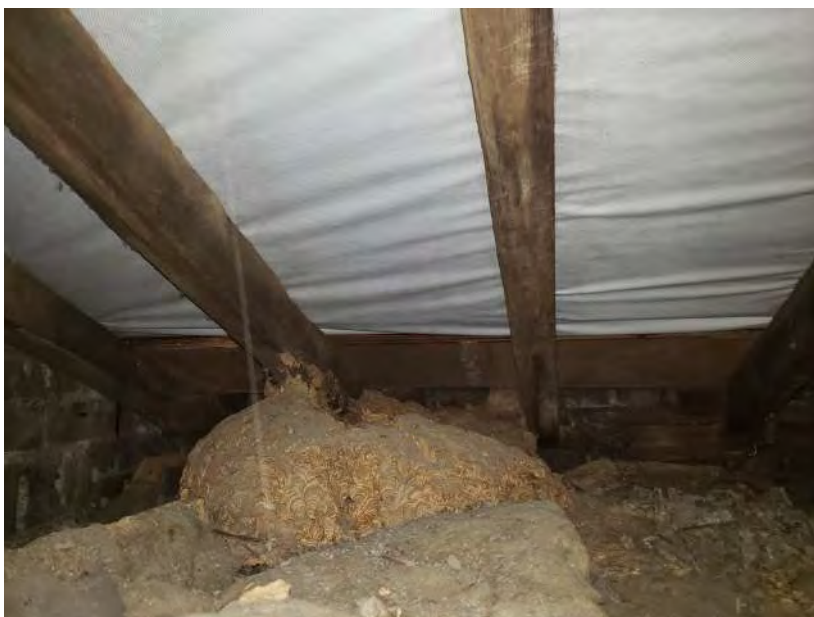
**Fig 12:**

Internal, roof void; showing a focused view of the south-west corner of the roof void which featured a historic wasps nest

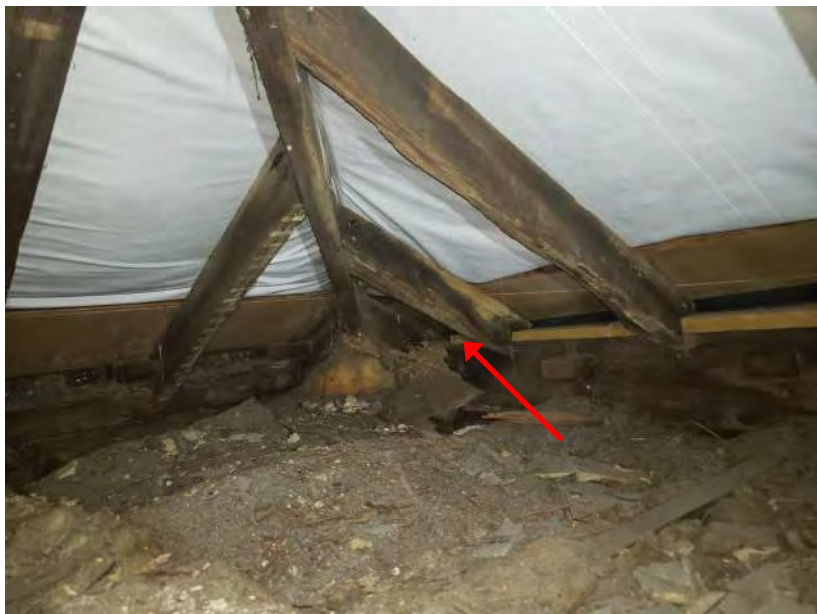
**Fig 13:**

Internal, roof void; showing a focused view of the hip rafter at the south-west of the roof structure. Note the likely decayed jack rafters

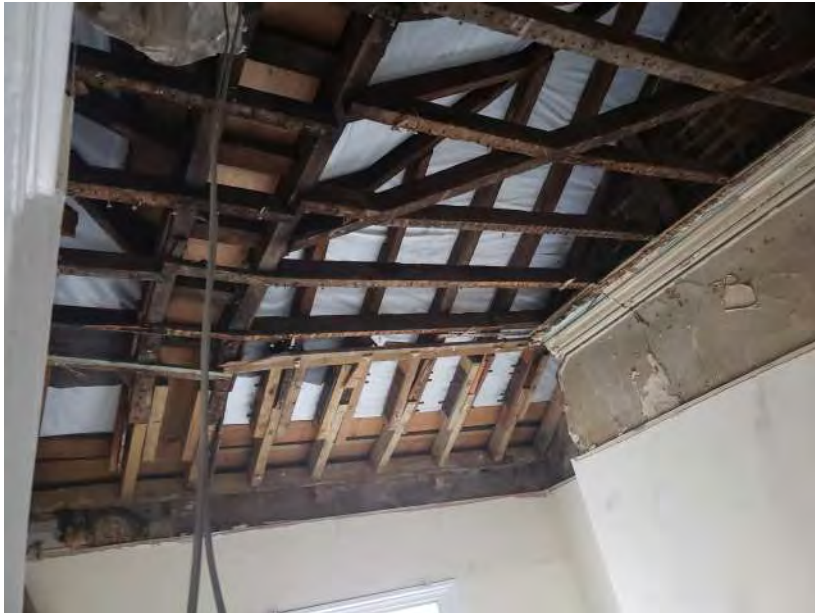
**Fig 15:**

Internal, second floor; showing a general view of the exposed roof structure visible within the east room. Note the presence of contemporary repairs at eaves level that indicated previous failures and recent remedial intervention

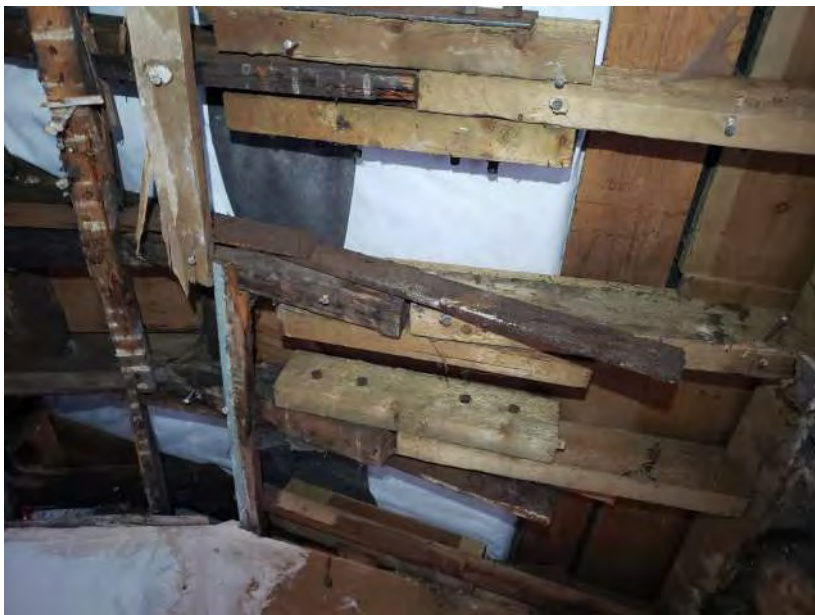
**Fig 16:**

Internal, second floor; showing multiple partner repairs to docked common rafters at the east of the roof structure. Note that some of these were seen to be failing and of poor quality

*The adequacy of the common rafter repairs should be assessed by a Structural Engineer and allowances should be made for replacement or further remedial works to take place where it is deemed necessary. H+R can provide further advice if instructed*

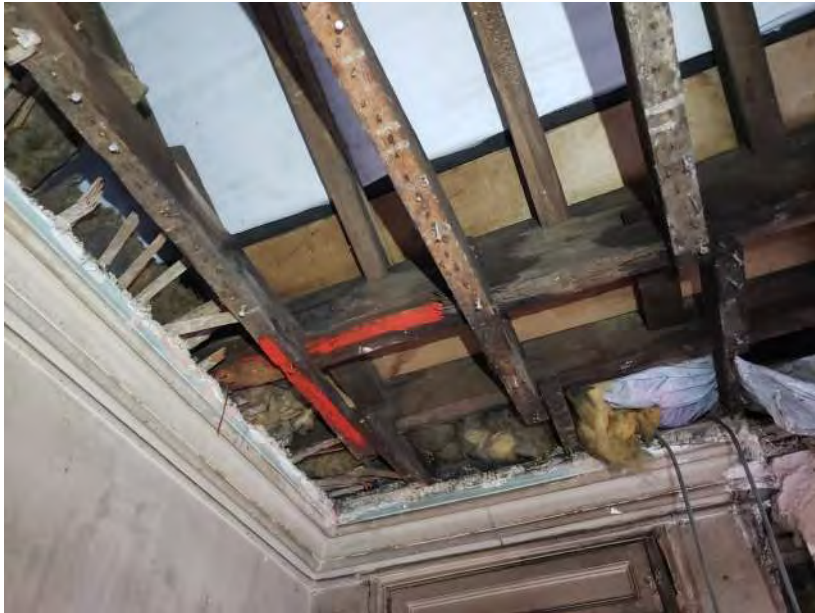
**Fig 17:**

Internal, second floor; showing 2 no. sections of decay to a rafter plate and a ceiling joist. The fungal decay organism was deemed to be a 'wet' rot species and the moisture reading was seen to be below the threshold for the survival and growth of fungal decay organisms

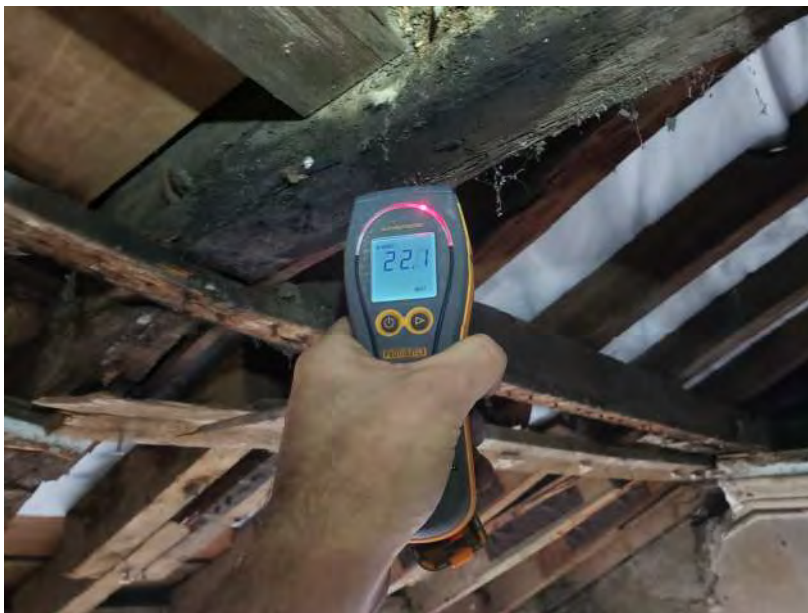
**Fig 18:**

Internal, second floor; showing significantly elevated surface moisture readings to certain elements within the east roof structure. These were deemed to likely be due to high levels of humidity

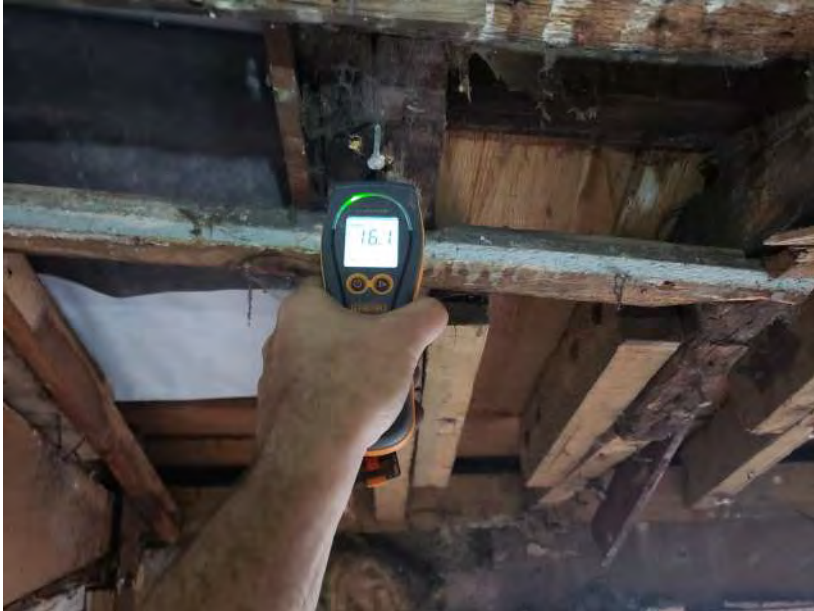
**Fig 19:**

Internal, second floor; showing slightly elevated surface moisture readings of common rafters at the west of the roof structure. This was deemed to be due to previous elevated humidities within the roof void, as opposed to active leaks through external roof materials above

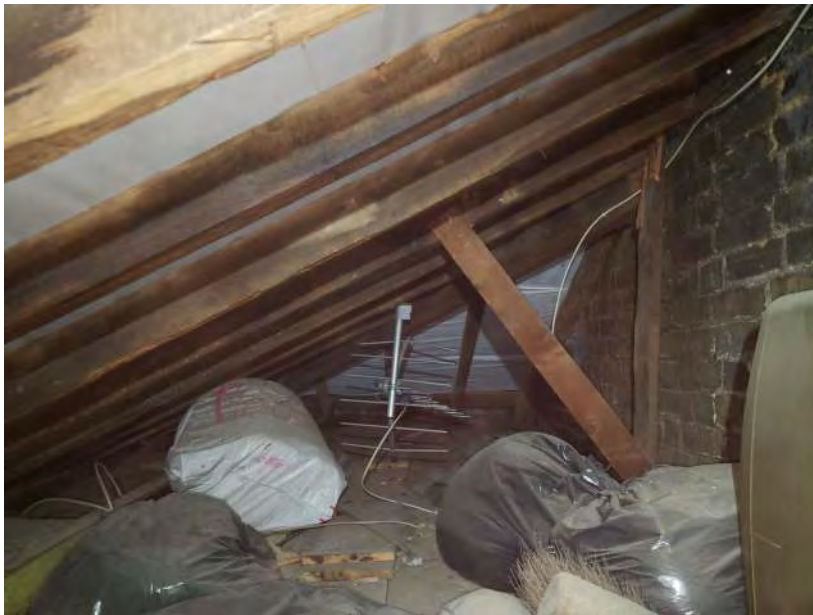
**Fig 20:**

Internal, roof void; showing a general view of the north lean-to roof pitch. Note the presence of contemporary roof membrane

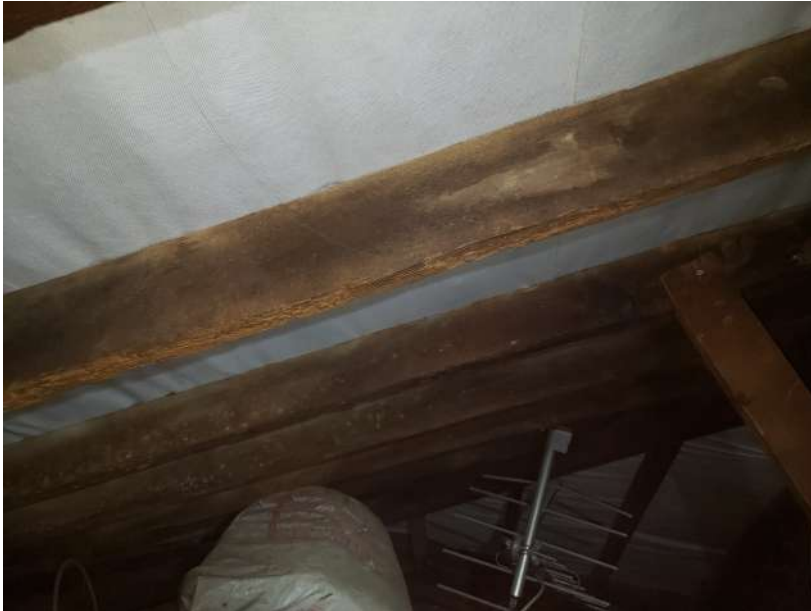
**Fig 21:**

Internal, roof void; showing a focused view of superficial decay to the underside of a common rafter forming the south pitch. The decay organism was preliminarily identified as being House Longhorn beetle (*Hylotrupes bajulus*)

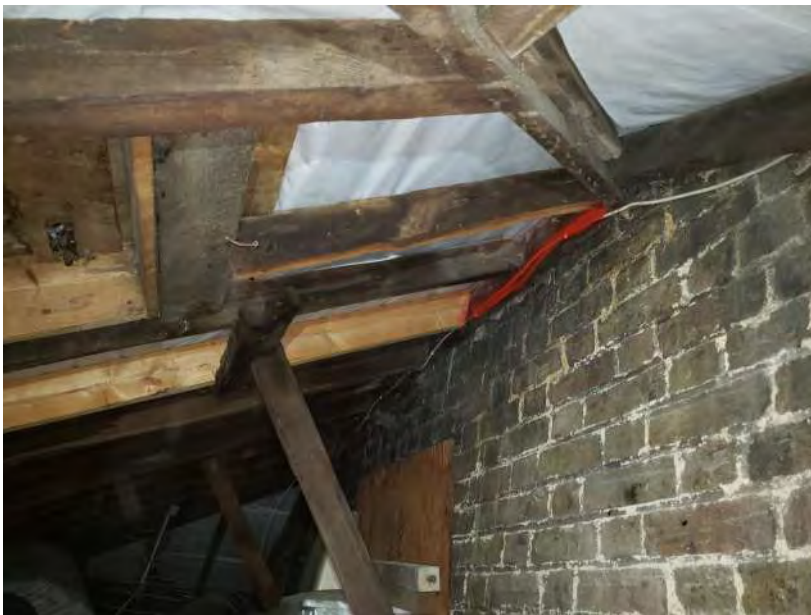
**Fig 22:**

Internal, roof void; showing a general view of the arrangement of timber elements at the top of the north pitch. Note the upper lean-to rafter plate was found to be splitting for ~750mm

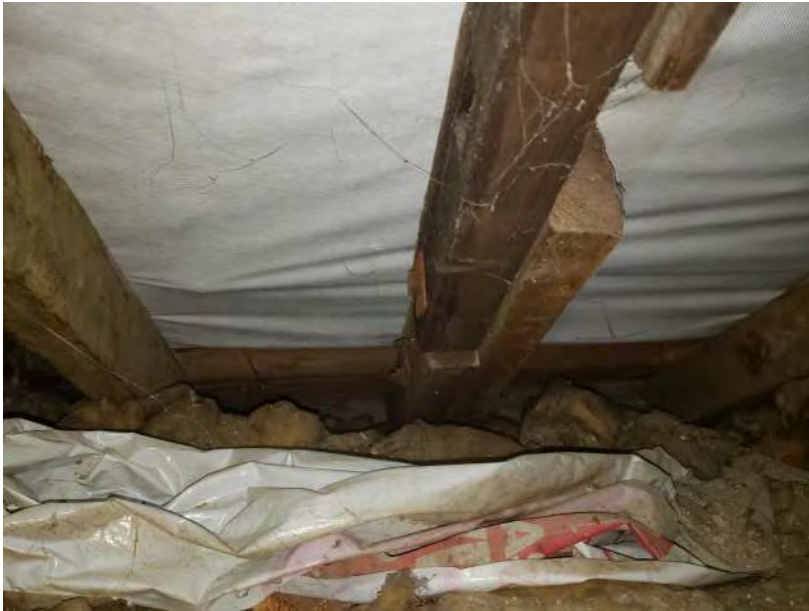
**Fig 23:**

Internal, roof void; showing the lower section of a common rafter forming the north pitch of the roof structure. Note that recent partner repairs were identified

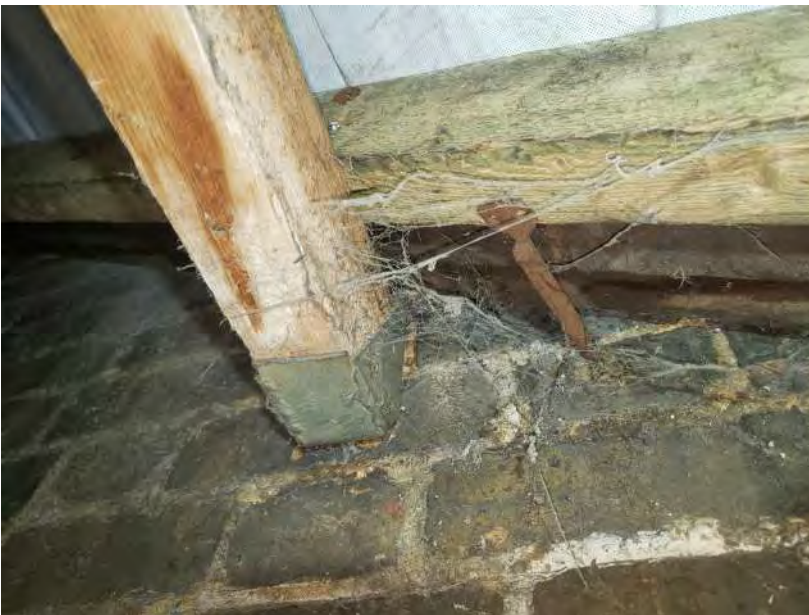
**Fig 24:**

Internal, roof void; showing the presence of a contemporary hanger embedded into the north wall within the roof void, used to support the bearing end of a length of purlin that had likely been a recent installation during previous refurbishment works

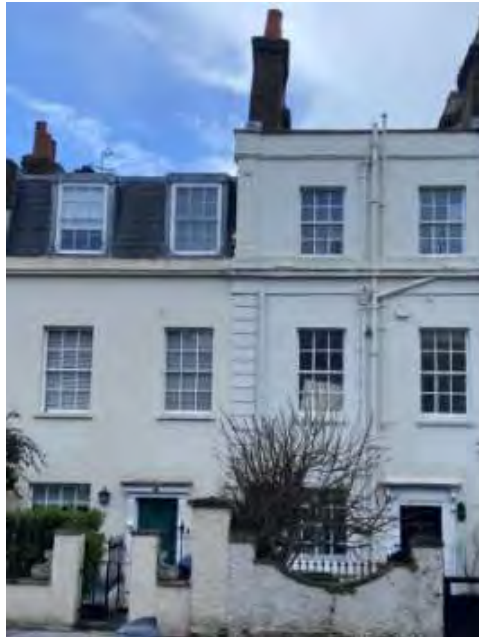
The stack is 2½ bricks thick (approx. 570mm) and is approximately 3.2m high. The stack leans by approx. 4"-5" from parapet level. The shaft wall thickness is expected to be ½ brick thick. The lean ratio is significantly higher than the 1mm:100mm limit recommended in the BRE Good Repair Guide 15. Also, the centre of mass of the shaft wall is outside the middle third of its width and as such is unstable.

*Figure 1 - Front chimney stack on left hand side has significant lean inwards*
