**TECHNICAL REPORT ON A SUBSIDENCE CLAIM**

**Crawford Reference: SU2201802**

**2 Lansdowne Road,  
London  
N17 9XE**

**SUBSIDENCE CLAIM**

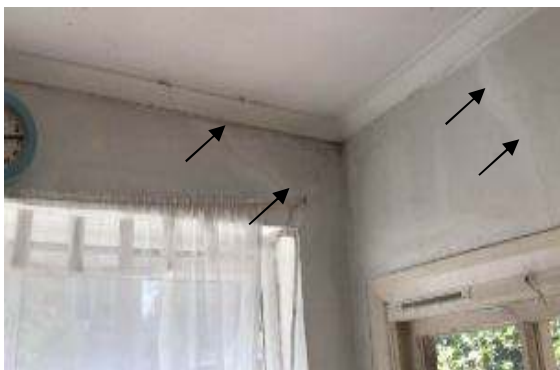
Rear Elevation Kitchen – Outrigger Ground Floor. Hairline cracks historically repaired. Not indicative of subsidence.

- There are hairline cracks to the rear plastered wall finish and across the ceiling. These cracks appear historic in nature whilst also attributed to thermal movement of the finish materials. Damage is not consistent with structural movement.

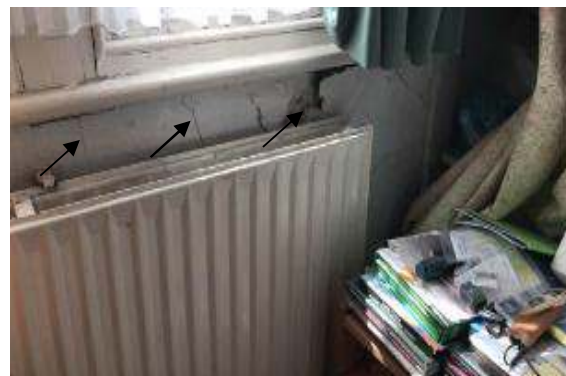
First Floor Rear Right Bedroom. Delamination of wallpaper, historic in nature and not indicative of subsidence.

- There is evidence of delamination of wallpaper under the window of the rear bedroom.

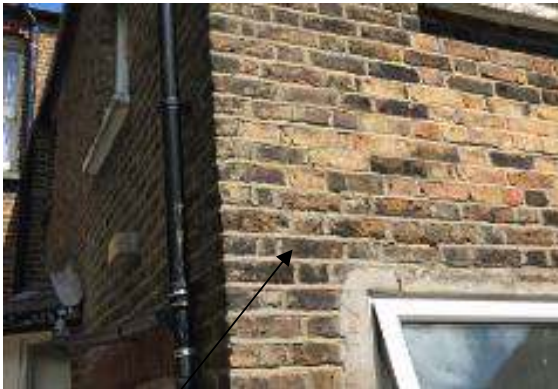
Rear Elevation Outrigger – Ground Floor.  
Stepped cracking through 8 courses of  
brickwork.

- There are stepped cracks to brickwork to the rear right corner of outrigger extending 8 courses of brickwork 1-2mm in width.
- There is a vertical crack to the underside of the rear window of the rear outrigger extending 4 brick courses 1-2mm in width. Note, full observation / inspection not possible due to tenants stored items in garden.

In structural terms the damage falls into Category 2 of Table 1, Building Research Establishment<sup>5</sup> Digest 251, which describes it as "slight".

The pattern and nature of the cracks is indicative of an episode of subsidence. The cause of movement appears to be either clay shrinkage or subsoil softening/erosion due to drains leakage.

Further site investigations will be required. Typically, these would involve trial pit(s) to determine the nature of the footings and subsoil and a localised drainage survey.

On receipt of the Site Investigation reports which we shall now instruct on behalf of Insurers, we will advise on causation and the scope of mitigation works required.

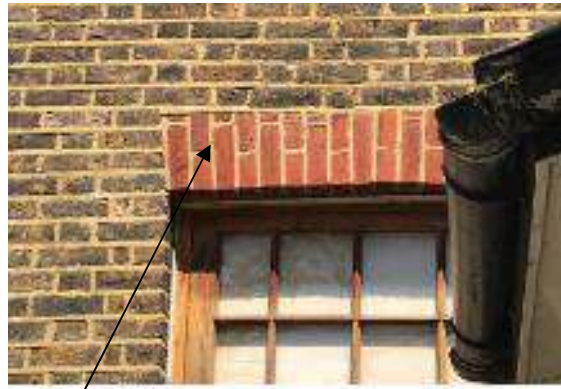
Rear Elevation Main House – Ground Floor.  
Hairline crack through soldier course and 2  
brick courses above.

- There is a stepped crack to soldier course brick lintel extending 2 courses 1mm width.

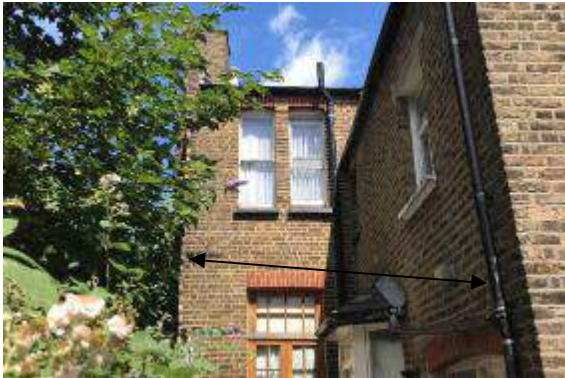
Site Investigations will be instructed to determine the cause of damage. By nature of the damage location, there is a drain and rainwater / foul water gully adjacent which may be damaged. This will need investigating. The neighbours Sycamore tree is also in close proximity adjacent to area of damage and, following site investigations, we will be able to determine its influence.

Neighbour (St Marys Church) Sycamore Tree 4m proximity from area of damage.

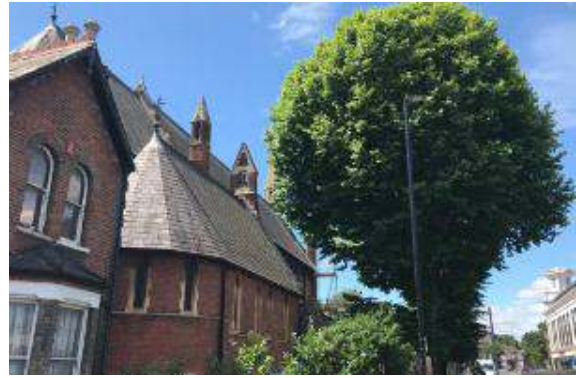
Neighbour (St Marys Church) Sycamore Tree to front of property.

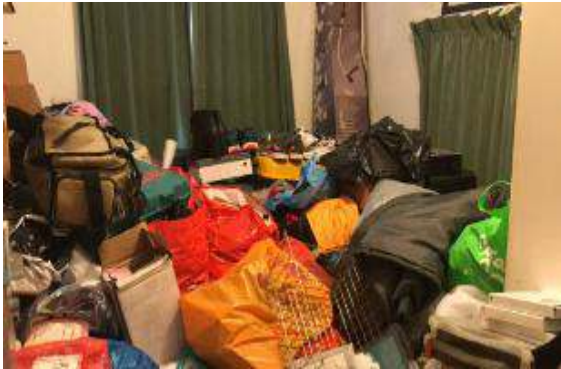
- No evidence of structural damage noted. Due to the tenant's stored items, clear access and inspection was not achievable.

First Floor Rear Bedroom over Outrigger and above Kitchen. Poor access due to Tenants stored items.
