# Site Investigation Report

138280.1.USI

| <b>Brief</b> | Auger were commissioned by Crawford & Co to undertake a site investigation and CCTV inspection of the underground drainage within the area of concern (AOC) at the property. |

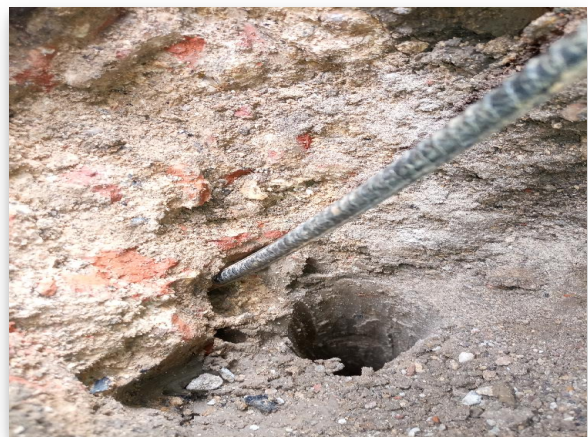
Fig 1.2: Trial Hole 1 Footing

Location: Rear right corner of rear projection

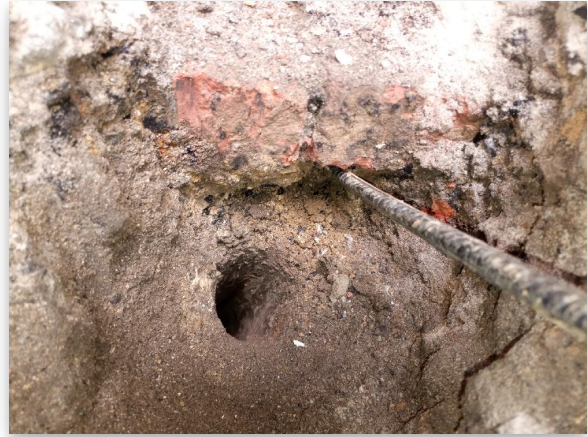
Fig 2.2: Trial Hole 2 Footing

Location: Rear right corner of main house

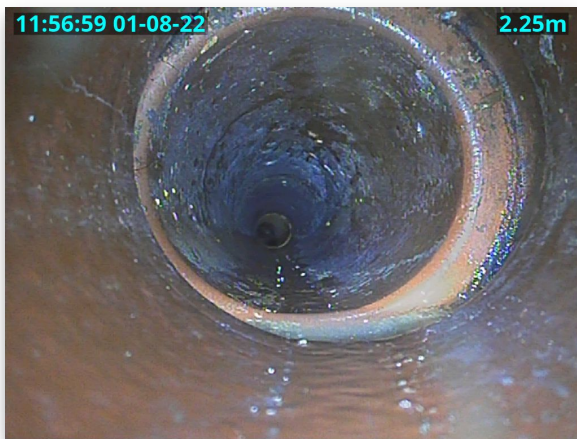
Fig 3.1: Line 1

| <b>Drain Survey</b> | <p>We carried out a CCTV survey of the below ground drainage system, our findings of which are as follows:</p> <p><b>Line 1 - From SVP downstream to MH1</b><br/>Our survey of line 1 revealed joint displacements (see fig 3.1)</p> <p><b>Line 2 - From MH2 upstream to the head of the line (disused)</b><br/>Our survey of line 2 revealed no significant defects to the pipework on this line which could be allowing an escape of water.</p> <p><b>Line 3 - From MH1 upstream to WG</b><br/>Our survey of line 3 revealed no significant defects to the pipework on this line which could be allowing an escape of water.</p> <p>The above mentioned defects to the below ground drainage system have been caused by ground movement.</p> |

| <b>Refer Back to Client</b> | <p>It is recommended that the following repairs are carried out to prevent an escape of water from the system:</p> <p><b>Line 1</b><br/>Excavate and replace the SVP restbend and 1m of 100mm pipework directly downstream at a depth no greater than 1.0m through concrete. Then install 3m of 100mm liner directly downstream of the excavation.</p> <p>Our investigations revealed potential defects within drainage lines that we understand to be LWA assets. These defects could be leading to an escape of water into the surrounding ground. If the Loss Adjuster/Engineer is of the opinion that these defects are an influence in the cause of subsidence to the building structures, we recommend you inform the LWA of the problem and request that they (the LWA) inspect and repair their asset. We cannot undertake any further inspection or repair of LWA assets without the express approval of the LWA.</p> <p>We will now refer the claim back to the client in order to progress the claim.</p> |
