# Arboricultural Appraisal Report

## Subsidence Damage Investigation at:

2 Lansdowne Road  
London  
N17 9XE

| MWA REF: | SUB221221-11808 |

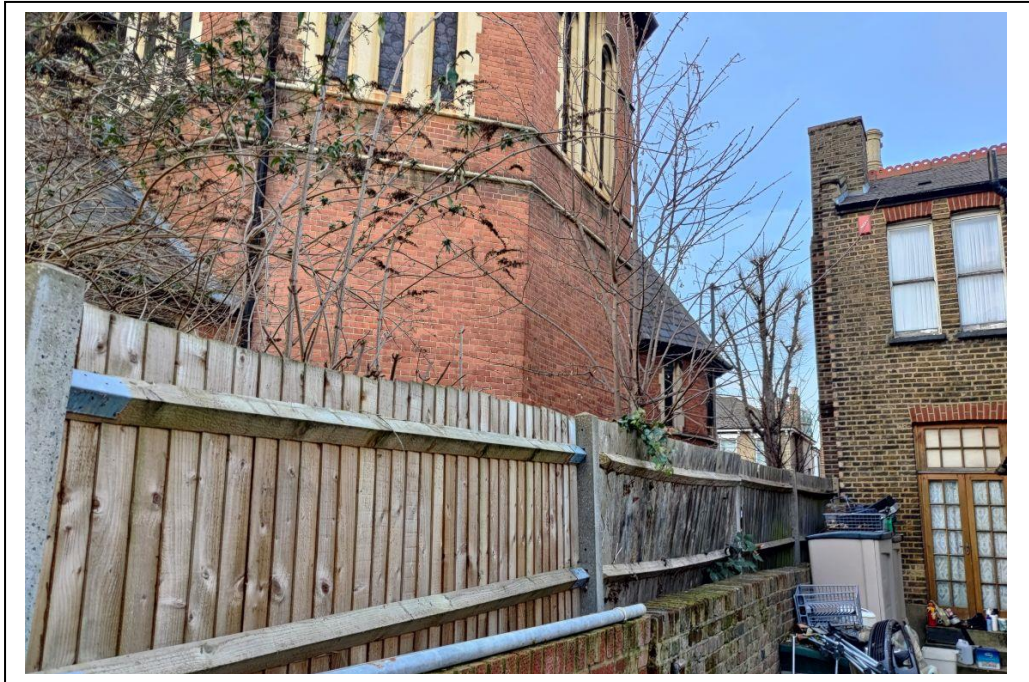
Roots were observed to a depth of 1.2m bgl in TP/BH2, and recovered samples have been positively identified (using anatomical analysis) as *Acer* spp.; the origin of which will be the nearby Sycamore stems of TG1 group.

| Tree No. | Species | Ht (m) | Dia (mm) | Crown Spread (m) | Dist. to building (m) | Age Classification | Ownership |
|---|---|---|---|---|---|---|---|
| TG1 | Group of Sycamore, Sycamore, Elder and Buddleia | 10.0 | 210 Ms * | 6.5 | 1.0 | Younger than Property | Third Party<br>St Marys Vicarage<br>N17 9XE |
| Management history | | Subject to past management/pruning - previously crown reduced. Likely lapsed self-sown. | | | | | |

View of TG1 group

If an arboricultural solution is to be implemented to mitigate the influence of the implicated trees/vegetation we recommend that TG1 group is removed. Other vegetation recorded presents a potential future risk to building stability and management is therefore recommended. Recommended tree works may however be subject to change upon receipt of additional information.

| Tree No. | Species | Ht (m) | Dia (mm) | Crown Spread (m) | Dist. to building (m) | Age Classification | Ownership |
|---|---|---|---|---|---|---|---|
| Recommendation | | Remove (fell) all to near ground level and treat stumps to inhibit regrowth. | | | | | |

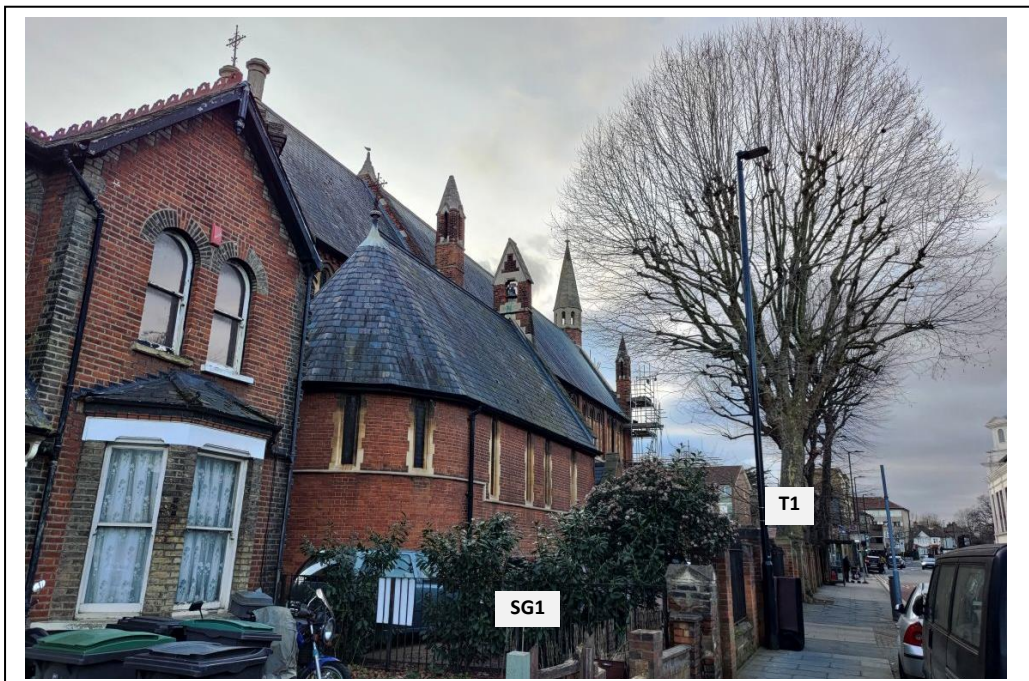
| Tree No. | Species | Ht (m) | Dia (mm) | Crown Spread (m) | Dist. to building (m) | Age Classification | Ownership |
|---|---|---|---|---|---|---|---|
| T1 | London Plane | 22.0 | 990 * | 17.5 | 18.0 * | Similar Age to Property | Third Party<br>St Marys Church<br>N17 9XE |
| Management history | | Subject to past management/pruning – previously heavily crown reduced/pollarded. | | | | | |
| SG1 | Laurel and Viburnum group | 2.5 | 50 Ms * | 2.5 | 1.1 | Younger than Property | Third Party<br>St Marys Church<br>N17 9XE |
| Management history | | No significant past management noted. | | | | | |

View of SG1 and T1 London Plane

| Tree No. | Species | Ht (m) | Dia (mm) | Crown Spread (m) | Dist. to building (m) | Age Classification | Ownership |
|---|---|---|---|---|---|---|---|
| Recommendation | | No works required at present – subject to review if movement persists. | | | | | |
| Recommendation | | Maintain broadly at no more than current dimensions by periodic pruning. | | | | | |
