# **Inspection of Decorative Wall Panelling and Wooden Sprung Floor to the Assembly Room at Hornsey Town Hall**

**Ardmore Construction Group Limited**

**Date:** 07/01/2020

**Document Reference:** TC 19432

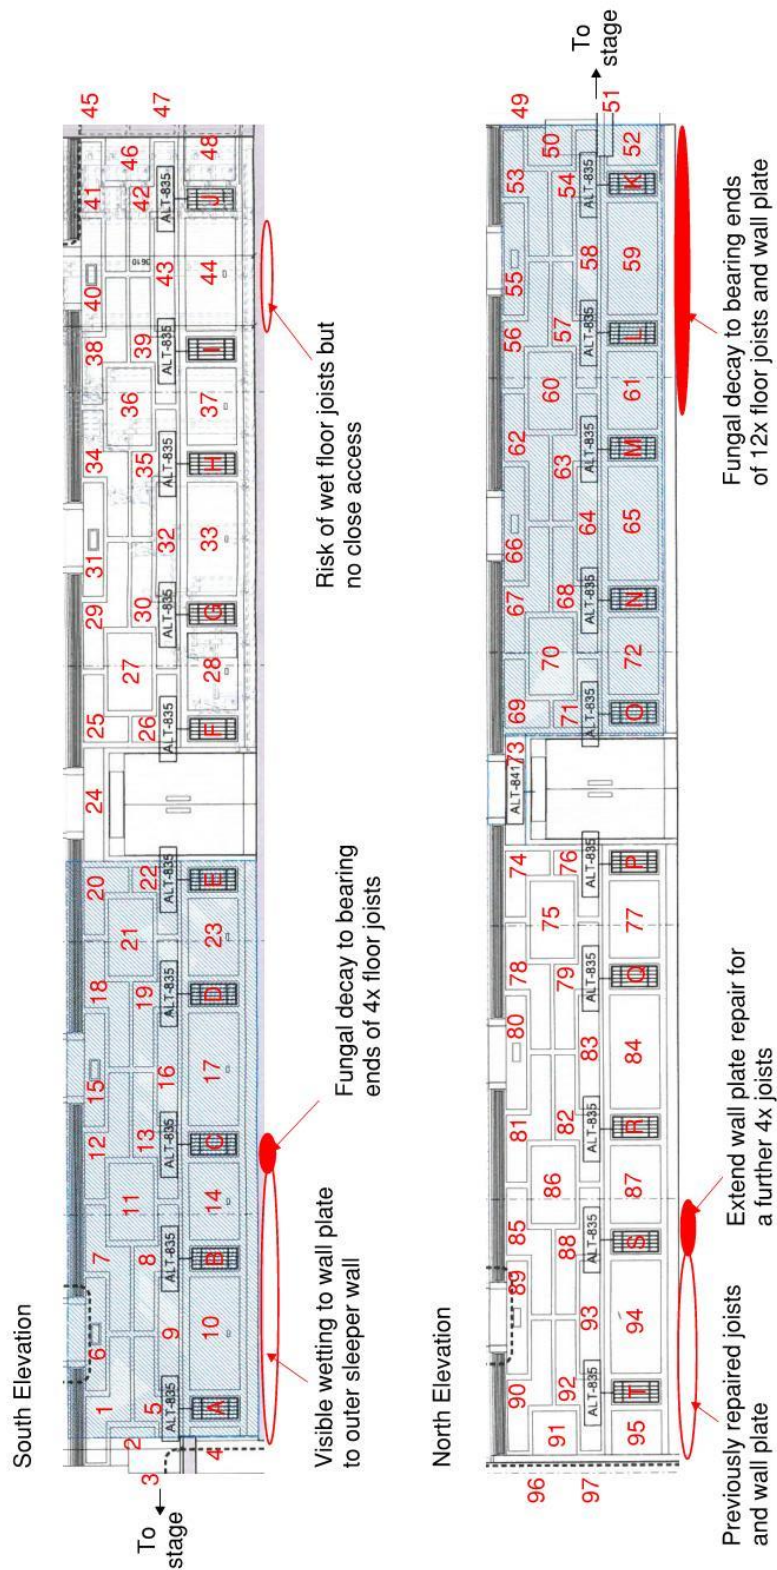
Fig 1. Assembly Room panel and ventilation grill references

The panels have been subjected to prolonged water ingress to the north and south elevations, resulting in deterioration ranging from minor damage to surface coatings, to panels being entirely decayed.

- A.** Fungal decay present in panelling and delamination of decorative face veneer and backing panels.
- B.** Delamination to the decorative face veneer and backing panel, but without fungal decay.
- C.** Delamination to the decorative face veneer and/or damage to the quadrant beading.
- D.** Water damage and/or de-bonding of the surface coating.
- E.** Generally good condition with only minor indentations or scratches.

**Table 1.** Summary of damage to decorative panels – South Elevation

**Table 2.** Summary of damage to decorative panels – North Elevation

There was fungal decay to the south bearing ends of 4x floor joists adjacent to ventilation grill C. Where the joists were decayed the underlying wall plate of the south outer sleeper wall was also decayed. The decay extended for up to 1000mm from the south ends of the joists, but did not extend as far as wall plate on the south inner sleeper wall. Moisture content readings were above the fungal decay threshold for timber, indicating that the decay was active at the time of inspection.

There was visible evidence of on-going wetting and mould growth to the wall plate of the south outer sleeper wall, extending between the east end and the decayed joists adjacent to ventilation grill C.

Extensive remedial works are required ranging from complete replacement of panels and supports, to repair of minor scratches and indentations

BM TRADA recommends that decayed timbers are cut back to sound wood and repaired in accordance with instruction by a structural engineer. Ensure that all timbers have a moisture content no greater than 20% before closing-up.
