# ARBORICULTURAL ASSESSMENT REPORT

35 Upper Tollington Park, London, N4 3EJ

PRI Ref: 251797

Survey Date: 03/02/2023

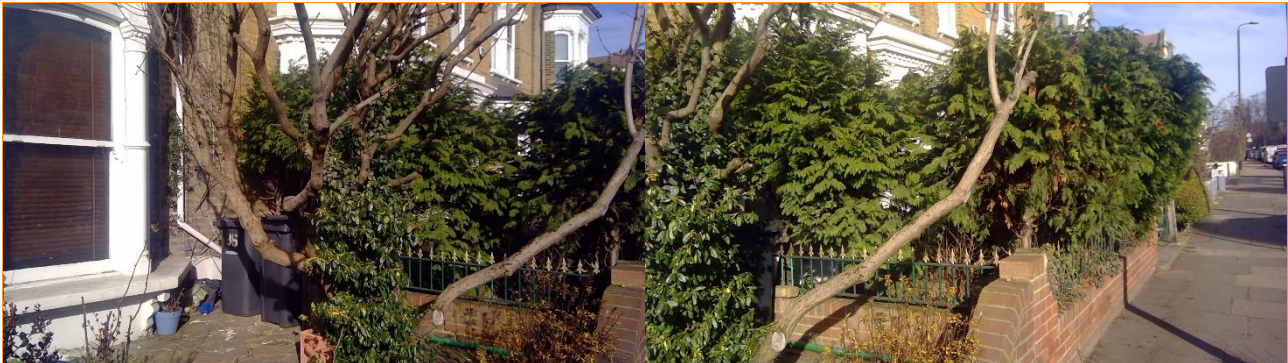
T1 - Lilac

| Tree No | Common Name | Age Class | Condition | Height (m) | Crown Spread (m) | Stem diam. (mm) | Dist to bldg. (m) | Roots Implicated | Pruning history | Recommendation | Tree work constraints | Notes | Owner address | Owner |
|---|---|---|---|---|---|---|---|---|---|---|---|---|---|---|
| T1 | Lilac | Mature | Good | 4 | 4 | 125 | 1.7 | N | Subject to past reduction management (within last year). | Fell and treat stump with eco plugs (broadleaved). | Parking restrictions. | | 35 Upper Tollington Park London N4 3EJ | PH |

| Tree No: | Species | Works Required |
|---|---|---|
| T1 | Lilac | Fell and treat stump with eco plugs (broadleaved). |

| Tree No | Common Name | Age Class | Condition | Height (m) | Crown Spread (m) | Stem diam. (mm) | Dist to bldg. (m) | Roots Implicated | Pruning history | Recommendation | Tree work constraints | Notes | Owner address | Owner |
|---|---|---|---|---|---|---|---|---|---|---|---|---|---|---|
| H1 | Cypress (Leyland castlewellan) | Early Mature | Good | 2 | 1.0 | 86 | 2.3 | N | Subject to past reduction management (within last 1/2/3years). | No work required. | | | 37 Upper Tollington Park London N4 3EJ | P3P |

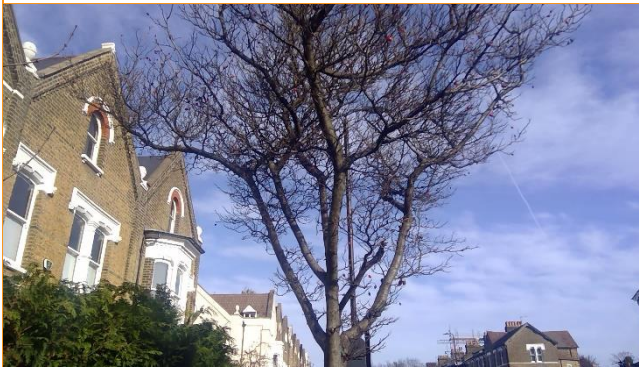
T2 - Apple (Crab)

| Tree No | Common Name | Age Class | Condition | Height (m) | Crown Spread (m) | Stem diam. (mm) | Dist to bldg. (m) | Roots Implicated | Pruning history | Recommendation | Tree work constraints | Notes | Owner address | Owner |
|---|---|---|---|---|---|---|---|---|---|---|---|---|---|---|
| T2 | Apple (Crab) | Early Mature | Fair | 3 | 2 | 150 | 5.9 | N | No significant past tree works. | No work required. | | | London Borough of Haringey | LA |
