# Arboricultural Consultancy for Aviva

| Insured | Mr and Mrs Richard and Maria Corrigan | Address | 2 Elms Avenue, Muswell Hill, London, N10 2JP | | |
| Report Date | 23/08/2021 <b>Revised:</b> 13/07/2022 | | | | |

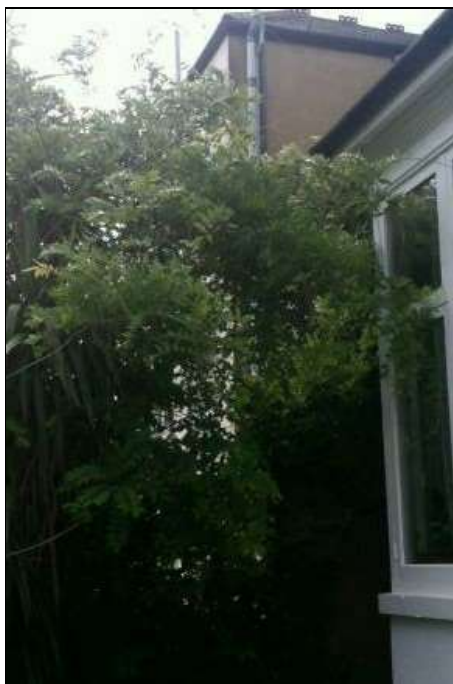
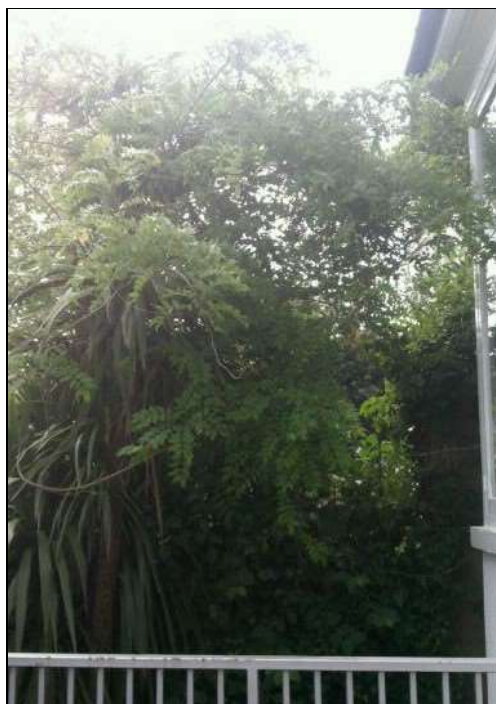
C1 - Wisteria

However, whilst not positively implicated by root analysis, the Wisteria (C1) cannot be discounted as contributing to the overall level of soil drying proximate to the area of damage and is therefore also considered to retain a contributory influence, albeit in a localised capacity to the rear bay window only.

The size and proximity of the above vegetation is consistent with the location of damage; it is our opinion on balance of probability that roots from C1 will also be in proximity to the footings of the insured property.

| Tree No. | Species | Age Cat | Approx. Height (m) | Distance to Building (m) * | Ownership | Action | Requirement |
|---|---|---|---|---|---|---|---|
| C1 | Wisteria | 1 | 4.4 | 2 | A - Third Party | Remove | Remove close to ground level and treat stump to inhibit regrowth. |

Consequently, complete removal of C1 & T5 will offer the most certain arboricultural solution likely to restore long-term stability.

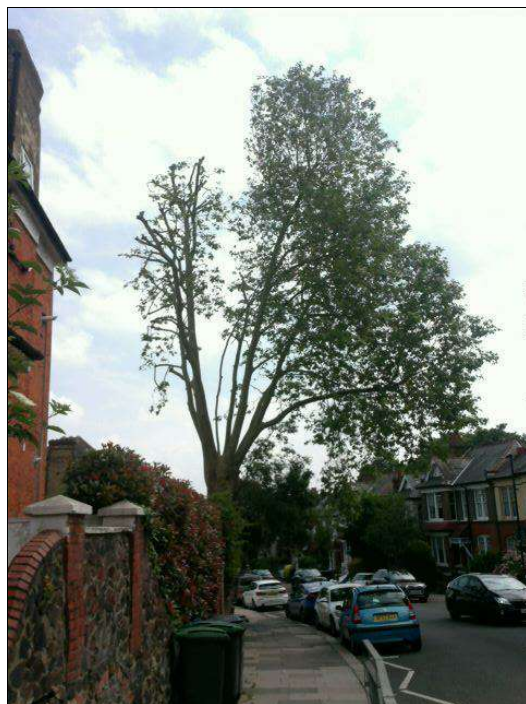
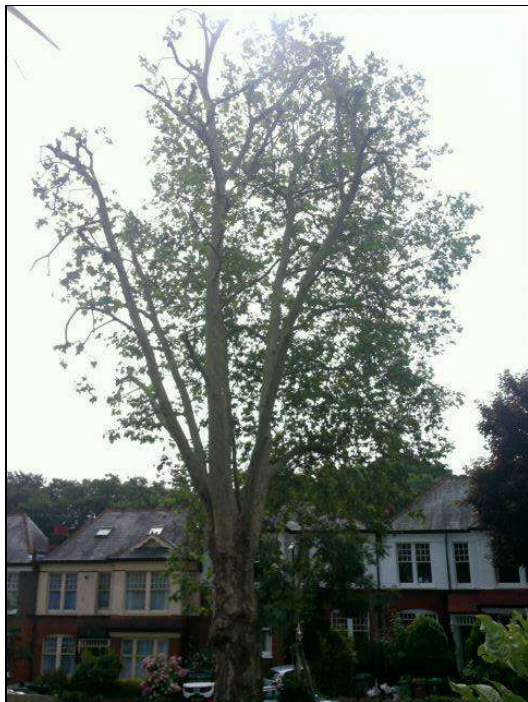
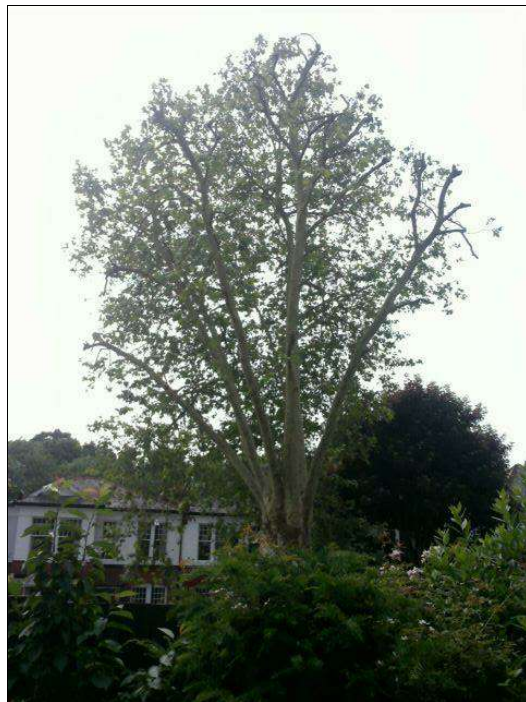
T5 - Plane (London)

Roots have also been recovered below the property (TP/BH1 & TP/BH2); samples of these roots were recovered from underside of foundations and throughout the borehole, these roots were identified (using anatomical analysis) as having emanated from the genus *Platanus* spp. (Plane)

Our survey of the site identified the London Plane (T5), given its position relative to the damage it is our opinion that the roots identified will emanate from this vegetation and accordingly we have identified it as the principal cause of the subsidence damage.

| Tree No. | Species | Age Cat | Approx. Height (m) | Distance to Building (m) * | Ownership | Action | Requirement |
|---|---|---|---|---|---|---|---|
| T5 | Plane (London) | 1 | 18 | 16 | A - Third Party | Remove | Remove close to ground level and treat stump to inhibit regrowth. |

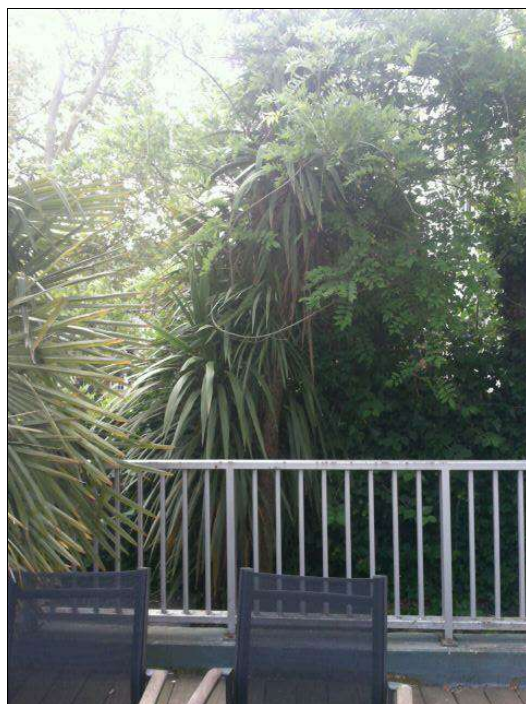
T1 - Palm

| Tree No. | Species | Age Cat | Approx. Height (m) | Distance to Building (m) * | Ownership | Action | Requirement |
|---|---|---|---|---|---|---|---|
| T1 | Palm | 1 | 4.4 | 2.6 | C - Insured | No action | No works. |

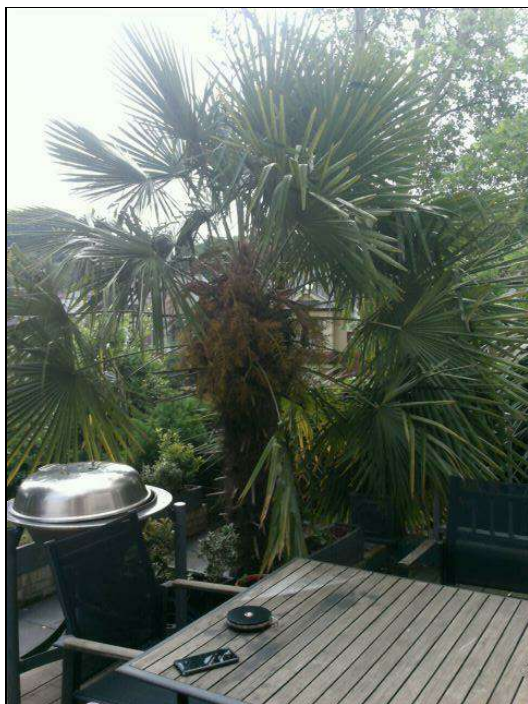
T2 - Palm

| Tree No. | Species | Age Cat | Approx. Height (m) | Distance to Building (m) * | Ownership | Action | Requirement |
|---|---|---|---|---|---|---|---|
| T2 | Palm | 1 | 3 | 5 | C - Insured | No action | No works. |

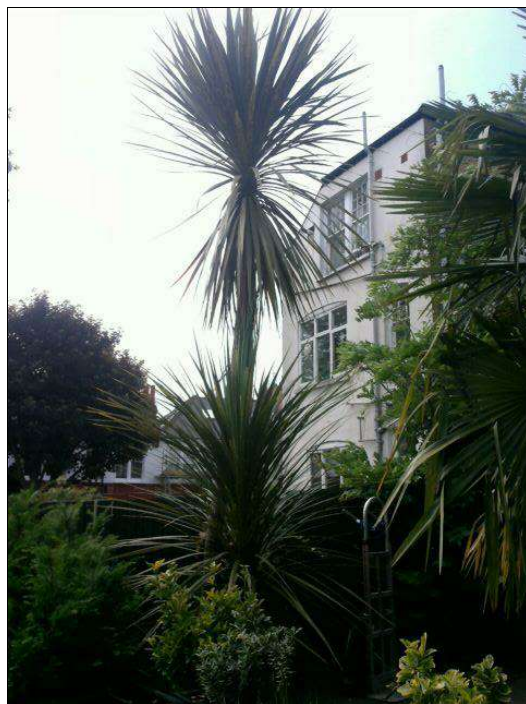
T3 - Palm

| Tree No. | Species | Age Cat | Approx. Height (m) | Distance to Building (m) * | Ownership | Action | Requirement |
|---|---|---|---|---|---|---|---|
| T3 | Palm | 1 | 4 | 5.4 | C - Insured | No action | No works. |

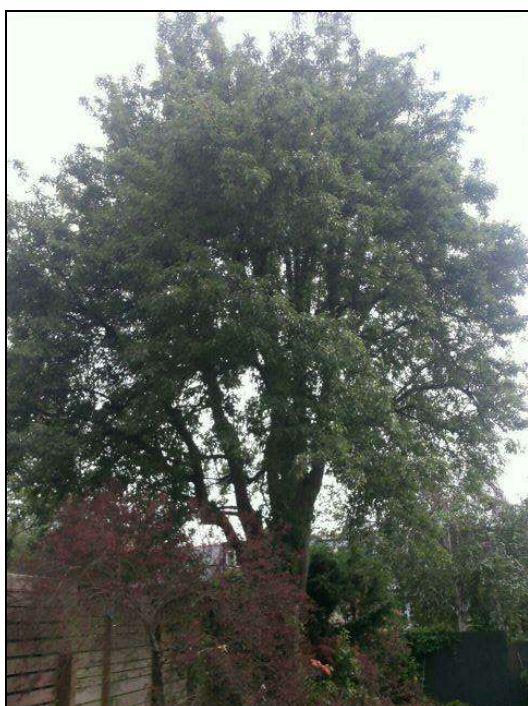
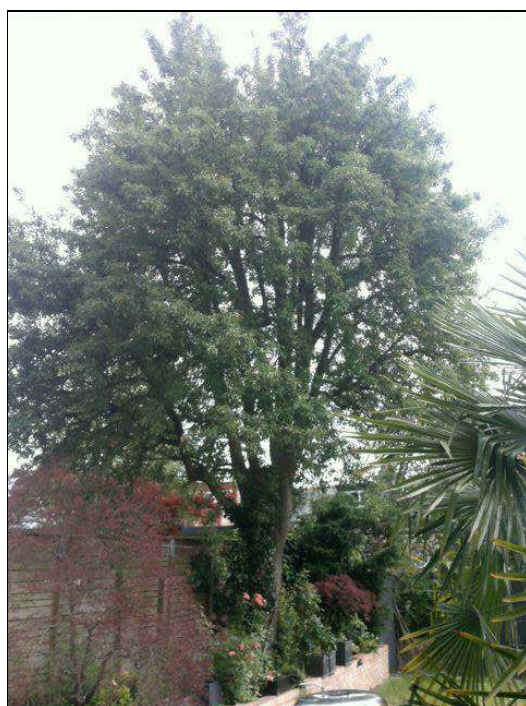
T4 - Pear

| Tree No. | Species | Age Cat | Approx. Height (m) | Distance to Building (m) * | Ownership | Action | Requirement |
|---|---|---|---|---|---|---|---|
| T4 | Pear | 1 | 13.5 | 12.3 | C - Insured | Action to avoid future risk | Maintain at broadly current dimensions by way of regular pruning |
