# Arboricultural Appraisal Report

## Subsidence Damage Investigation at:

36 Grand Avenue  
Muswell Hill  
London  
N10 3BP

| MWA REF: | SUB221215-11722 |

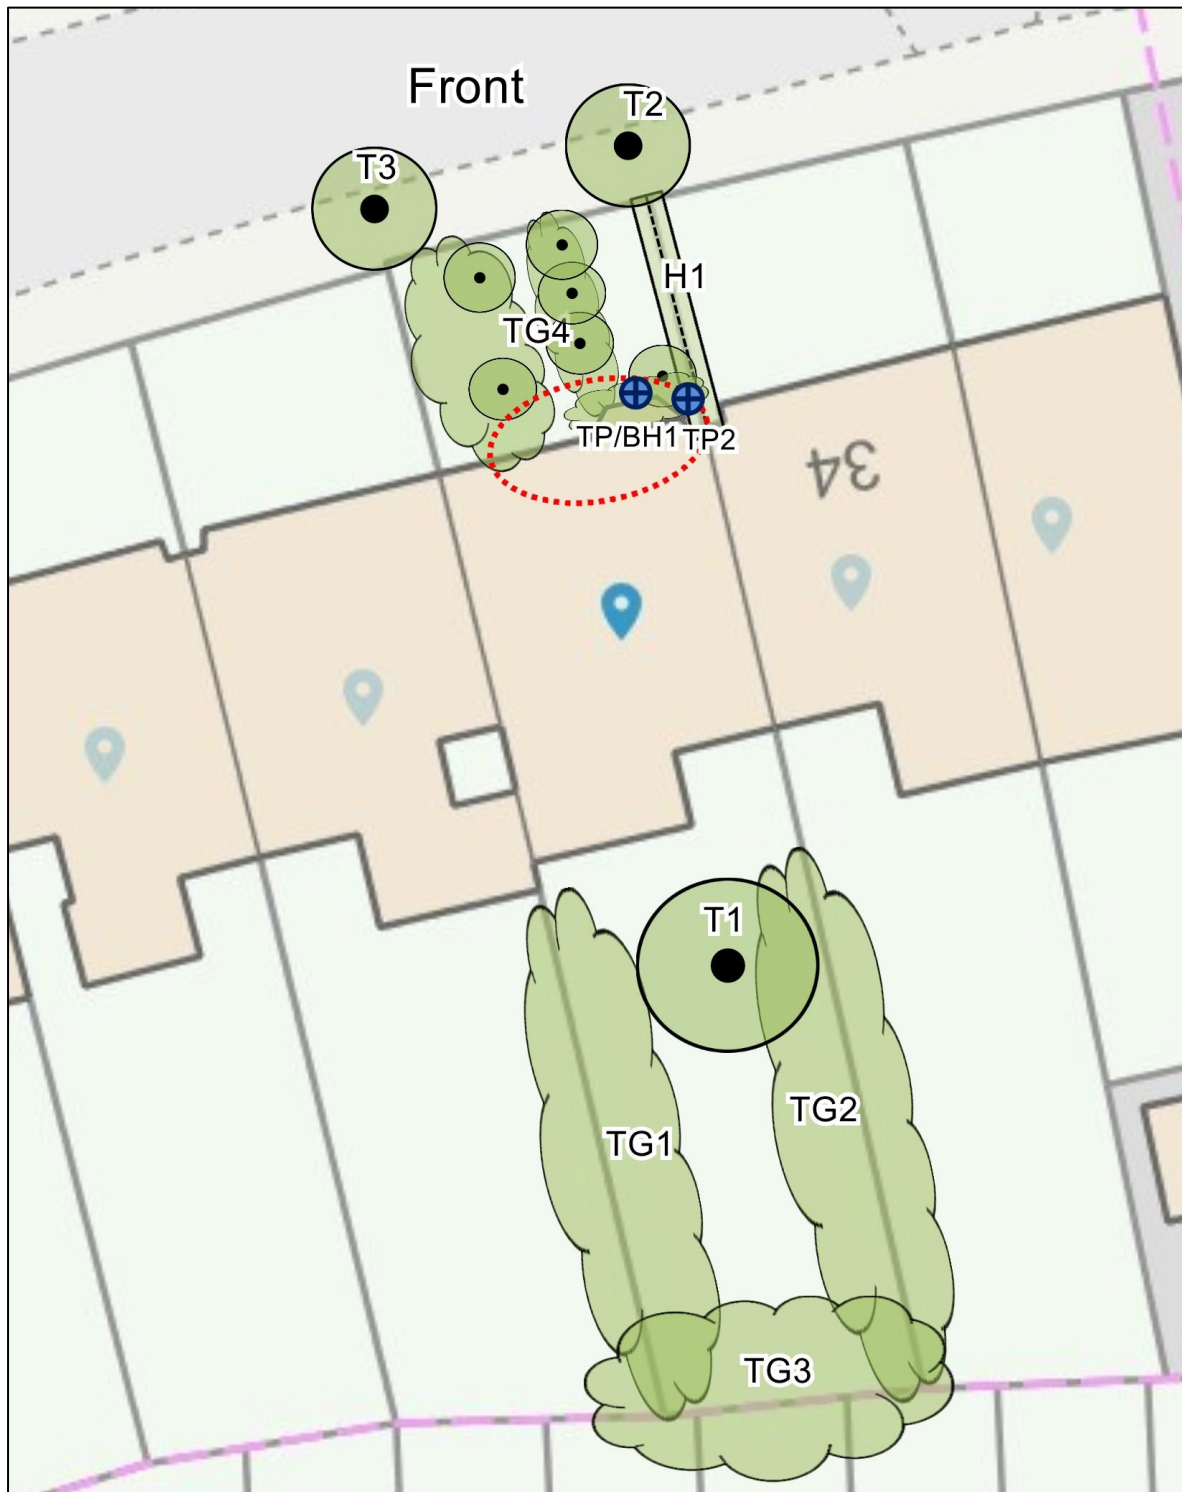
## Site Plan

Approximate areas of damage

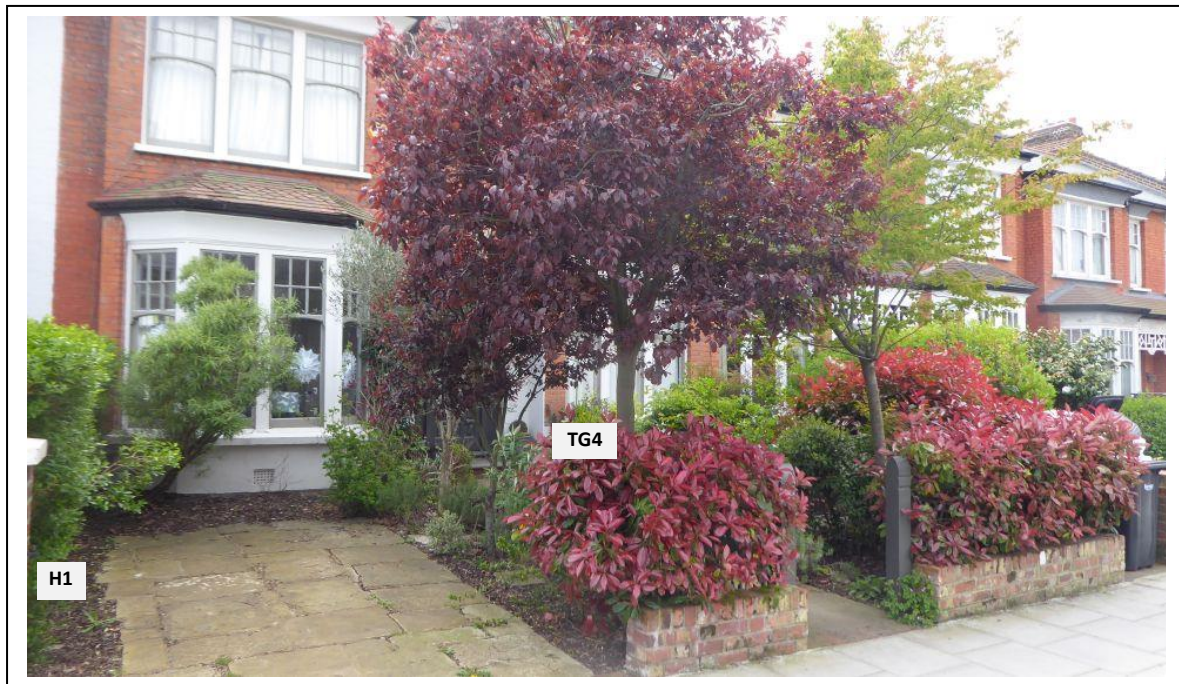
Irrespective of the identification of recovered root samples, the roots of the H1 Privet hedge and multiple other of the larger elements of TG4 group of trees and shrubs within the property front garden may also be present below foundation level in proximity to the area of movement/damage and contributing to the influence of soil moisture and volumes.

| Tree No. | Species | Ht (m) | Dia (mm) | Crown Spread (m) | Dist. to building (m) | Age Classification | Ownership |
|---|---|---|---|---|---|---|---|
| TG4 | Mixed spp. group of mostly Bottlebrush, Olive, Purple Leaved Plum, Amelanchier and Cherry with understorey shrubs of mostly Lavender, Jasmine, Rose, Forsythia, Current, Photinia, Hydrangea and Viburnum | 5.0 | 130 | 4.0 | 0.2 | Younger than Property | Policy Holder |

View of TG4 group in property front garden with H1 Privet hedge to left of frame

| Tree No. | Species | Ht (m) | Dia (mm) | Crown Spread (m) | Dist. to building (m) | Age Classification | Ownership |
|---|---|---|---|---|---|---|---|
| Recommendation | | Remove (fell) all woody shrubs within 1.5m of the bay window to near ground level and treat stumps to inhibit regrowth.<br>Remove (fell) tree elements [Bottlebrush, Olive, Purple Leaved Plum, Amelanchier and Cherry] to near ground level and treat stumps to inhibit regrowth.<br>Prune remaining woody shrubs back to individual form no larger than 1.0m high by 0.5m spread and re-prune annually thereafter to maintain at reduced dimensions. | | | | | |
| Recommendation | | Reduce height to 1.5m and trim back sides to leave hedge no thicker than 0.5m. Trim thereafter on an annual cycle to maintain at broadly reduced dimensions. | | | | | |

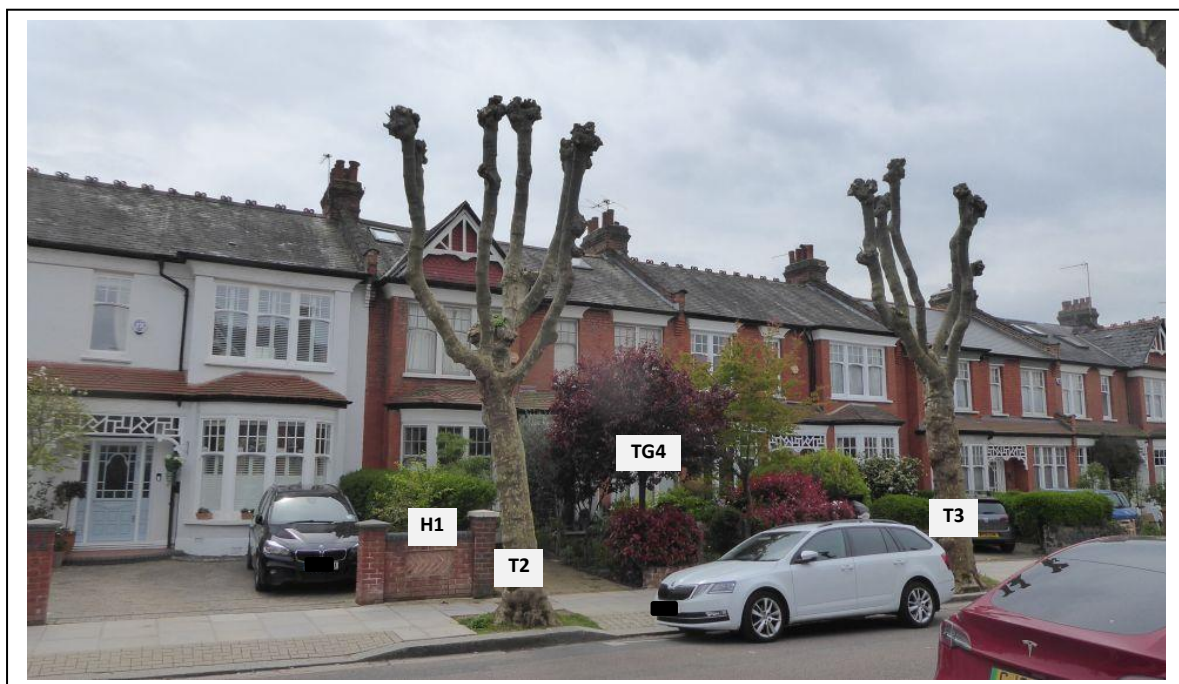
Roots were observed to a depth of 1.6m bgl in TP/BH1, and recovered samples have been positively identified (using anatomical analysis) as *Platanus* spp. and *Prunus* spp.; the origins of which will be T2 and T3 London Planes – both of which are within influencing distance of the property frontage – and the Cherry and/or Purple Leaved Plum elements of the TG4 group within the property front garden.

The London Planes T2 and T3 had been pollarded shortly prior to our survey, affectively reducing their soils moisture uptake until new growth emerges. At this stage no further works to T2 or T3 are considered necessary.

View of T2 and T3 London Planes with TG4 group and H1 Privet hedge beyond

| Tree No. | Species | Ht (m) | Dia (mm) | Crown Spread (m) | Dist. to building (m) | Age Classification | Ownership |
|---|---|---|---|---|---|---|---|
| Recommendation | | Pollard on biennial cycle. | | | | | |
