# Site Investigation Report

145370.1.USI

Auger were commissioned by Crawford & Co to undertake a site investigation and CCTV inspection of the underground drainage within the area of concern (AOC) at the property.

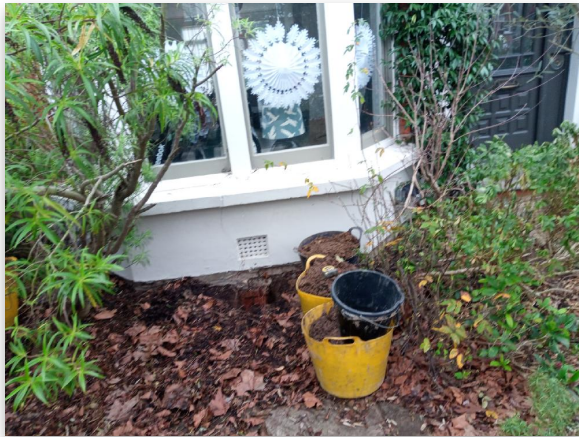
Fig 1.1: Trial Hole 1 Location

TH1 was moved to front of bay window because where the loss adjuster requested the TH, it wasn't possible to complete it there due to the open porch. This was In the way of exposing the main house footings there. We moved it to the front of the bay window. Within TH1 we revealed the footing and augered to the required depth (3m). We took soil and root samples. These measurements are shown in Trial Hole Log 1 below.

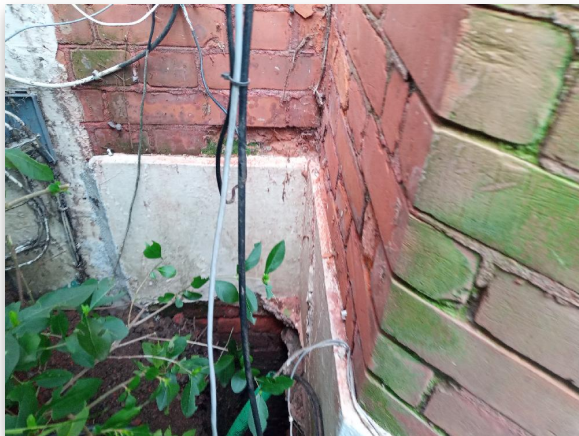
Fig 1.3: TH1b

TH2 was moved to front left hand side because where the loss adjuster requested the TH, it wasn't possible to complete it there due to the open porch. This was In the way of exposing the main house footings there. Within TH2 we revealed the footing and augered to the required depth (3m). These measurements are shown in Trial Hole Log 1b below.

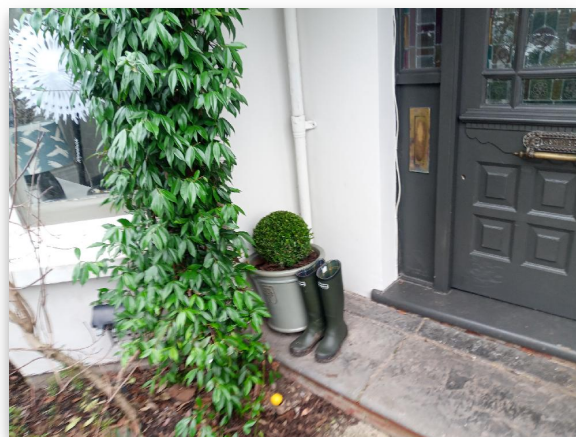
No CCTV survey of the underground drainage was undertaken whilst on site due to the RWP at the front of the property being the only drainage within the area of concern. This requires a break in through the porch step.

Fig 2.1: RWP requires below ground break in

Break through step carry out a below ground break in to further CCTV the RWP, Auger will attempt to reinstate the step however is the customer is not happy with the reinstatement. A specialist may be required to reinstate.

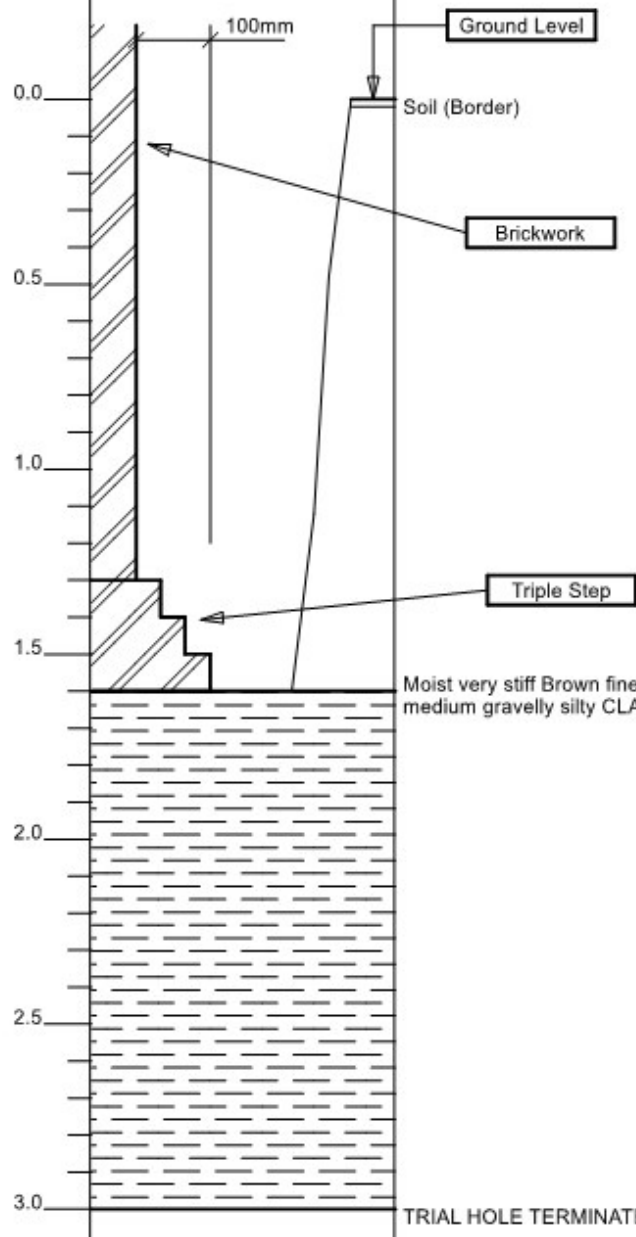
# Trial Hole Log No.1

Location: Front of bay window.

| Depth<br>(m) | Symbolic Log | Strata Description | Insitu Tests | | Soil<br>Sample | Root<br>Sample |
|---|---|---|---|--|---|---|
| | | Moist very stiff Brown fine to medium gravelly silty CLAY | 92kpa | | Soil @ 1.6m | Root @ 1.6m |
| 2.0 | | | 96kpa | | Soil @ 2.1m | |
| 2.5 | | | 98kpa | | Soil @ 2.6m | |
| 3.0 | | TRIAL HOLE TERMINATED | 98kpa | | | |
